U.S. Fire Administration/Technical Report Series

Apartment Building Fire East 50th Street New York City

USFA-TR-019/January 1988

This is Report 019 of the Major Fires Investigation Project conducted by TriData Corporation under contract EMW-86-C-2277 to the United States Fire Administration, Federal Emergency Management Agency.

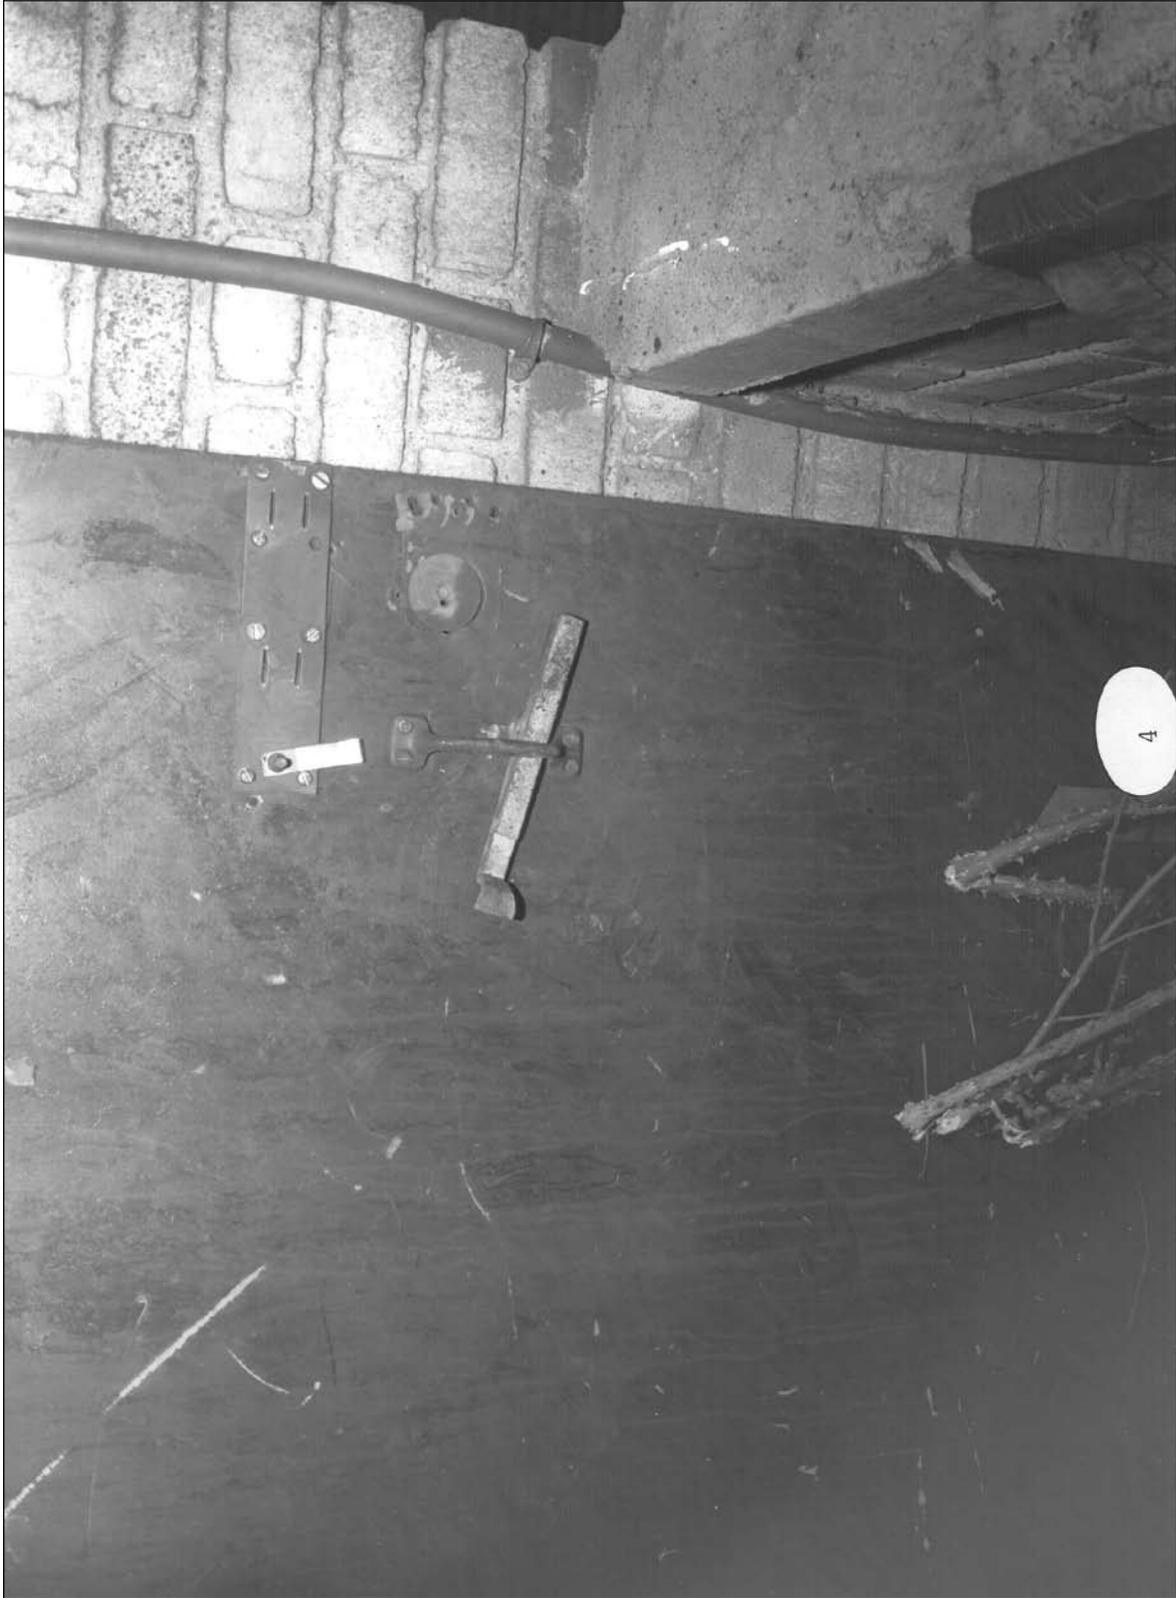
As noted earlier, the two stairwells each begin in the lobby and terminate on the tenth floor with entrances from the stairwells to the roof. The two doors leading to the roof were latched with slide bolts. Two tenants who attempted to escape through these doors were unable to unlatch them in the heavy smoke. Their bodies were found at the doors. Further complicating escape were inadequate lighting in the stairwells and the absence of illuminated exit lights in the halls.

4. Doorway to roof on west side of building. Note slide bolt broken off (2 bodies found at base of door).

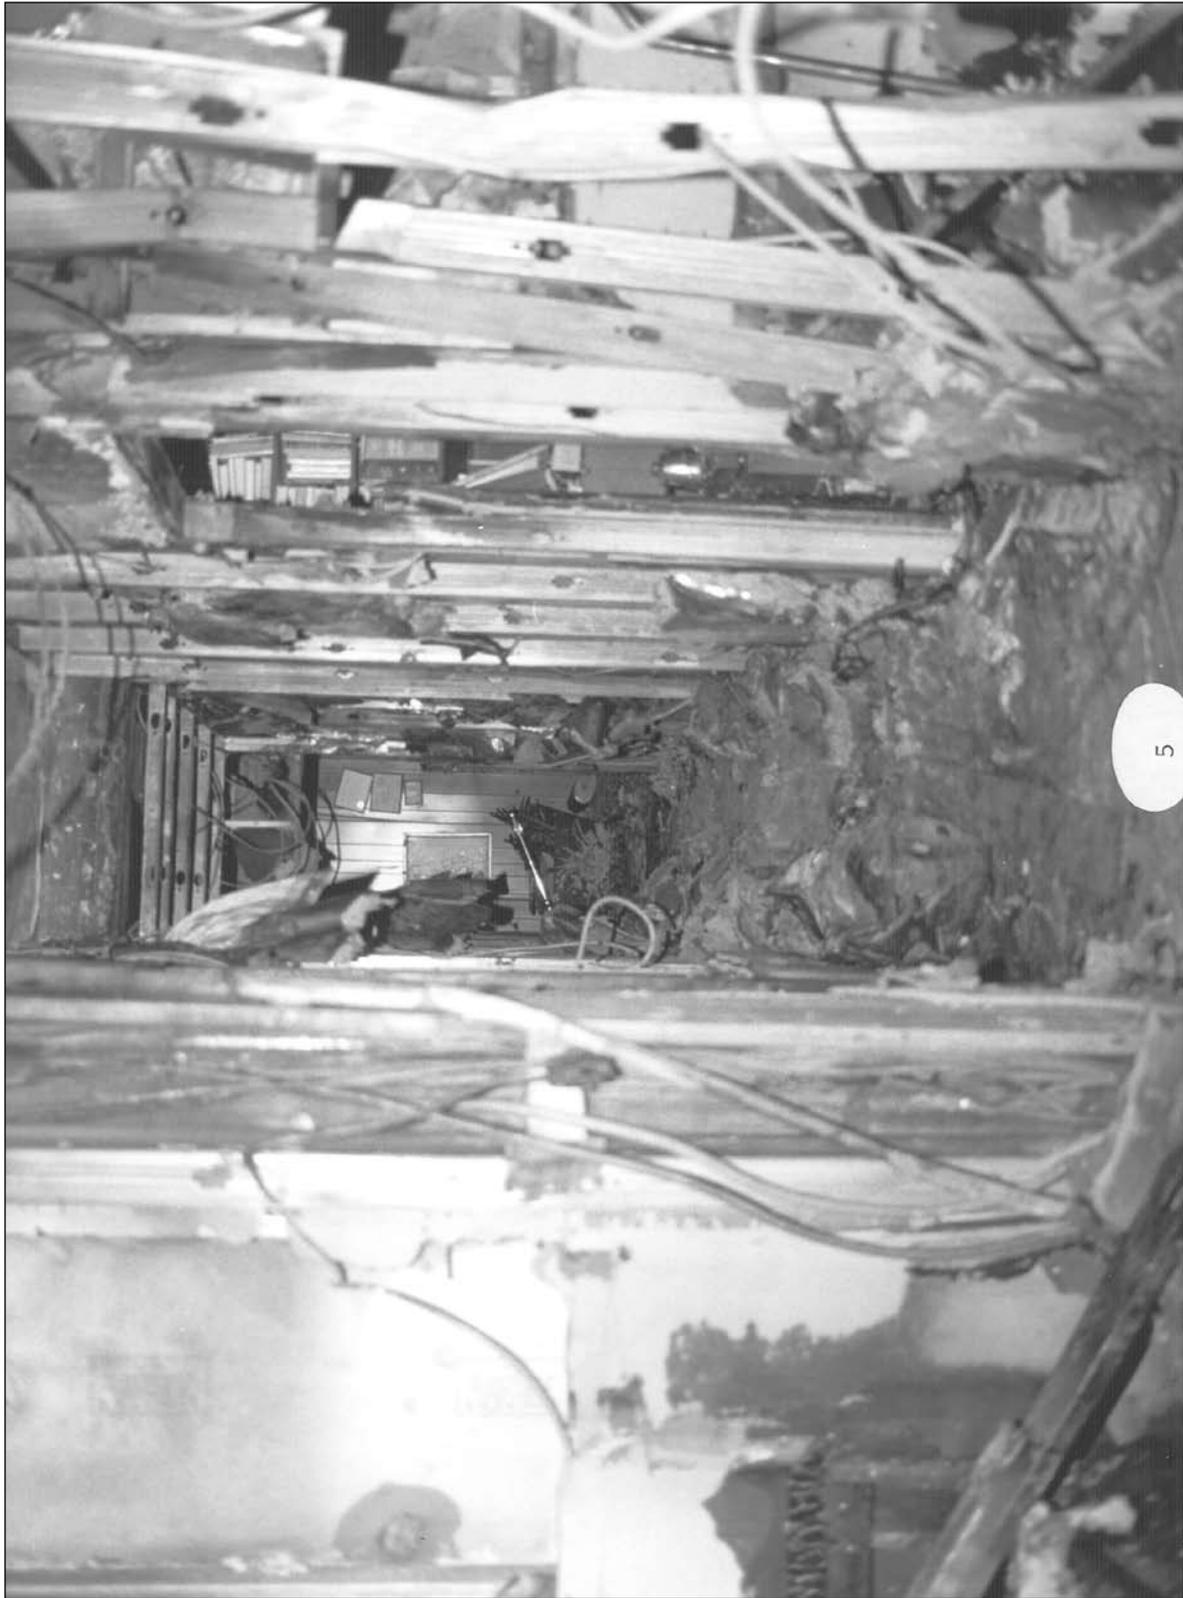
5. West corridor damage in office area.

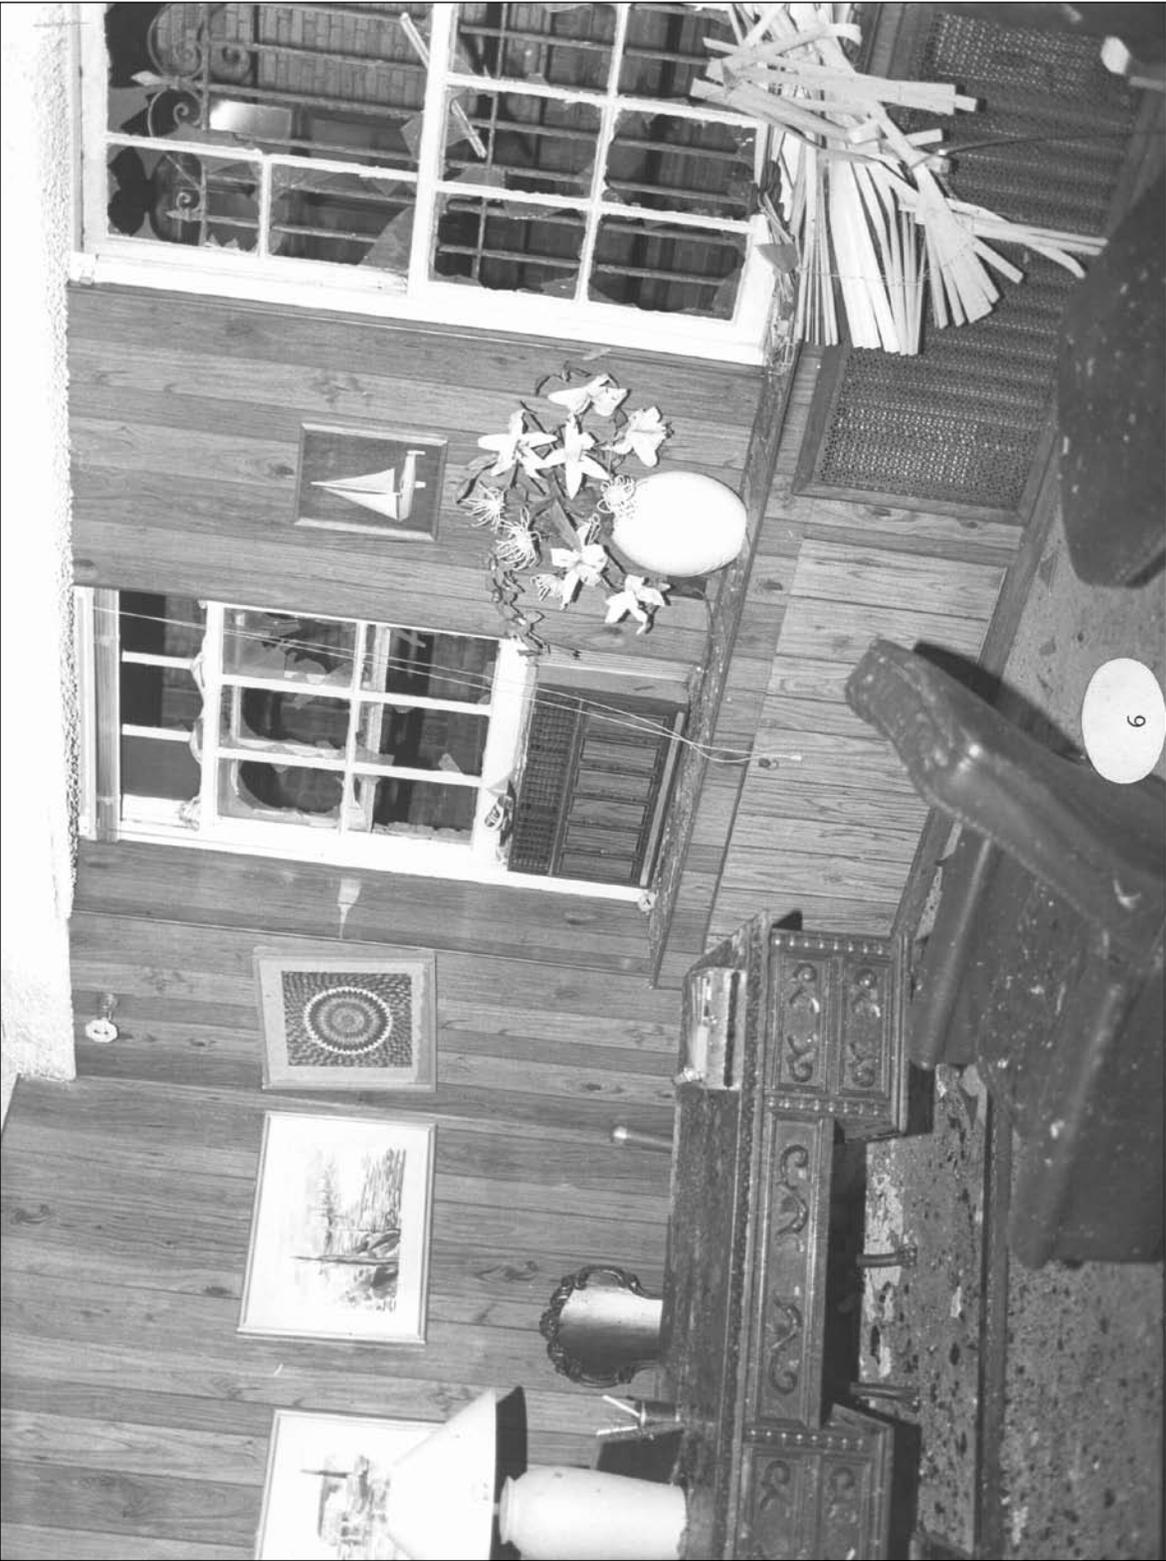
The wood paneling in the doctors' offices does not meet the current code; a sprinkler system would be required in the offices to be in compliance. However, the paneling was permitted as "decoration" over the old walls under the old code. Because the renovation did not exceed 20 percent of the cost of the building, the new code did not apply.

The wood paneling utilized throughout the office complex allowed the fire to spread quickly while generating tremendous heat and smoke. The spread of smoke was exacerbated by the open stairwell doors from the lobby area, which allowed rapid movement through the upper stories. Heat from the fire broke the glass, in the mail chute which goes from the lobby area to the tenth floor. This provided another avenue for the smoke to travel upward.

6. Office on first floor. Note pre-finished paneling on walls and bars on windows.

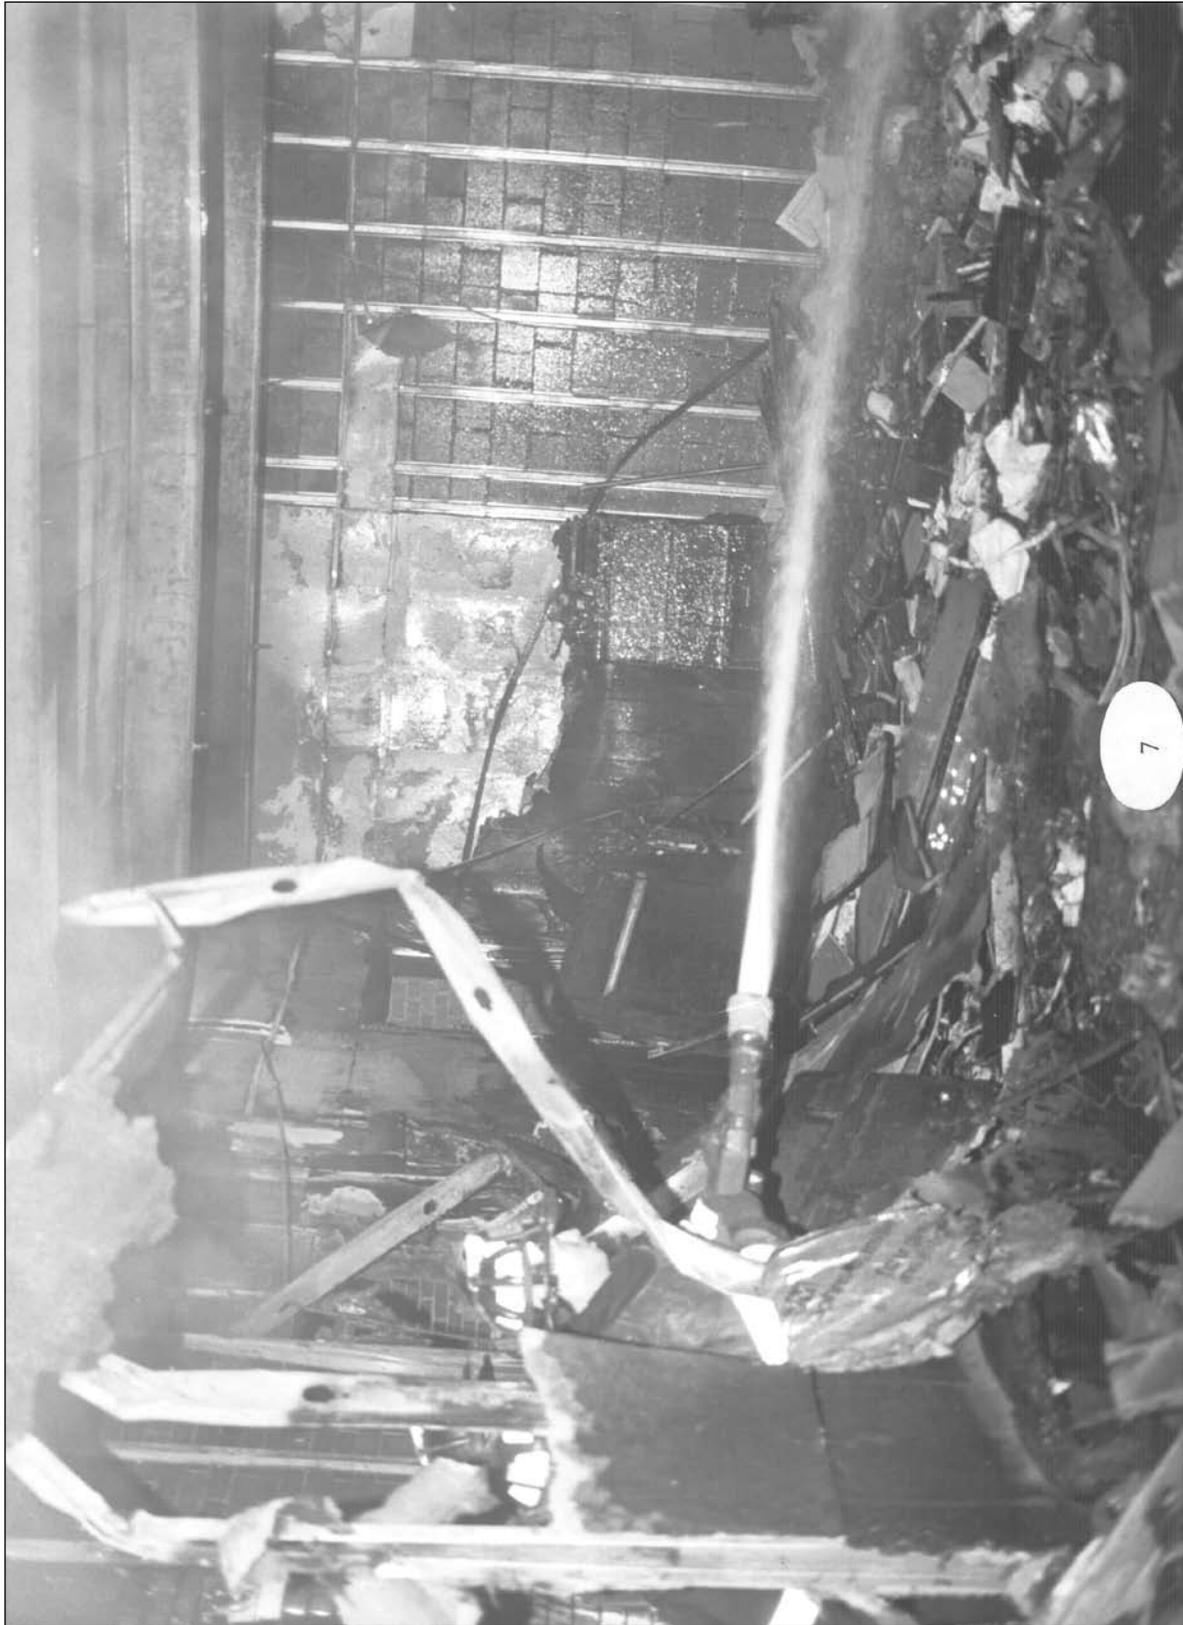
7. Fire damage to rear office unit.

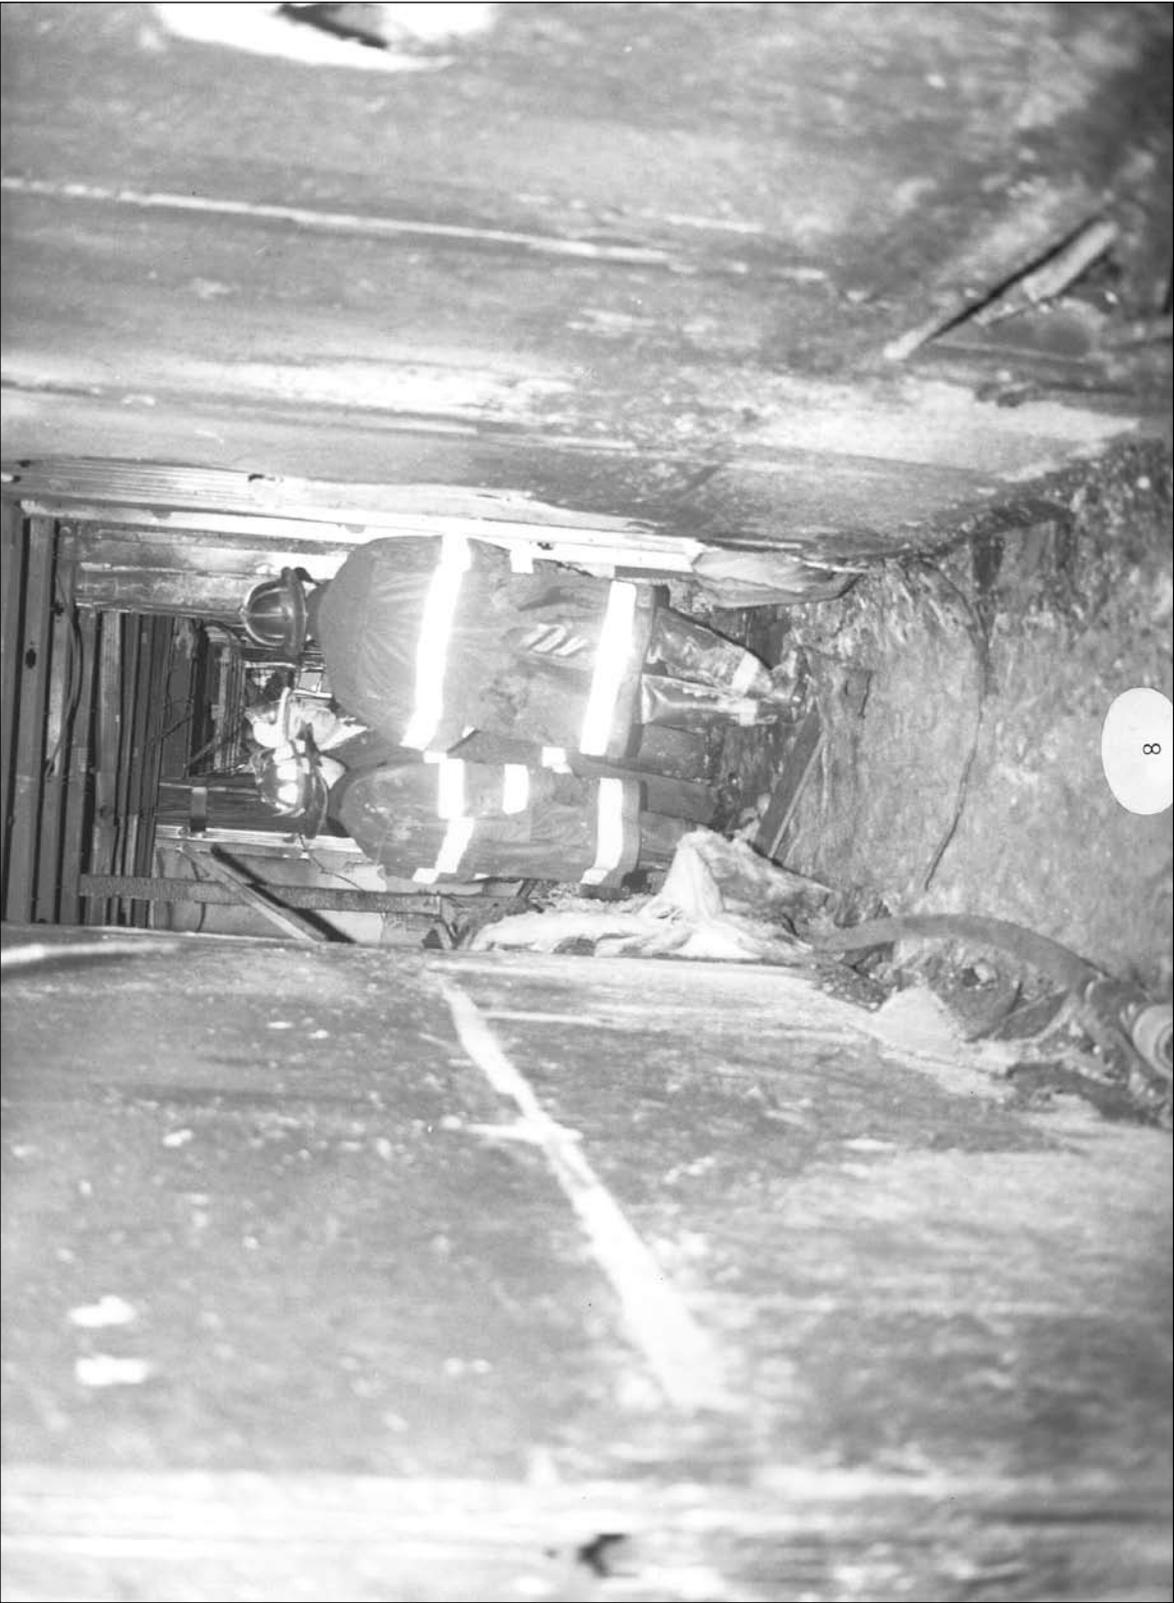
8. Fire damage to corridor in office area.

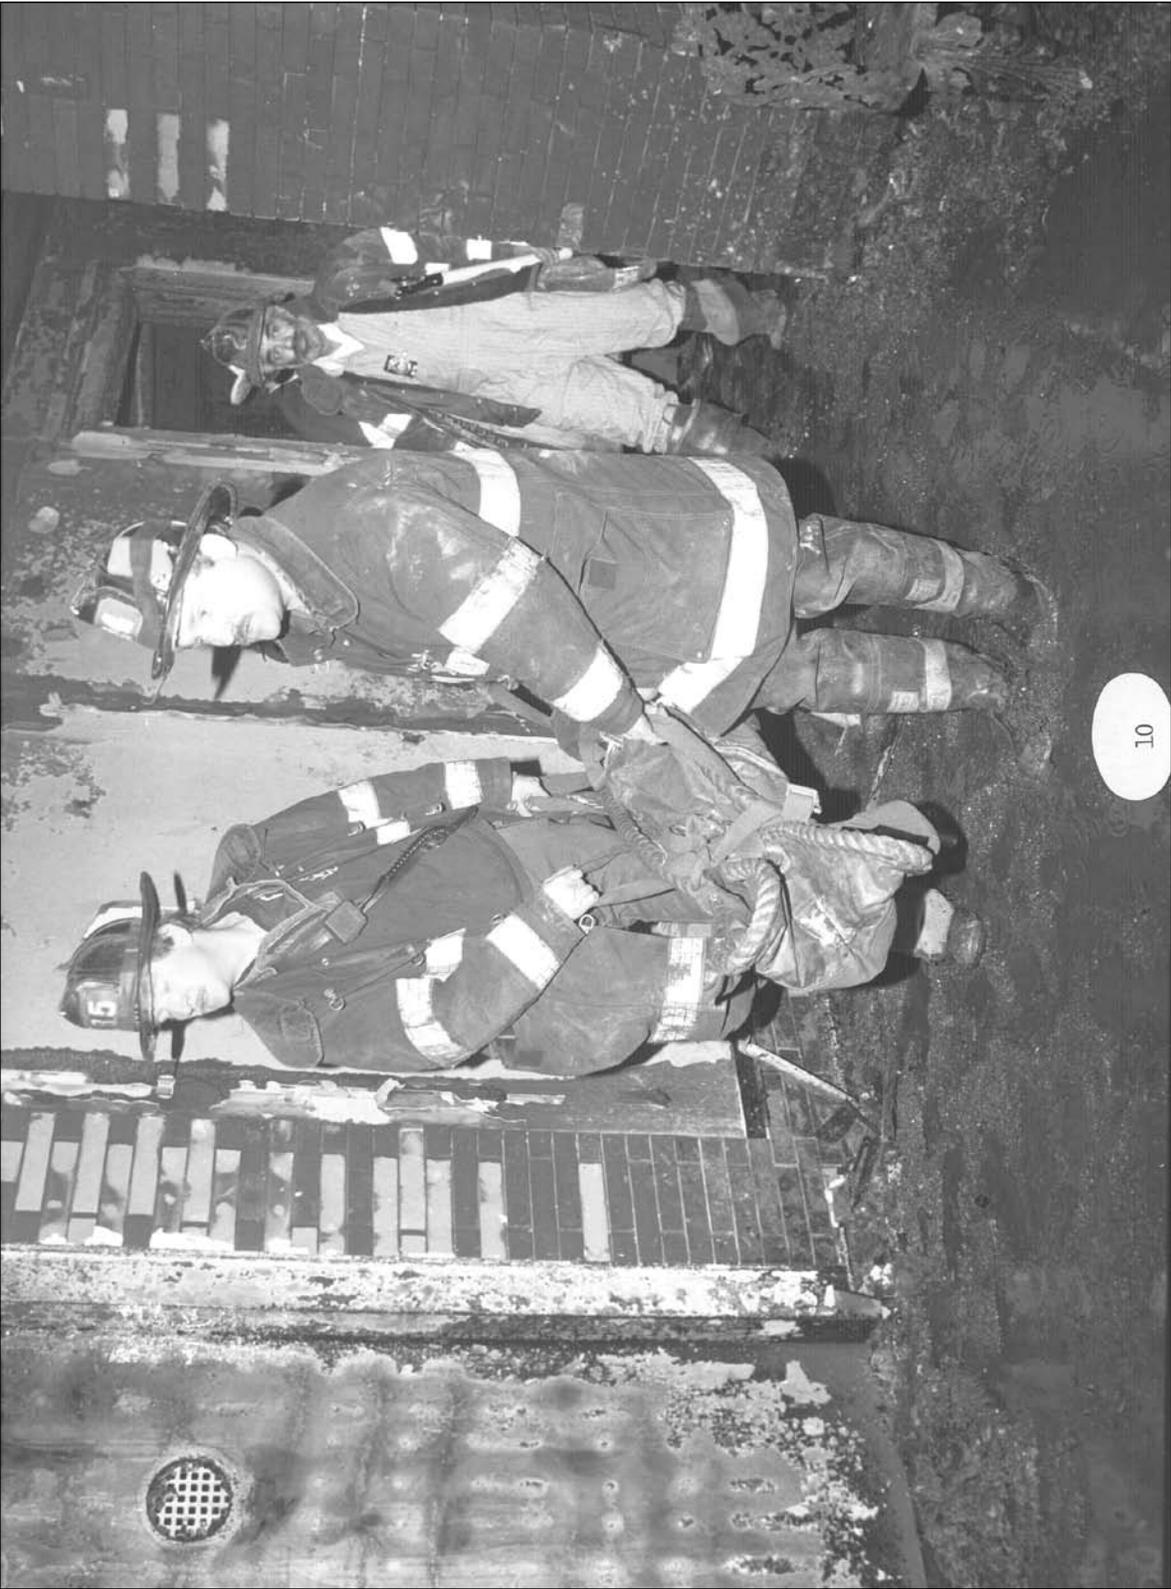
10. Fire damage to lobby area; note elevator door.

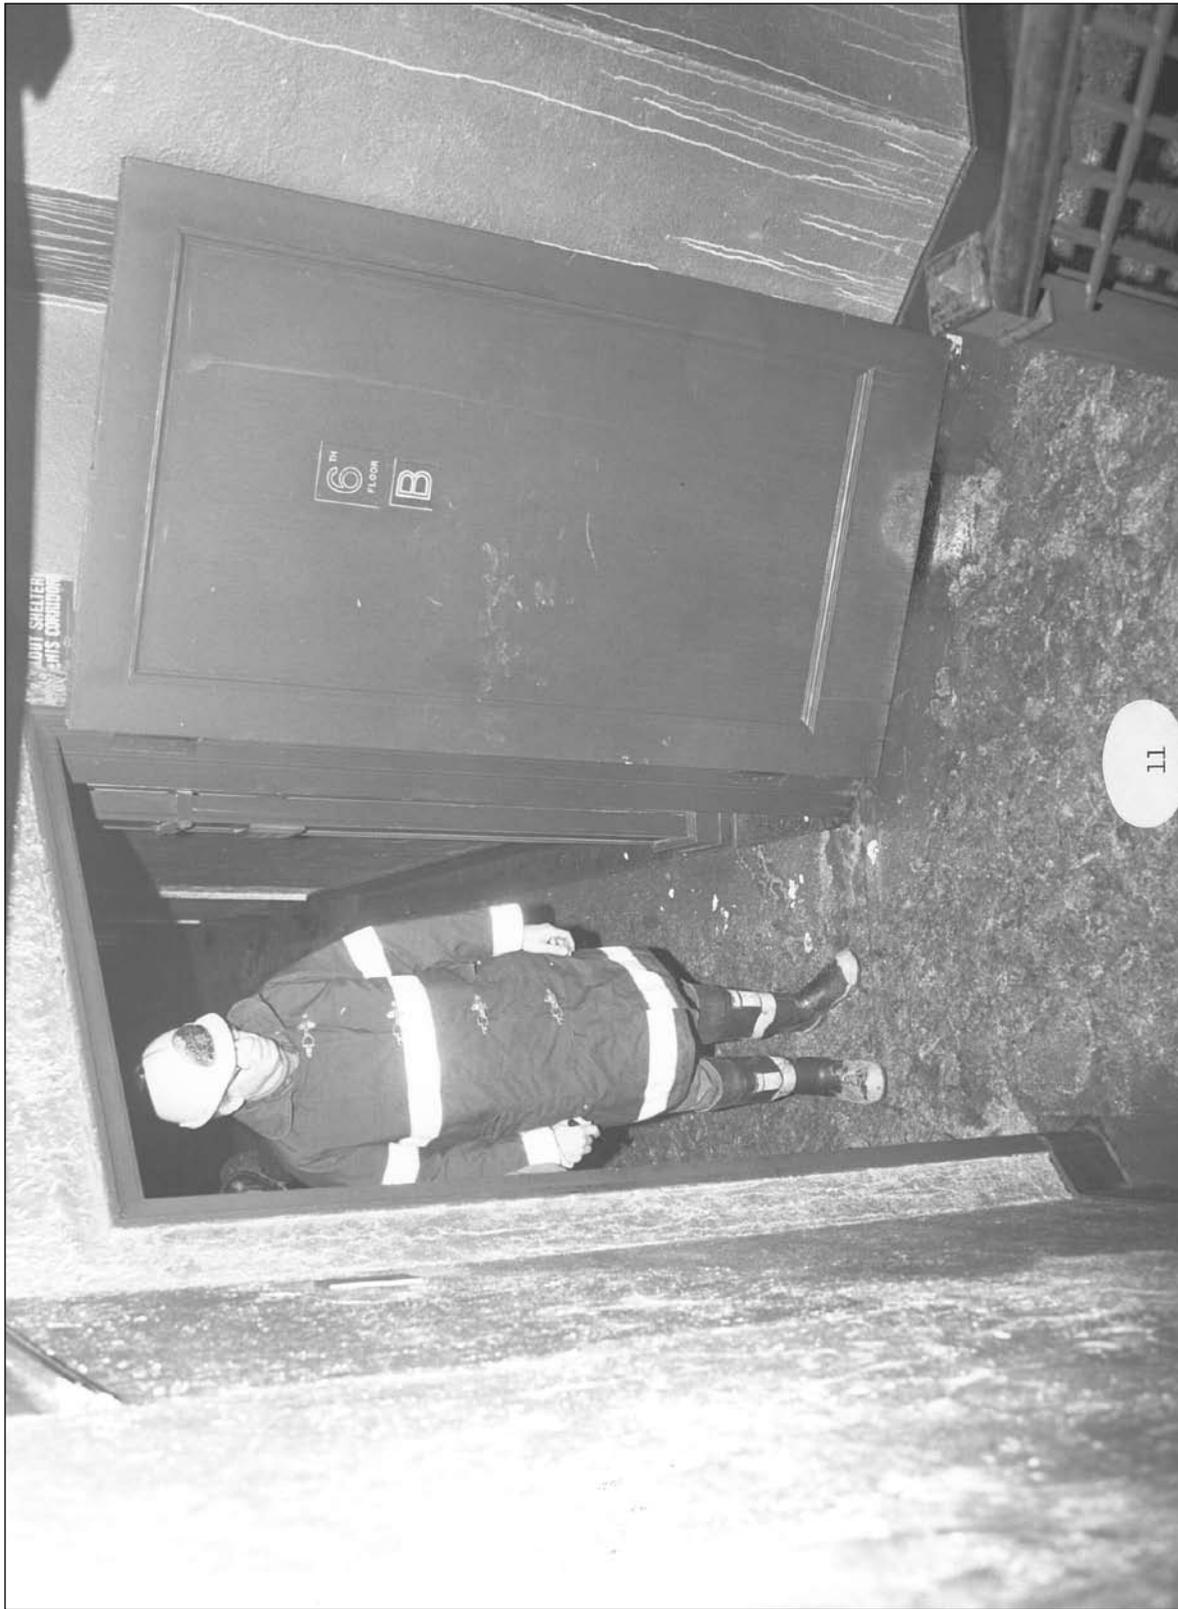
11. Entrance to floor from stairwell B; note heavy smoke damage.

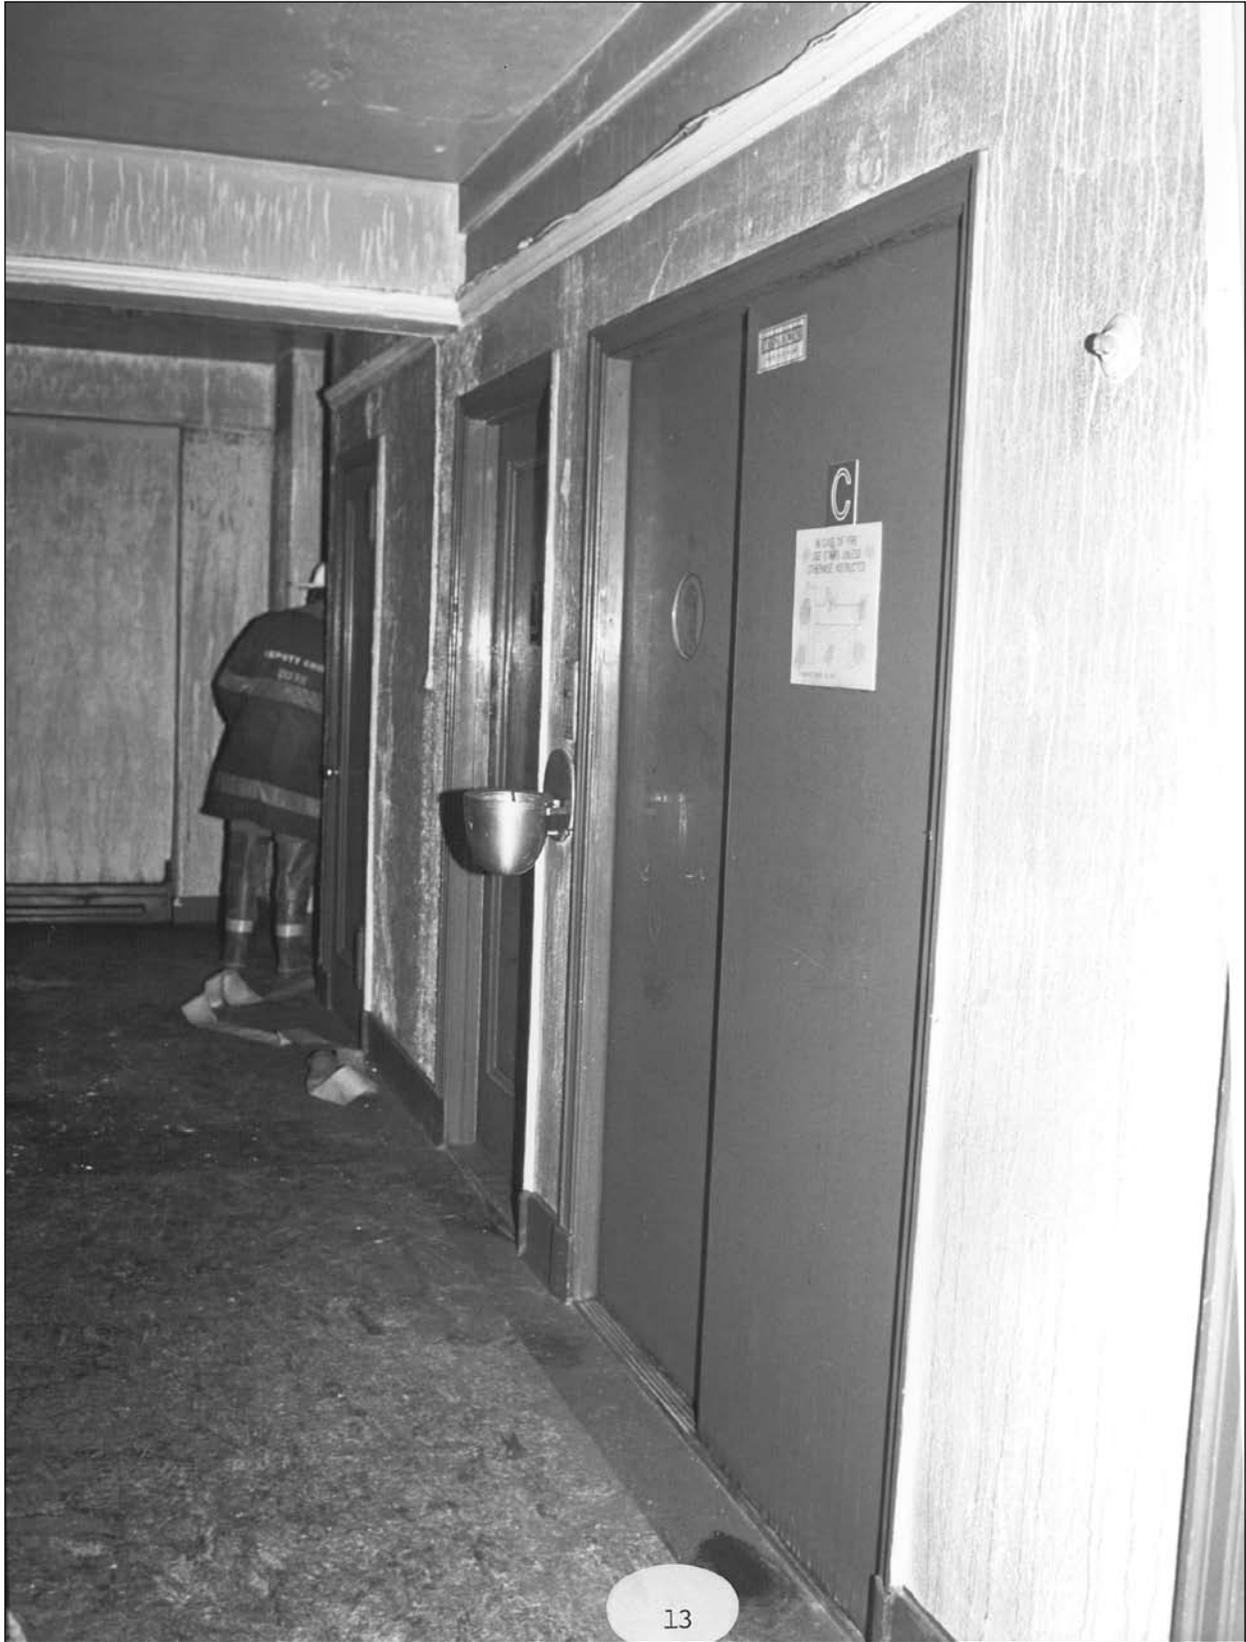
13. Typical corridor on upper floor; note smoke damage.

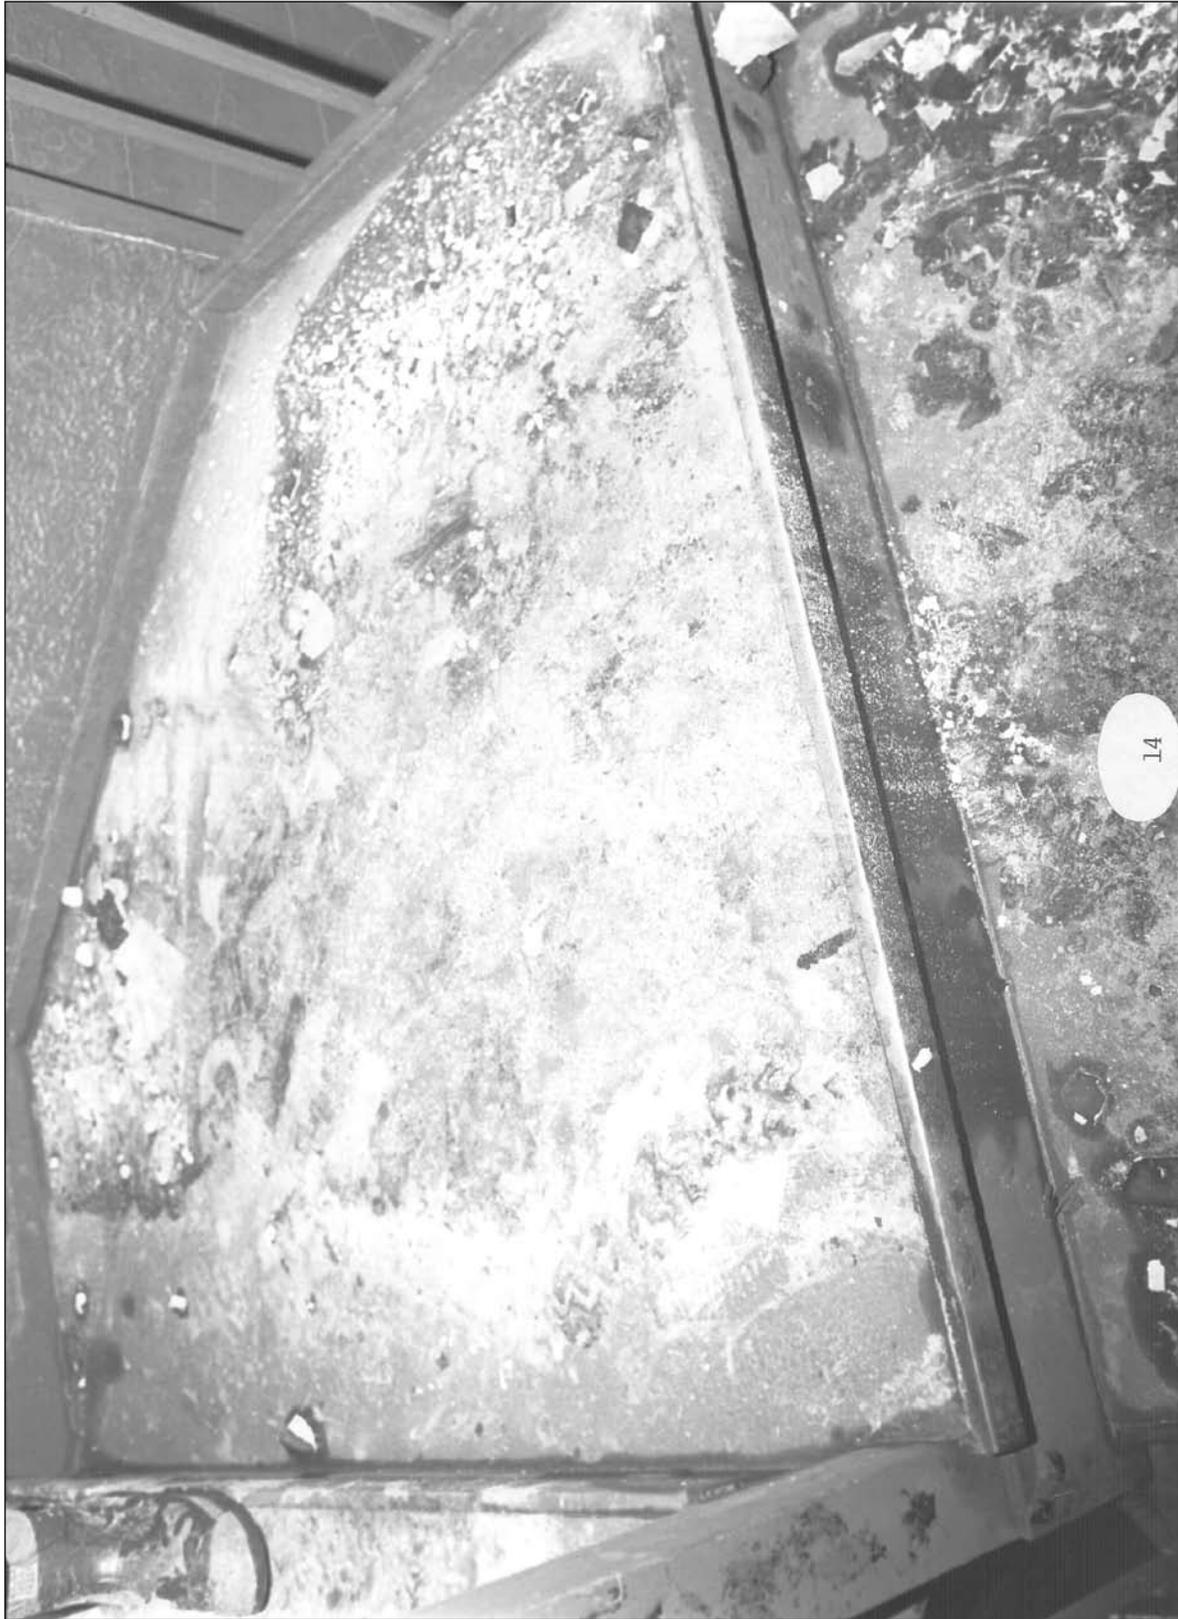
The third and fourth victims (one male, one female) were found on the tenth floor landing of Stairwell A at the door leading to the roof. Both victims were D.O.A. It was determined later that they had died of smoke inhalation. The male victim lived in apartment 10F; the female victim in apartment 9H. They probably left their apartments, found the stairwell full of smoke, crossed through the corridor to the other side of the building, saw smoke in the stairwell, and attempted to flee to the roof, but could not get out the door.

14. Landing to roof exit where two bodies were found.

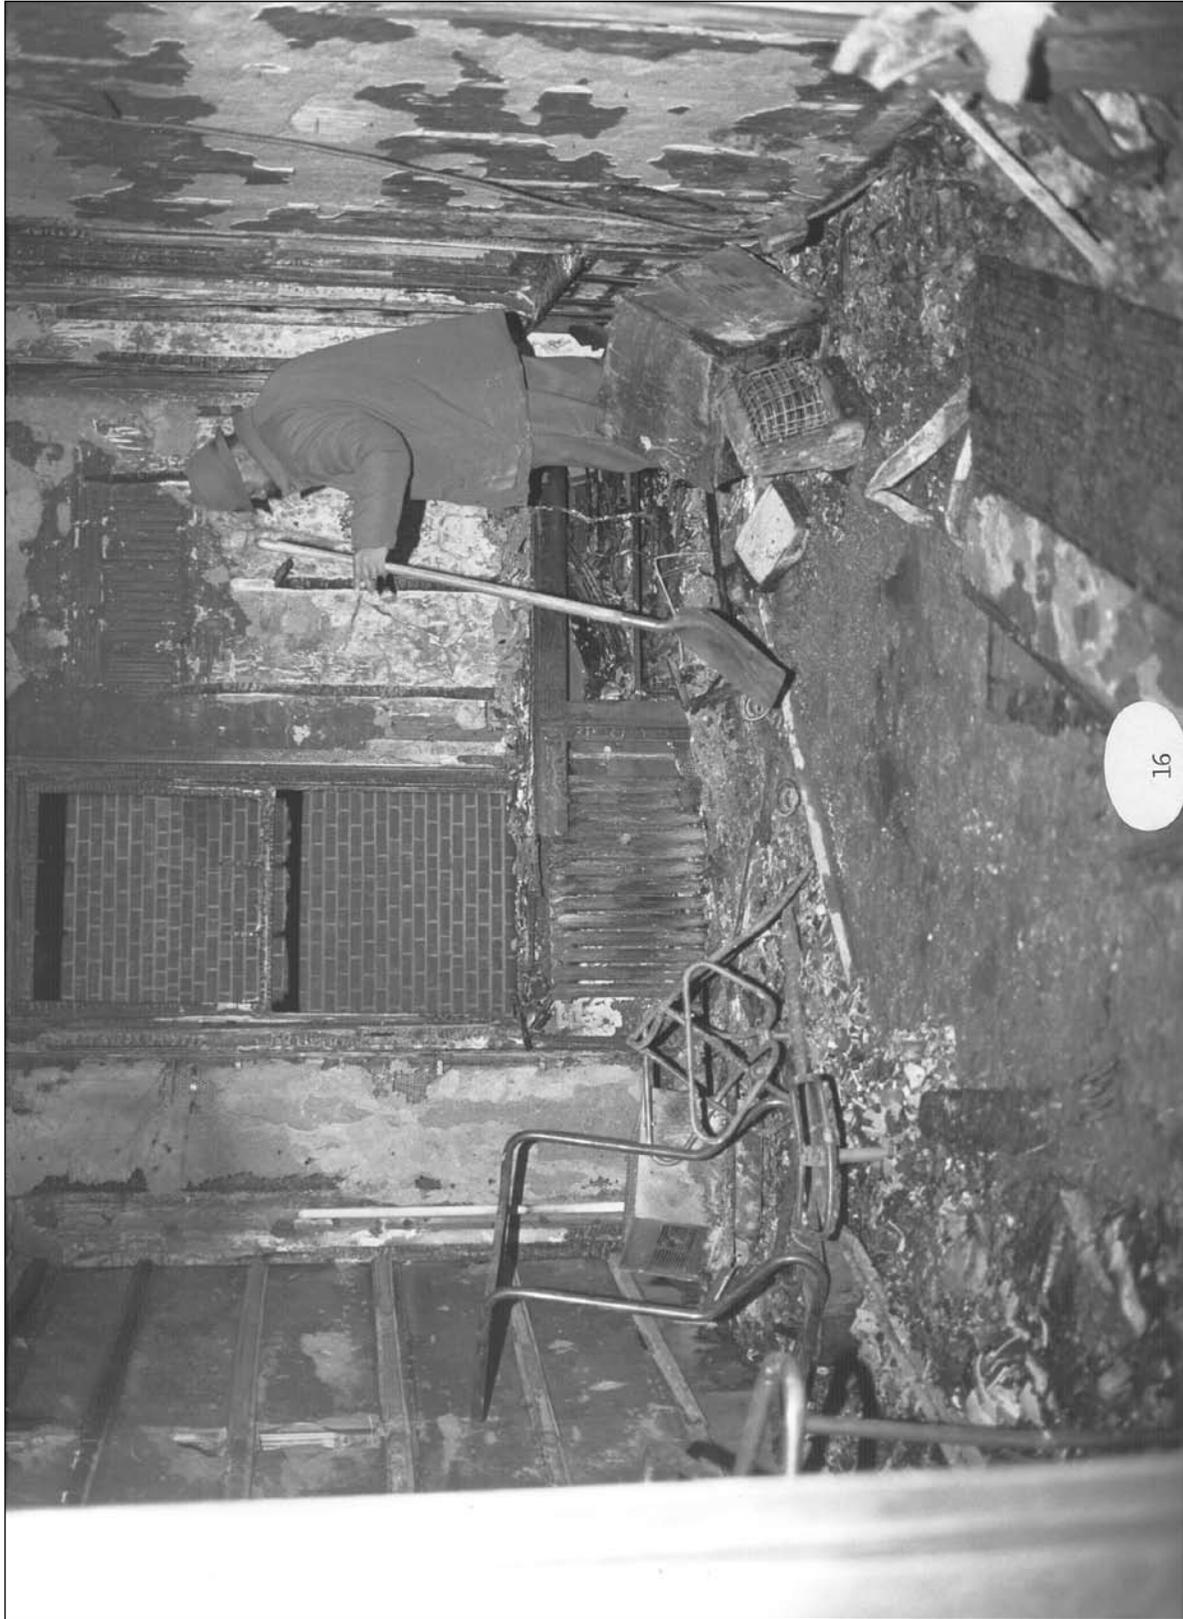
The fire began in the upholstered sofa of a psychologist's office on the first floor off the waiting room area. The cause of the fire is unknown and was still under investigation when this report was written.

16. Office #103, room of fire origin.

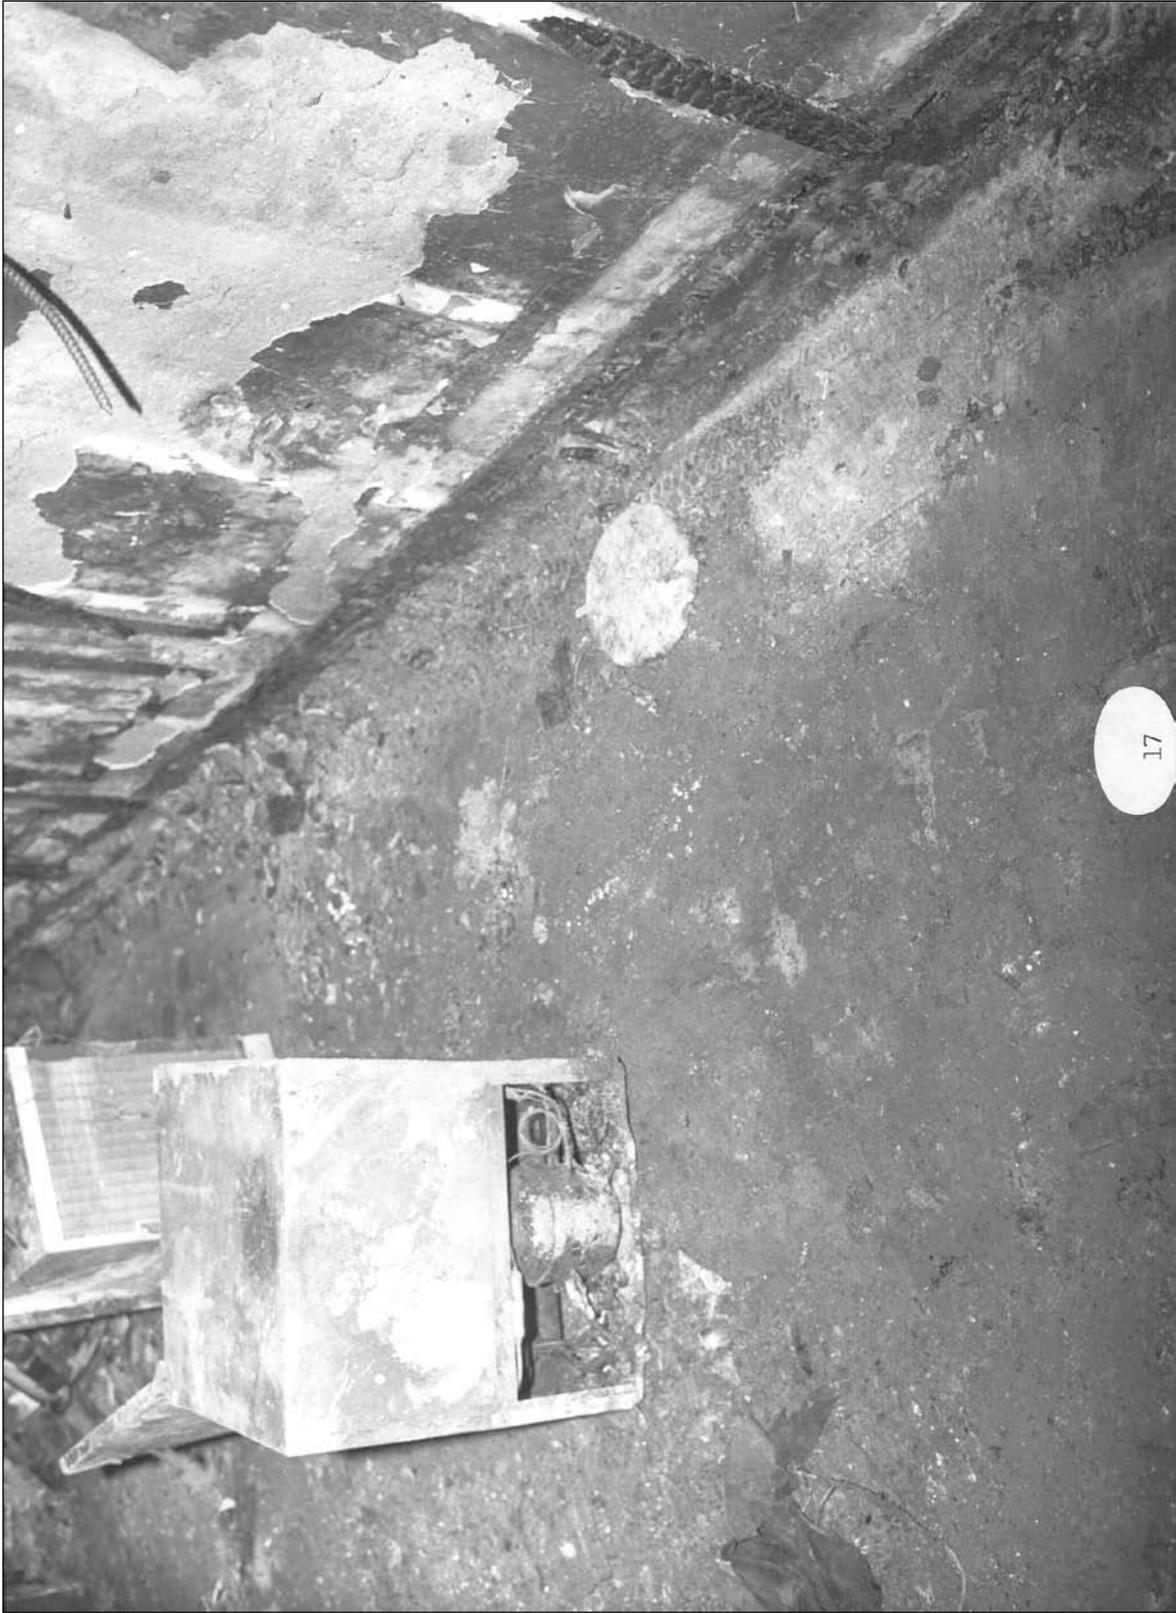
17. Point of origin in Room 103 – east wall.
