U.S. Fire Administration/Technical Report Series

Apartment Building Fire East 50th Street New York City

USFA-TR-019/January 1988

This is Report 019 of the Major Fires Investigation Project conducted by TriData Corporation under contract EMW-86-C-2277 to the United States Fire Administration, Federal Emergency Management Agency.

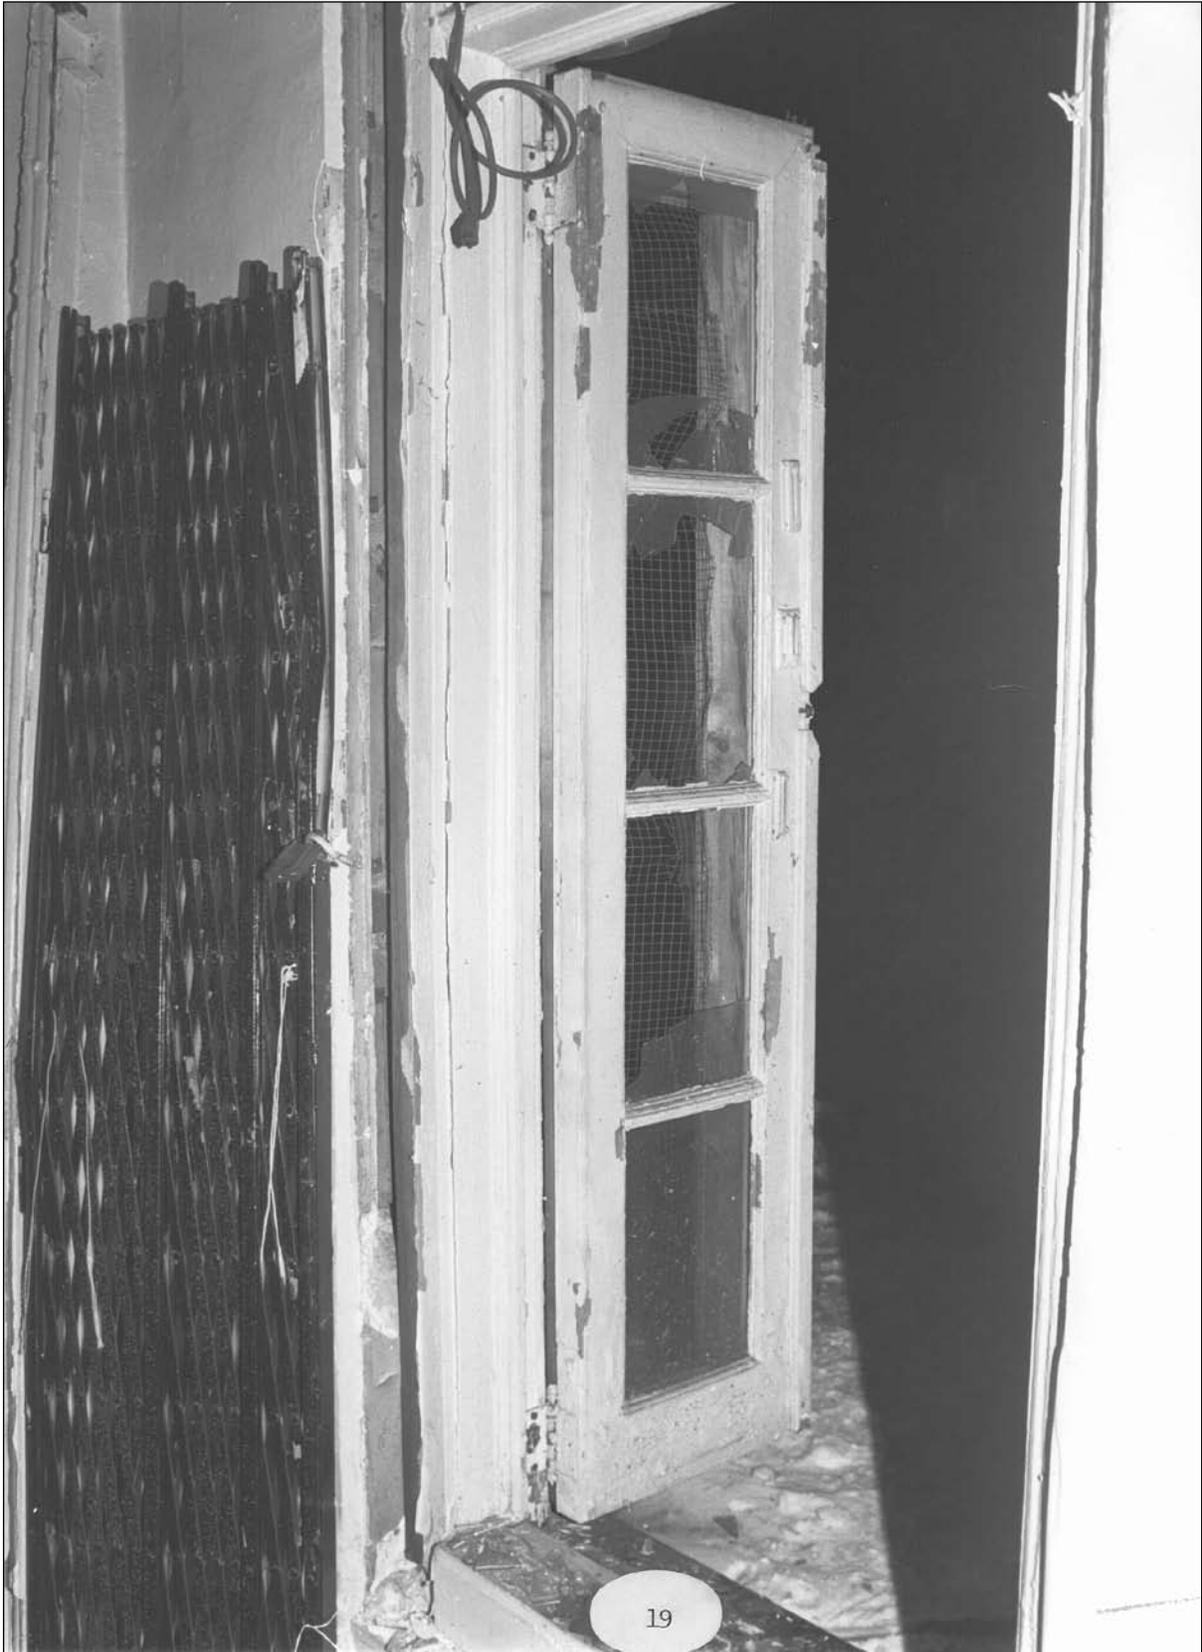
Apartments located in the rear of the building have direct access to the fire escapes by way of windows. The windows have metal security grates which had to be unlocked and opened. They may have provided obstacles to tenants evacuating the units. They were certainly an obstacle for firefighters attempting to gain entry for search and rescue.

19. Typical window on rear of building; note folding security gate.

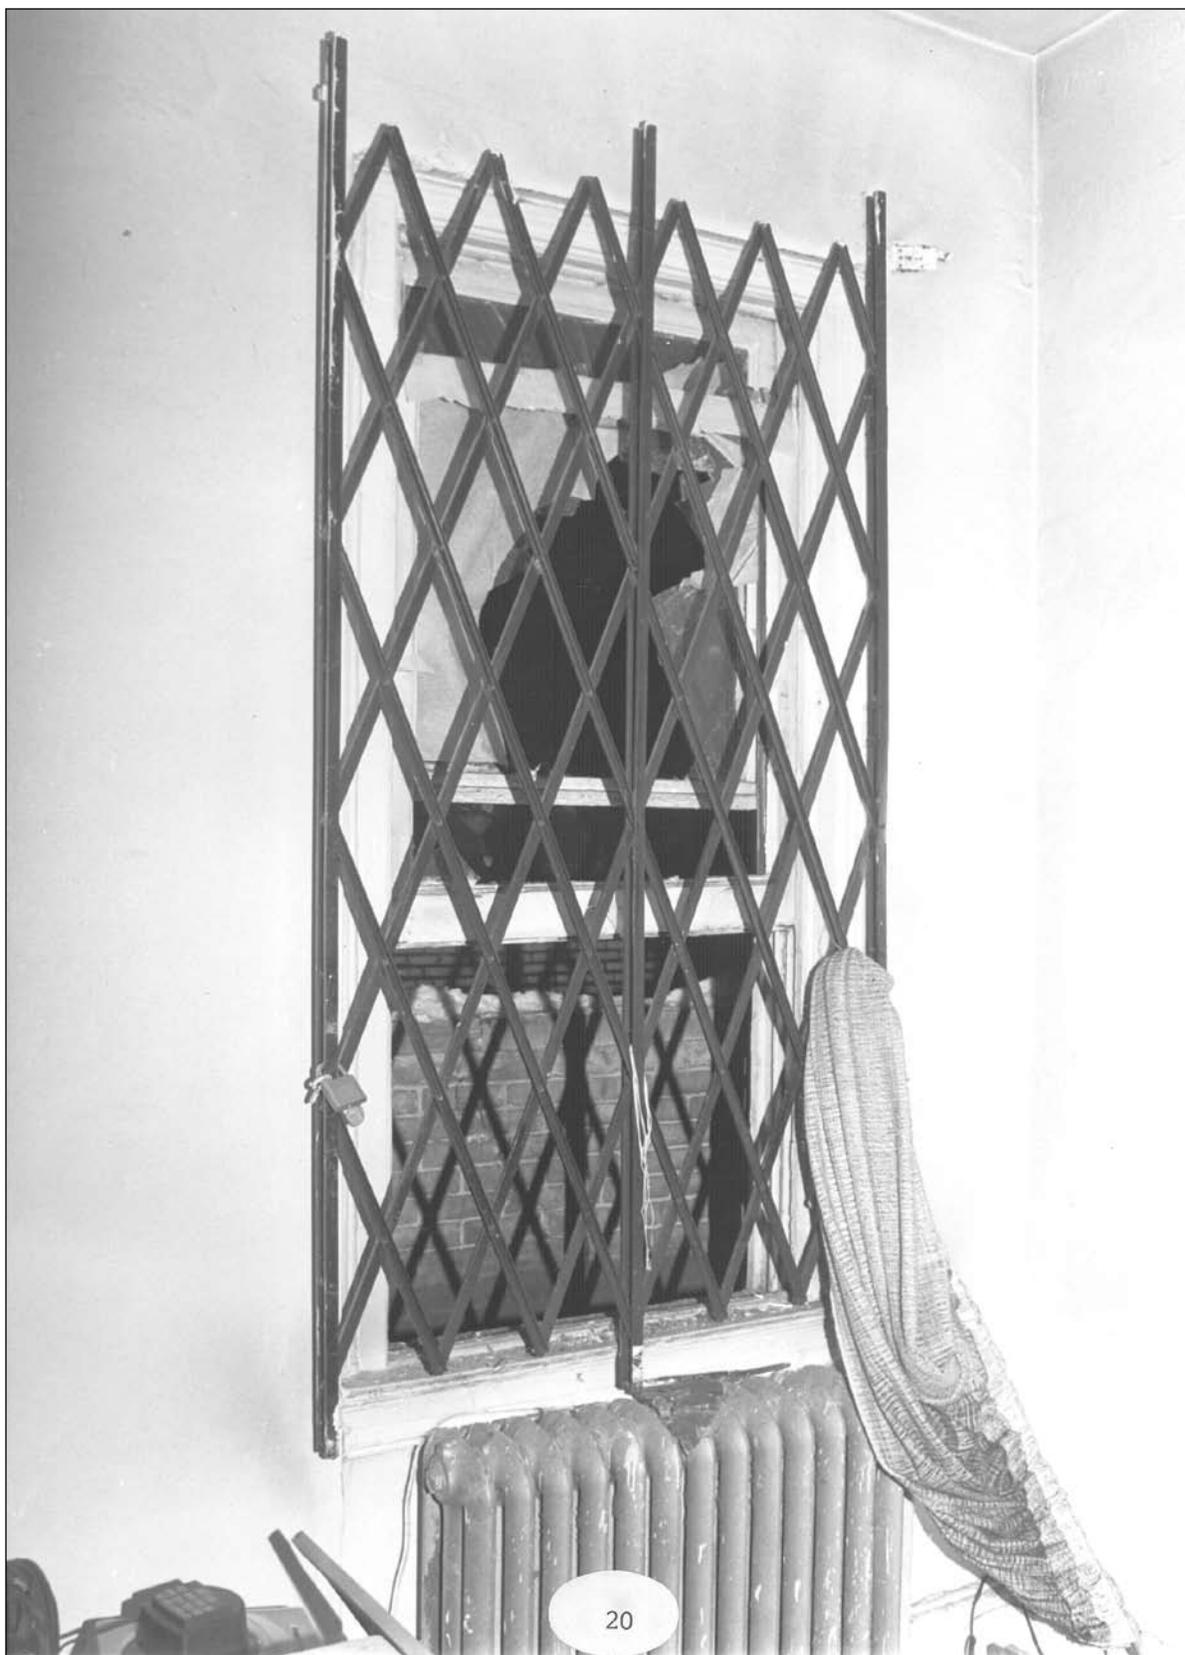
20. Security grate from typical apartment unit on rear of building.

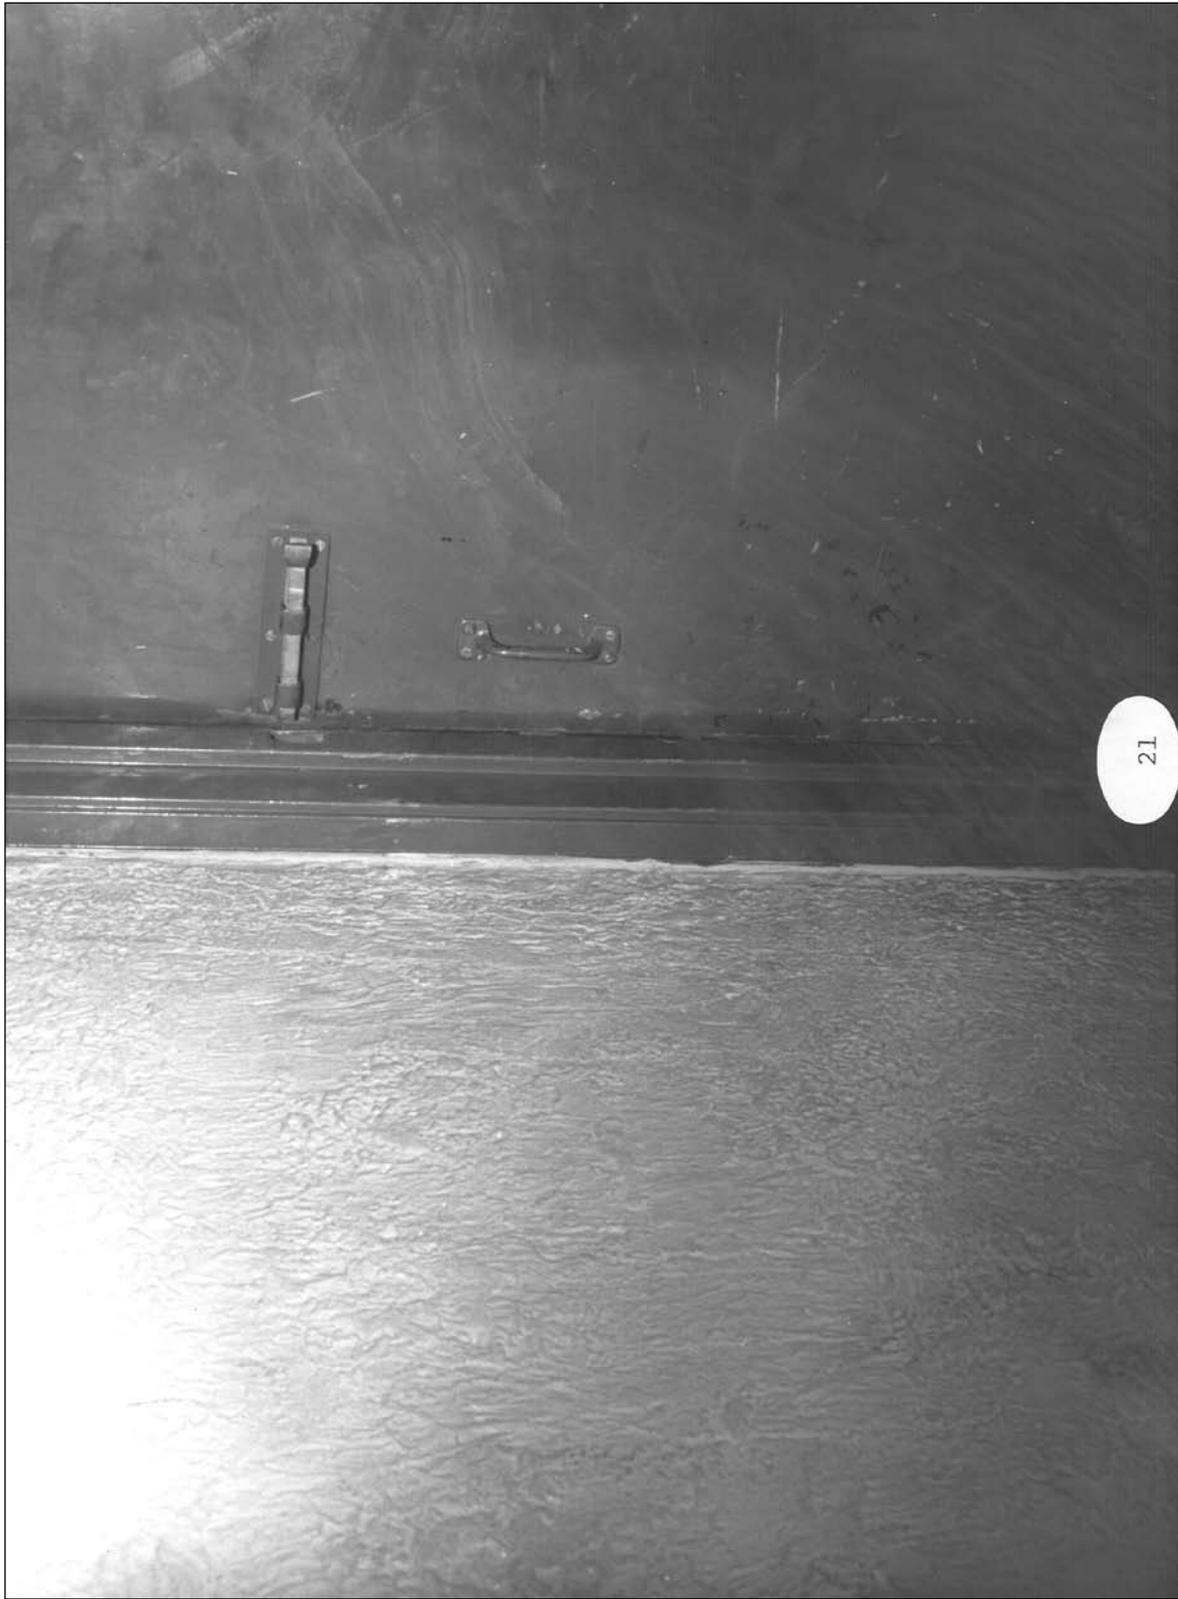
21. Roof exit door from tenth floor. Note sliding bolt and heavy smoke damage.

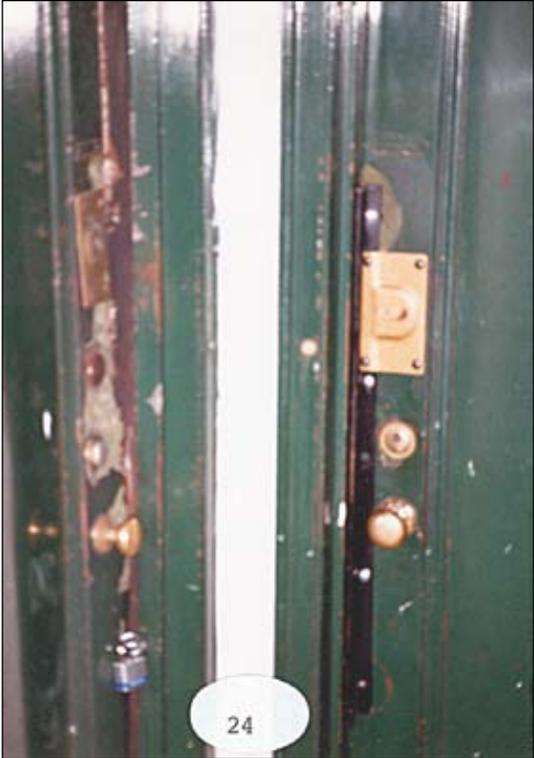
Apartments that did not respond to firefighters' knocks at the door had to be forcibly entered to make sure there were no casualties within. The doors to the apartment units are metal and each was equipped with various lock, which made entry laboriously difficult.

The individual apartment entrance doors, having multiple locks, were subjected to considerable damage when firefighters had to force them open for search and rescue.

24. Variety of locks on typical apartment door.

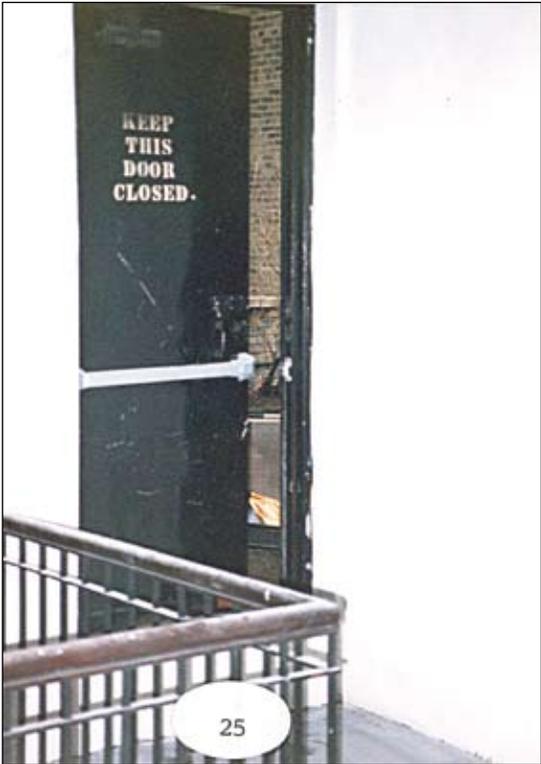
25. Newly installed panic hardware, after fire event.

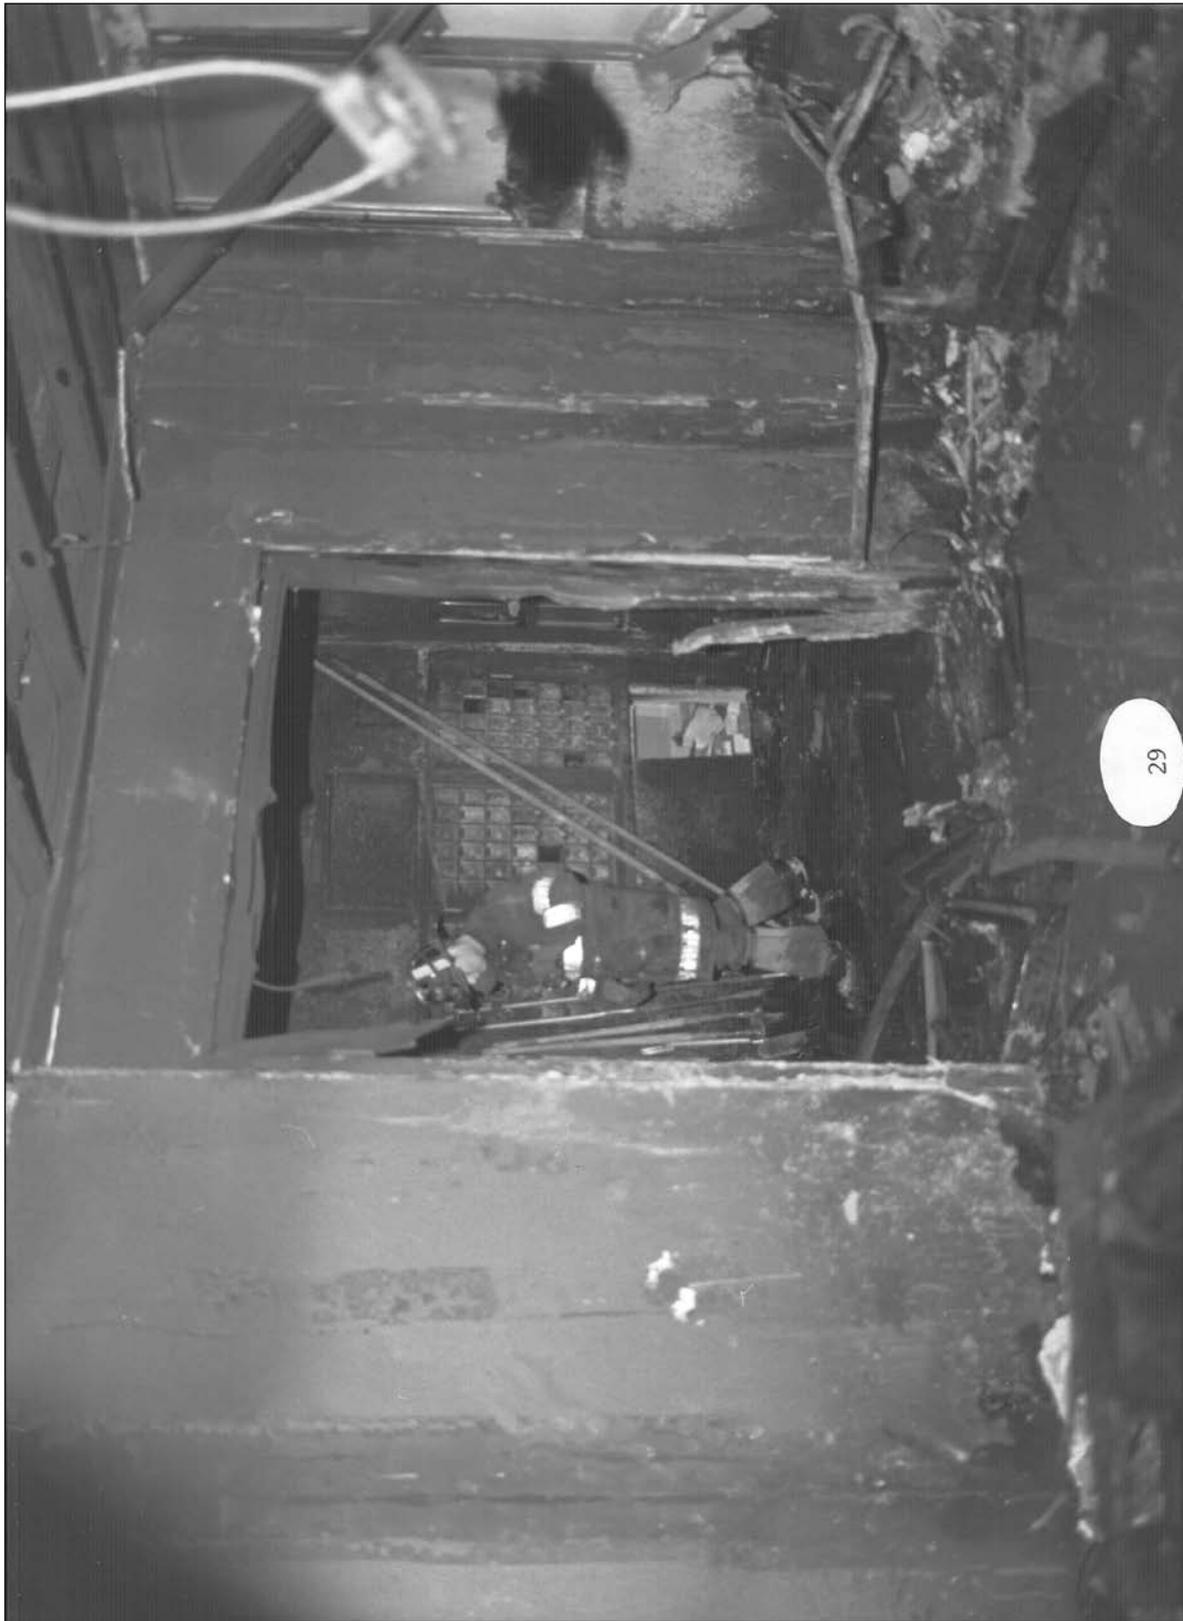
The alarm was received by the fire department at 2019. First due units arrived on the scene within four minutes at 2023. When entering the lobby door, firefighters encountered heavy smoke rolling over their heads and coming from the direction of the waiting room area. A set of glass doors separating the waiting room from the lobby had completely melted.

29. Waiting room doors which had melted.

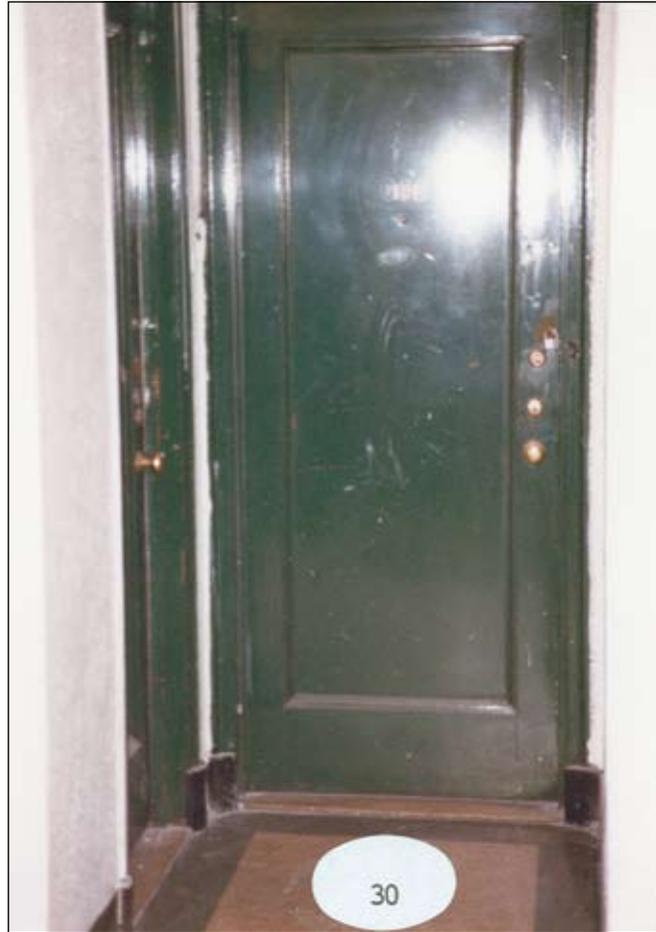
All exit and apartment doors are metal fire doors, but they had been designed with a half-inch gap at the bottom to promote air circulation.

Smoke penetration into individual apartments was aided by the 1/2-inch gaps at the bottom of the doors. However, all who stayed in their apartments survived.

30. Half-inch gap at bottom of apartment doors.
