United States Fire Administration

Technical Report Series

High-rise Office Building Fire One Meridian Plaza Philadelphia, Pennsylvania

United States Fire Administration Fire Investigations Program

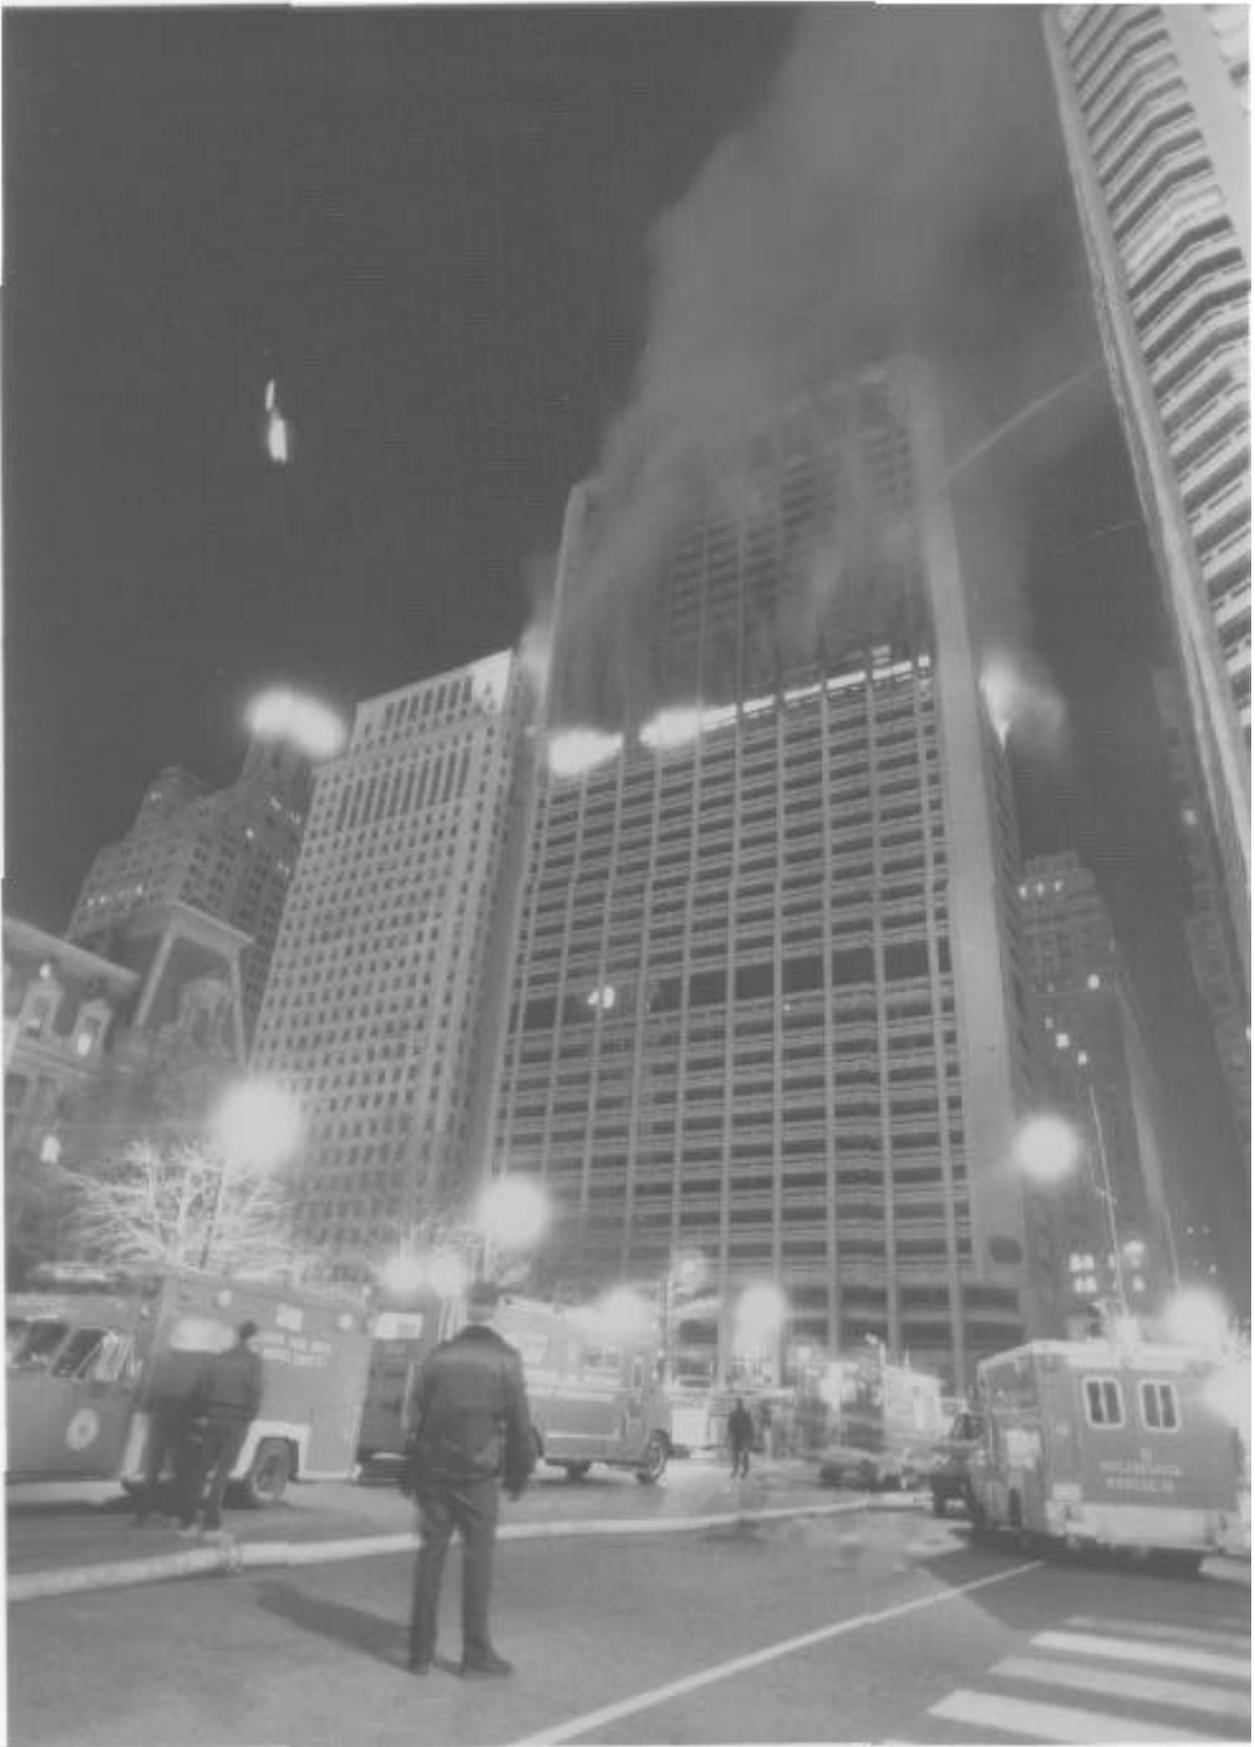
Exterior view of One Meridian Plaza and fireground operations in the early morning hours of February 24, 1991. Fire involves the 22nd, 23rd, 24th, and part of the 25th floors. Note the heavy stream played on the exterior from an adjacent building.

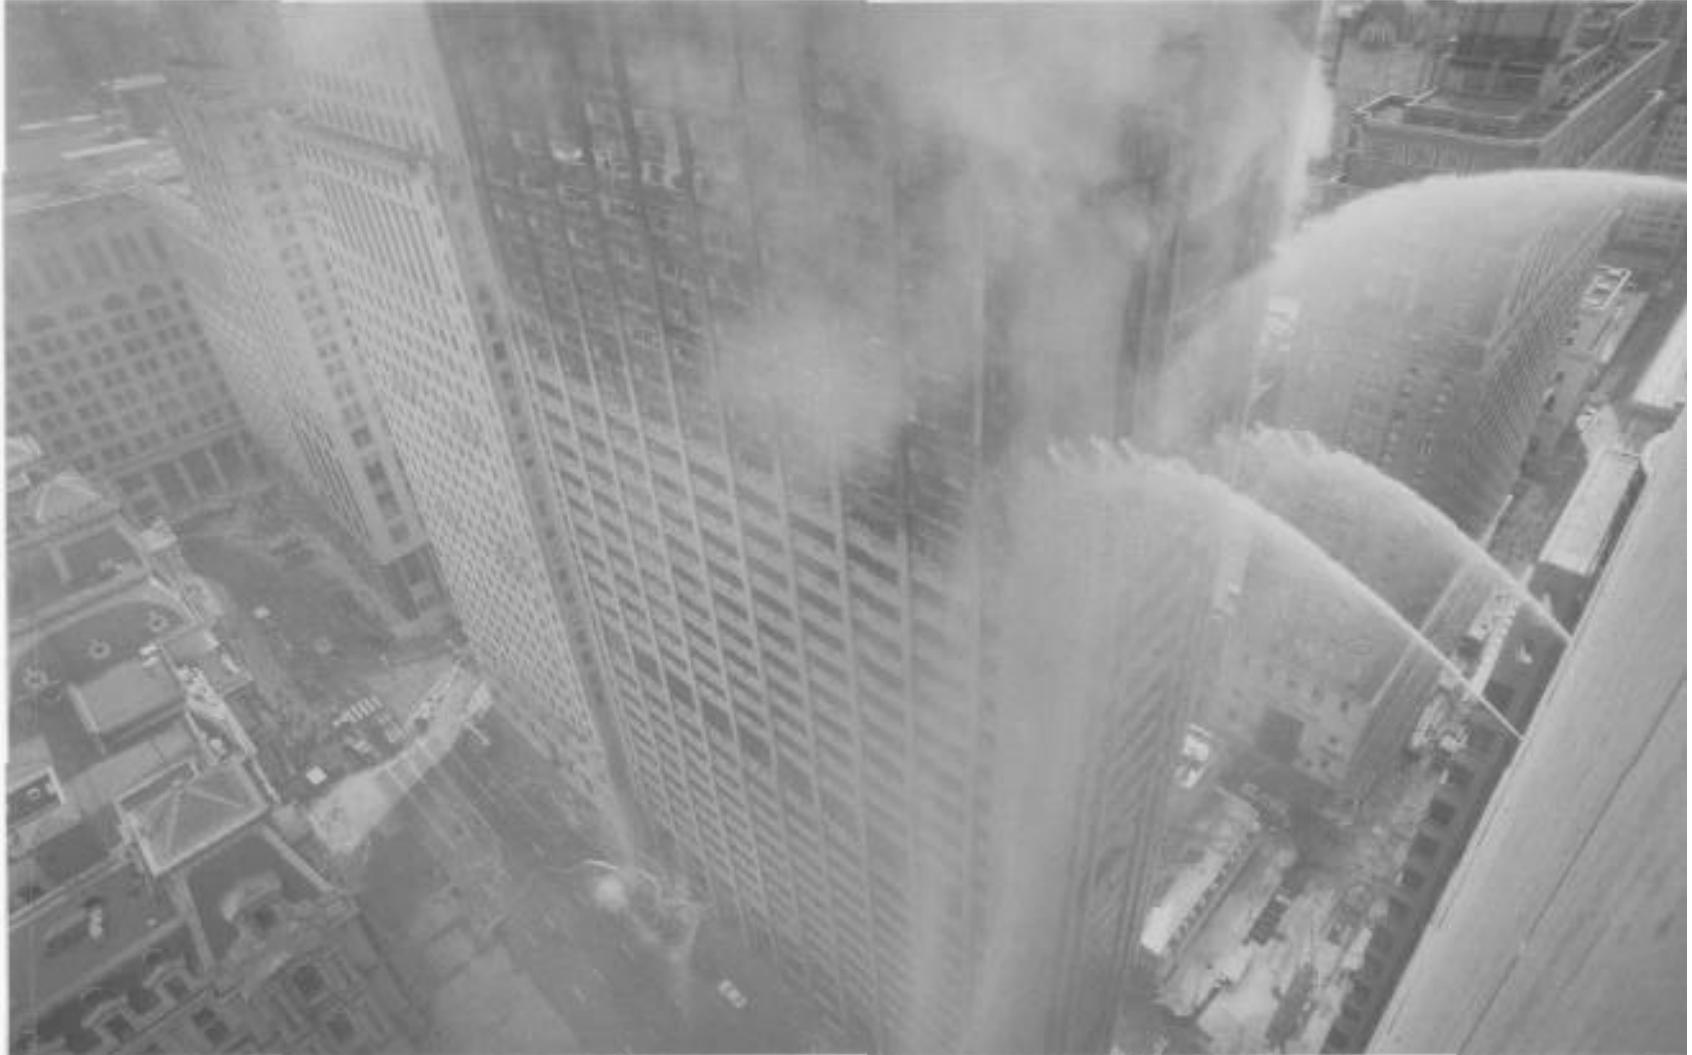
Aerial view of exterior firefighting operations after dawn on February 24,1991.

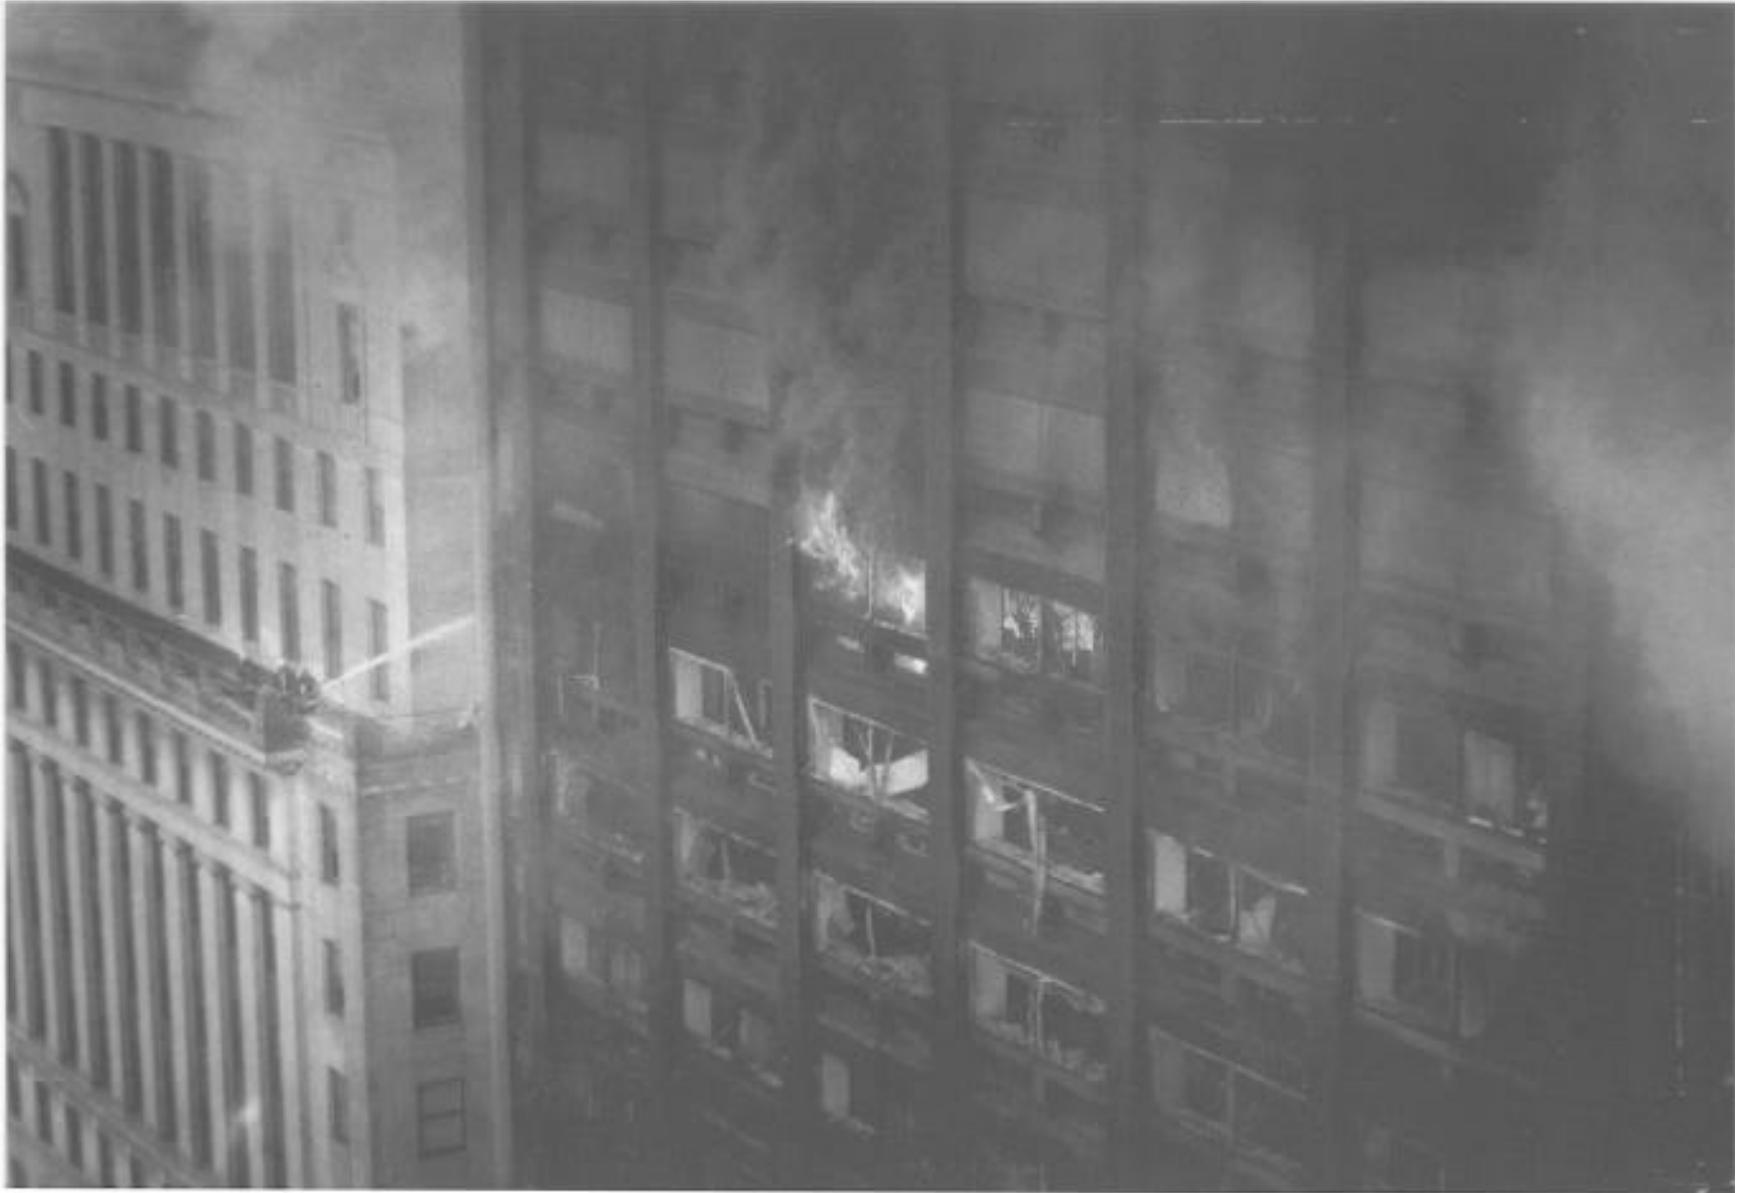
Exterior firefighting efforts from the Girard Building #1, east of One Meridian Plaza, The two buildings are connected on lower floors.

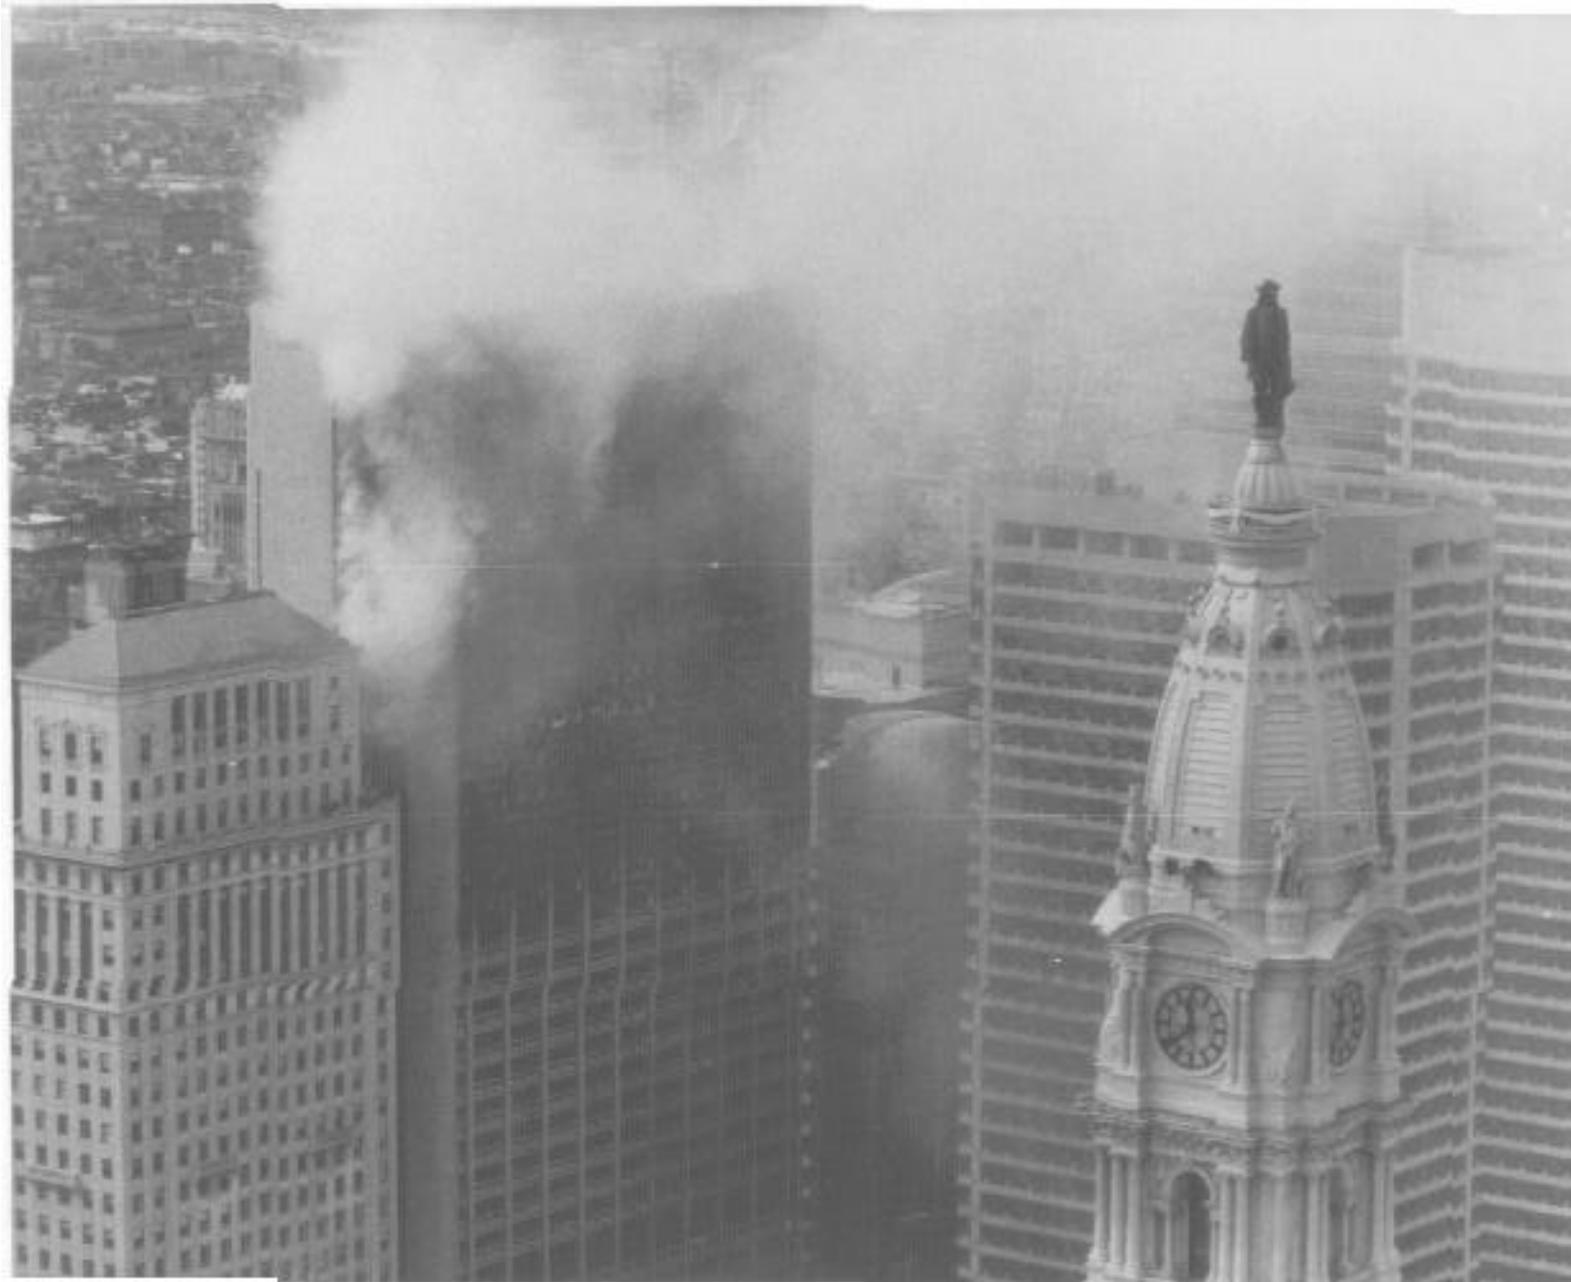
Smoke pours from One Meridian Plaza as William Penn looks on from atop Philadelphia City Hall the morning of February 24, 1991, after interior firefighting efforts have been suspended.

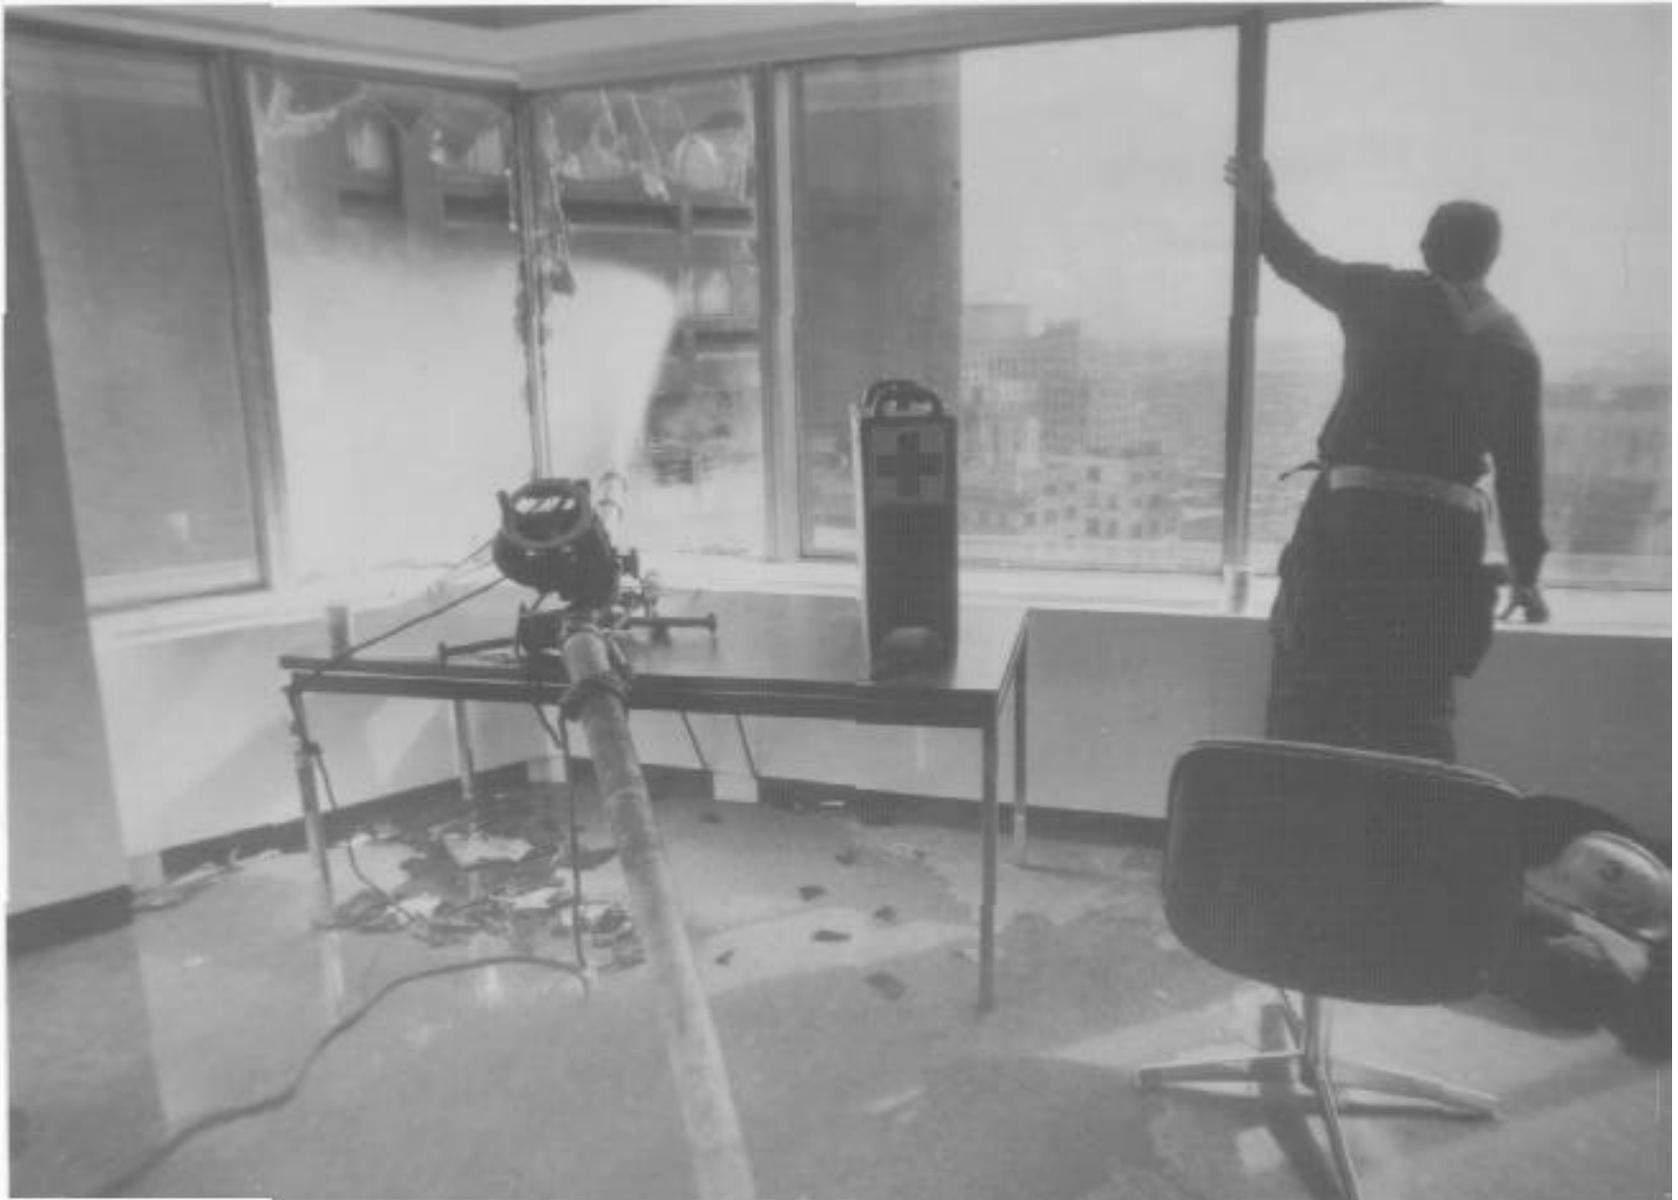
View of deluge set operating from One Centre Square.

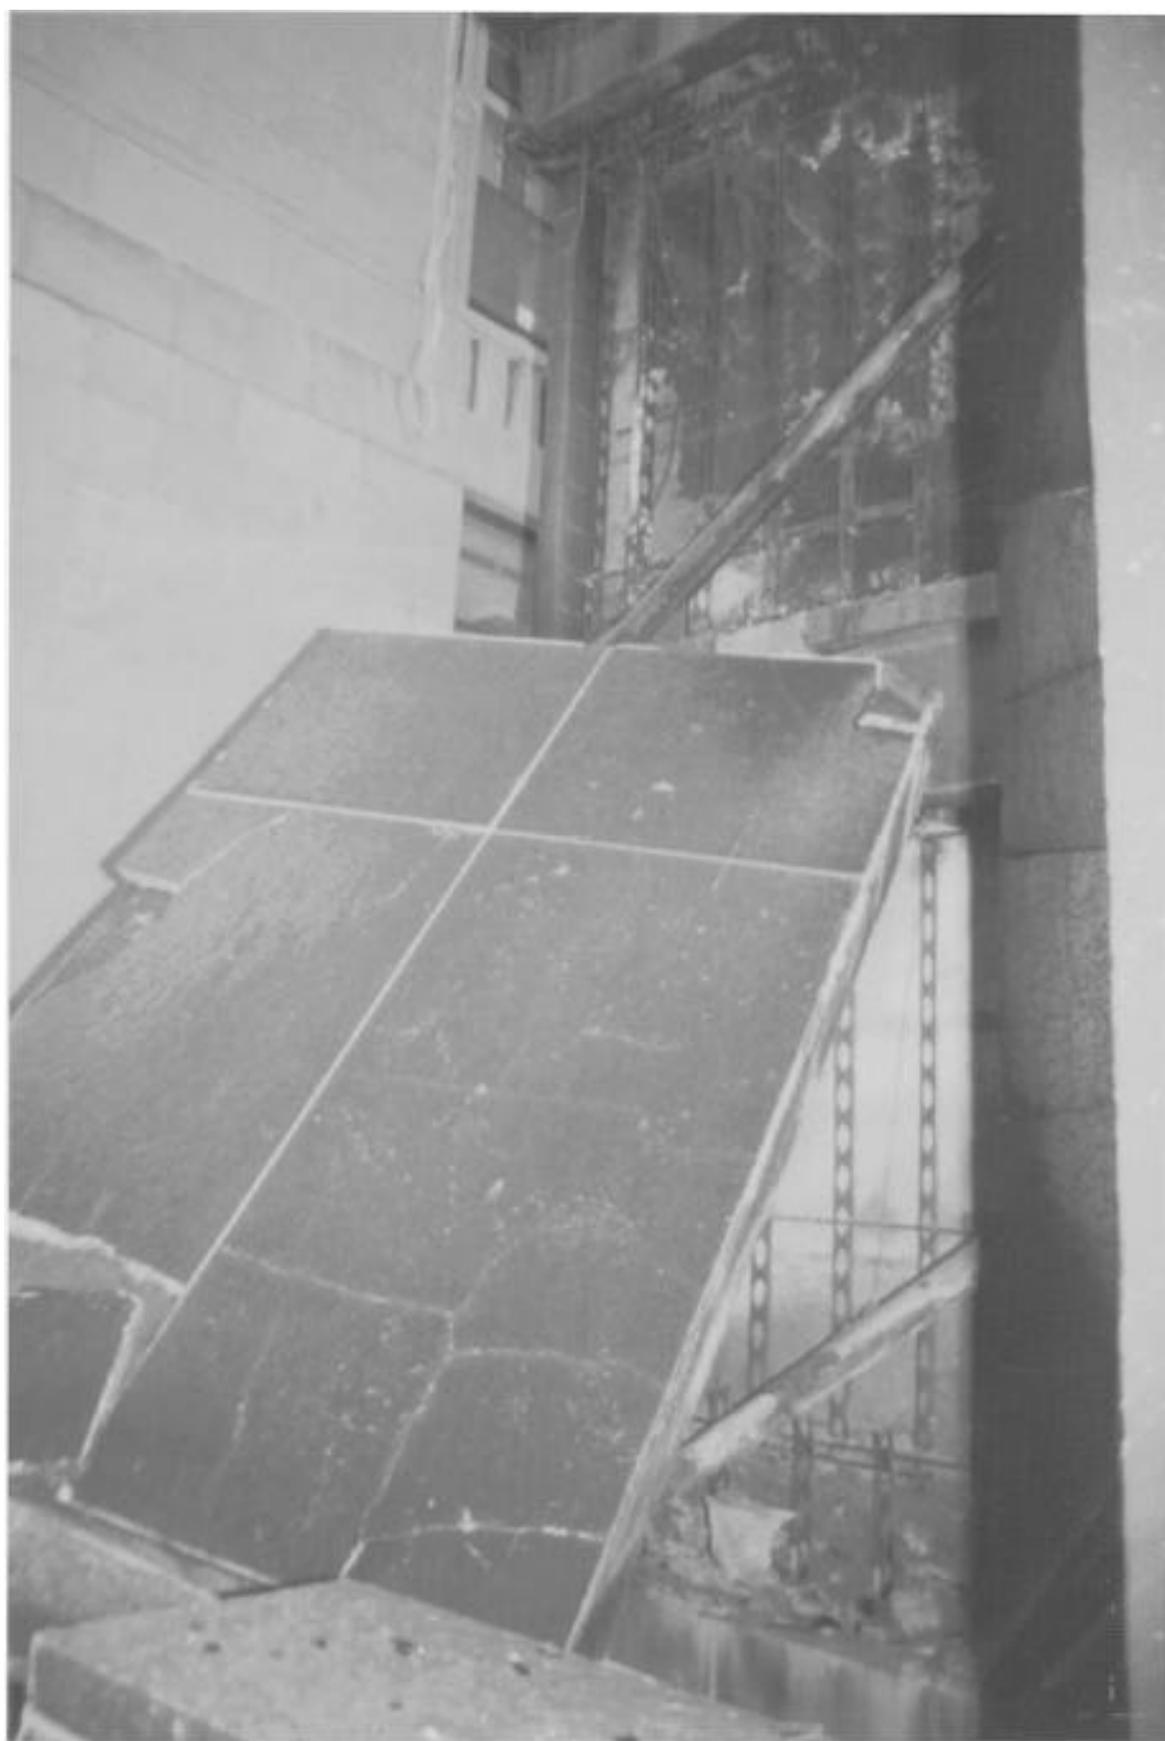
Here and in the next two photos exterior granite panels from the east stair tower were dislodged due to the thermal expansion of the steel frame of the building.

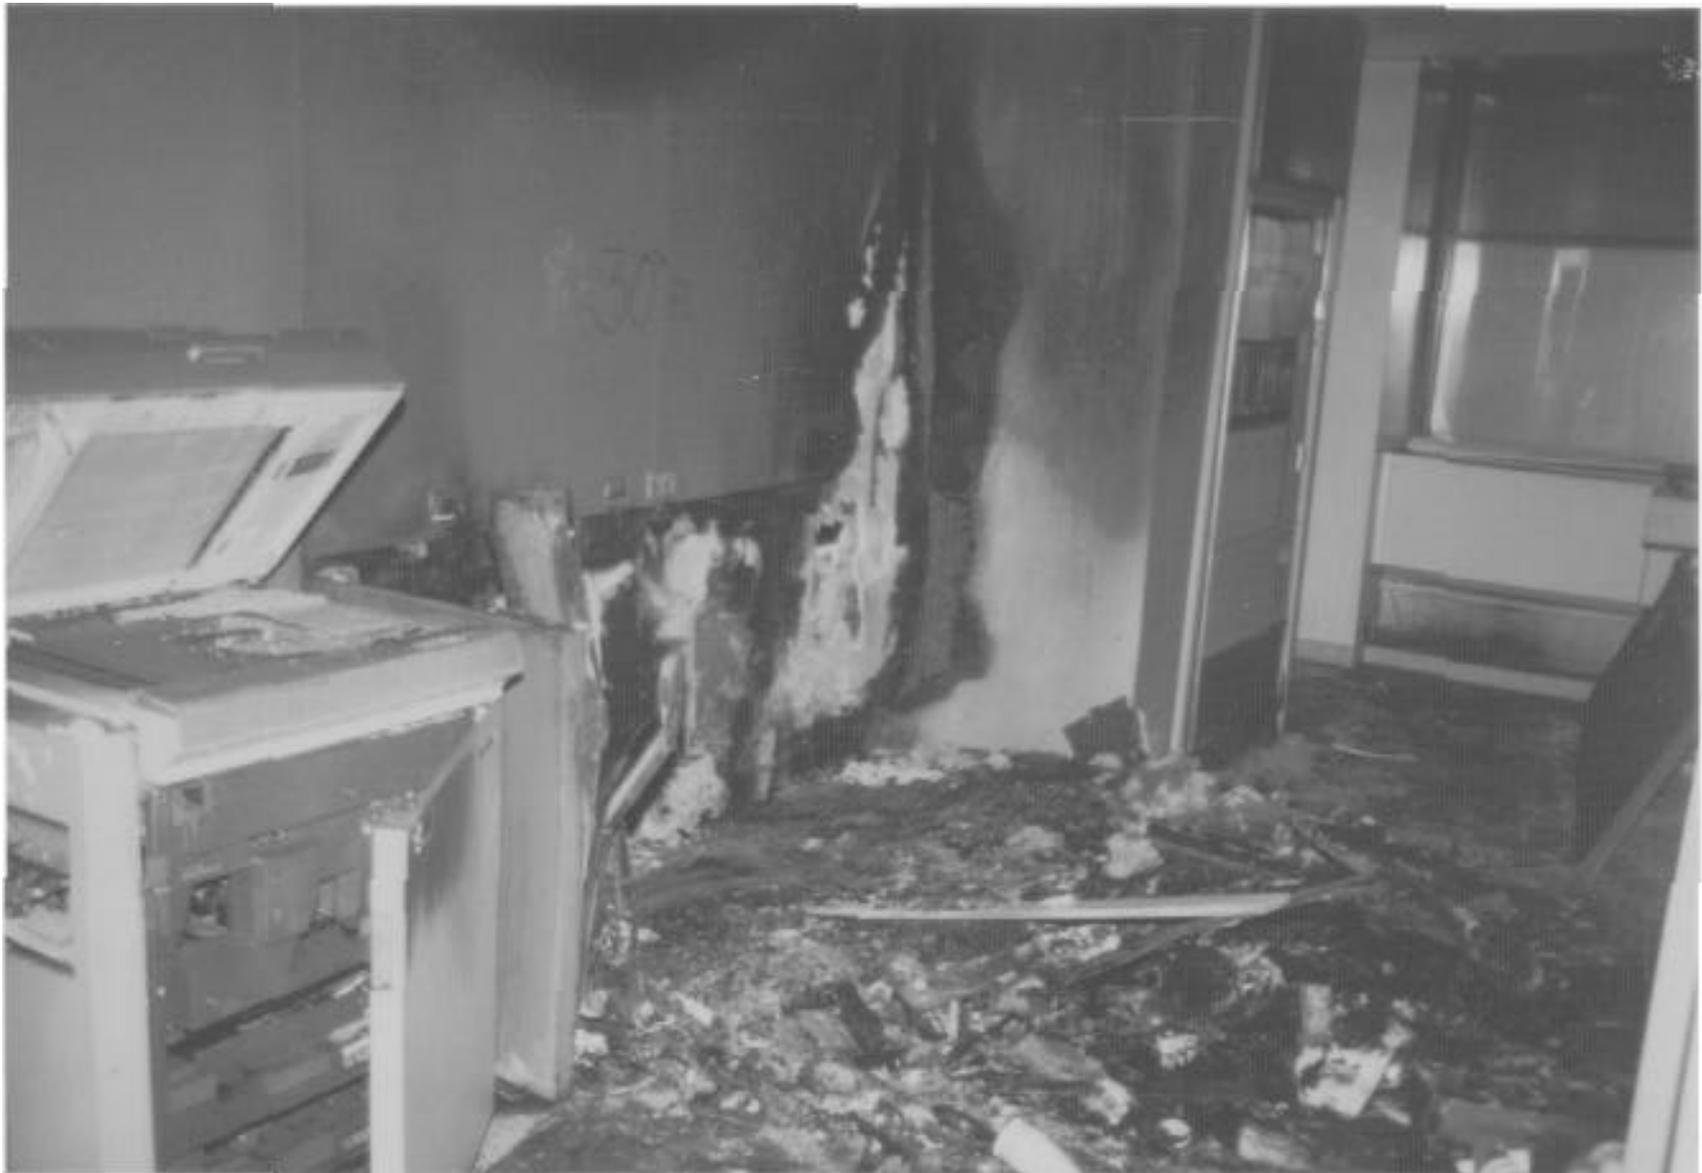
The fire was stopped when it reached the 30th floor, which was protected by automatic sprinklers. As the fire ignited in different points this floor level through the floor assembly and by autoexposure through the windows, 10 sprinkler heads activated and the fires were extinguished at each point of penetration. The vertical spread of the fire was stopped solely by the action of the automatic sprinkler system, which was being supplied by Fire Department pumps. The 30th floor was not heavily damaged by fire, and most contents were salvageable. The fire was declared under control at 3:01 p.m., February 24, 1991.

One of the areas of fire penetration on the 30th floor where a single sprinkler head activated to stop the upward extension of the fire.

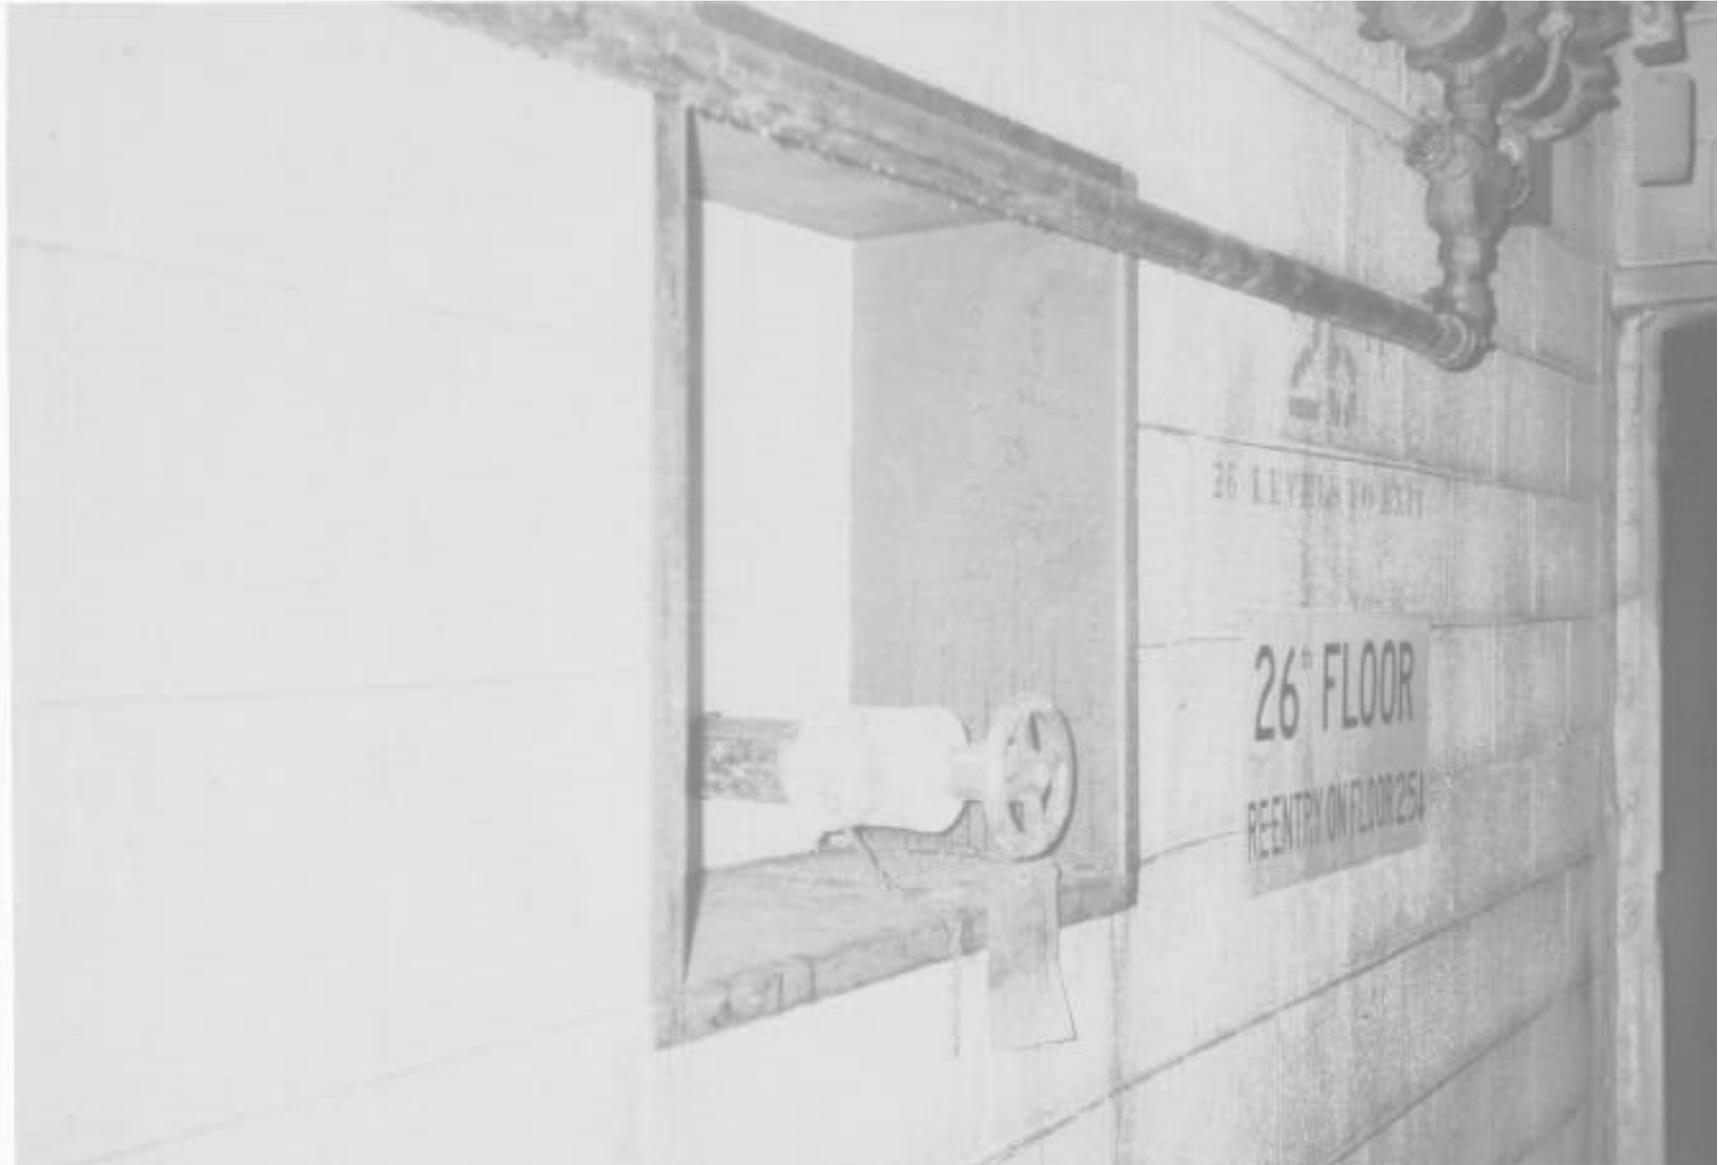
When the PRVs were originally installed, the pressure settings were improperly adjusted. Index values marked on the valves did not correspond directly to discharge pressures. To perform adjustments the factory and field personnel had to refer to tables in printed installation

Several fire department pumpers were connected to the Fire Department connections to the standpipe system in an attempt to increase the water pressure. The improperly set PRVs effectively prevented the increased pressure in the standpipes from being discharged through the valves. The limited water supply prevented significant progress in fighting the fire and limited interior forces to operating from defensive positions in the stairwells. During the next hour the fire spread to the 23rd and 24th floors primarily through autoexposure, while firefighters were unable to make entry onto these floors due to deteriorating heat and smoke conditions and the lack of water pressure in their hose lines. Windows on the 22nd floor broke out and the 23rd and 24th floor windows were subject to autoexposure from flames lapping up the sides of the building.

Standpipe hose outlet with pressure reducing valve (PRV), 26th floor.
