Ten Elderly Victims From Intermediate Care Facility Fire

Colorado Springs, Colorado

USFA-TR-050/March 1991

Ten Elderly Victims from Intermediate Care Facility Fire Colorado Springs, Colorado March 1991

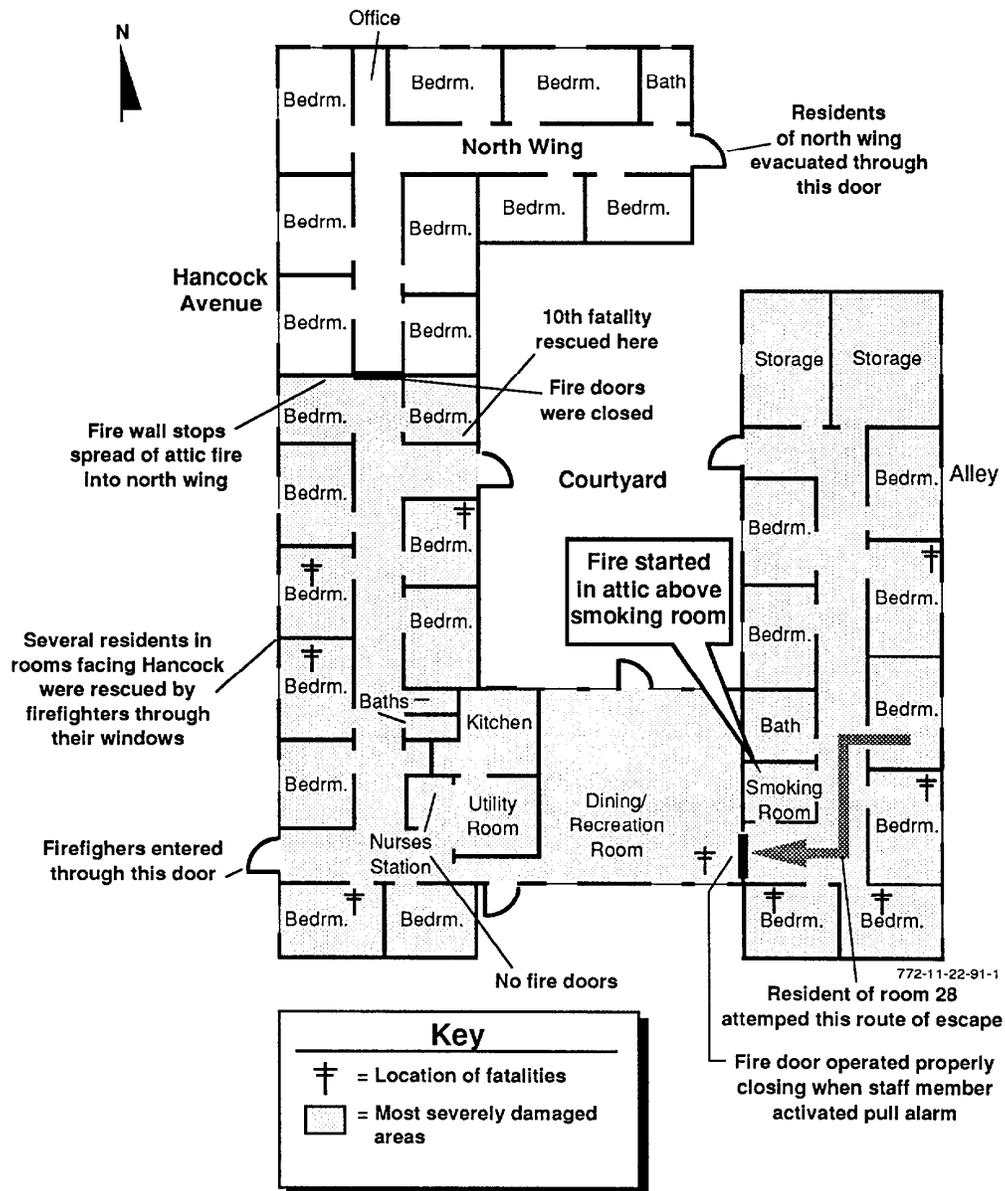
Floor Plan Showing the Point of Origin, Locations of Bodies, and the Extent of the Fire

An accidental fire determined to have originated above ceiling level occurred in the early morning hours of March 4, 1991, to the Crystal Springs Estates personal care boarding home in Colorado Springs, Colorado. All indicators point to this fire as having been burning in the attic undetected for some period of time, perhaps as much as an hour or more before breaking through the ceiling drywall and having smoke detectors react.

Heat detectors were found in the attic but had not functioned. A pull station's use and a 9-1-1 call alerted the fire department, but upon arrival they found a fire already ventilated through roof turbines. Nine elderly occupants perished, all as a result of carbon monoxide poisoning, in this fire. A tenth victim died months later of smoke aggravated lung problems.

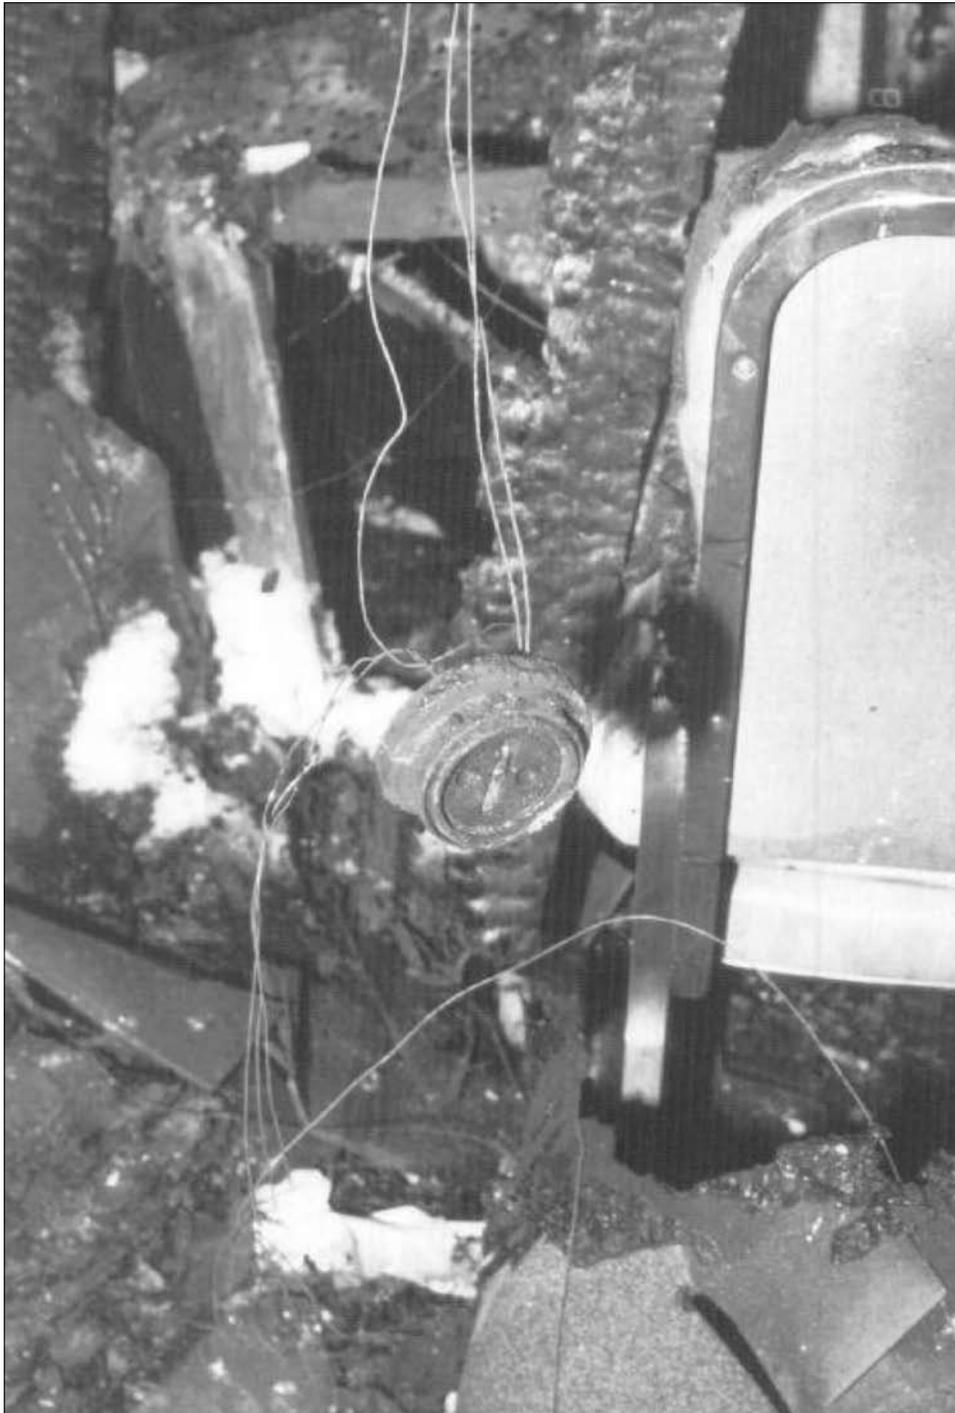
This facility was equipped with rate of rise heat detectors in each room and in the halls. Smoke detectors were in-place in the halls and dining area. There were also heat detectors found within the attic space, however, in that the fire burned undetected within the attic before breaking through the ceiling, it is felt these detection devices were not connected or properly functioning.

It is unknown why the heat detectors found in the attic area of the east wing did not warn of the fire in that area. Inspection of the alarm panel revealed 2 fuses which were blown at some unknown time. The condition of the system before the fire has not been established.

Heat sensors from the attic, either not hooked up or not working as there was no early warning to any panel.

All detection equipment in-place must be kept in working condition. The system must be checked on a scheduled basis by trained personnel. Battery assistance to hard-wired heat/smoke detectors offers the greatest safety. Although not a factor in this loss, the scenario of this incident illustrates the threat of loss of power.

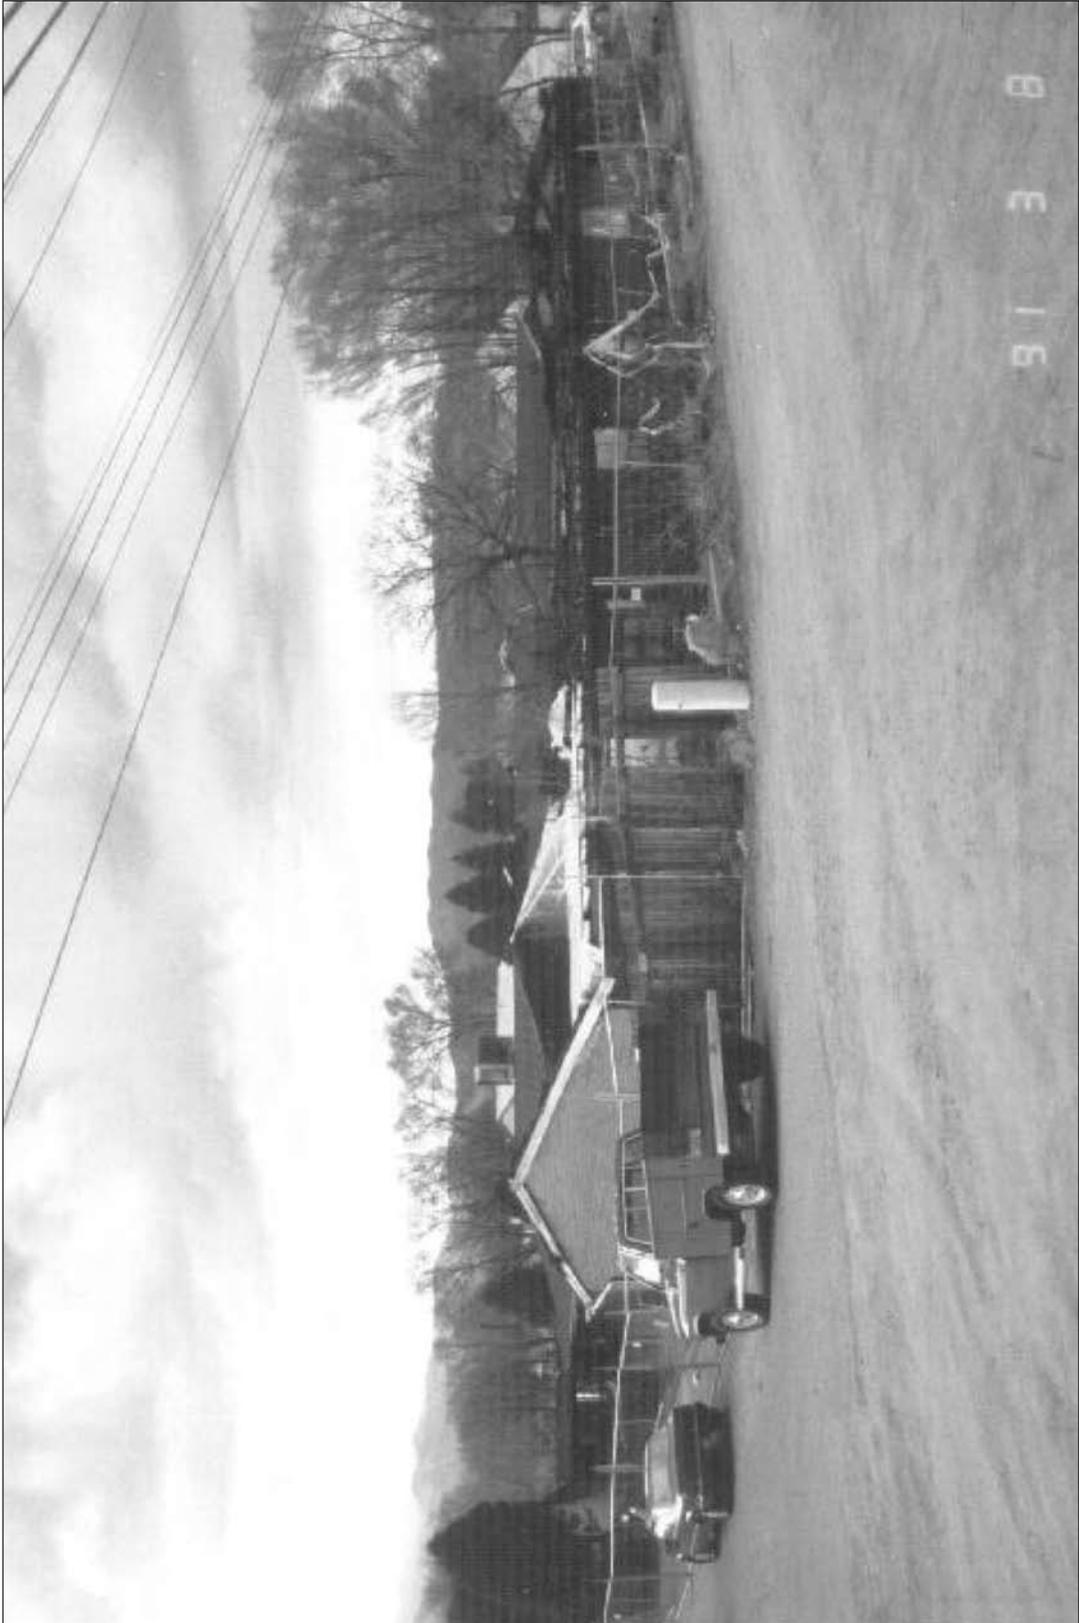
Exterior of the structure as seen from the southeast and looking to the northwest. The east wing is to the right and the south wing is to the left.

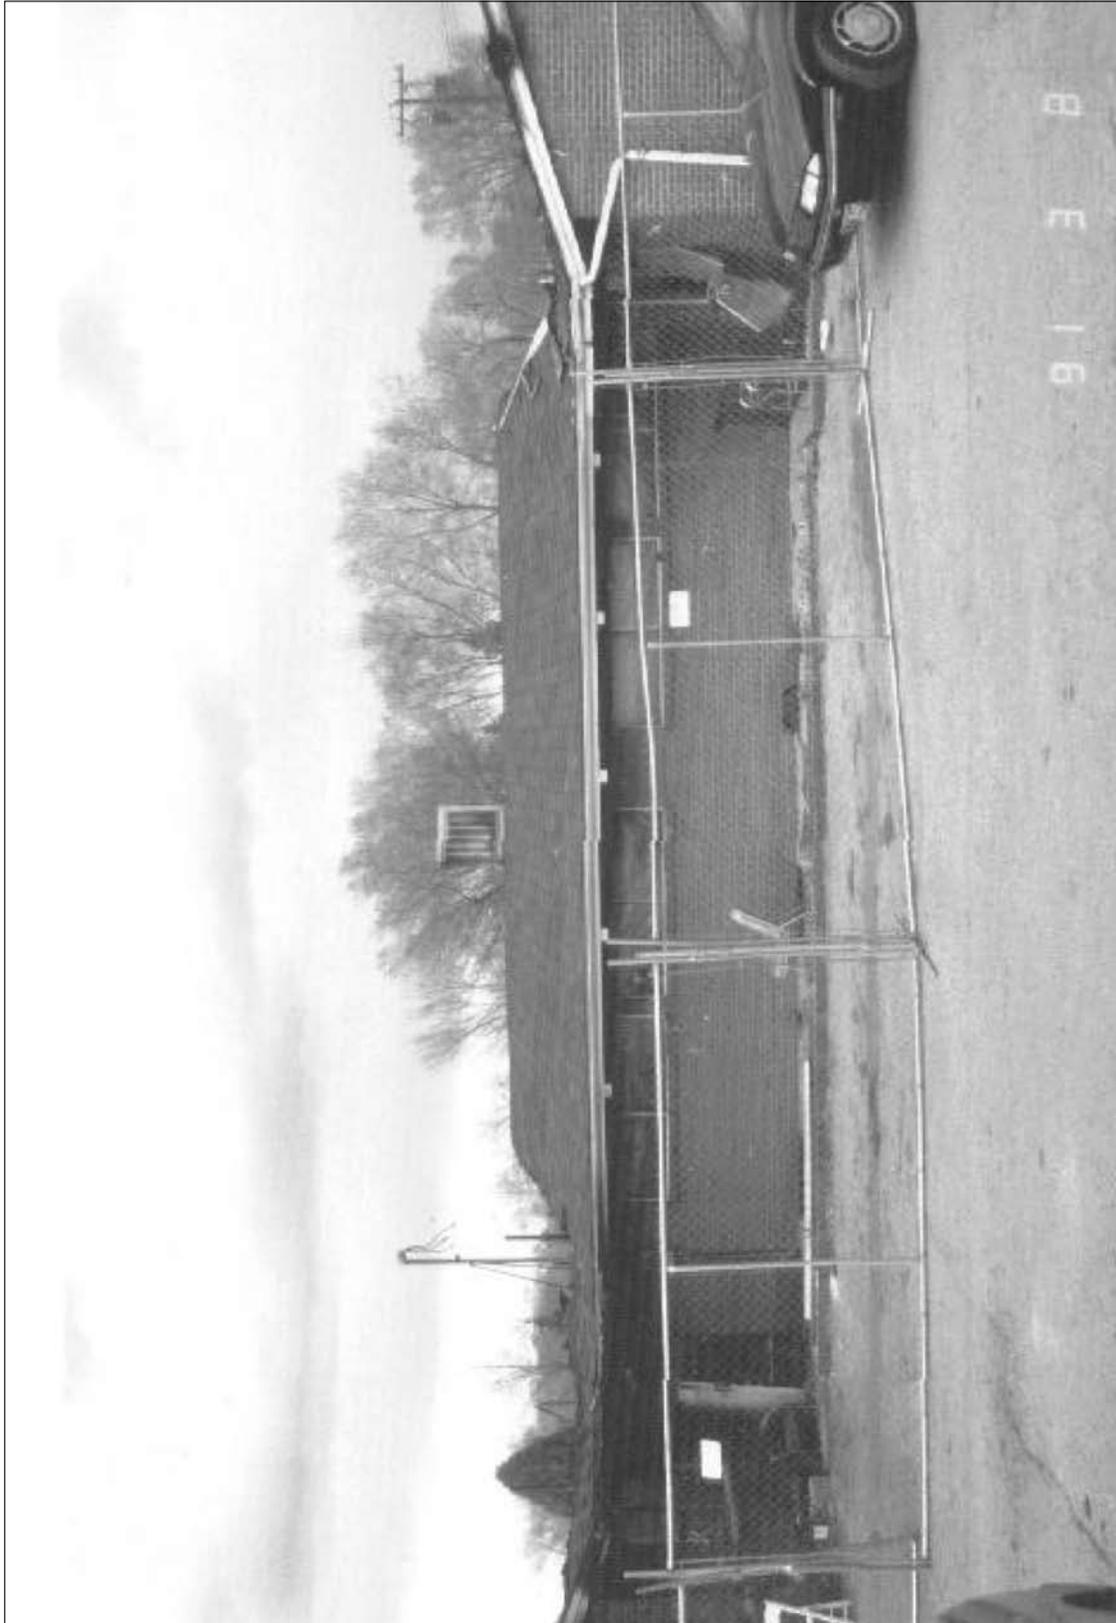
The dining room burned at a very high temperature due to its heavy timber roof/ceiling construction and possible cooking grease/oil deposits which had adhered to it over time. Fire further extended into the west wing, burning north until being stopped by the brick wall subdividing the attic space.

Exterior as viewed from the south and looking north at the wall and roof area over the dining room.

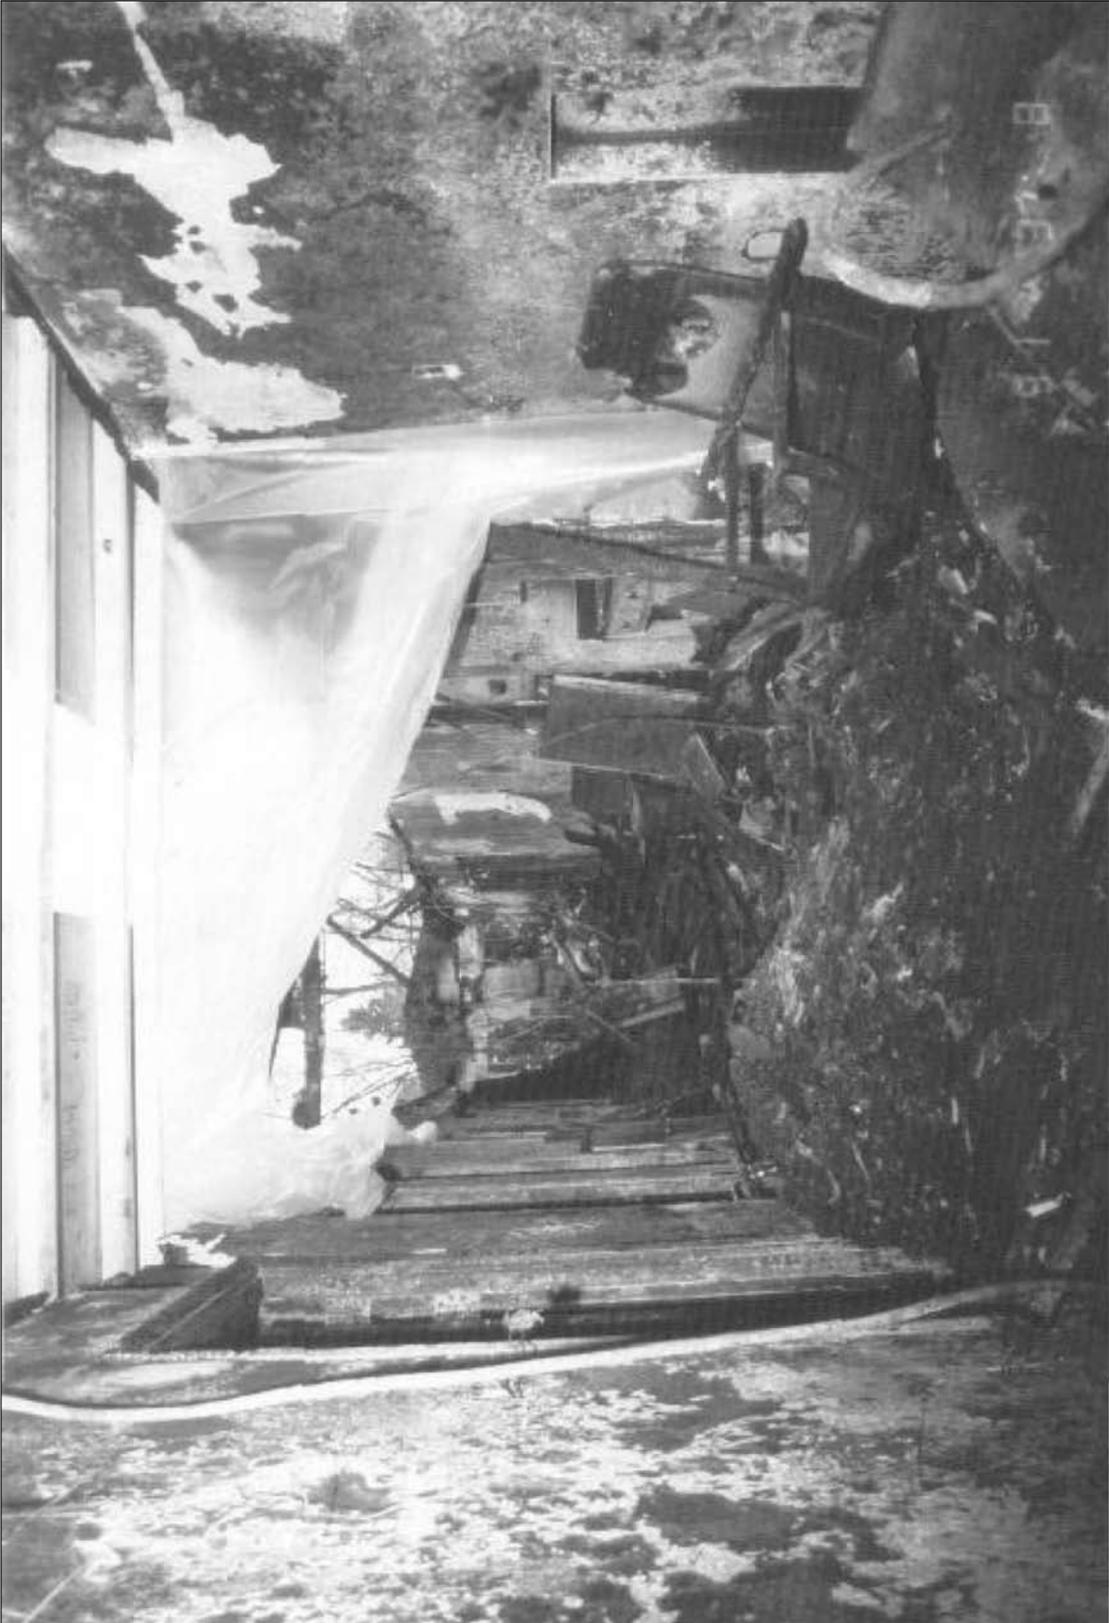
View of the east wing hall as seen from the south to the north. The smoking room where the fire began overhead is the first door on the left.

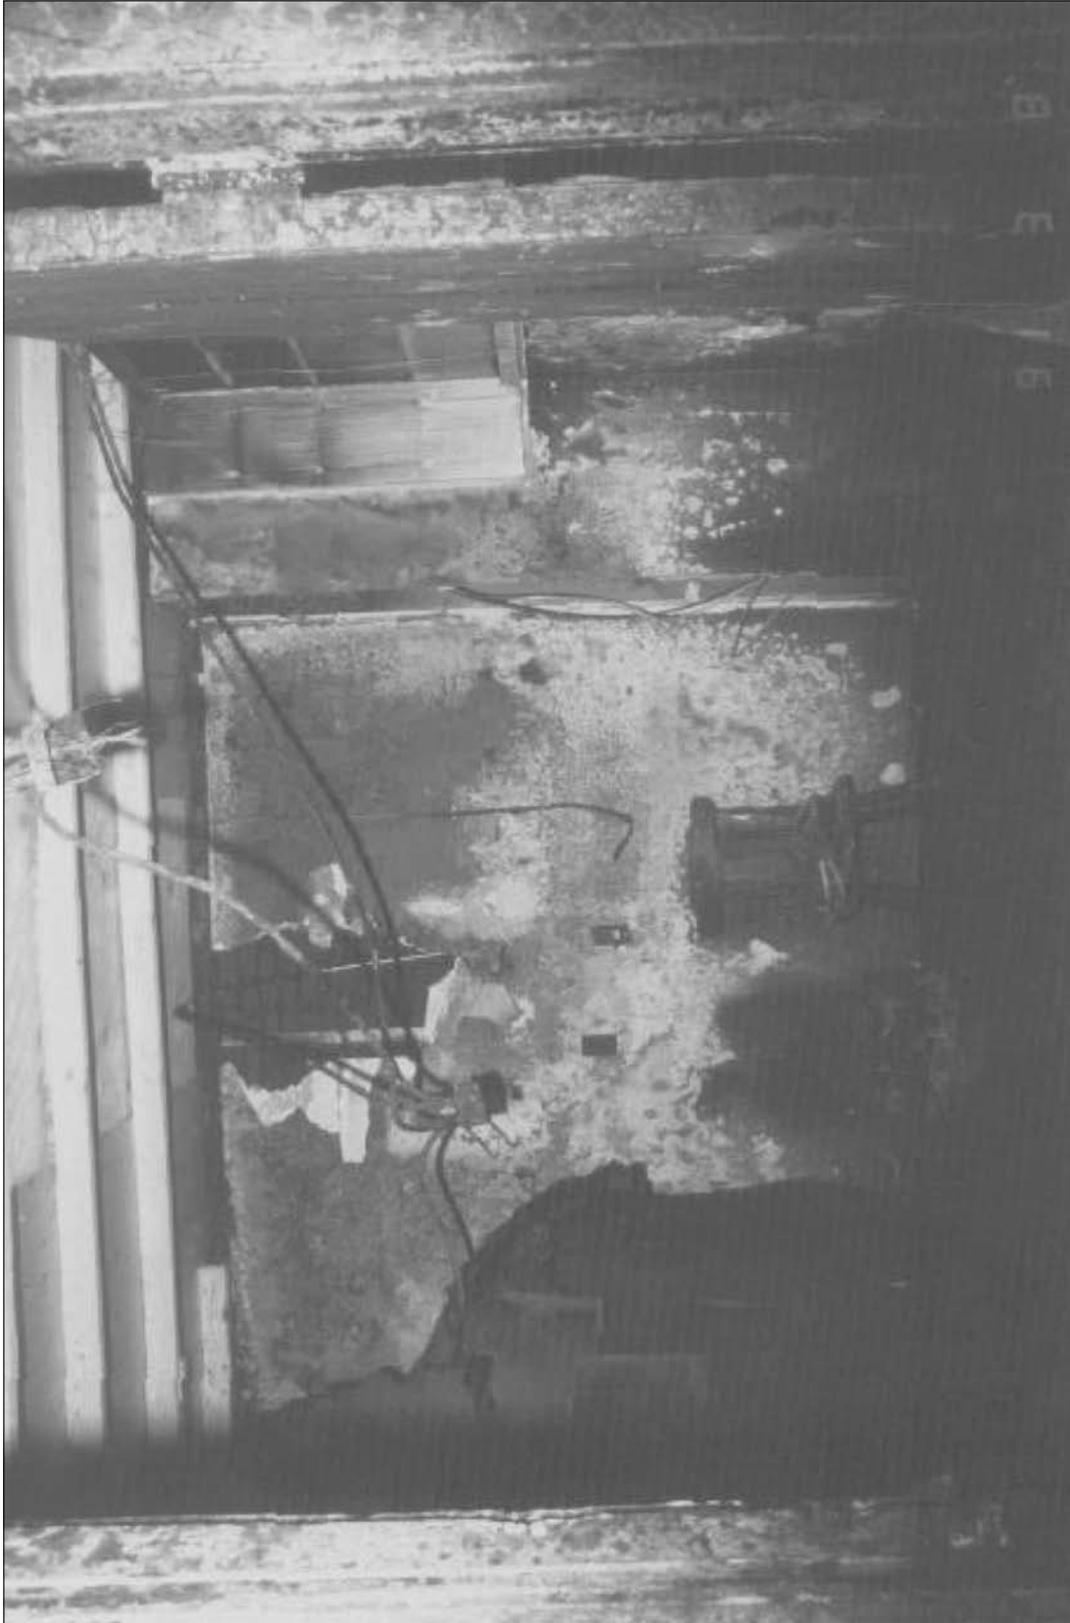
A second area of severe burning was located approximately 8' west of the exhaust fan, at the enclosure to the furnace flue extending from the basement. This flue is immediately next to the extreme east end of the dining room. The top plate surrounding this flue revealed extreme burning on the north side where a support strap

A representative of the National Fire Protection Association, upon viewing the two areas of burn, theorized that the fire burned deeply near the flue because the enclosure was open and unrestricted from the basement to the attic. This permitted a sustained flow of fresh air into the attic at this point, which allowed very hot, and efficient, burning to take place.

The smoking room. The corner to the right is the northwest corner where the vent stack to the heating unit below is located. This was thought originally to be the Area of Origin.

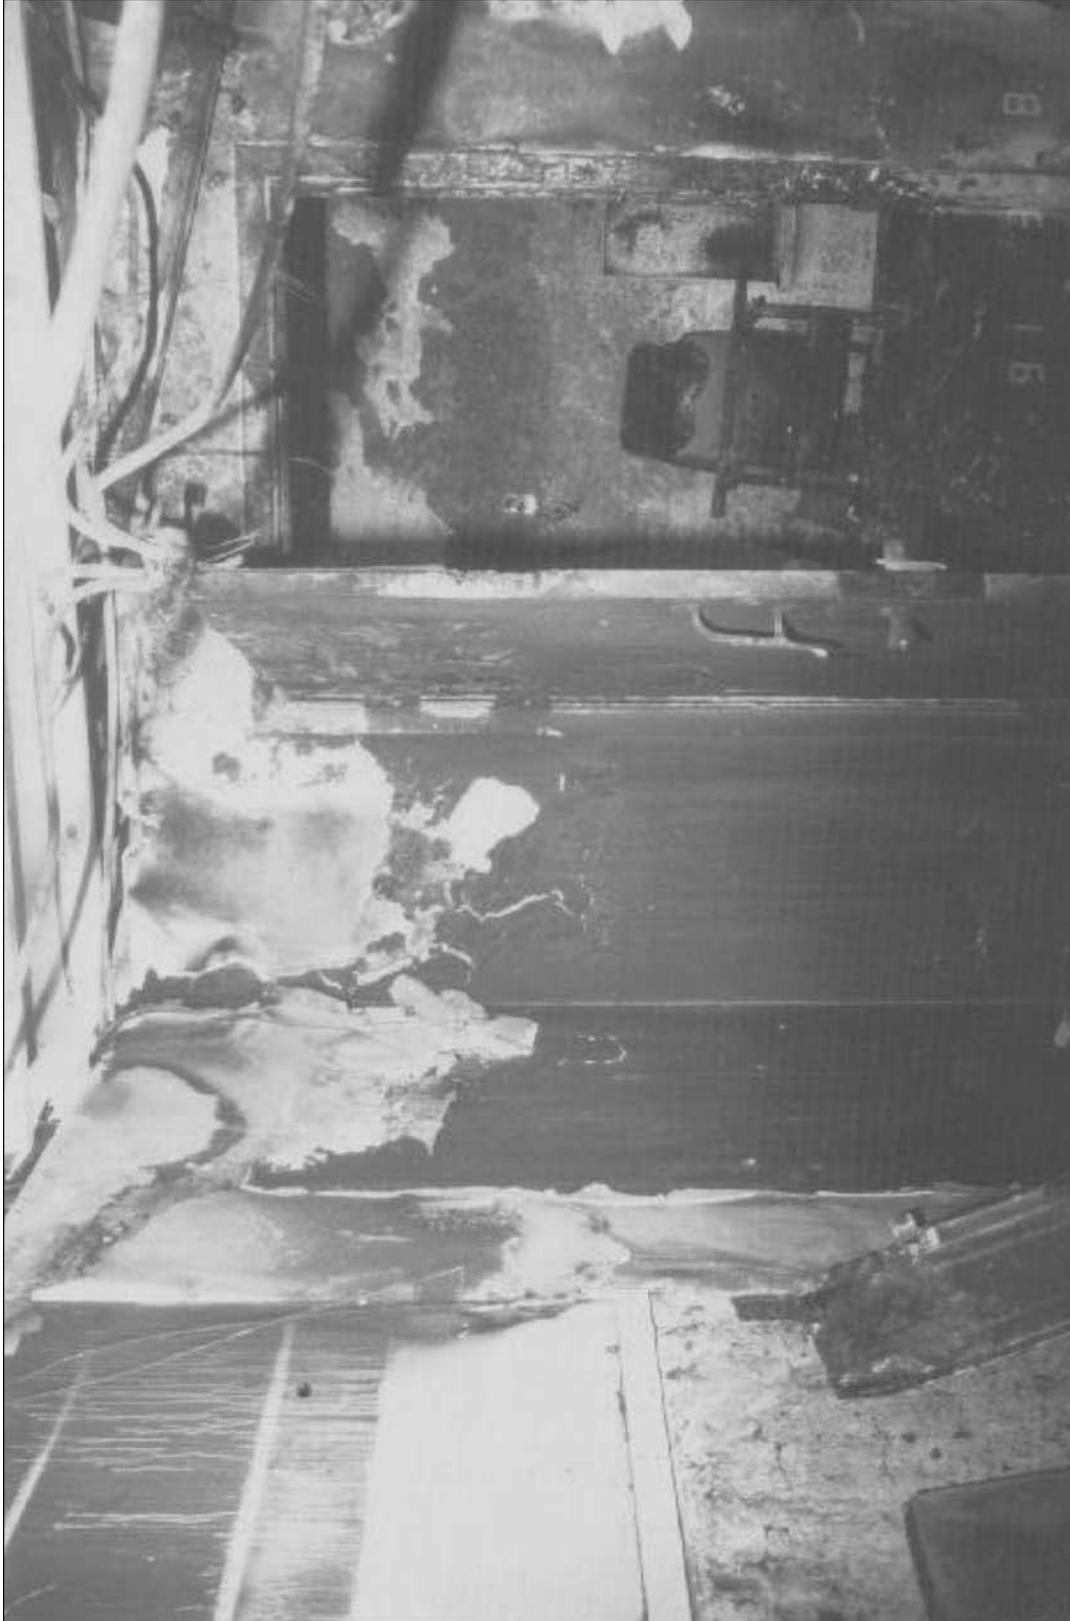
A "consumer grade" 110 volt ceiling exhaust fan, similar to that found in residential bathrooms, was recovered from the debris in the smoking room. An employee informed investigators that the ceiling fan was controlled by the overhead lighting and was very noisy. She also said the fan was present when the building was purchased by the current owners.

Closer inspection revealed that the bearing assembly to the fan showed evidence of extreme wear, with the bearing/bushing being worn into an oblong shape. An owner later stated that approximately 1 month before the fire, the exhaust fan became very noisy so someone removed the fan cover and sprayed WD-40 into the motor housing. This reduced the amount of noise the fan made.

The double 2"x 4" top plate on the north wall of the smoking room showed evidence of extreme heat and near total destruction above the location where the ventilating fan was found. Distinct burn patterns were also found on the wall beneath this area of the room's north wall. A wall mounted cabinet was also burned at its top, east edge immediately adjacent to the exhaust fan area.

An electrician inspected the circuit to the overhead lighting and exhaust fan and found them to be powered by the only 15 amp circuit breaker in the electrical panel. The breaker was tripped sometime during the fire and showed evidence of extreme internal heat. The electrician stated the breaker was no longer functional and indicated that it may have been operating very near its capacity for a long time. Adjacent breakers showed no signs of heat and appeared to remain functional.

View of the northeast corner of the smoking room. The light switch behind the door (just under the white spot in the center) controlled the fluorescent lights and the ventilation fan. The fan was located in the northeast corner. When the lights were on the fan was on. Since the switch location was difficult to get to, the lights and fan stayed on for hours and sometimes days at a time.

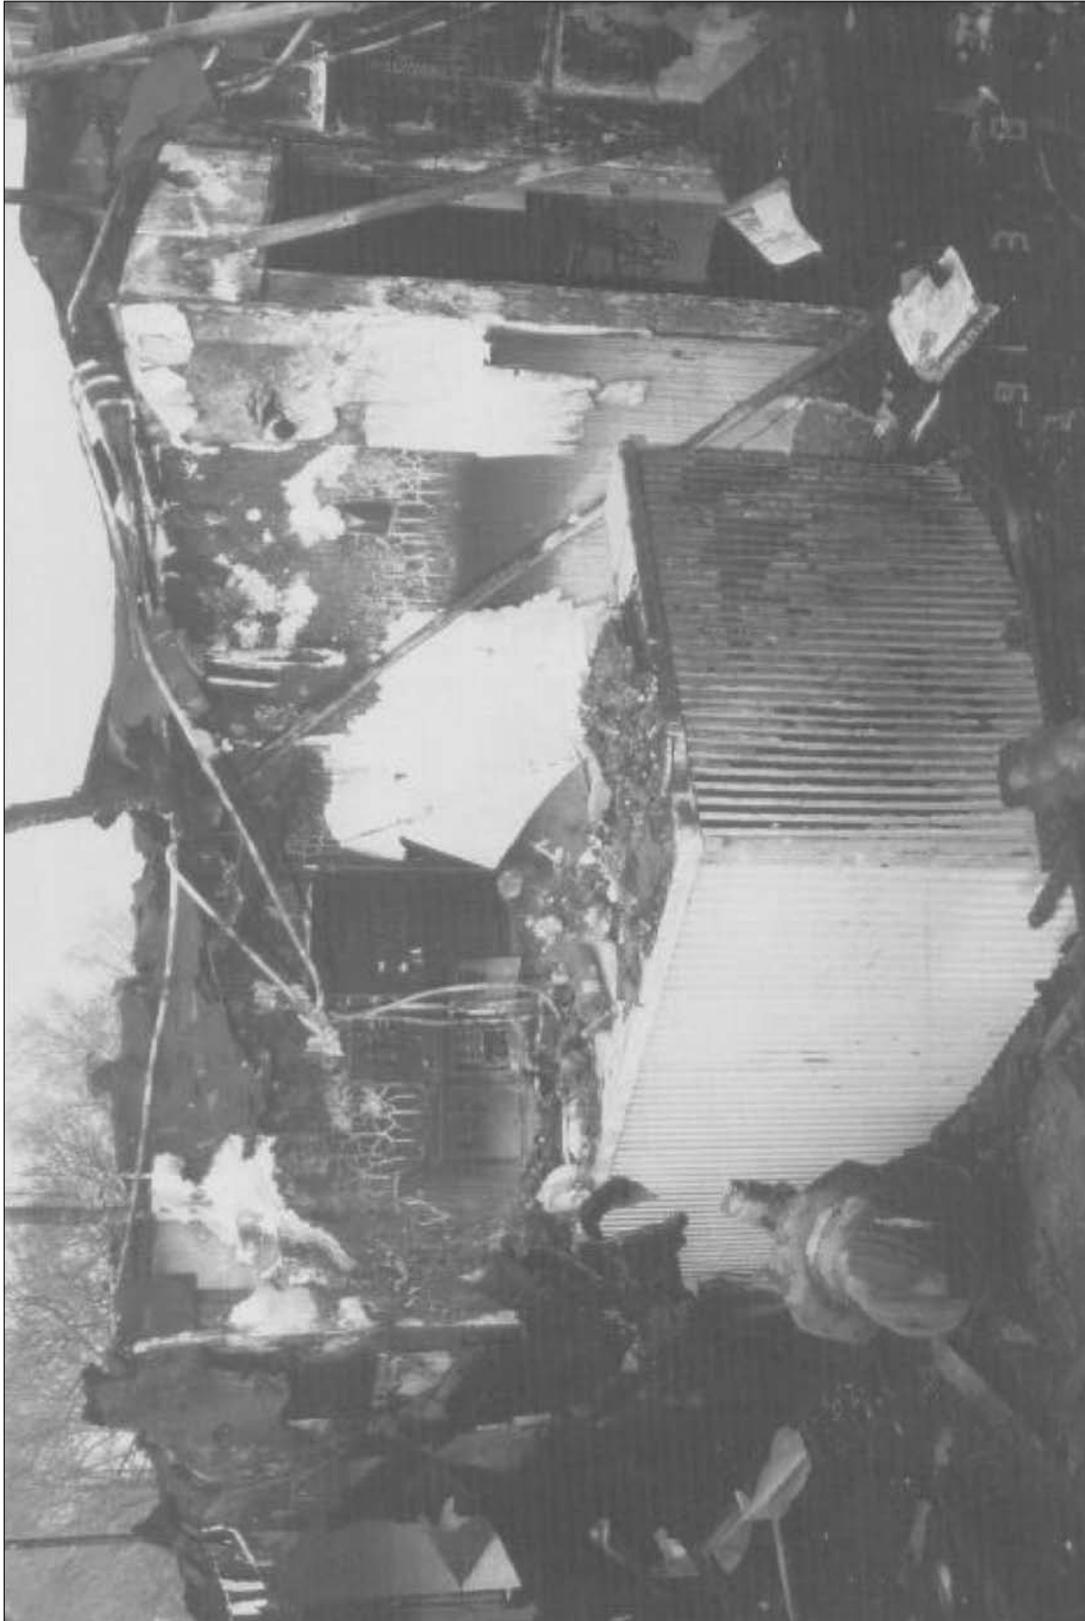
Nurses' station just inside the front (southwest) door. The alarm panel is at this station. View is toward the northeast.

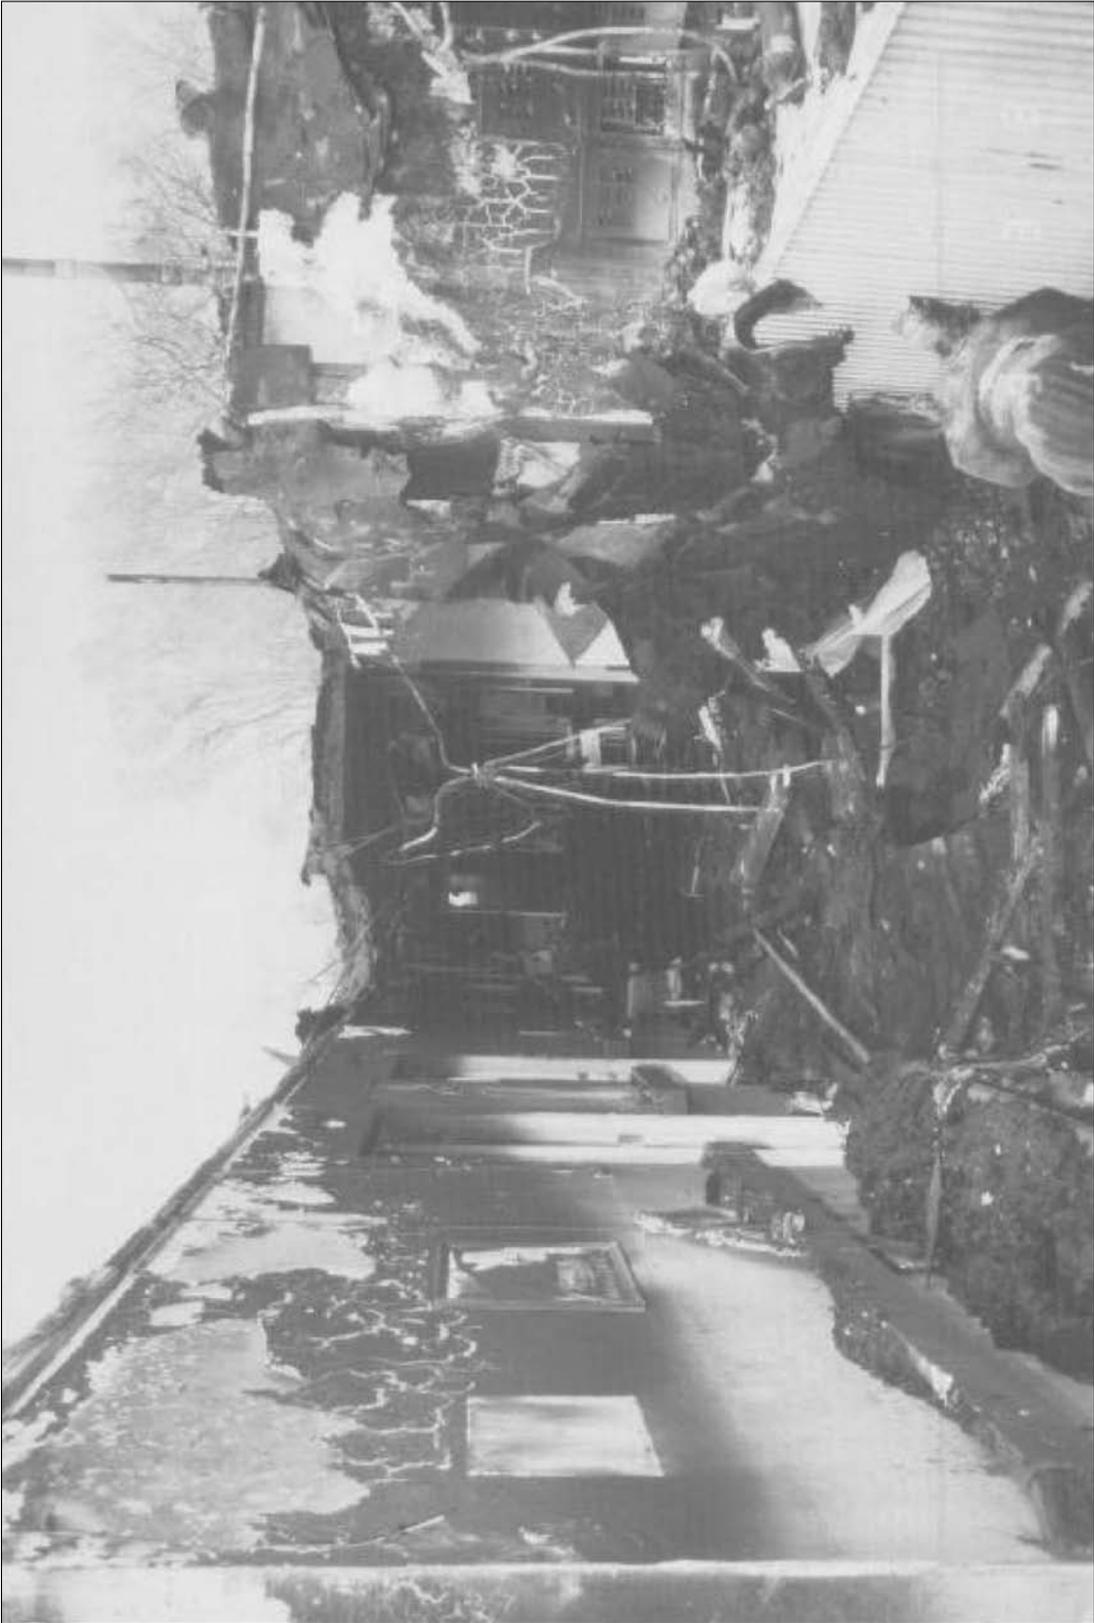
Looking north from the entry area by the nurses' station down the hall. Note all overhead framing was destroyed.

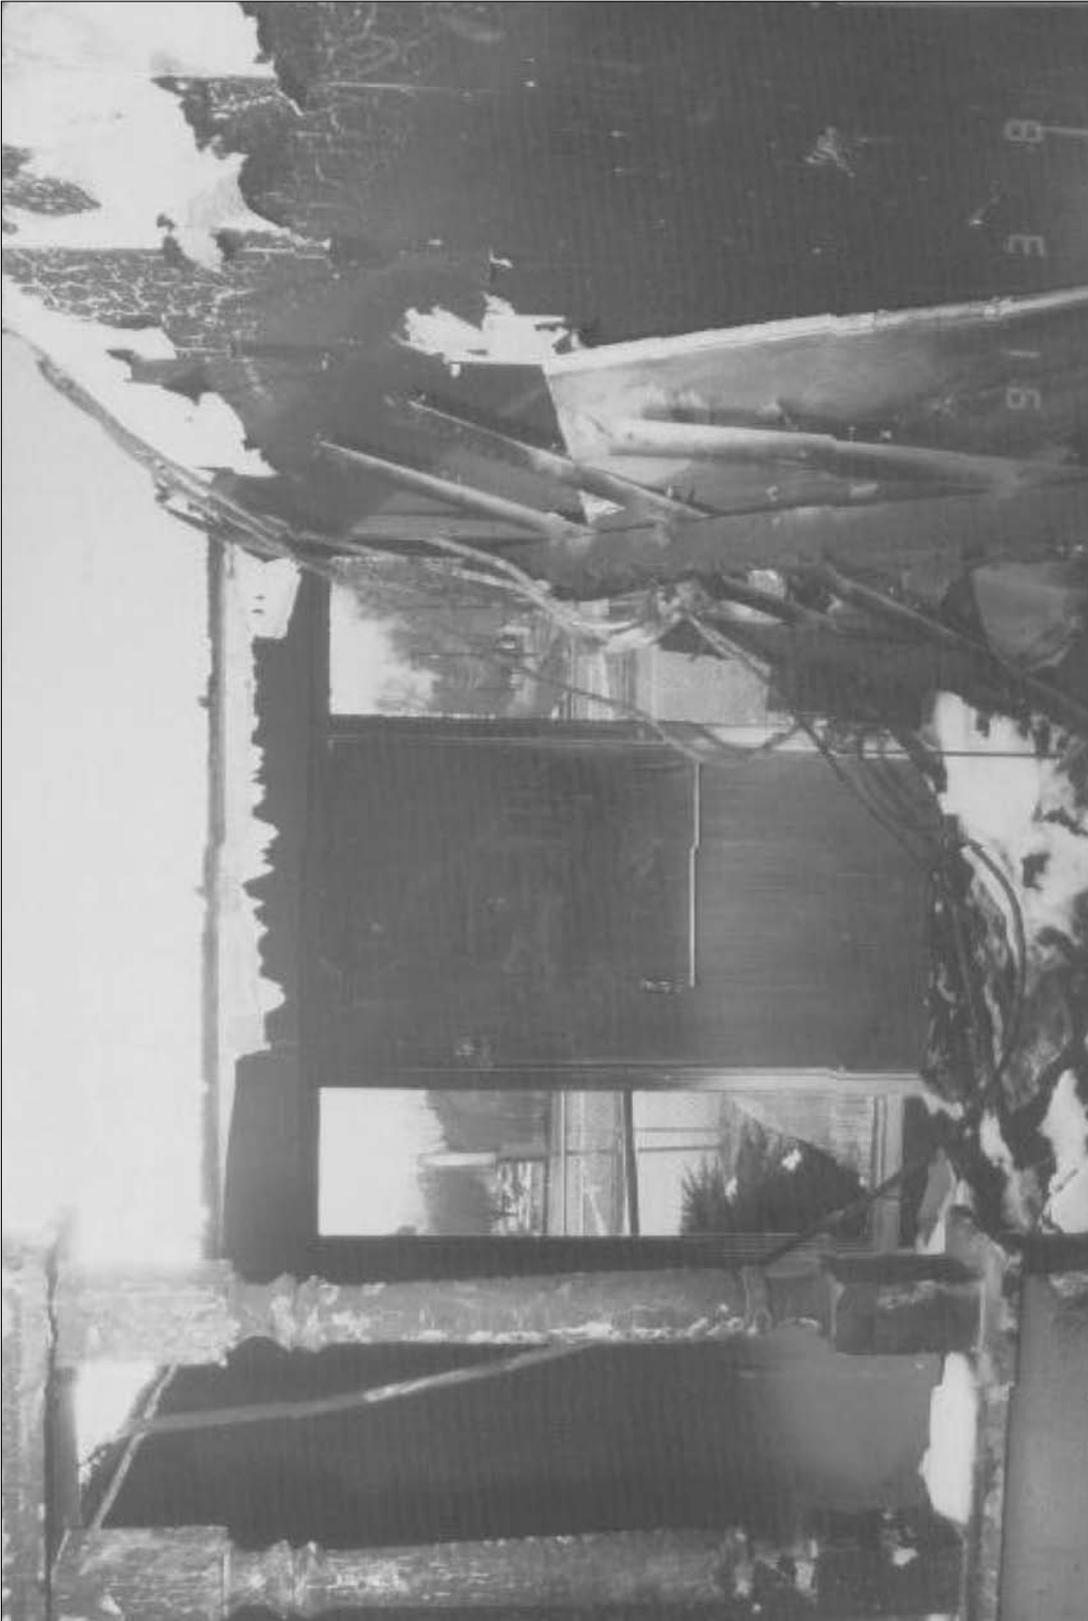
Front door through which initial interior attack was made, located at the southwest corner of the structure. View is from the interior toward the west.

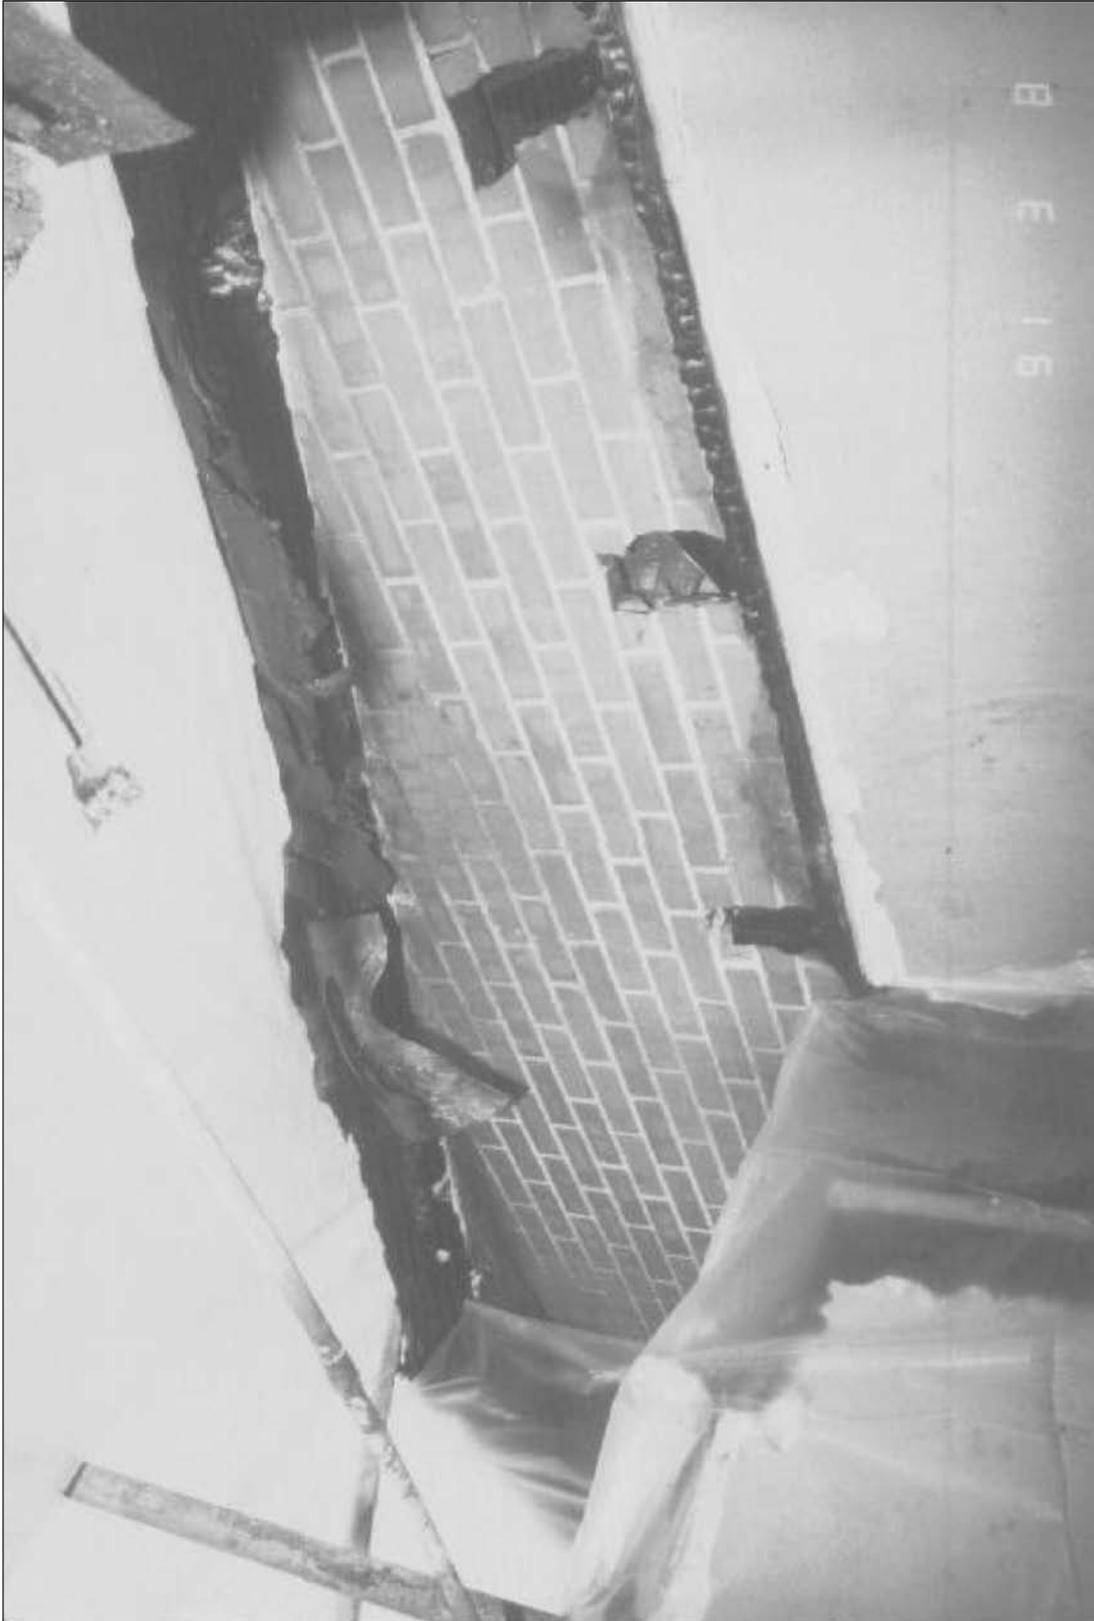
However, the actual structure did not have safety features that originally were thought to be there; in particular, properly rated and designed firewalls. A wall at the east end of the dining area was thought at first to be a firewall, however, closer inspection revealed that a tongue-in-groove ceiling extended over the top leaving exposed wood to the outside. A cinder block wall was constructed adjacent to it, but the integrity of the wall was breached when holes were punched in, in order to allow the ceiling joist for the east addition.

The east wall of the dining area. Note where holes have been punched in to put joists through. There was a cinder block wall behind this, but tongue-in-groove boards extended over the top exposing the boards to the brick area. Integrity of the firewall was breached from the holes and overlap of wood material.

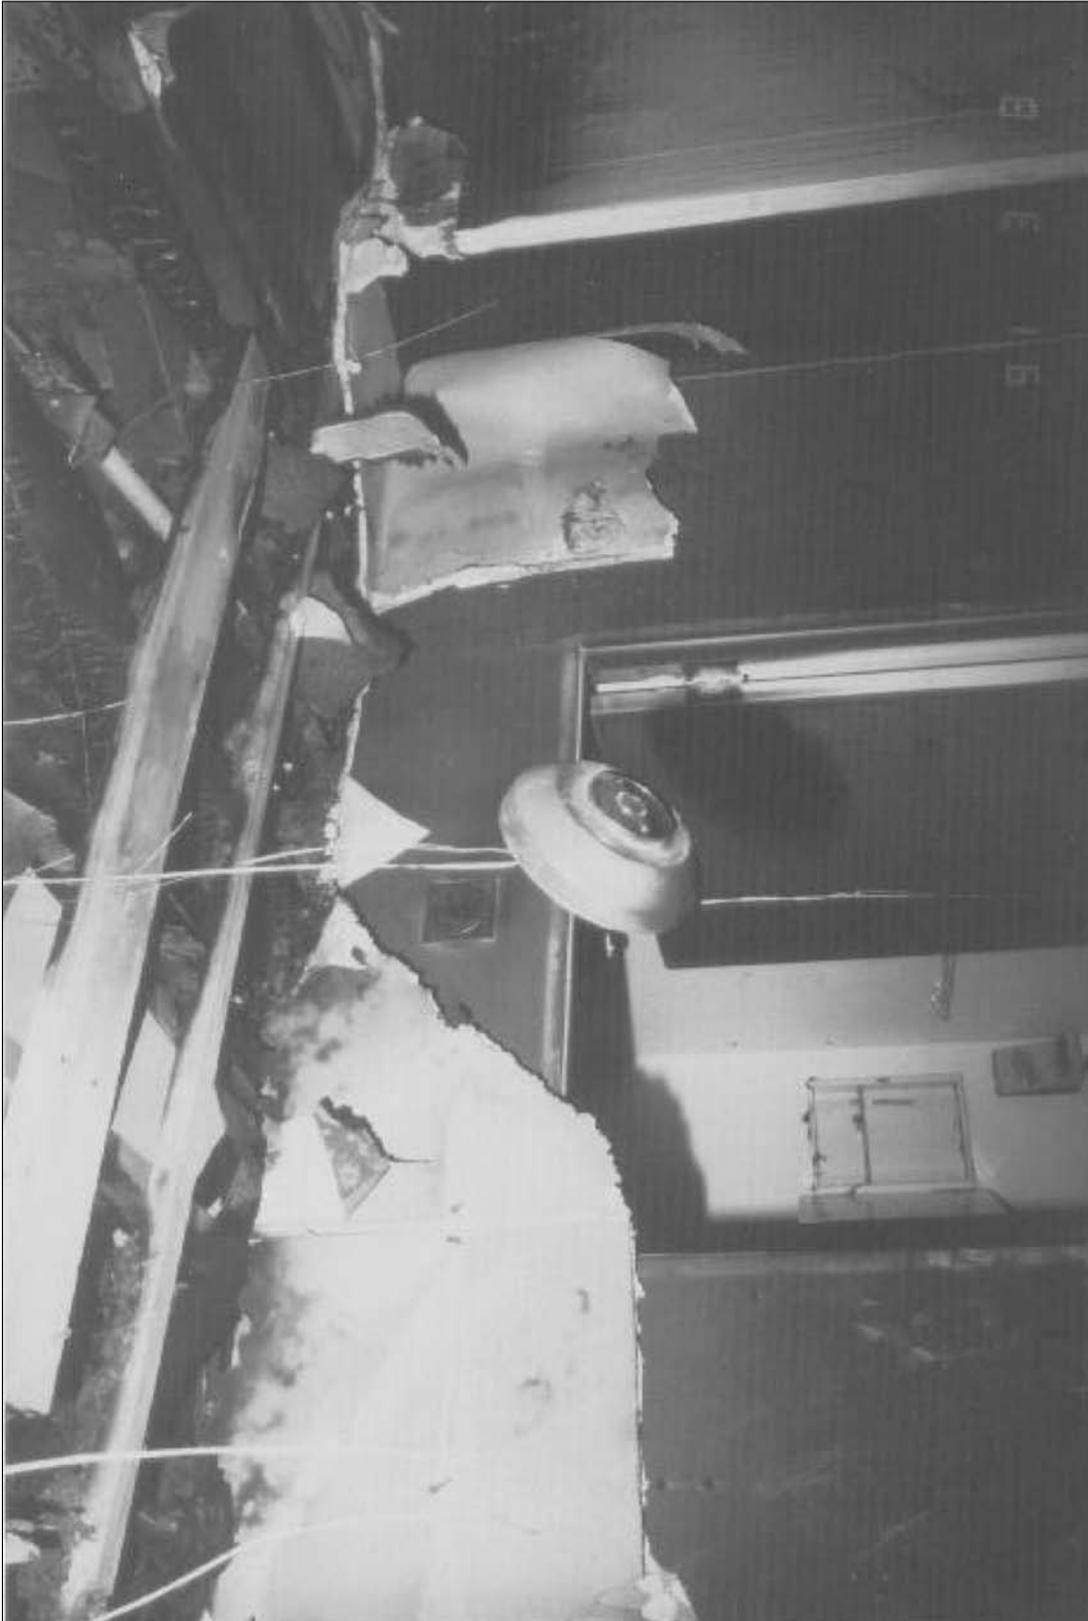
It also appeared all systems were hard-wired and were not battery backed.

Older existing smoke alarm in the structure, hard-wired, no battery backup.
