Ten Elderly Victims From Intermediate Care Facility Fire

Colorado Springs, Colorado

USFA-TR-050/March 1991

Ten Elderly Victims from Intermediate Care Facility Fire Colorado Springs, Colorado March 1991

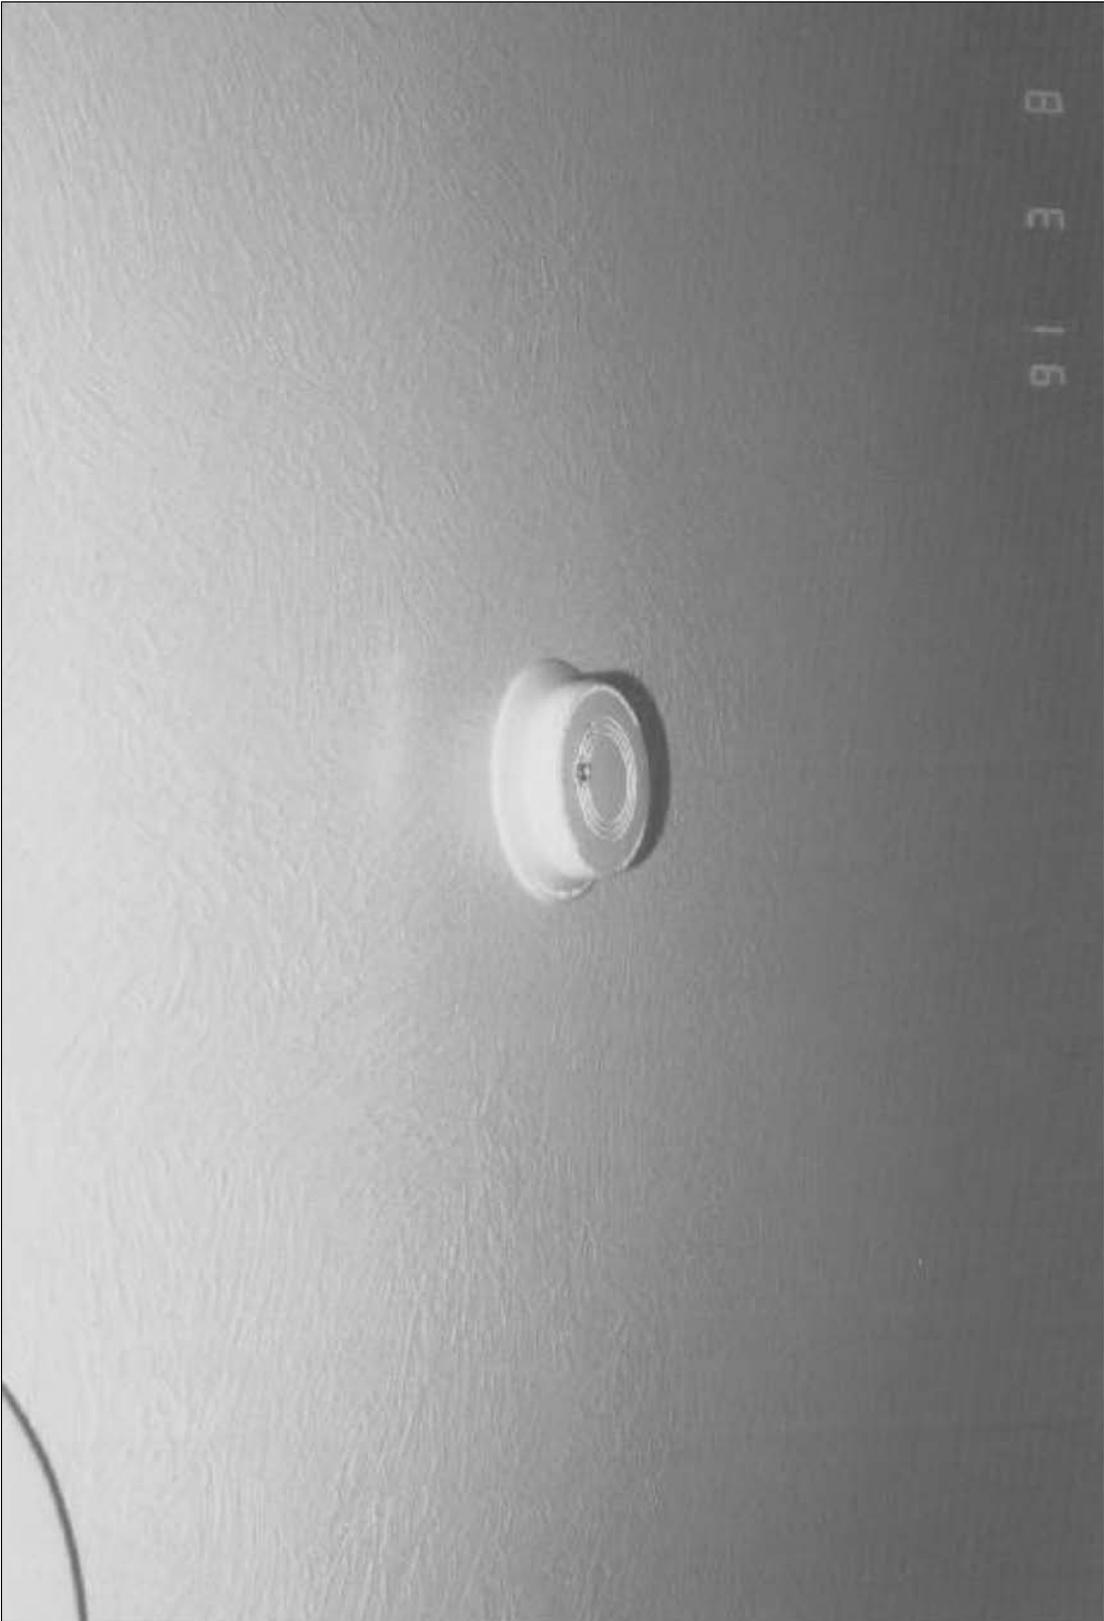
To satisfy the requirements of the State Health Department, an electrician installed 12 additional smoke detectors in the dining room and hallways approximately 1 week before the fire. These ionization detectors were interconnected so the activation of any detector would cause all 12 to sound an audible alarm. This 110 volt system received power through a separate circuit and was designed to sound a "local alarm" only. After verification of an emergency, a staff member must activate a pull station to send an alarm to the alarm monitor.

Photo by Jack Yates
New smoke alarm installed approximately one week prior to the fire in order to be in compliance with State regulations.
