\$12 Million Dollar Fire at Dogwood Elementary School

Reston, Virginia

November 2000

This is Report 135 of the Major Fires Investigation Project conducted by Varley-Campbell and Associates, Inc./TriData Corporation under contract EMW-97-CO-0506 to the United States Fire Administration, Federal Emergency Management Agency, and is available from USFA WEB Page at <http://www.usfa.fema.gov>.

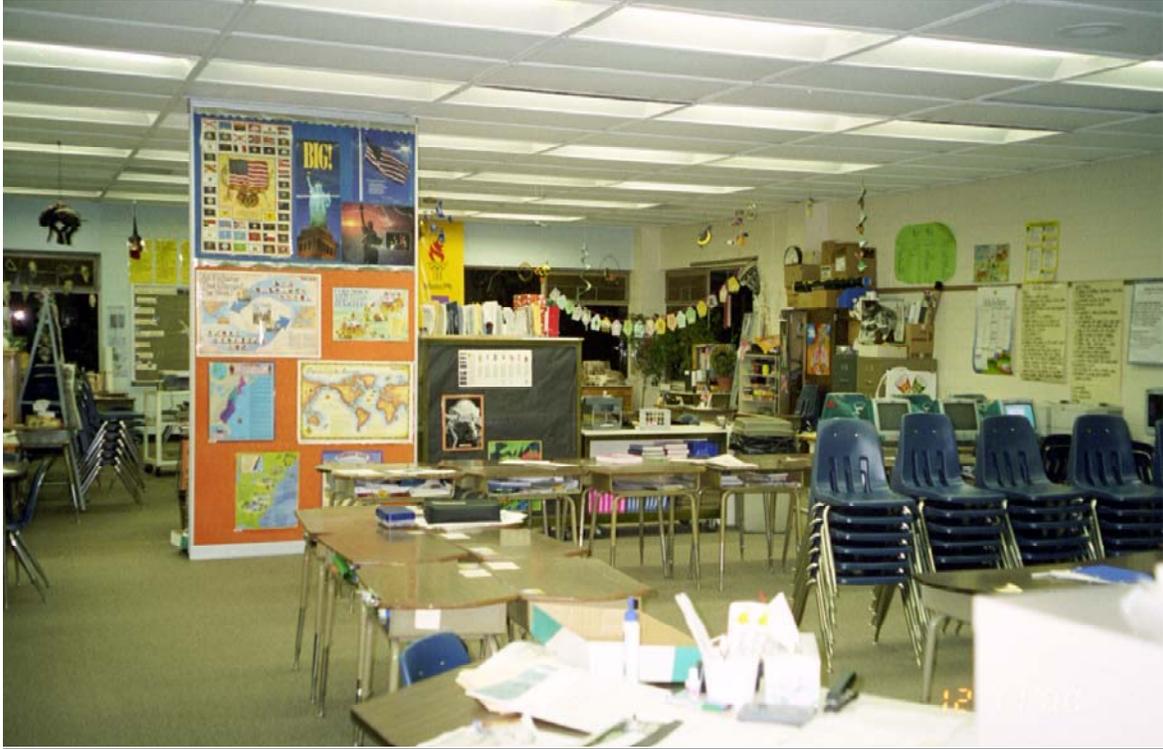
Figure 1. View of three classrooms characteristic of the “open classroom forum” design.

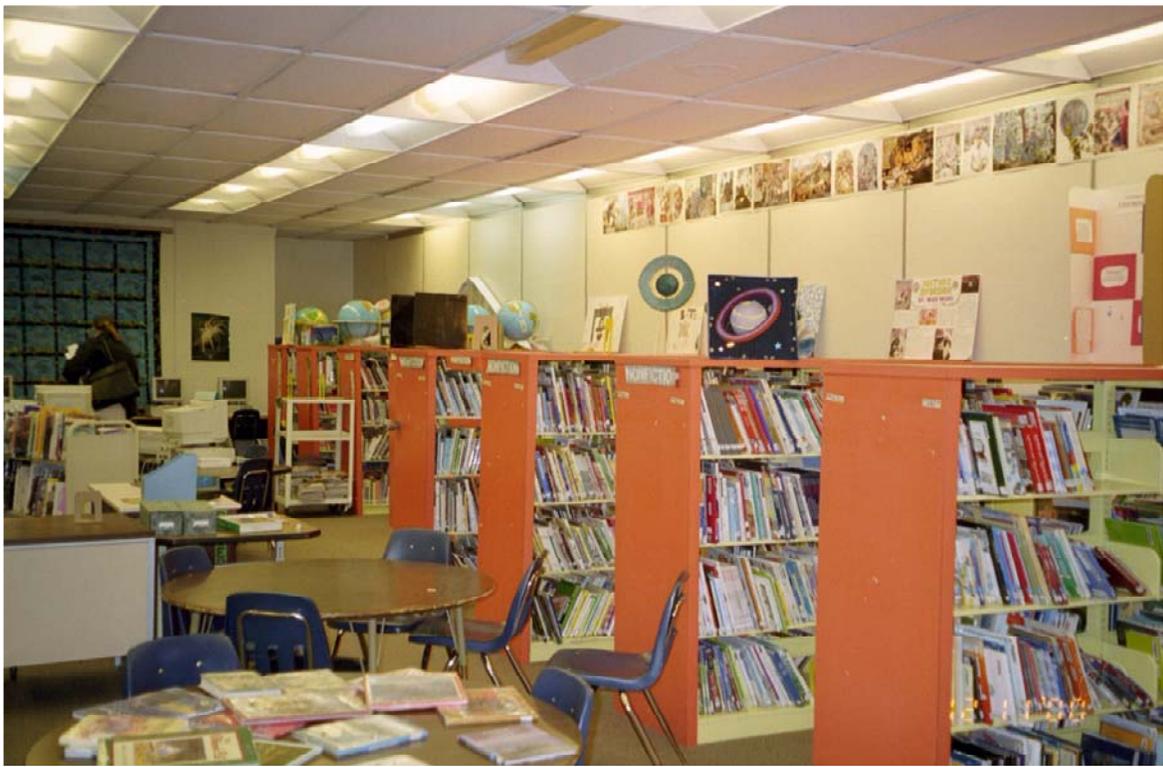
Figure 2. Library area of a similar school

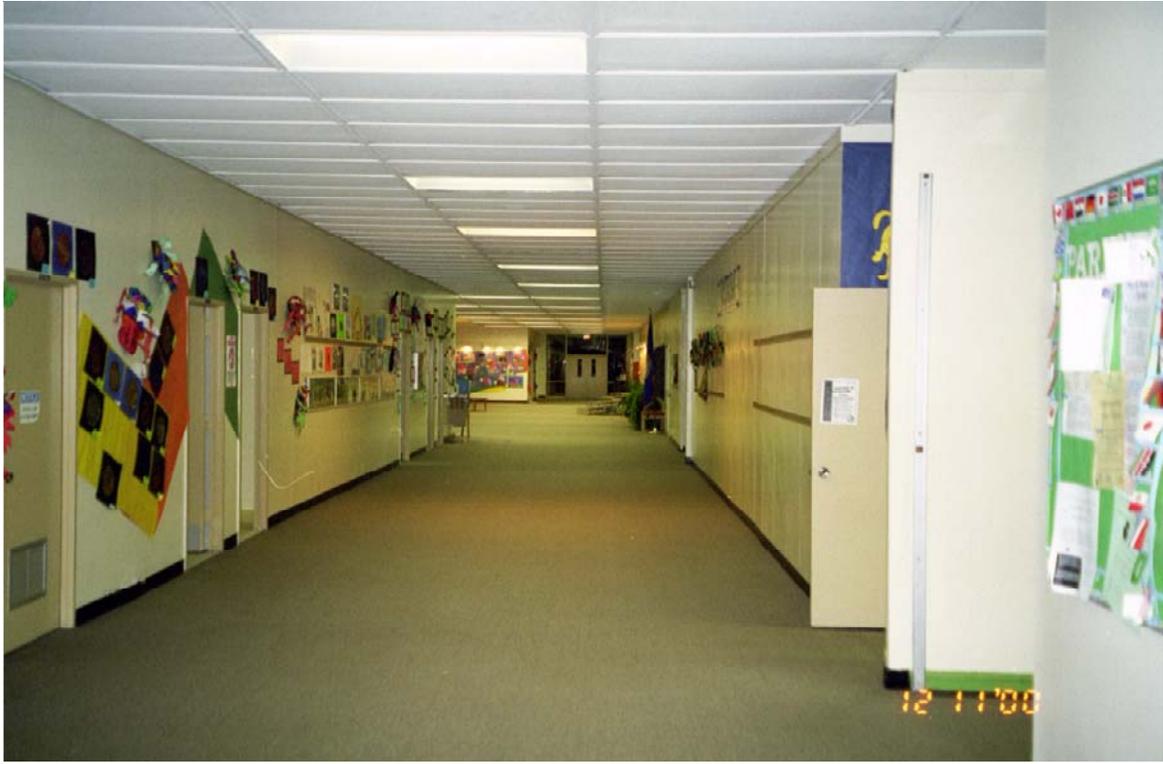
Figure 3. View along hallway of local school with similar “open classroom forum” design. Note use of “demountable” partitions for room and hall definition.

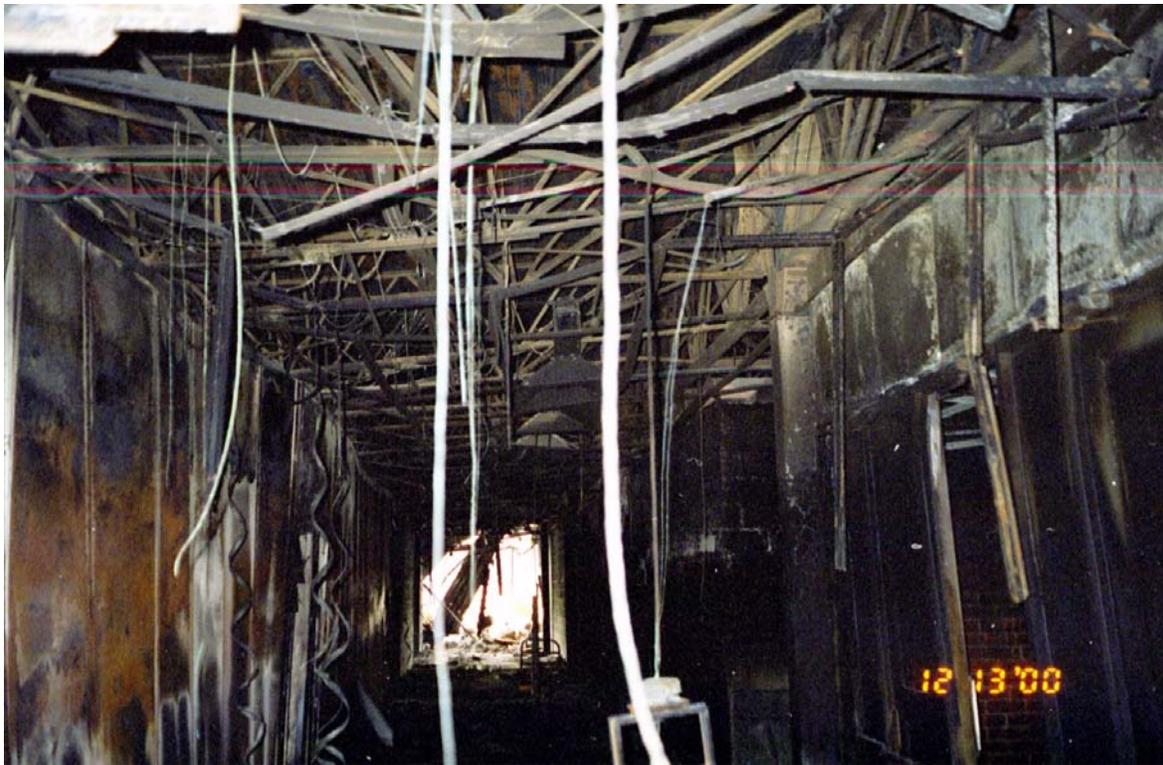
approximately 360,000 ft.³ (volume). In this configuration, the plenum was open from one end to the other (Appendix C, Figure 4)—creating an ideal environment for rapid fire extension throughout the school.

Figure 4. Similar hallway in non-collapsed portion of Dogwood Elementary School after fire. Collapse of ceiling tiles has exposed bar joists (spanning hallway) and girders in plenum area.

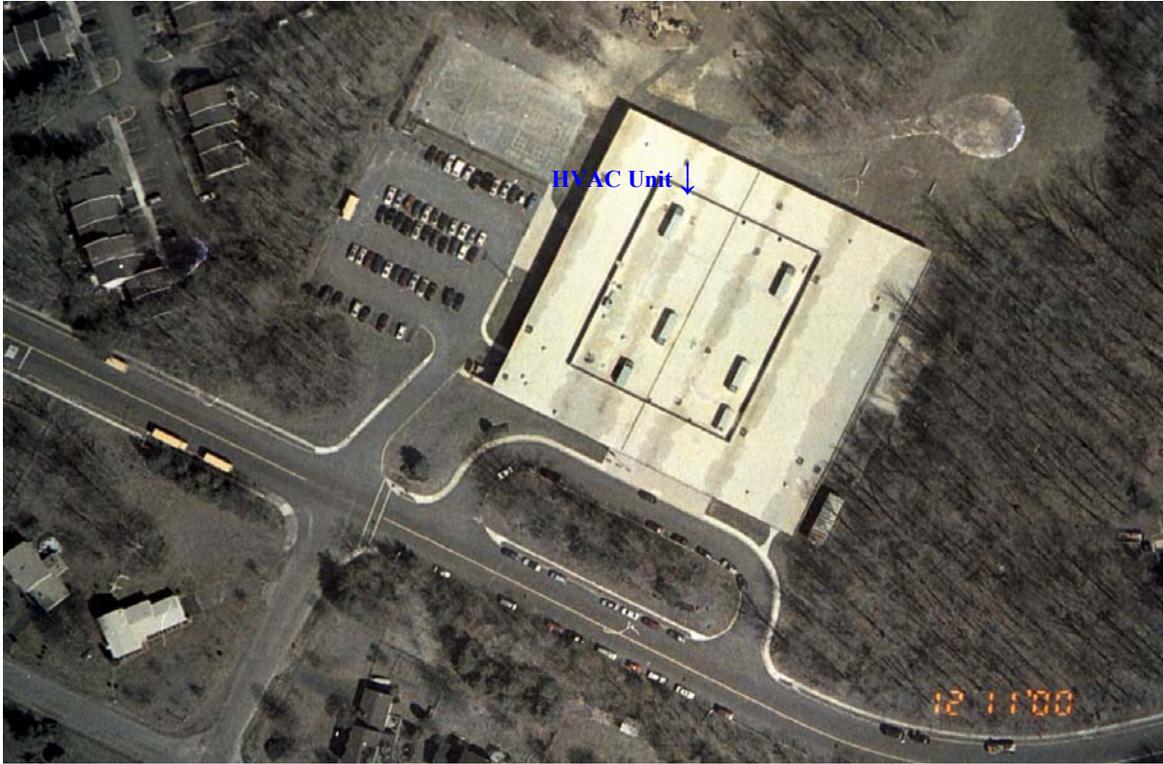
Load-bearing columns were positioned 30 feet apart in the approximate north-south directions of the school and were spanned by girders. The columns were spaced 60 feet apart in the perpendicular direction and were spanned by bar joists (Appendix C, Figure 4). The columns were comprised of 8-inch square tubular (welded) wrought steel of quarter-inch wall thickness, and girders of 3/8" wrought steel. Seven HVAC units were positioned on the building rooftop. The HVAC unit above and closest to the probable area of origin (indicated in Appendix C, Figure 5) and similar to five of the other six HVAC units on the roof, weighed 4 ¼ tons. An aerial view of the school, both before and after the fire, can be found in Appendix C, Figures 5 and 6. Appendix C, Figure 9, shows a post-fire view of the debris under the area of the HVAC unit indicated in Figure 5.

The rapidity of propagation, due primarily to almost unlimited fuel and ventilation availability, caused such extensive damage that Dogwood Elementary was declared a total loss, valued at \$12 million. The location of seven HVAC units on the roof, most weighing 4 ¼ tons, combined with the overhead presence of other heavy gauge steel structure and drainpipe, significantly accelerated structural collapse.

Figure 5. Aerial view of Dogwood Elementary School before fire, with HVAC unit closest to fire origin indicated. HVAC unit, one of 7, weighed 4 ¼ tons.

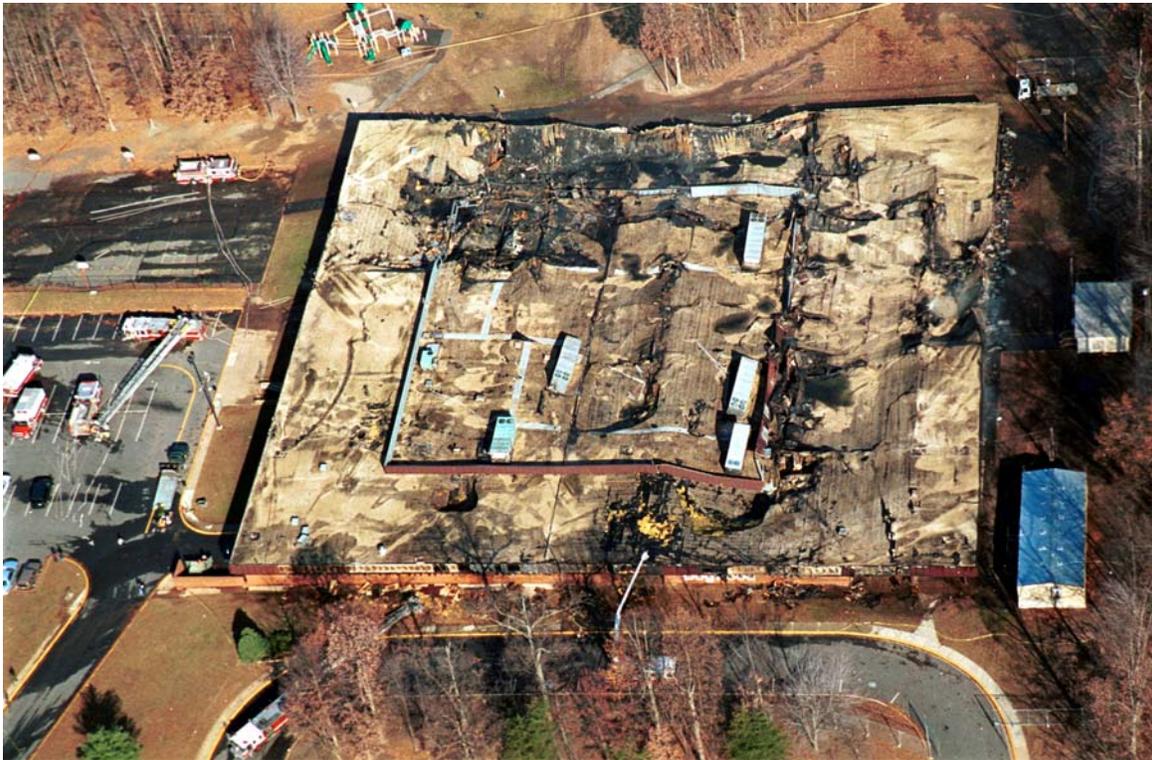
Figure 6. Aerial view of Dogwood Elementary School after the fire.

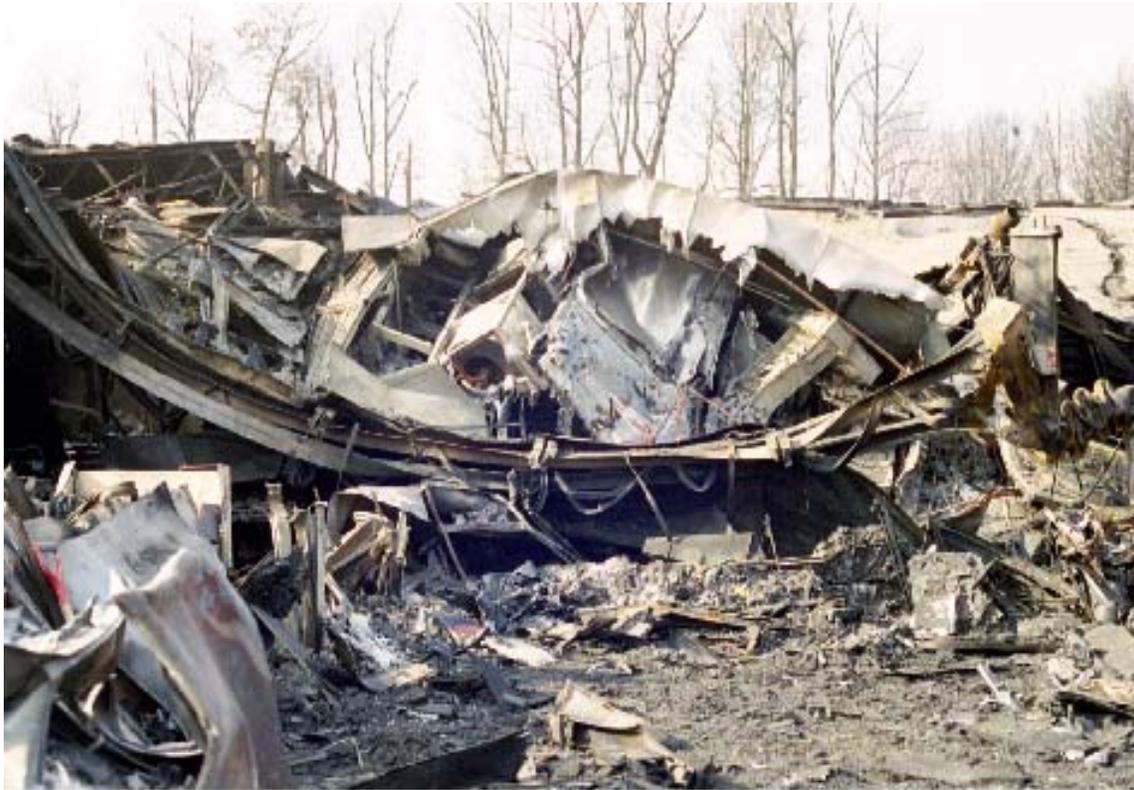
Positioning seven HVAC units weighing nearly 4 ¼ tons each on the school’s roof dramatically accelerated structural collapse due to the inverse relationship of the structural steel yield stress to temperature. This phenomenon is known as creep, where a metal can yield at stresses much below its normal yield strength when subjected to elevated temperatures (above approximately 1000° F) while under load.

Figure 9. HVAC unit (arrow in Figure 5) after fire, viewed from northeast.

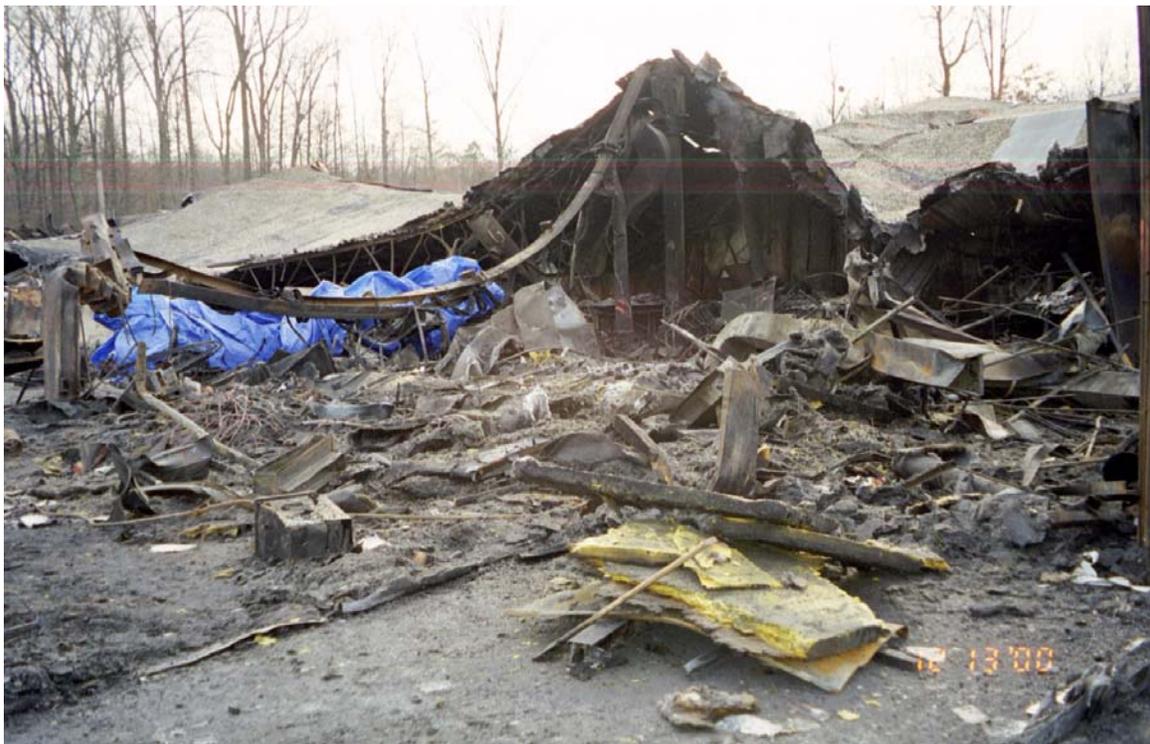
Figure 10. View of collapsed truss and accordioned support column (left side of picture)
