# Santana Row Development Fire

San Jose, California

USFA-TR-153/January 2004

**AUGUST 19, 2002**

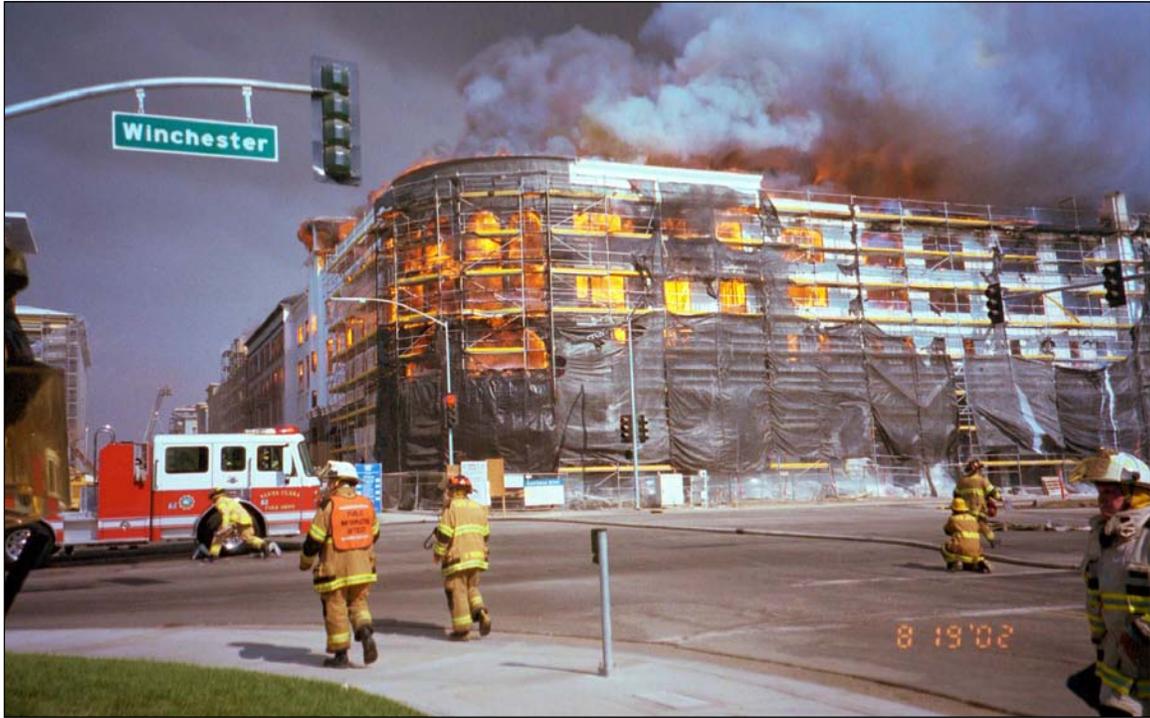
1. Fully involved corner at intersection of Winchester

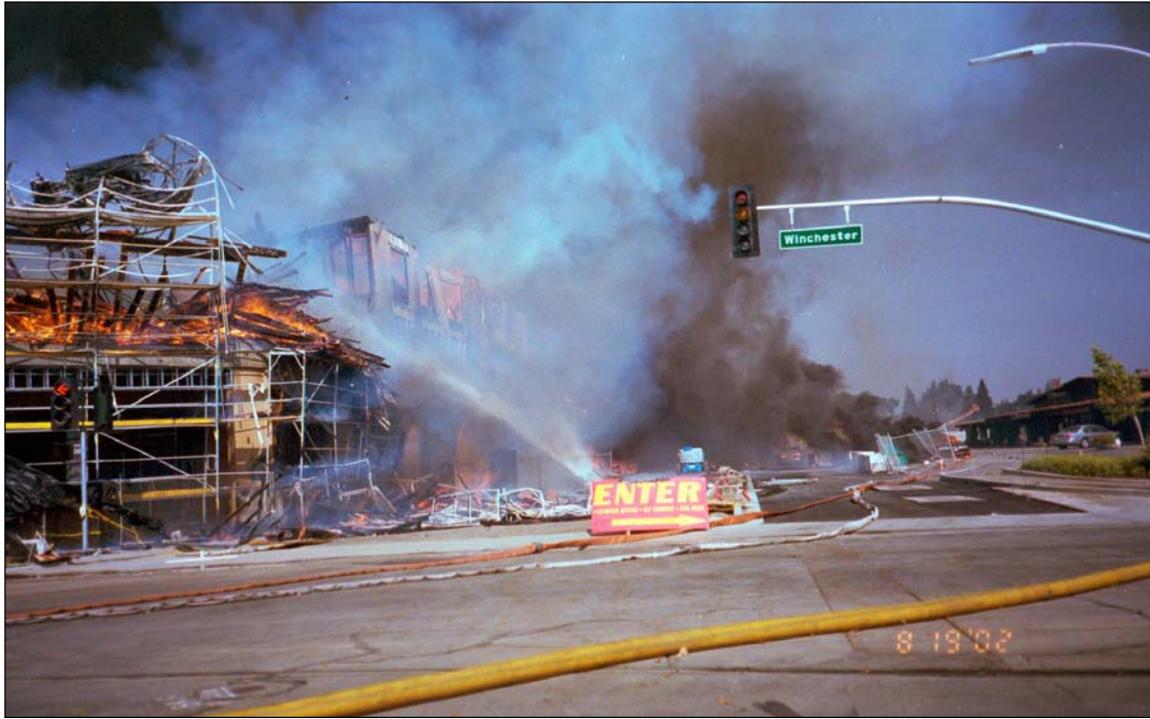
2. Building collapse, burning exposures, master stream, and supply line

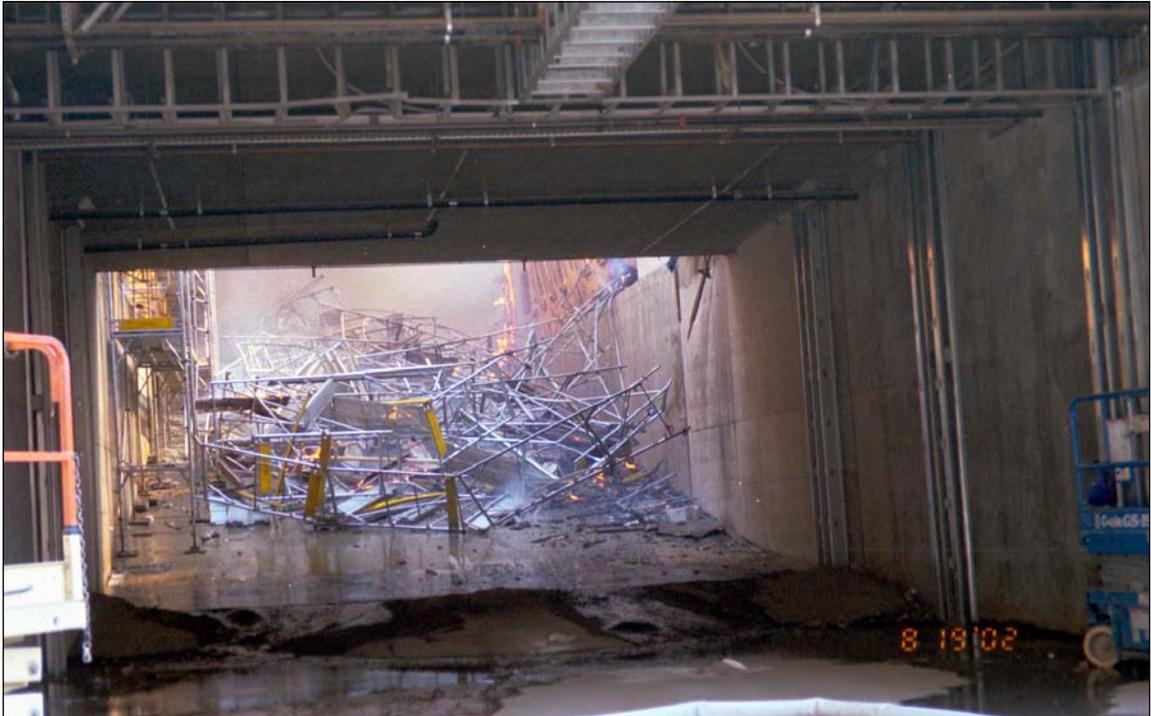
3. Collapsed scaffolding in access ramp

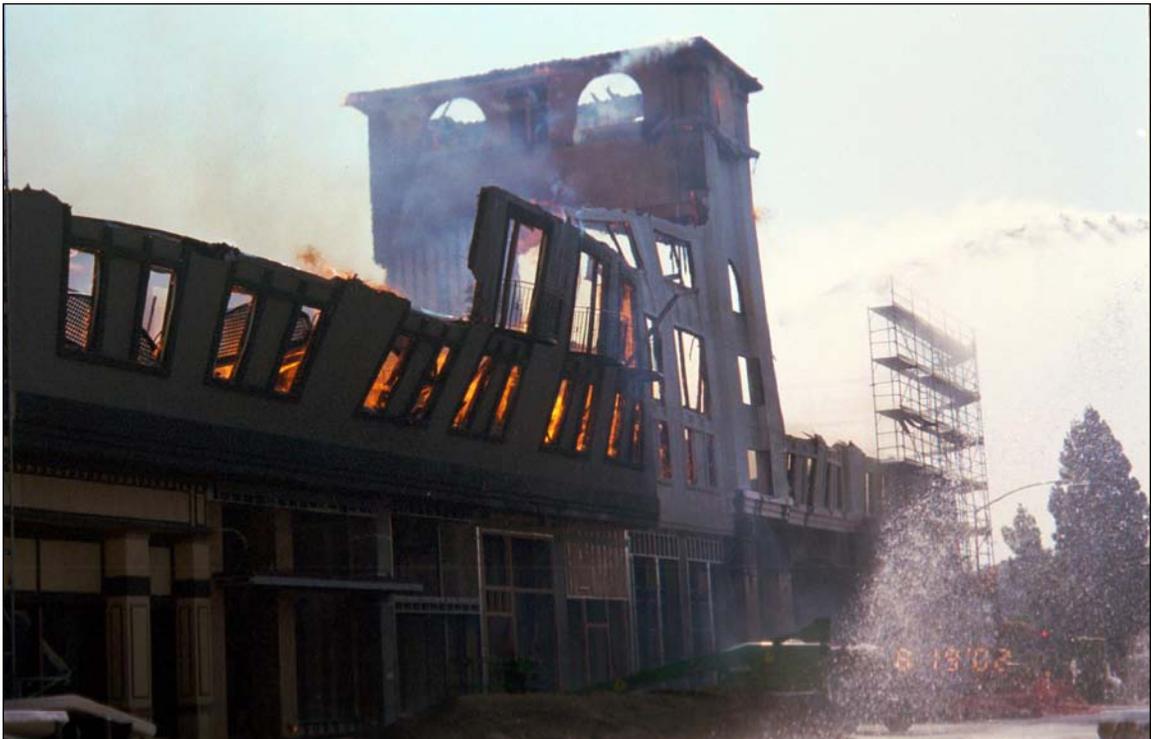
The building was completely surrounded by scaffolding, which was in direct contact with the flames. Fearing a collapse, Command ordered the establishment of collapse zones around the perimeter of the building, which were taped off. Even though ordered to stay out of these zones, some firefighters ignored the dangers and walked into the potential collapse areas. A number of collapses did occur, but no one was injured as a result. Flying embers and radiant heat ignited vehicles, forklifts, portable toilets, and dumpsters. The main office building for the project, located at 400 South Winchester, also sustained fire damage.

4. Building collapse

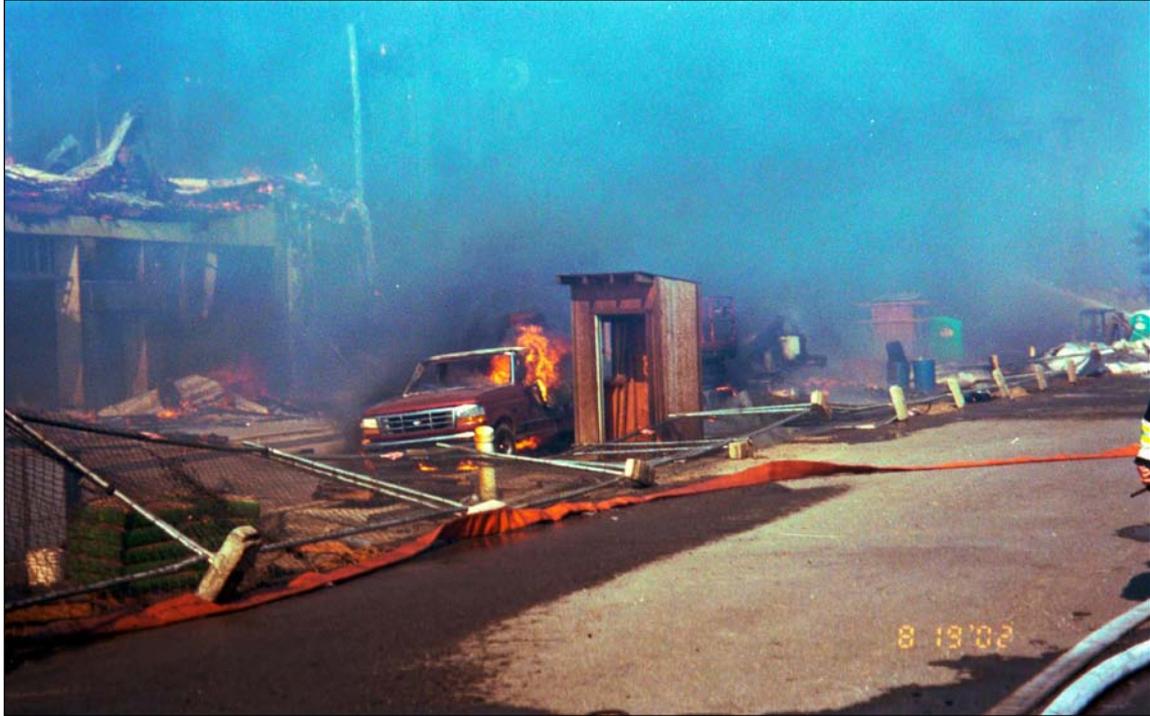
5. Exposure fire: burning vehicle

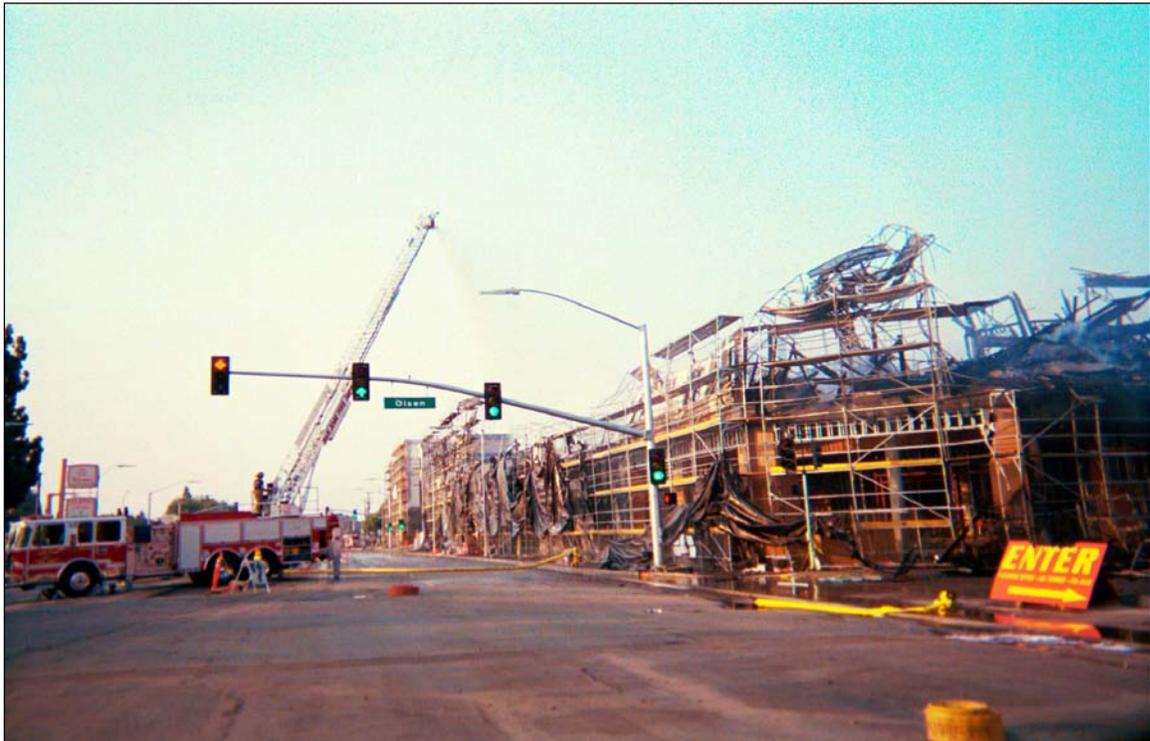
The investigation focused primarily upon interviews with witnesses and suspects because of the total destruction of the complex. All of the combustibles were destroyed above the twenty-foot level. Nearly five million board feet of lumber were consumed

6. Aftermath of destruction

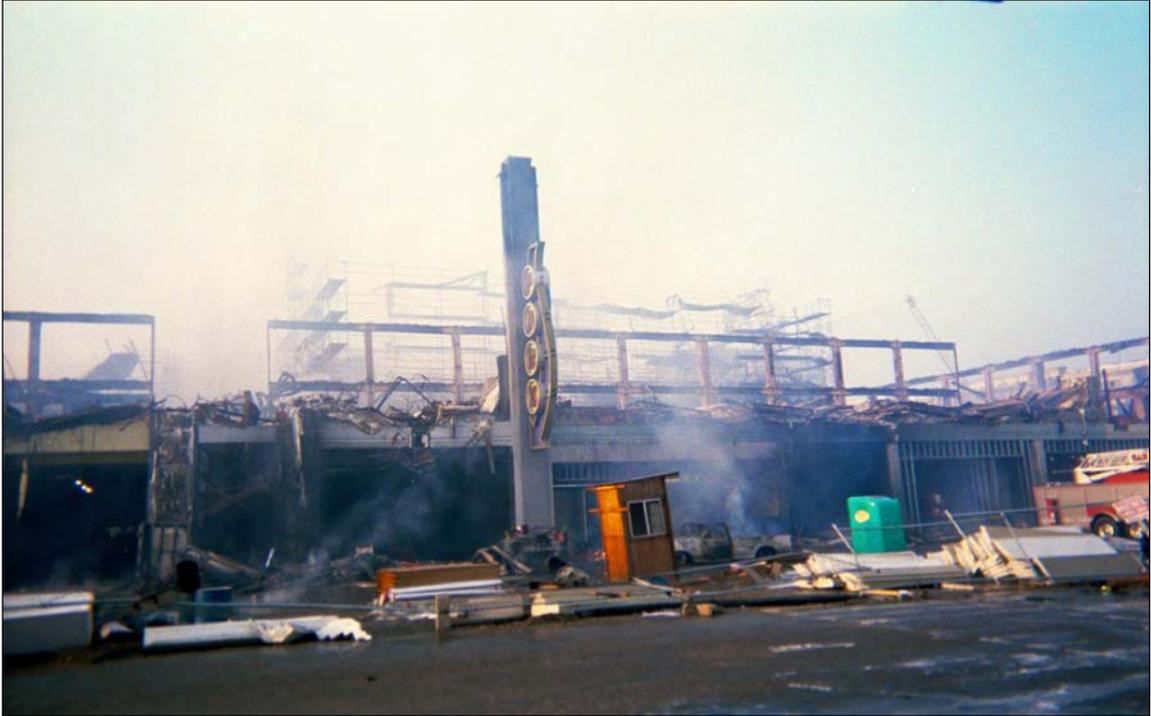
7. Another view of destruction

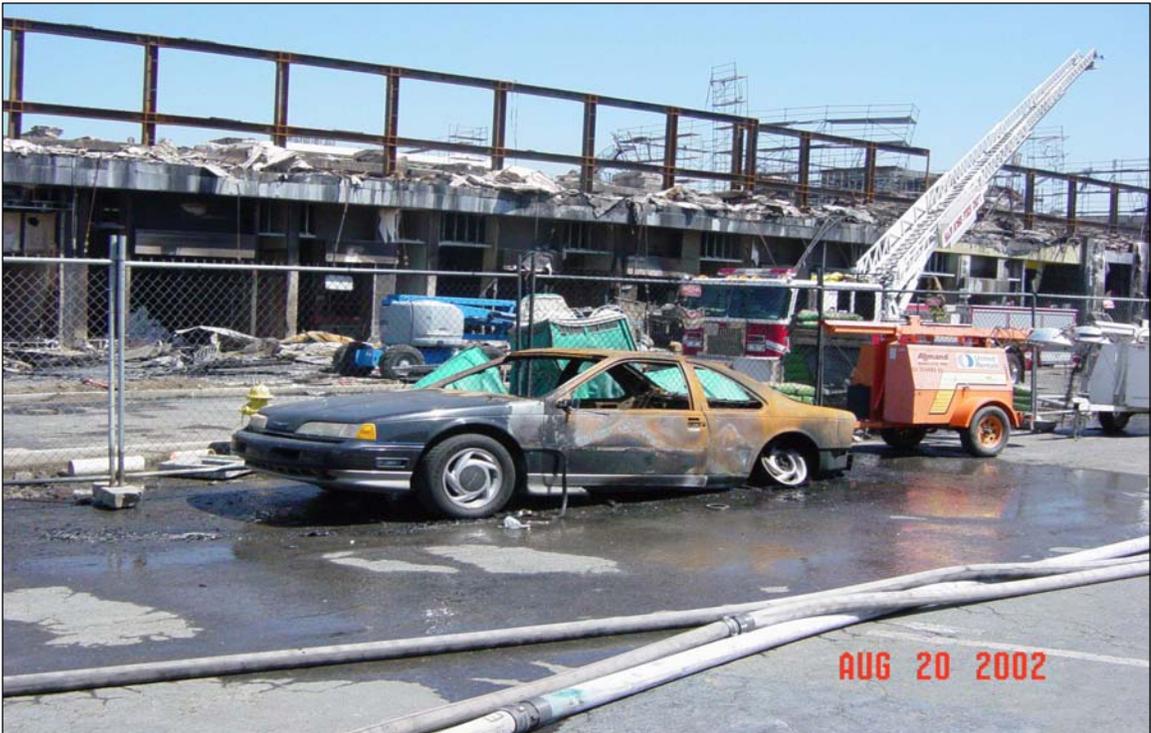
8. View of destroyed automobile and complex in background

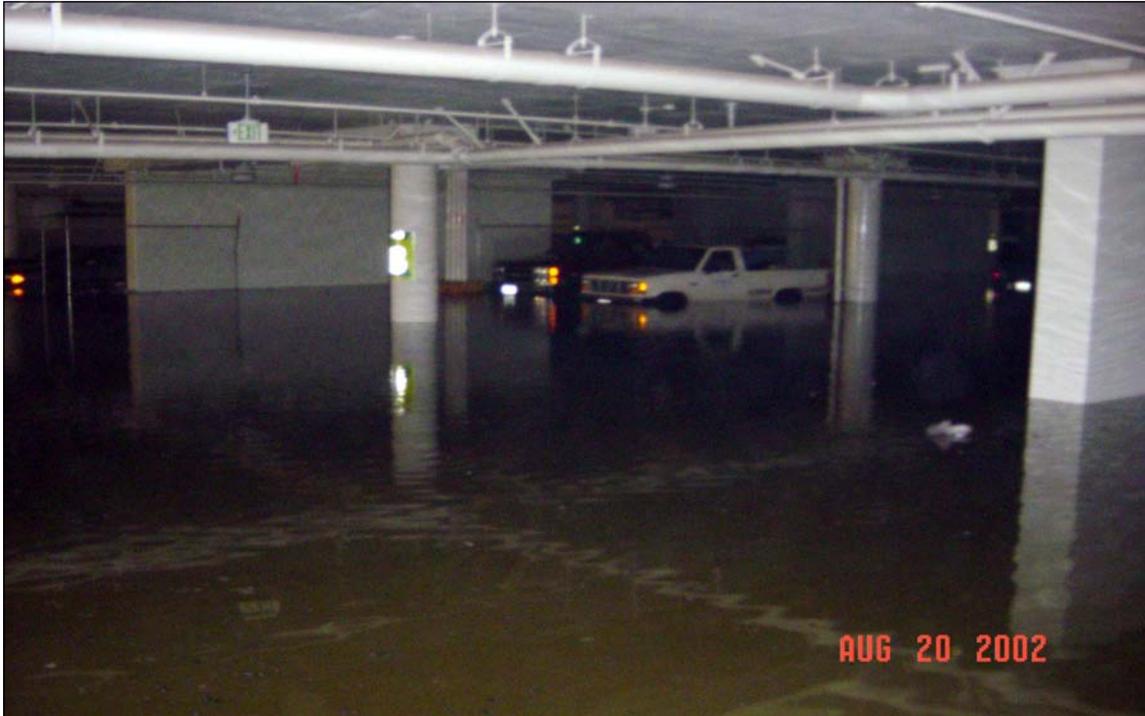
The water utility boosted water pressure to the area to the distribution system's maximum capacity. So much water was pumped onto the fire that the runoff flooded the underground parking garage, damaging approximately 160 vehicles.

9. Flooded parking garage

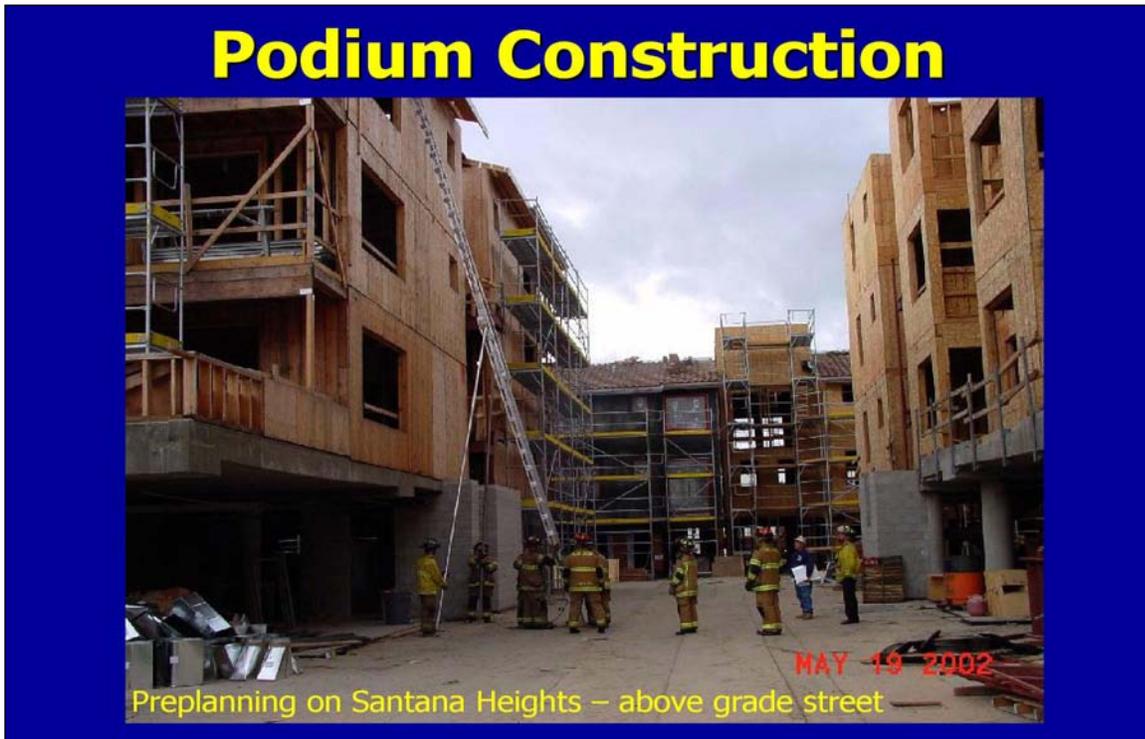
A fire watch was maintained at Santana Row for two days and firefighters continued to pour water on the pre-stressed concrete podium in an effort to cool the structure and prevent damage. A fire watch was also maintained for an additional day in the Huff/Moorpark area in case there was a rekindle.

10. Podium Construction

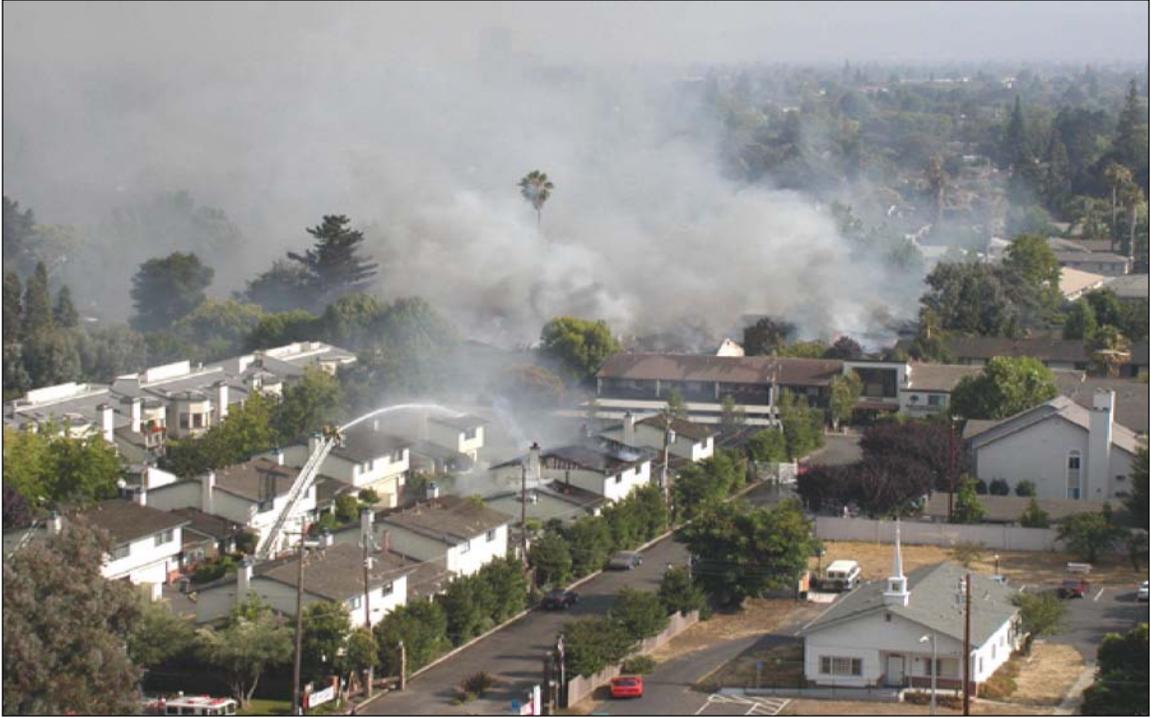
Access to both complexes was limited and none of the buildings were sprinklered. The primary source of ignition was the firebrands from the wooden shake roofs. Buildings with composition roof covering largely escaped the conflagration.

11. Overview of Huff/Moorpark Fire
