Wood Truss Roof Collapse Claims Two Firefighters

Memphis, Tennessee

USFA-TR-069/December 1992

U.S. Fire Administration Fire Investigations Program

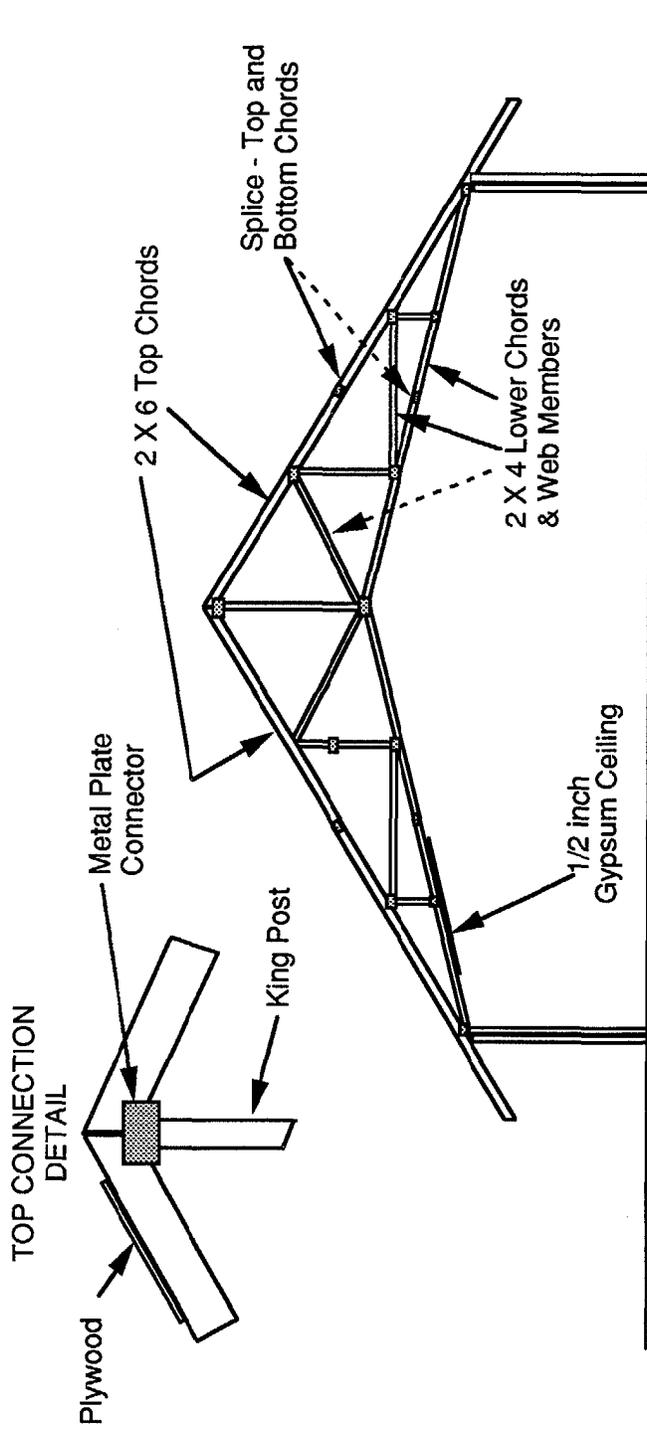
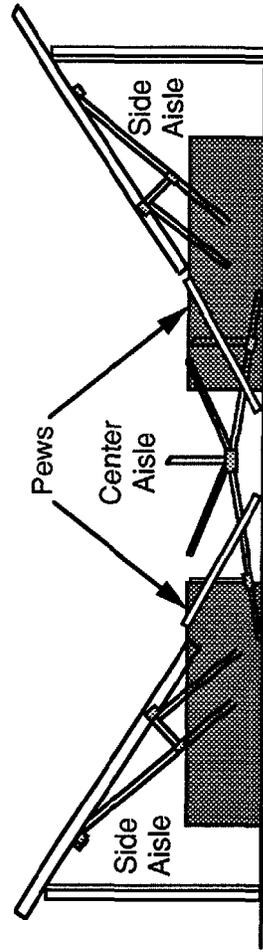
WOOD ROOF TRUSS DETAILS

The trusses were shop fabricated from ordinary dimension lumber with 2 by 6 top chords; the bottom chords and web members were fabricated from 2 by 4 sections. All of the connectors were stamped metal gusset plates providing 3/8-inch penetration of the pointed ends into the wood. All observed connectors were fabricated with gusset plates on both sides of each connection point.

The attachment of the trusses to the 1/2-inch plywood roof decking maintained their alignment. There was no evidence of stringers or cross braces to maintain the spacing and redistribute loads among the trusses. Without cross bracing, the trusses were not constrained from roll-over, which can result in a “domino effect” collapse when a partial failure occurs. Cross bracing can allow a group of trusses to act as a system, with several trusses working together to support the load.

The fire appears to have traveled along the underside of the roof, following the peak from east to west. The tops of all of the trusses were completely burned away for approximately 12 to 18 inches below the top connection point and could not be retrieved from the rubble. All of the lower connections could be located and most were still intact. The depth of char varied from almost full depth on the remnants of the higher members near the center of the span to almost no sign of burning on the lower and outer sections.

All of the top and bottom chords had splices near the mid-span points on each side of the trusses and most of these splices had failed, dropping the center section all the way to the floor, while the ends only rotated on their wall supports.

Many of the gusset plate connectors had failed, either by completely disengaging from the wood or by allowing one or more of the members to work free from a connection point. At the higher points the wood was charred beyond the depth of penetration of the gusset plate points, leaving empty pits in the charred wood where the gusset plates had been attached. As noted previously, virtually all of the top connection points were completely burned away. Some of the kingpost members were charred to a depth of more than 1/2-inch before the remaining unburned wood had broken; the diminished cross section of unburned wood fractured when it was unable to carry its load. (This would account for the “snap” sound reported by some of the firefighters just before the roof caved in.)

The roof collapse can be directly attributed to failure of the top connection points of the trusses, where the kingpost meets the top chord sections. It cannot be determined precisely which truss failed first and whether the gusset plates came loose from the top connection or the kingpost snapped and pried the gusset plates loose. The top connection is a critical point in each truss and its failure would result in the failure of that truss. It appears that several trusses failed in rapid succession – almost simultaneously following the first. All of the trusses would have been close to the point of failure and unable to support any additional load, so the load shift that occurred with the first failure probably caused several more trusses to collapse.

Cross bracing the trusses can reduce the probability of a sudden catastrophic failure and is more likely to result in visible sag before collapse. Without such load transfer mechanisms, the failure of any one truss can be sudden and catastrophic and can initiate the failure of a series of adjacent trusses in rapid succession, particularly if they are partially weakened and already close to their own point of failure.
