Doubletree Hotel Fire

New Orleans, Louisiana

USFA-TR-008/July 1987

Investigated by: Jeffrey M. Shapiro, P.E.

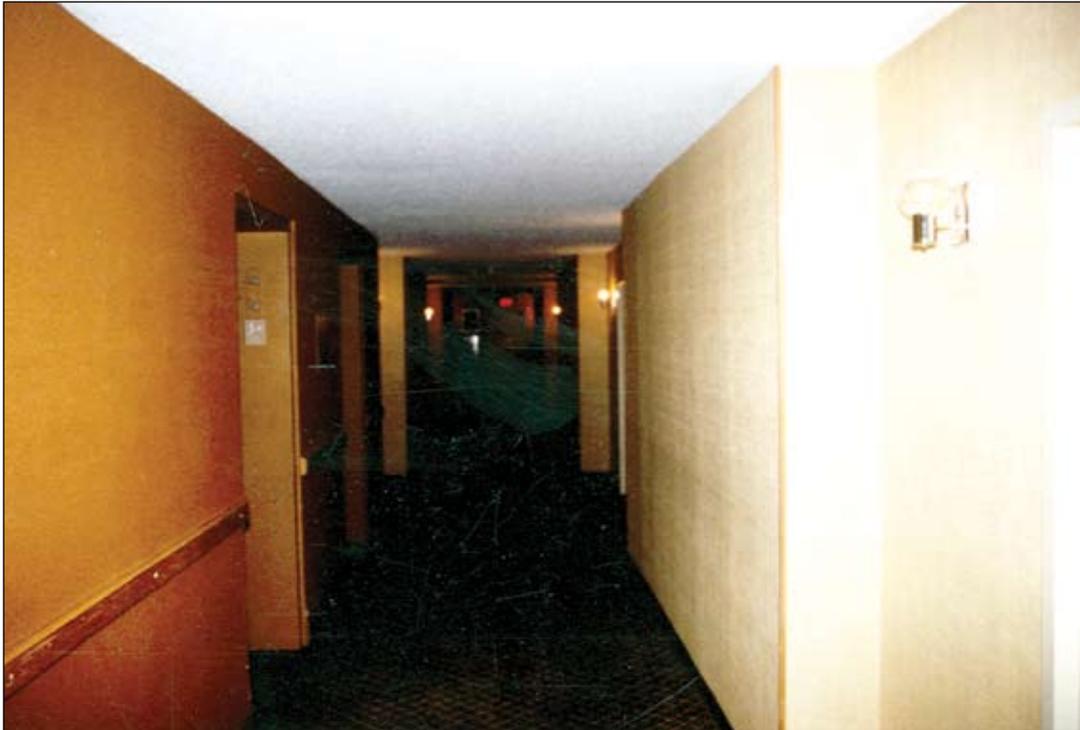
Figure 4. View of short corridor from area of origin toward Stairway 1 – 9th floor.

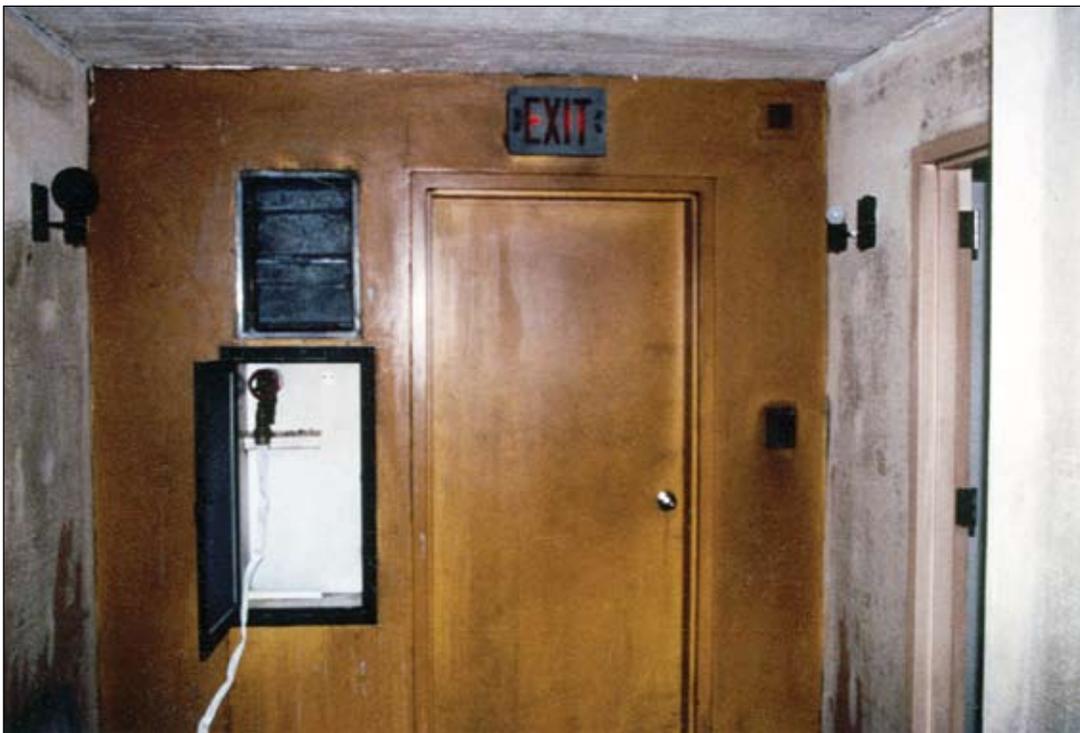
Figure 5. Entrance to exit Stairway 1 – 10th floor. Note the ventilator opening (upper left) and fire hose/extinguisher cabinet (lower left).

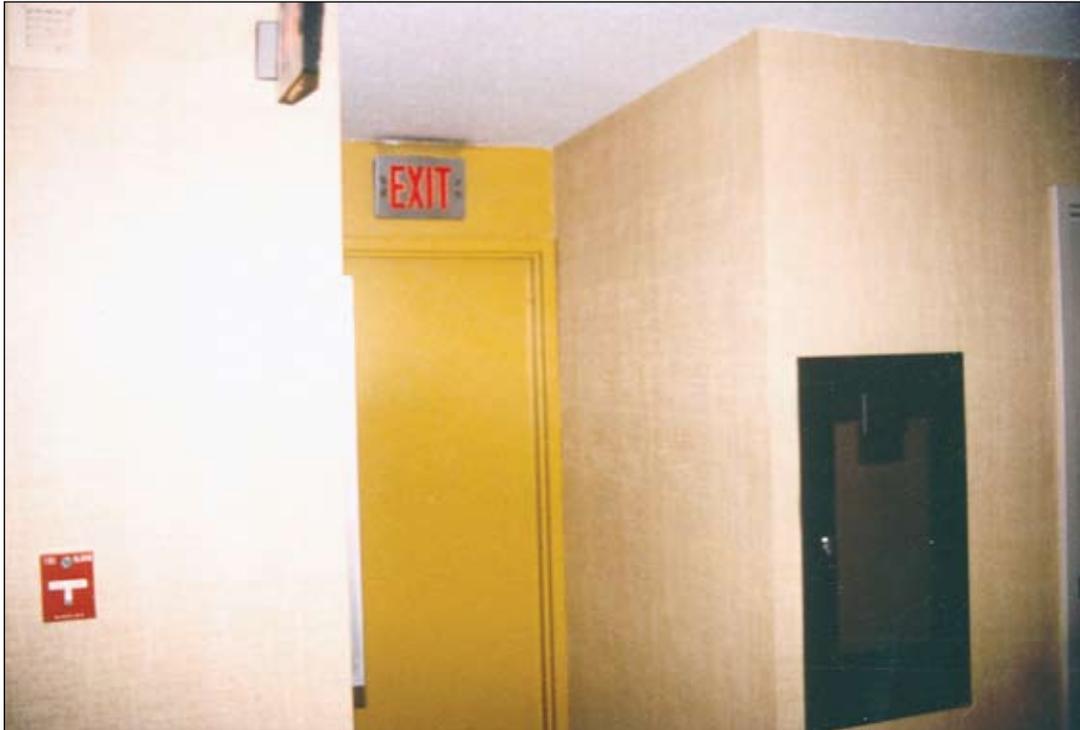
Figure 6. Entrance to exit Stairway 2 – 9th floor. Compare with Figure 7 after fire.

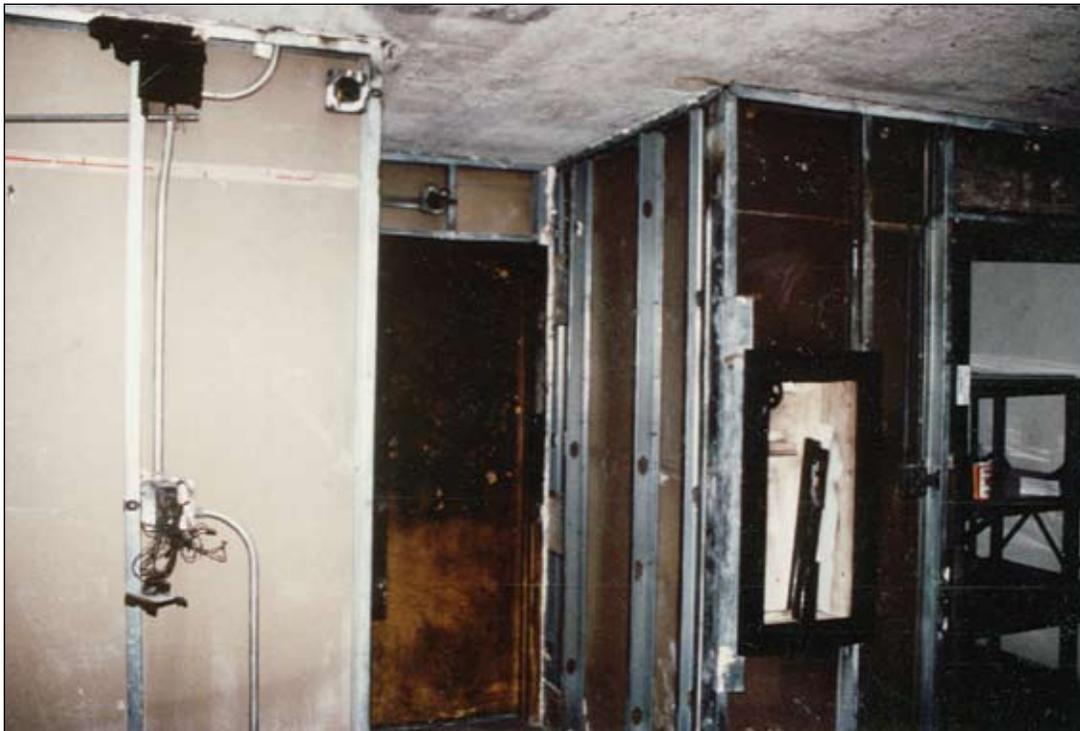
As the guard entered the tenth floor, he probably encountered heavy smoke (considering the volume of smoke that had already spread to the ninth and eleventh floors) but tolerable temperatures. From the pull station at Stairway 2, he was probably able to see the fire through the smoke, which was burning in front of Room 1001.

Figure 7. Entrance to exit Stairway 2 – 10th floor. Note pull station at left used to initiate local alarm by guard.

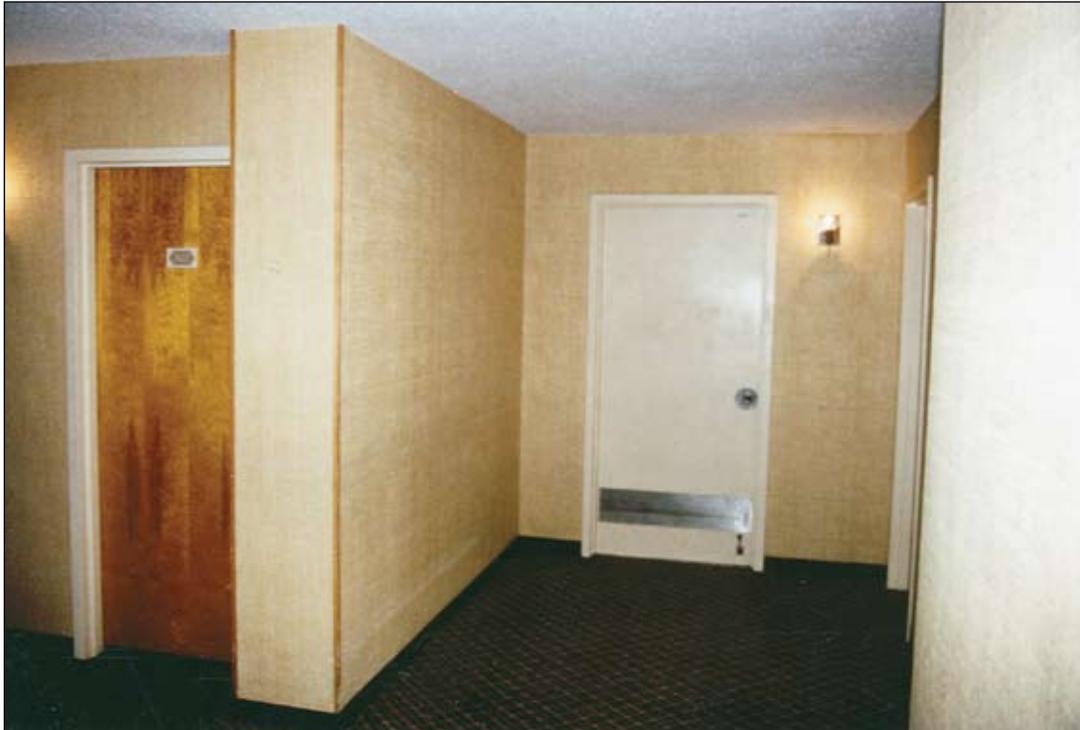
Figure 8. Area of origin on 9th floor, for comparison.

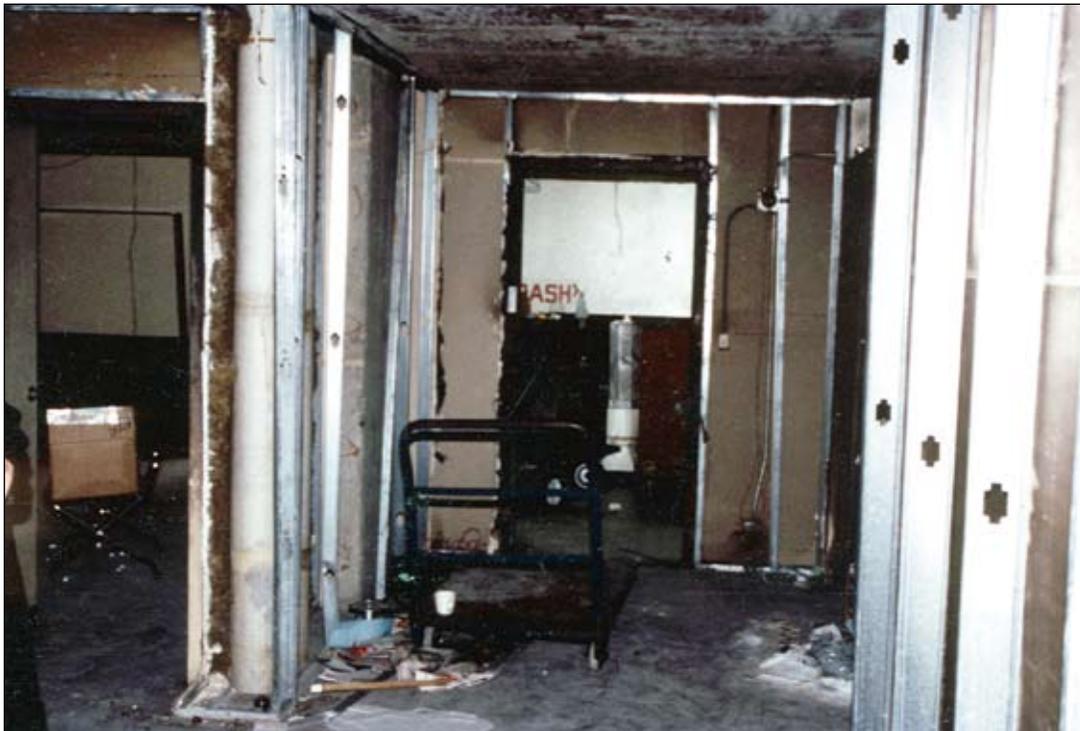
The fire is estimated to have originated sometime between 10:00 p.m. and 10:15 p.m., and is believed to have been caused by arson. The fire department determined that there were no other possible ignition sources present and that there was no possibility of an accidental smoldering fire because an eleventh-floor guest had been on the tenth floor to get ice less than ten minutes before the fire alarm sounded and had detected no sign of a fire. Figures 8 and 9 show the area of origin.

Figure 9. Area of origin on 10th floor.

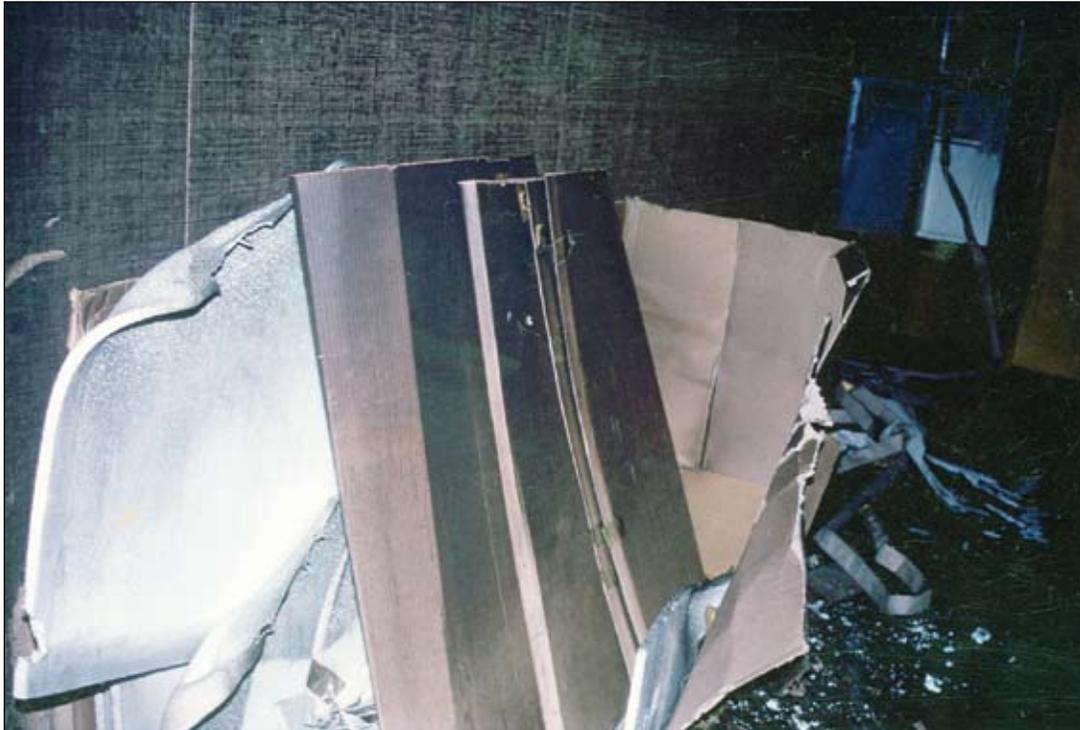
At the time of the fire, the tenth floor was unoccupied and undergoing renovation. As part of the renovation process, large wooden cabinets were being provided in each room. The cabinets were packaged in cardboard boxes and were packed with sheets of solid foam. Employees who had been installing the cabinets had stored the empty packaging material, most of which had been flattened and stacked against the wall, in the corridor (see Figure 10). An estimated 10 to 20 boxes that were stacked outside Room 1001 were probably burning when the guard entered the tenth floor.

Figure 10. Debris similar to that involved as first material ignited – 10th floor.

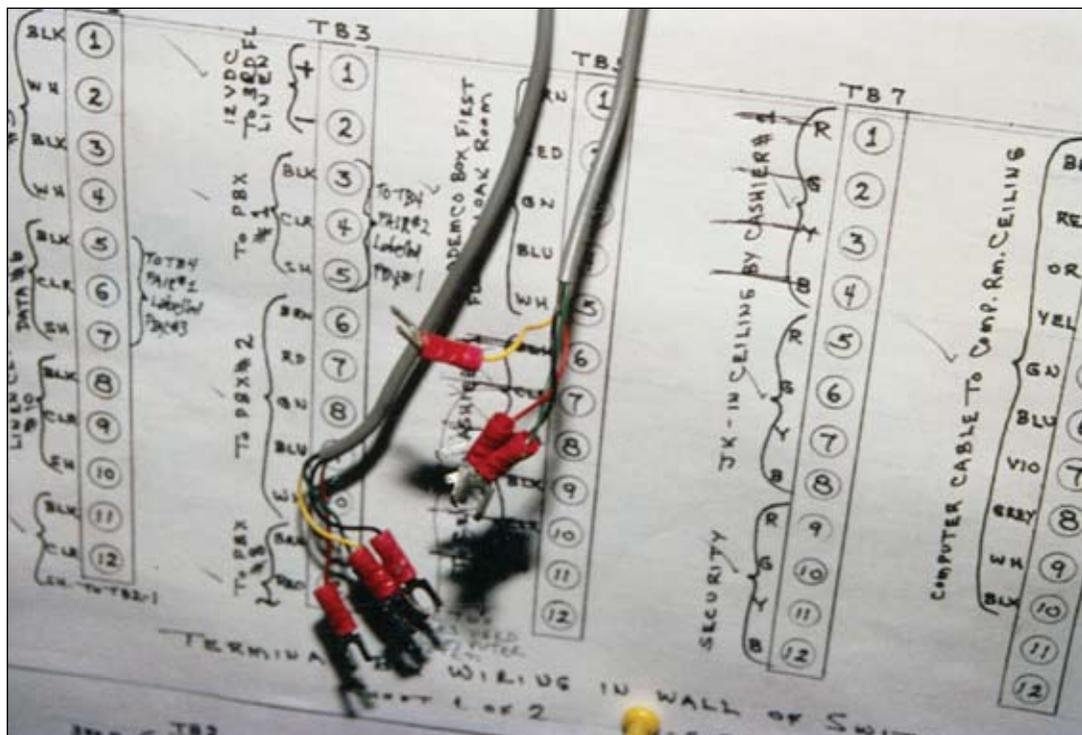
The governing standards dealing with installation of automatic fire alarms in New Orleans are NFPA 72A, "Standard for the Installation, Maintenance, and Use of Local Protective Signaling Systems for Guard's Tour, Fire Alarm, and Supervisory Service." And NFPA 72E, "Standard on Automatic Fire Detectors," published by the National Fire Protection Association. Although the system had been partially dismantled at the time of this investigation, it is still fairly conclusive that the automatic alarm failed to operate. A representative of the fire department – assisted by representatives of a local fire alarm company – attempted to activate the system by blowing smoke into the system's smoke detectors on the day after the fire but was unable to cause an alarm even though the photocell light sources were illuminated. This suggests that smoke detectors probably were not connected to the alarm panel or that the panel had malfunctioned. Furthermore, the automatic alarm system did not appear to connect to any audible alarms, nor did it appear to connect with the manual system, which had audible devices. Therefore, it seems that even if the smoke detectors had been able to detect a fire and the control panel had been functional, the system may only have been capable of indicating a fire at the control panel, which was located in an unoccupied closet on the third floor. Additional significant deficiencies included the use of telephone wire connecting all initiating devices to the control panel, and the placement of all corridor smoke detectors in "dead air" locations in the corridor (within 4 inches of a wall); see Figures 11 and 12 for detector locations.

Typically, a four-wire detection circuit will use two wires for powering detectors and two wires for initiating an alarm. Supervision of the power circuit can be either directly at the alarm panel or at each individual detector. Normally, in this arrangement, a trouble signal will sound at the control panel if power is interrupted or if detectors are disconnected. However, if detectors are powered from a source that is independent of the alarm control panel, the control panel could be disconnected or fail, disabling the trouble signal and alarm-initiating capability, and the detectors could still have power. In such a situation, detectors with a power-indicating lamp would appear functional due to the illuminated lamp but would be incapable of initiating an alarm because of the disabled or disconnected alarm panel. It appears that the automatic alarm system in the Doubletree fit this scenario.

Figure 11. Telephone wire used for automatic fire alarm system, security system, and public address system.

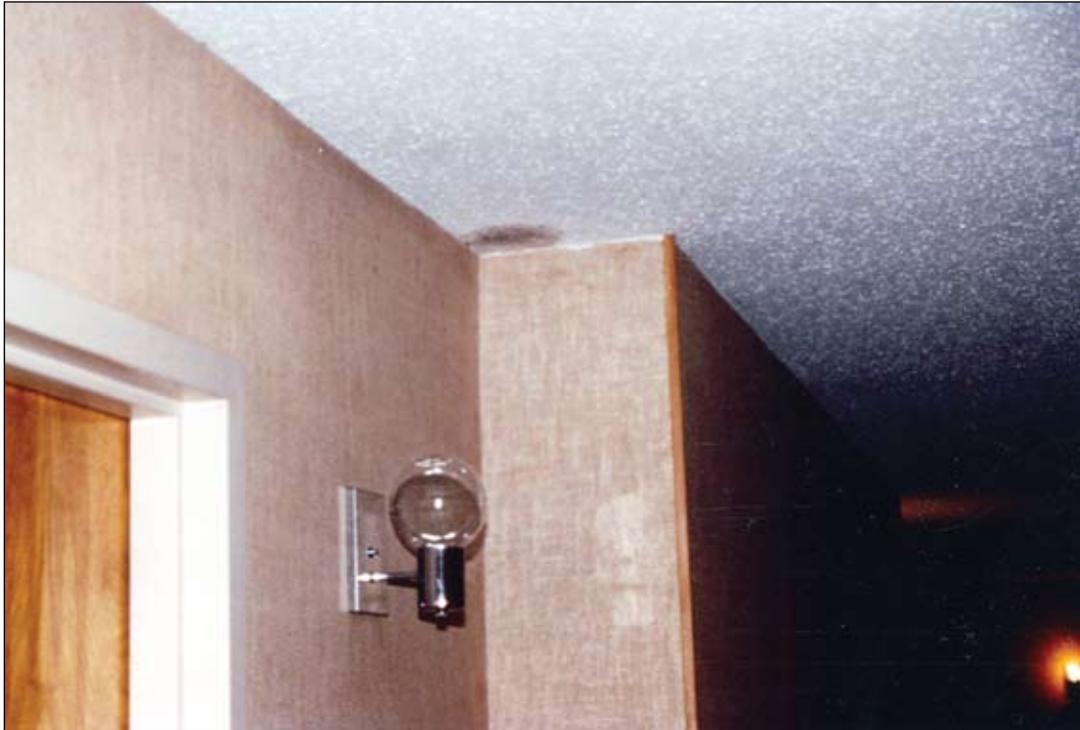
Figure 12. Location of corridor smoke detector (dark spot on ceiling).

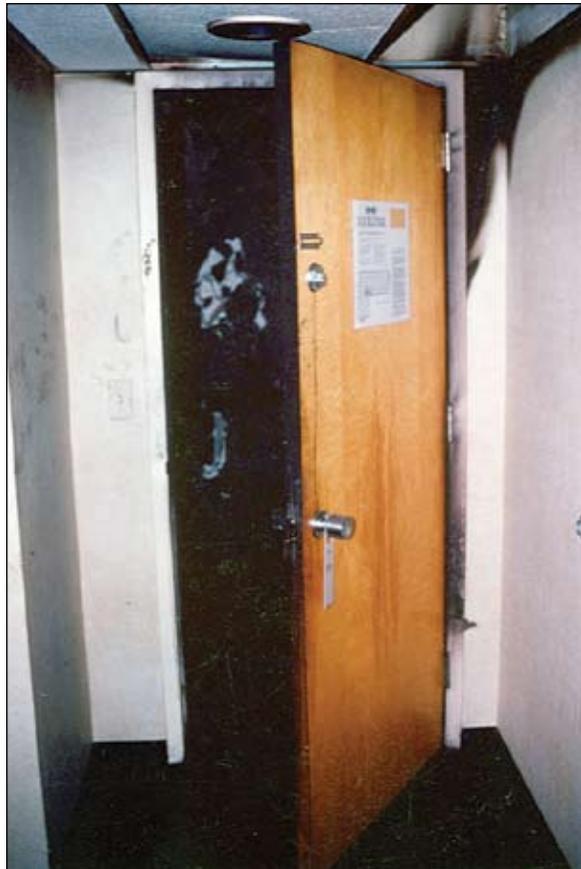
Figure 13. Guest rooms on 10th floor sustained minimal damage due to performance of doors.
