# Four-Fatality Fire in Residential Board and Care Facility

Bessemer, Alabama

USFA-TR-043 / September 1990

This is Report 043 of the Major Fires Investigation Project conducted by TriData Corporation under contract EMW-90-C-3338 to the U.S. Fire Administration, Federal Emergency Management Agency.

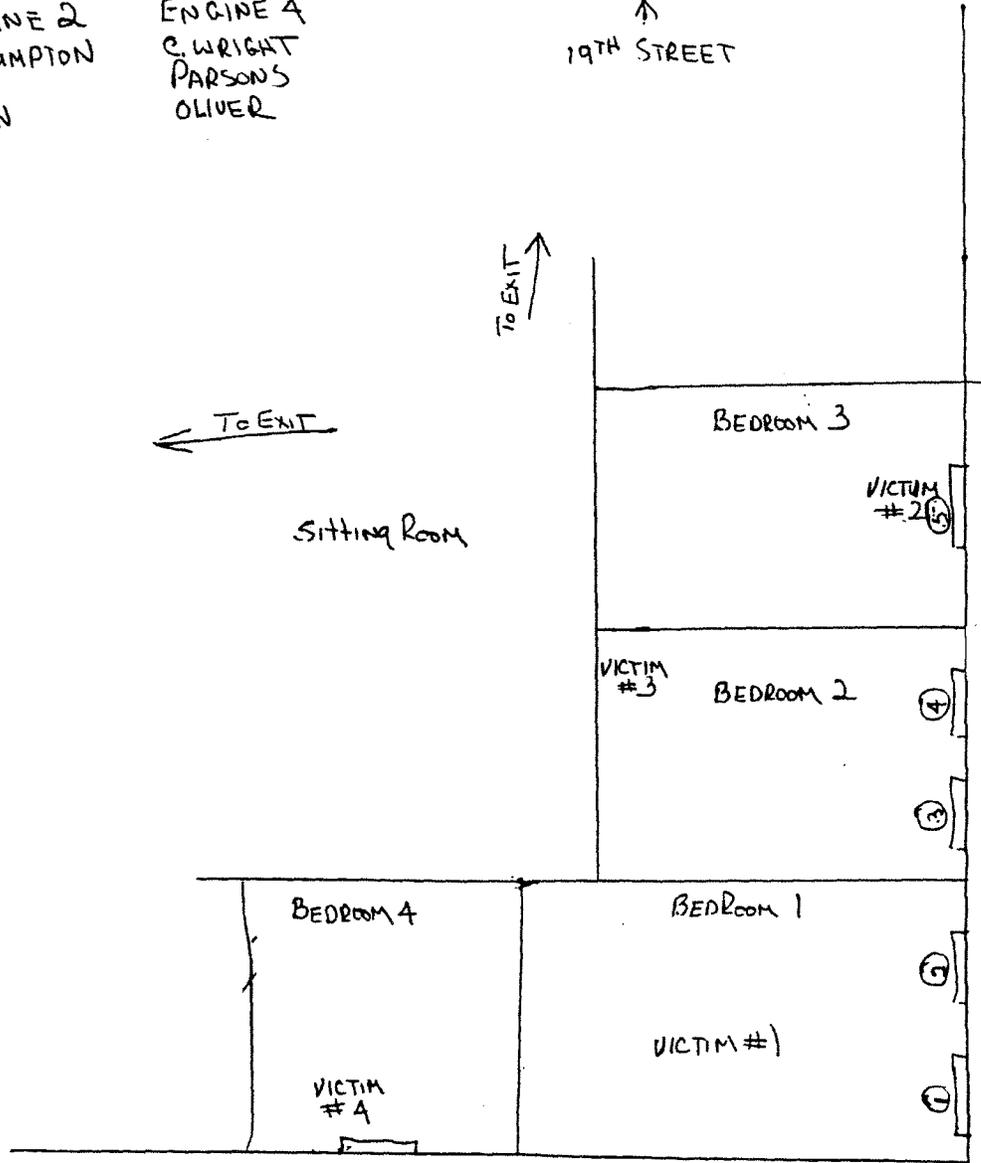
VICTIM #1 was found by <sup>CAIRNS DC</sup> ~~CAIRNS~~, 2' from bed in the center of the room.  
TIME - 2 MIN. after RESCUE 5 ARRIVED.

VICTIM #2 + #3 was found by Greg Davis. #2 was in bed under the window.  
#3 was in wheelchair in the doorway.  
TIME - 3 MIN after VICTIM #1 was found.

VICTIM #4 was found by Shadix in bed.  
TIME - SAME AS VICTIMS 2+3.

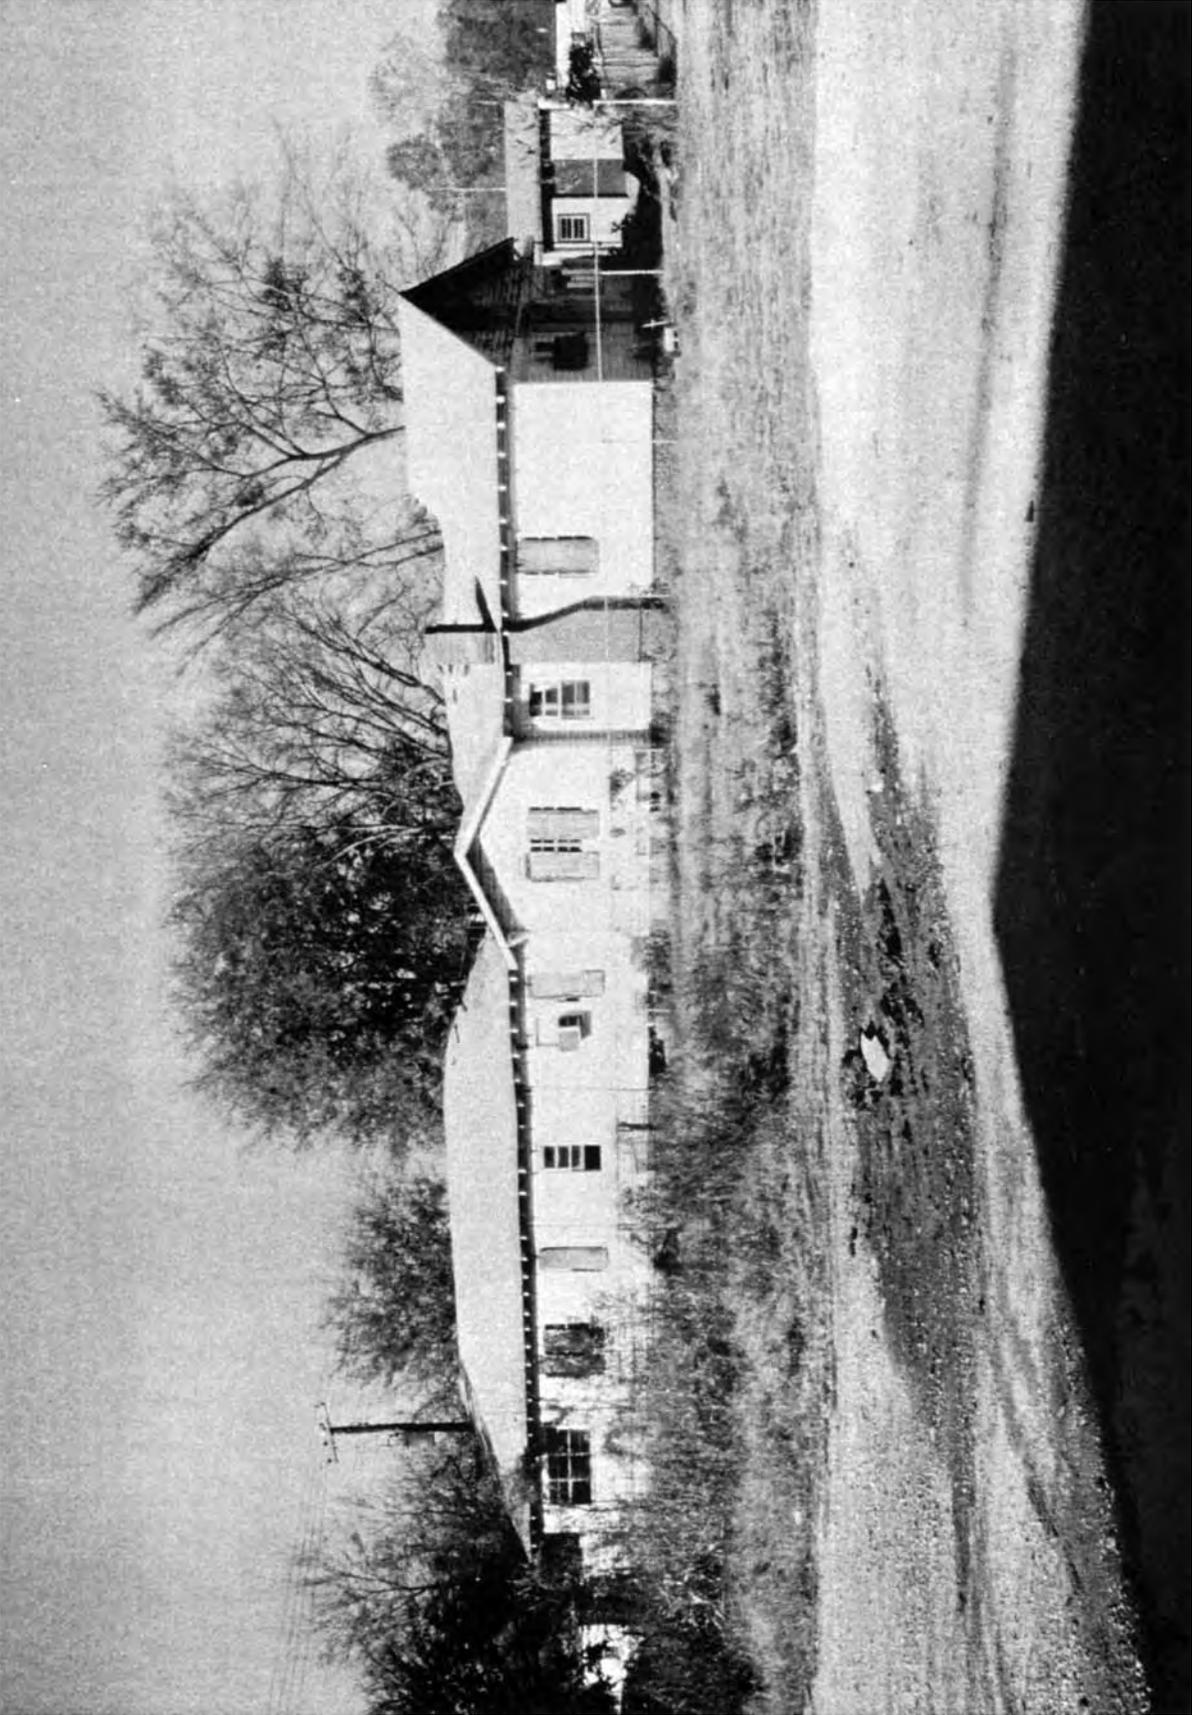
1. The exterior of the structure as seen from the northeast; the front is to the extreme right.

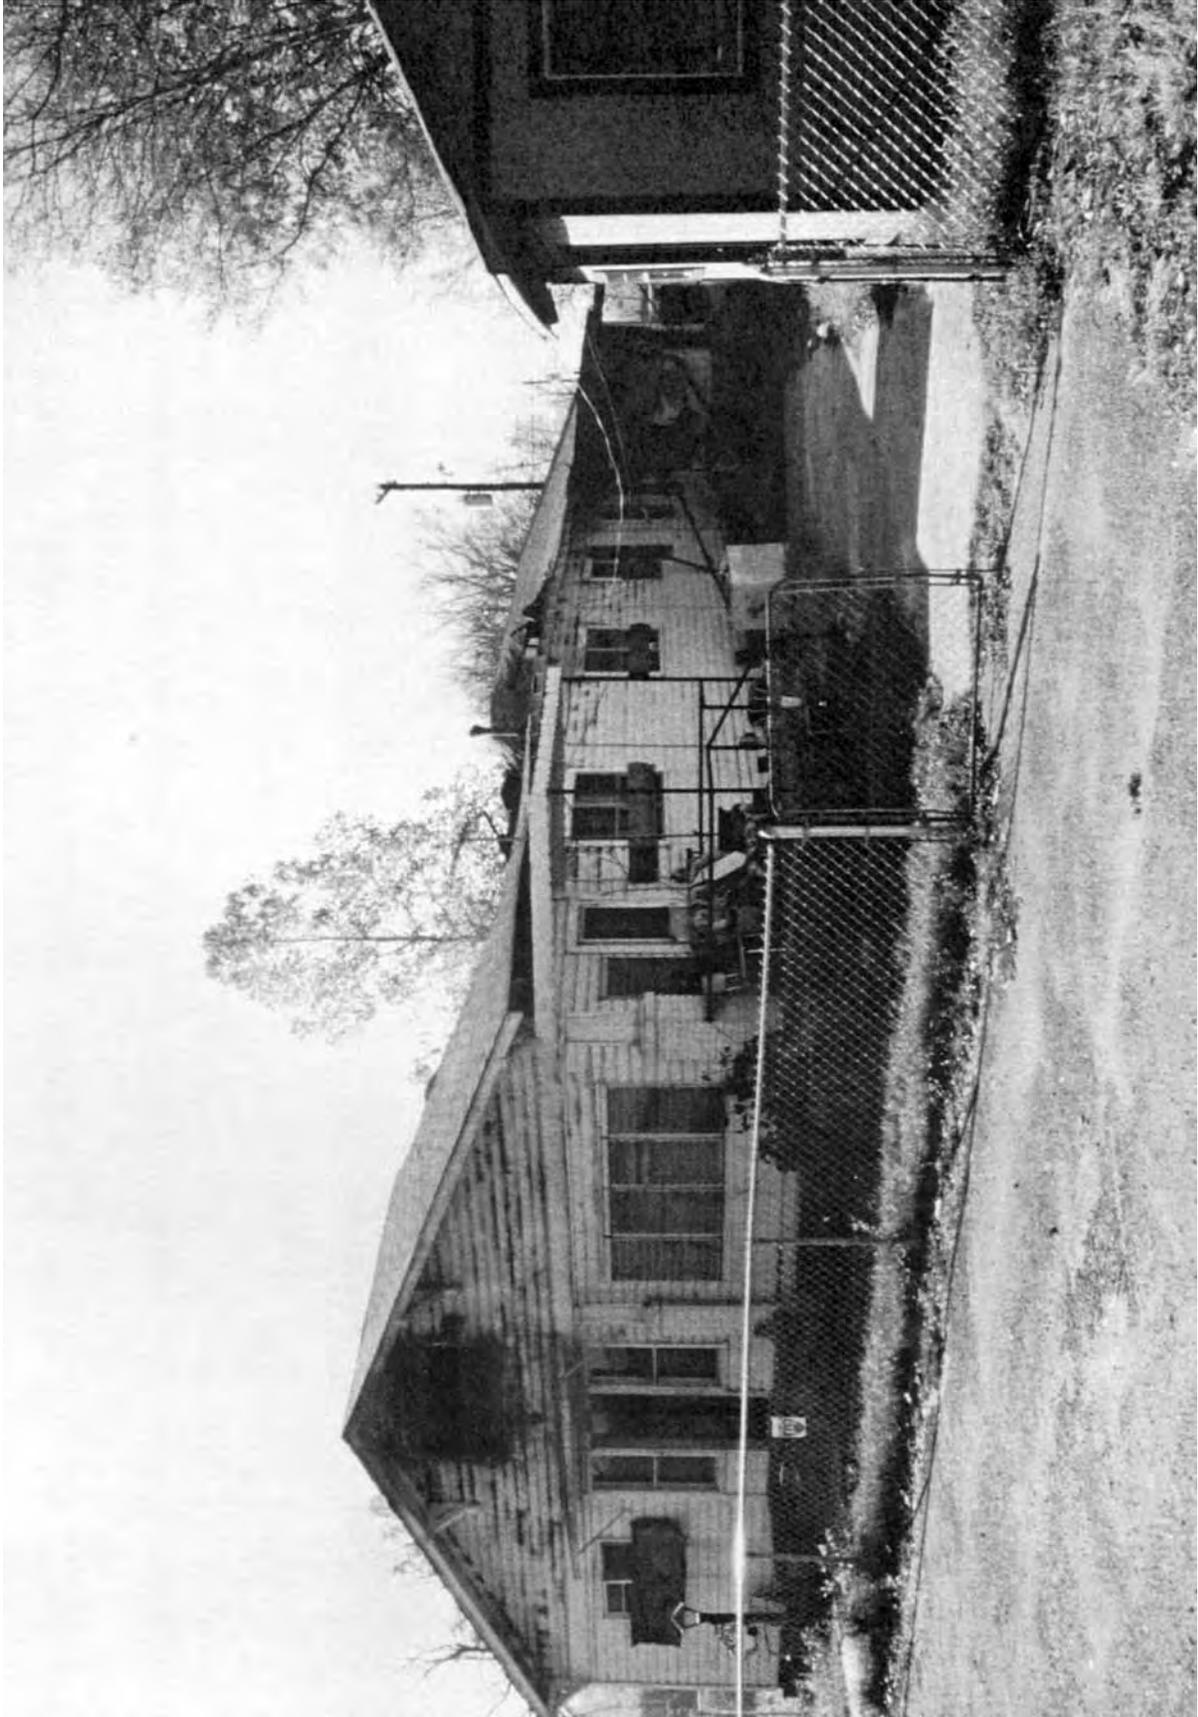
2. An exterior view from the northeast showing separate structure where office and manager's quarters were located.

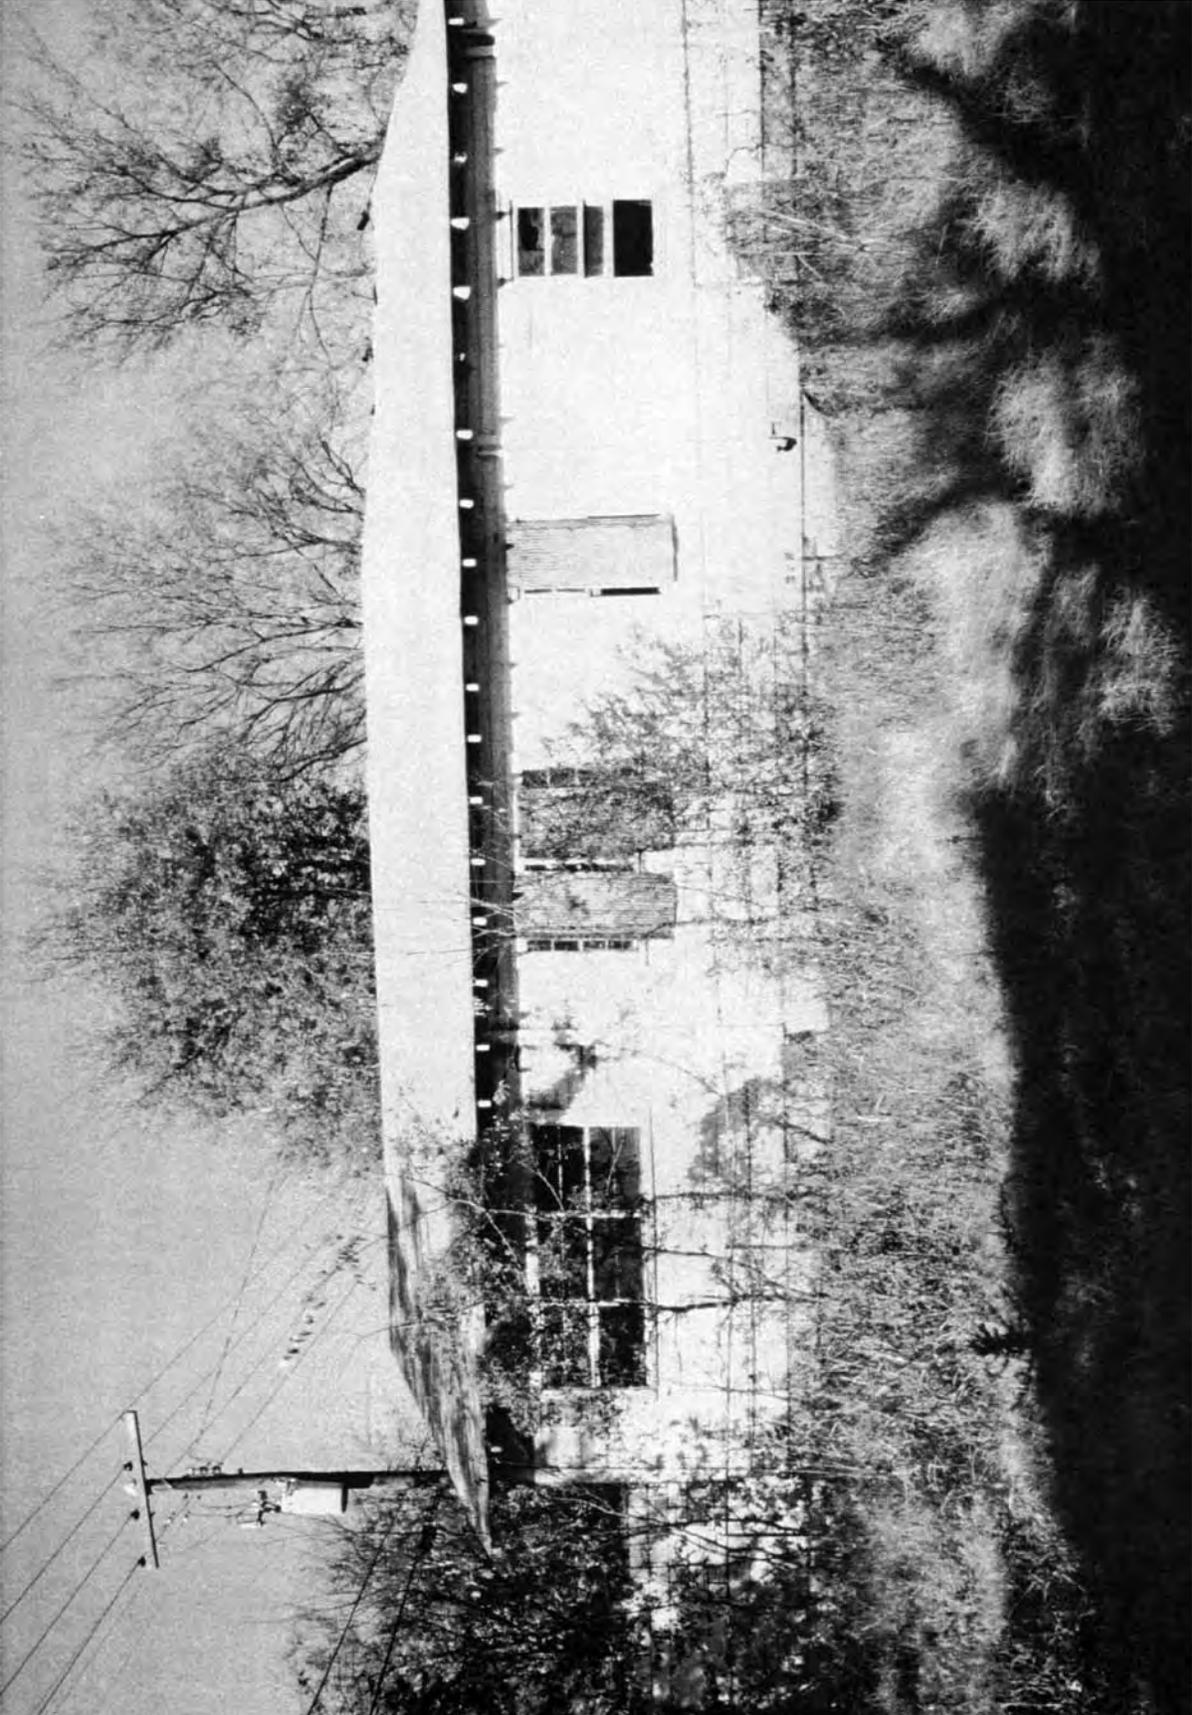
During the rescue and overhaul of operations, four of the residents were found in their rooms located off the sitting room which separated them from the outside exit. One victim, a 33-year-old male with muscular dystrophy, was found face down in his room next to the bed on the floor; two victims, ages 70 and 83, were found in their beds; and one victim, age 80, was found in a wheelchair. Carbon monoxide levels of the victims ranged from 56 percent to 78 percent.

3. An exterior view of the east side, showing the rooms where victims were found.

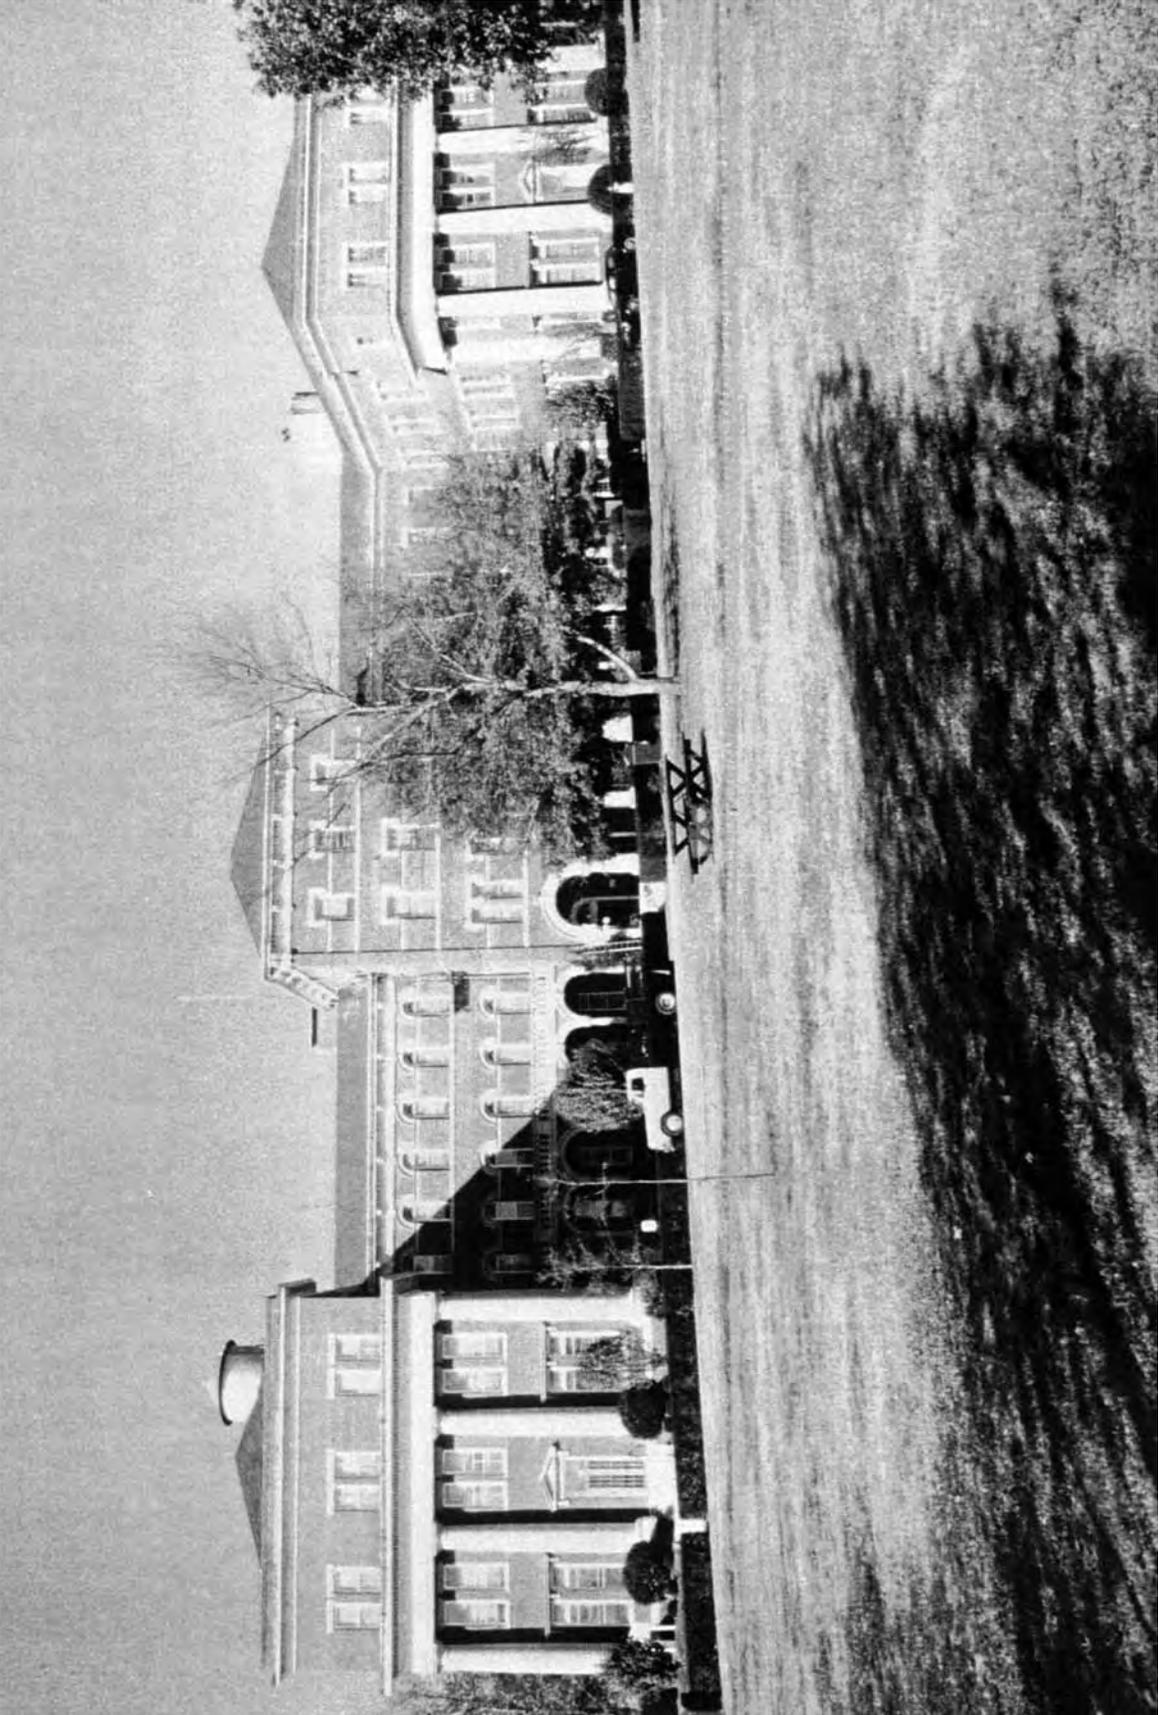
The fire occurred in the girl's section of "Central." The fire began as a result of an unattended candle that ignited class A common combustibles as it melted down. The college stated there were strict rules regarding the use of candles or any flammable material and the girls were in violation of these rules. Disciplinary measures were taken by the college in regard to the fire.

The positive aspect of this fire is that it was totally controlled and extinguished by the sprinkler system. The only direct damage was to a desk and some clothing next to it. There was water damage as a result of the sprinkler action. The fire occurred at approximately 10:00 p.m. The flow alarm on the sprinkler and smoke detector alerted the Montevallo Fire Department as well as campus security, but upon arrival it was found that the fire had been controlled and extinguished.

1. Exterior view of "Main Hall." West Wing is to the left; Central Wing, where fire occurred, is in the center; and East Wing is to the right.

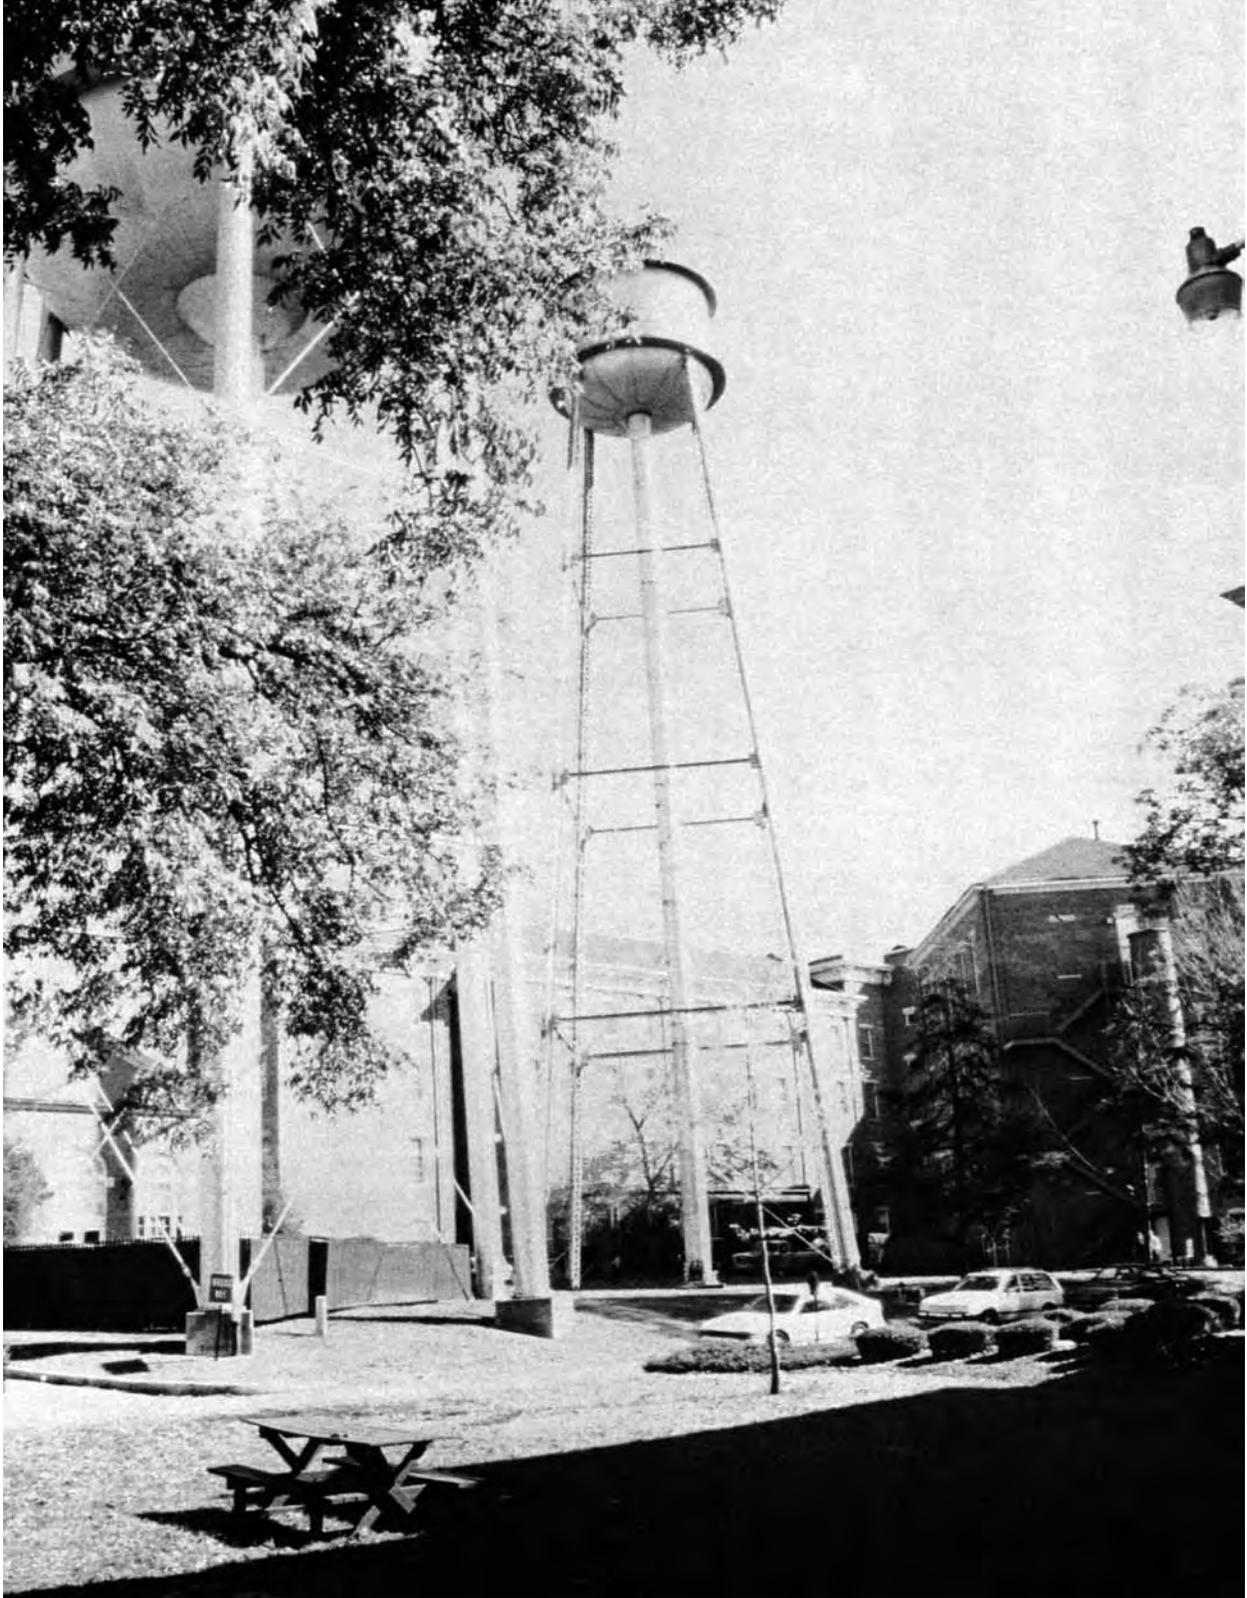
2. The 75,000 gallon reserve tank and the 400,000 gallon domestic water supply tank with dormitories in the background the system is designed to protect.
