Seven Fatality Fire at Remote Wilderness Lodge

Grand Marais, Minnesota

USFA-TR-055/July 1991

This is Report 055 of the Major Fires Investigation Project conducted by TriData Corporation under contract EMW-90-C-3338 to the United States Fire Administration, Federal Emergency Management Agency.

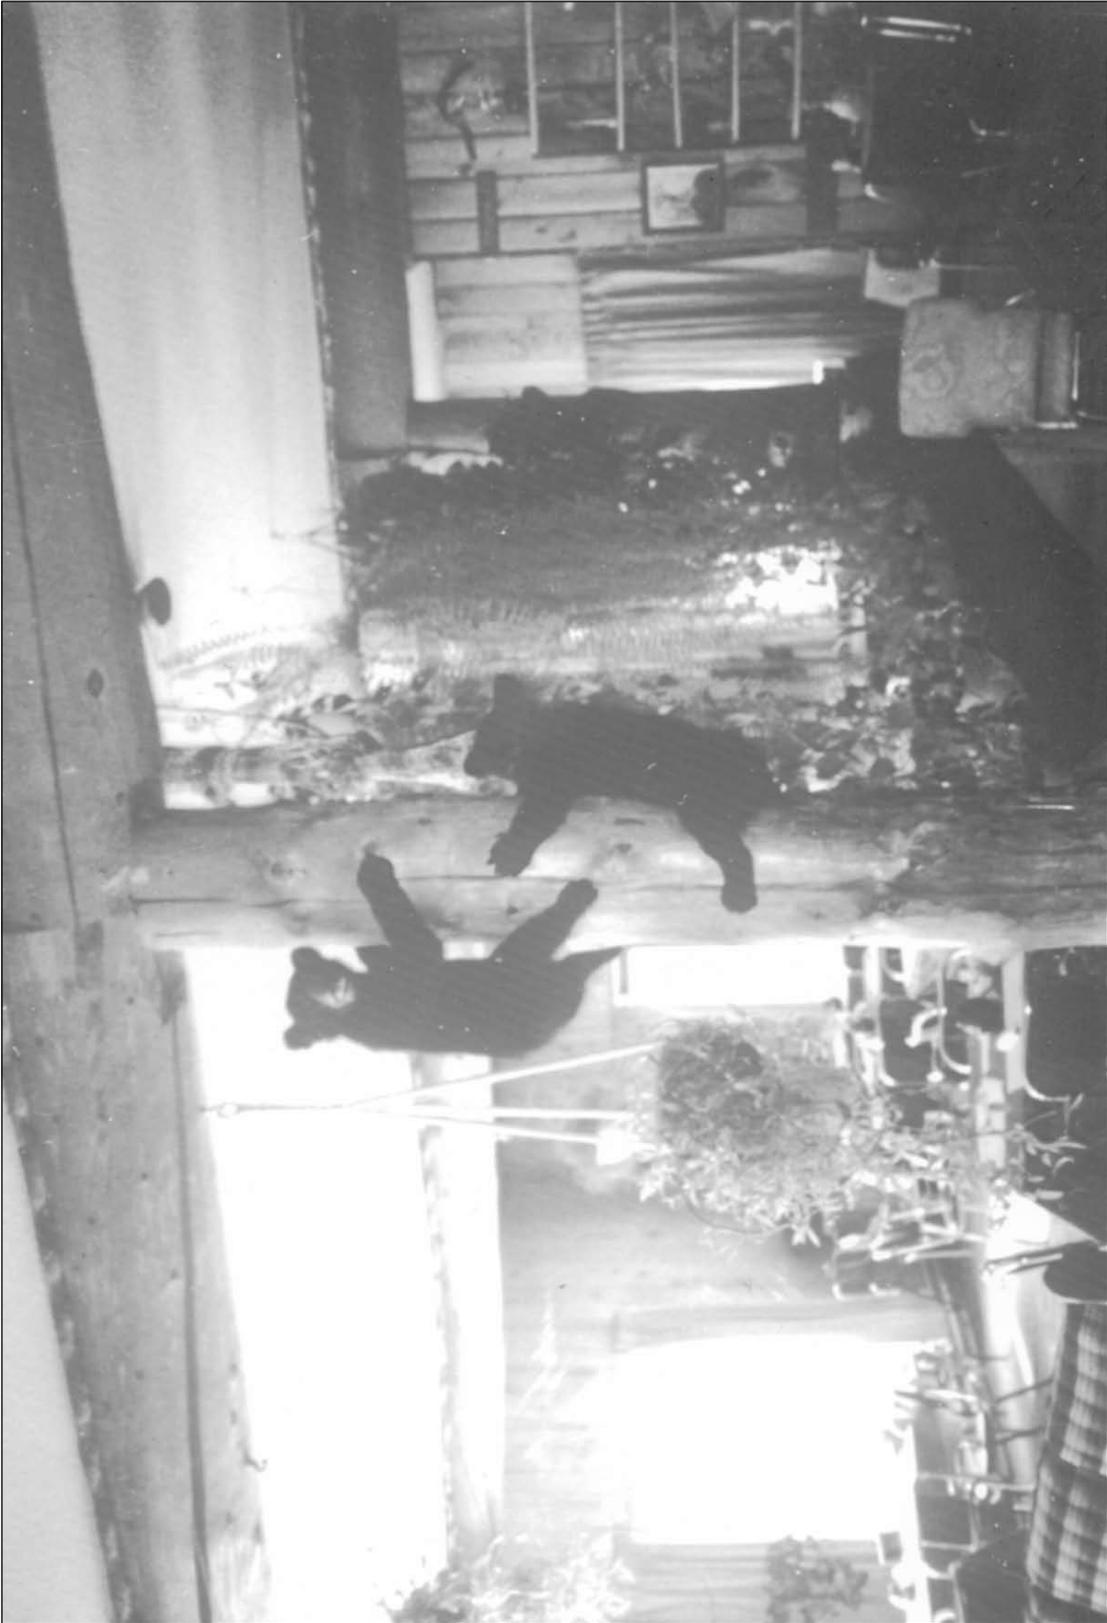
It was stated the ceiling construction on the first floor was drywall with exposed beams. However, there were indications from witnesses and photos that the drywall had large gaps where it met at the beams. This allowed fire to travel to the floor construction above and probably contributed significantly to the fire spread.

Photo provided by the Minnesota State Fire Marshal
Dining room and lounge area on first floor. Note ceiling separations at log beams.

5. Decorative elements, such as the exposed ceiling beams in this case, require that special efforts be made to insure the fire-resistive integrity of the construction.

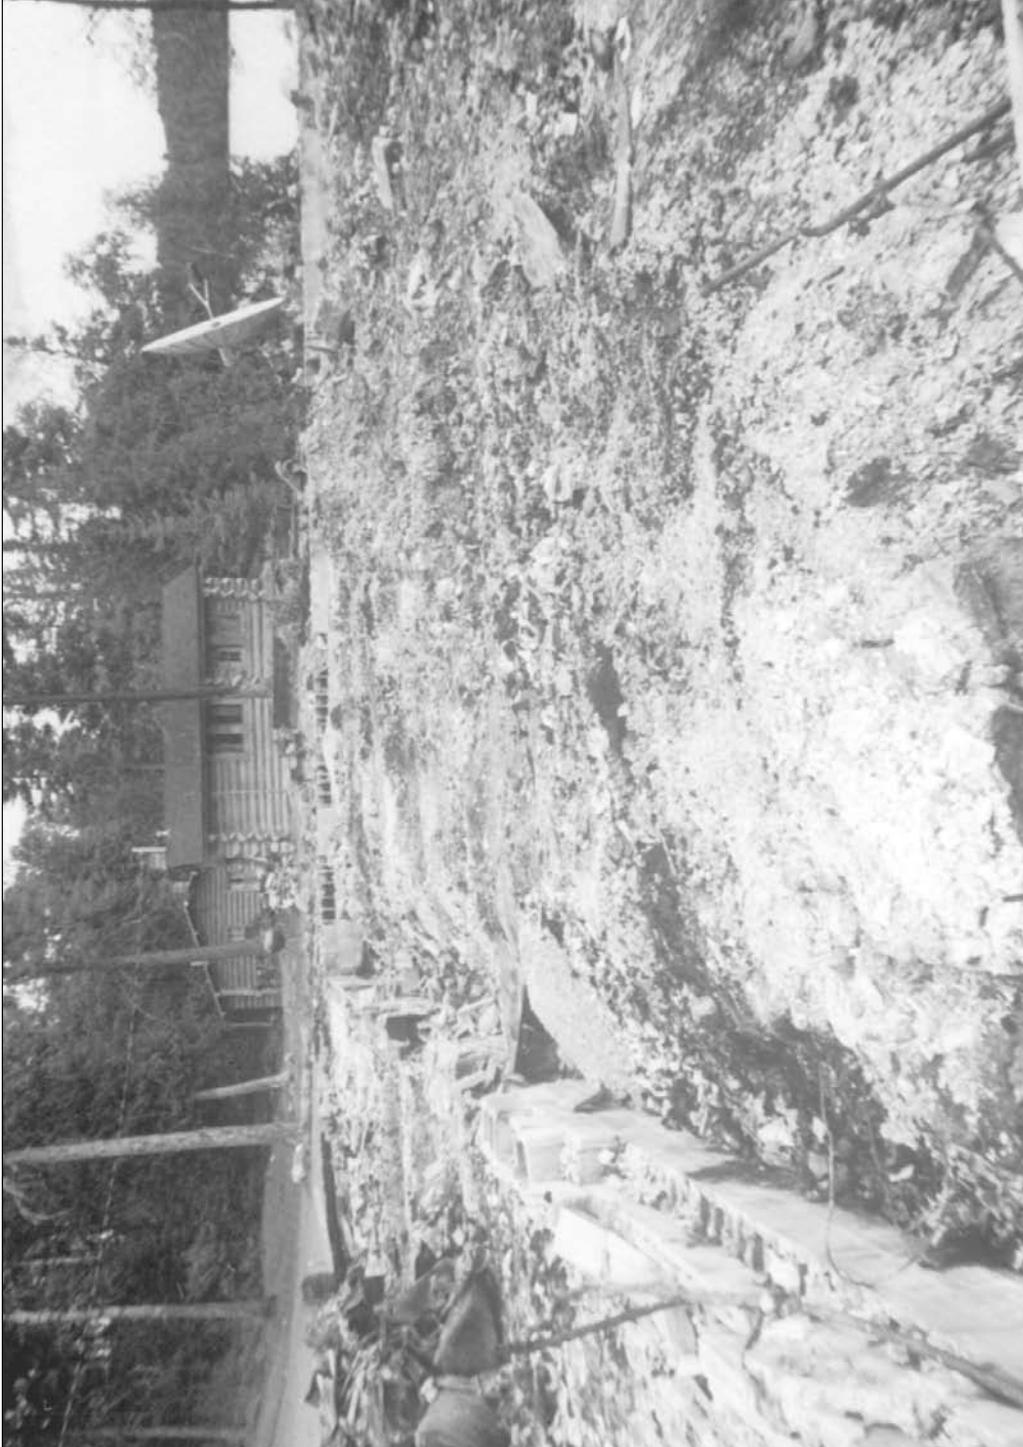
Photo by James W. David
View along north foundation wall shows total destruction of lodge by the fire.

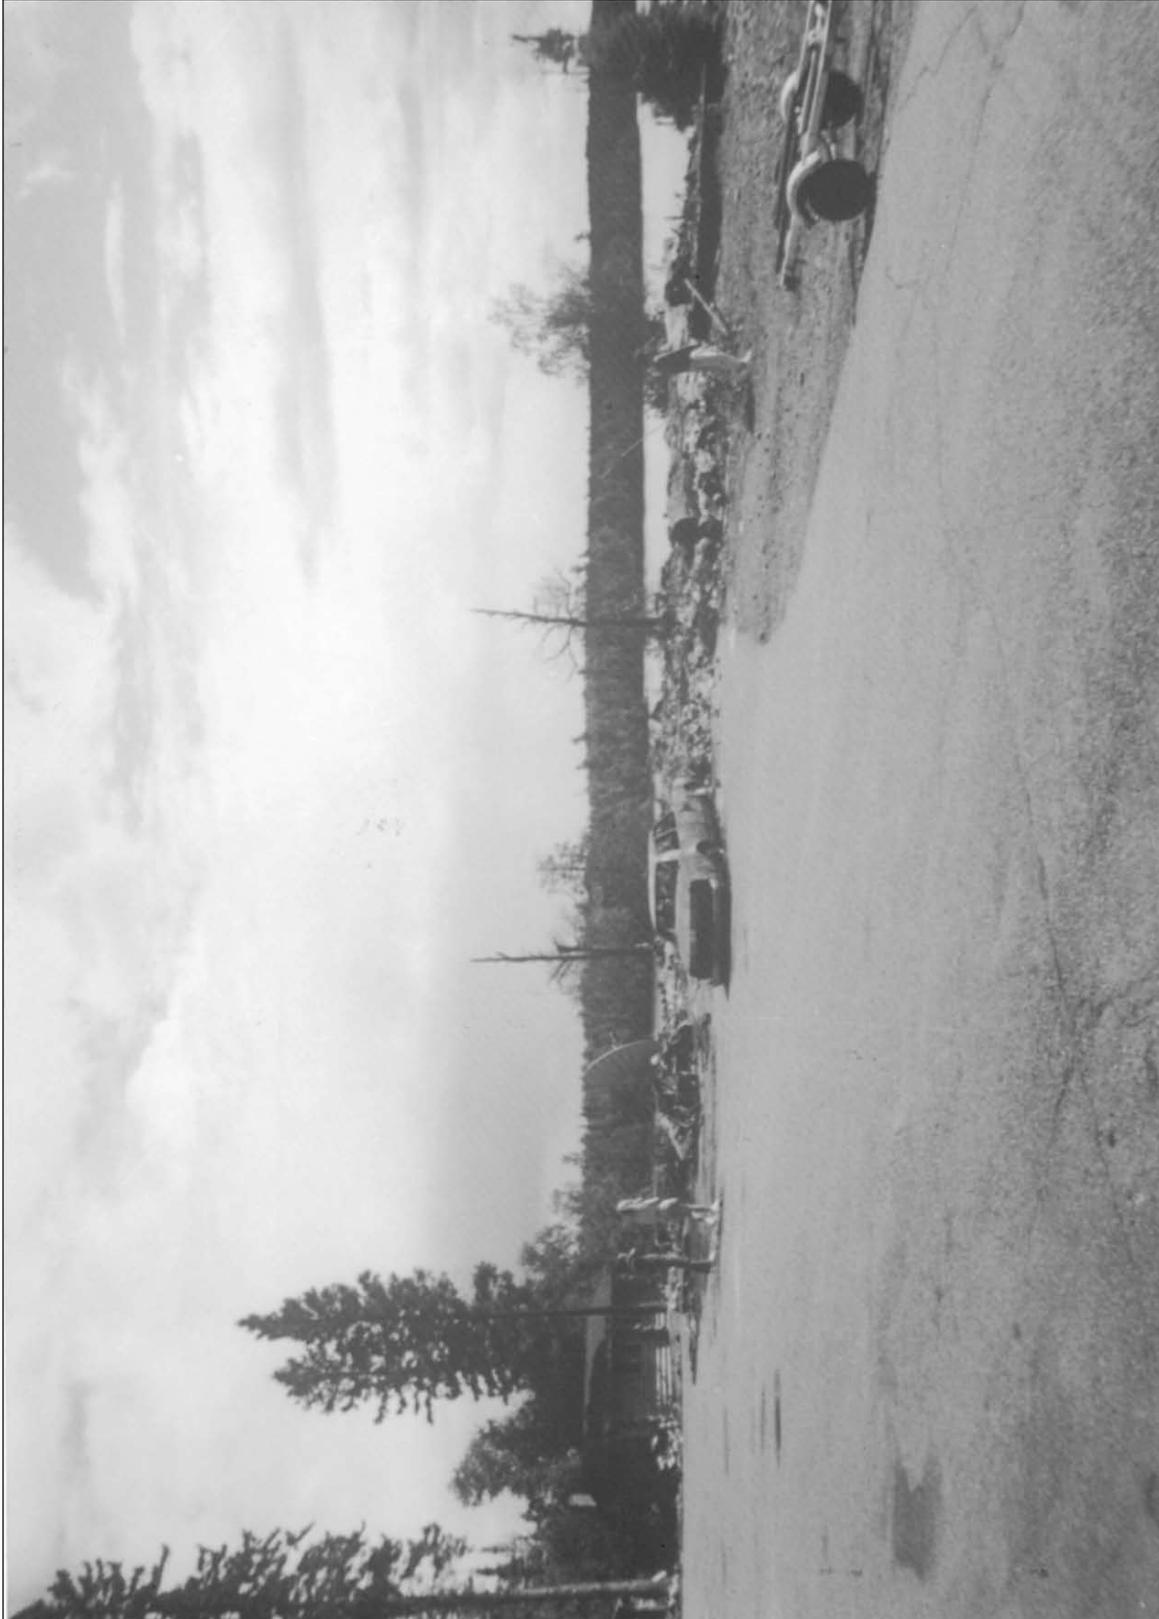
Remains of Lodge from west drive, facing lake.

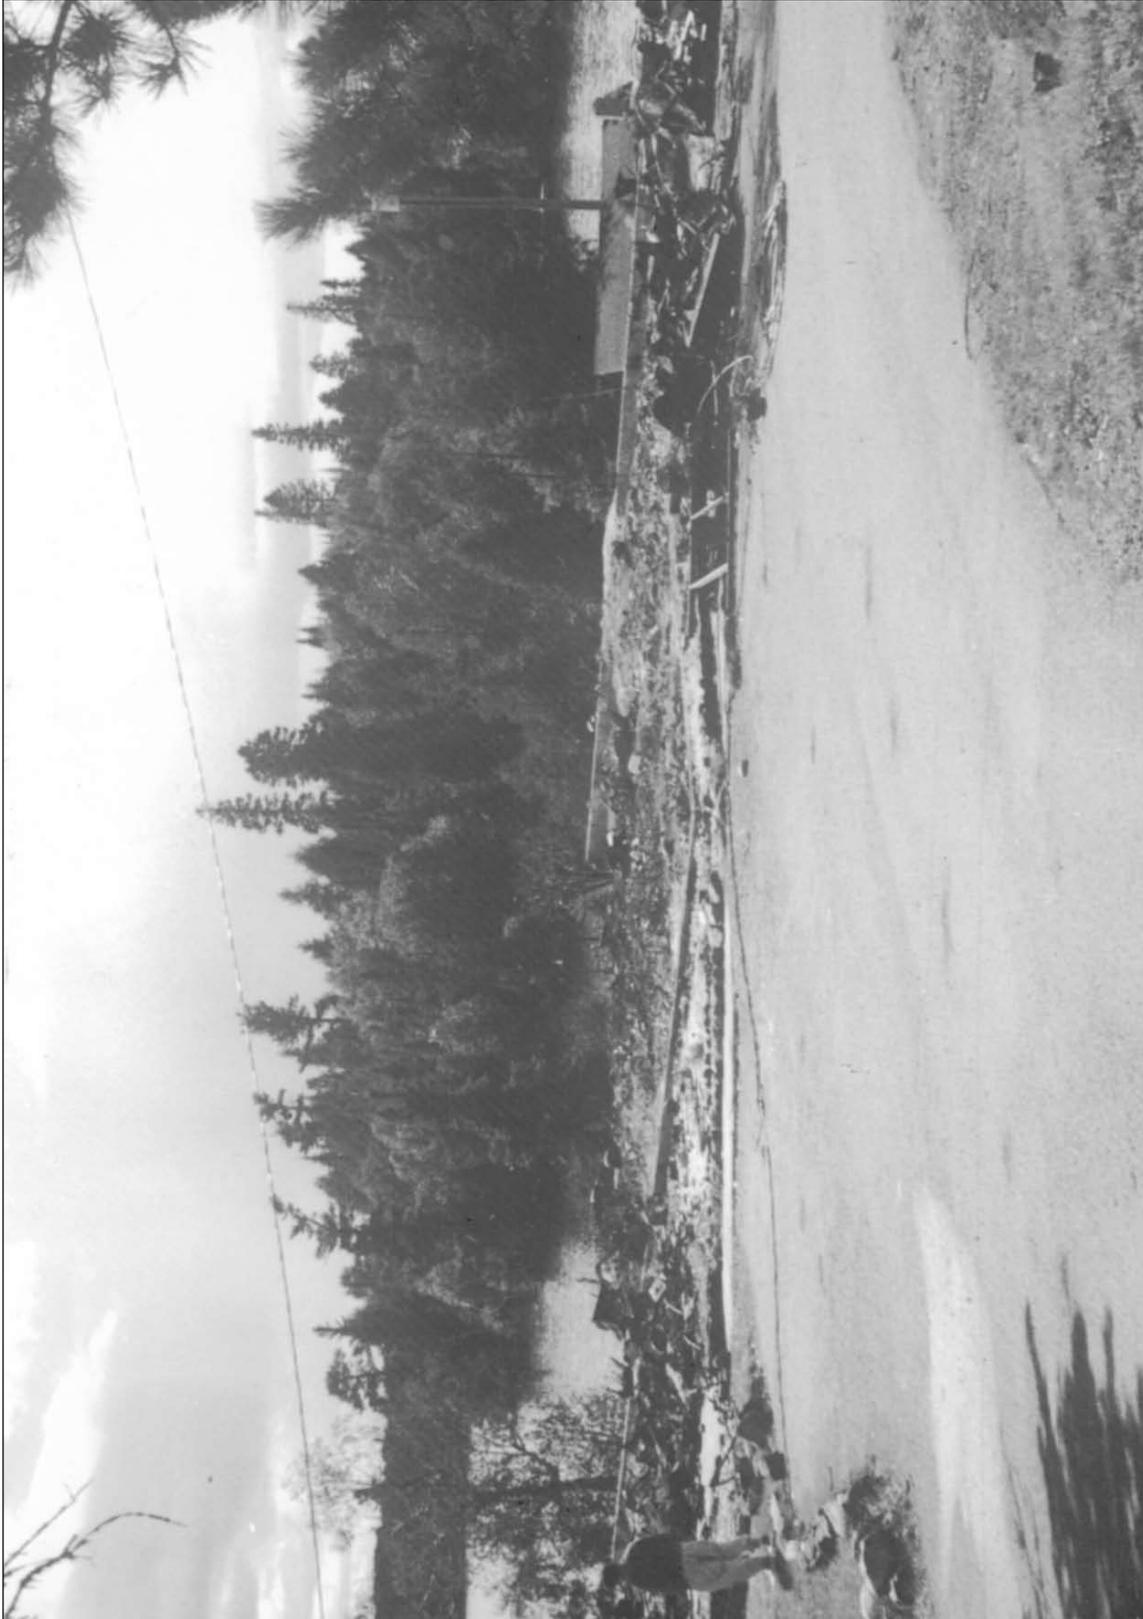
Remains of Windigo Lodge from east drive, facing lake.

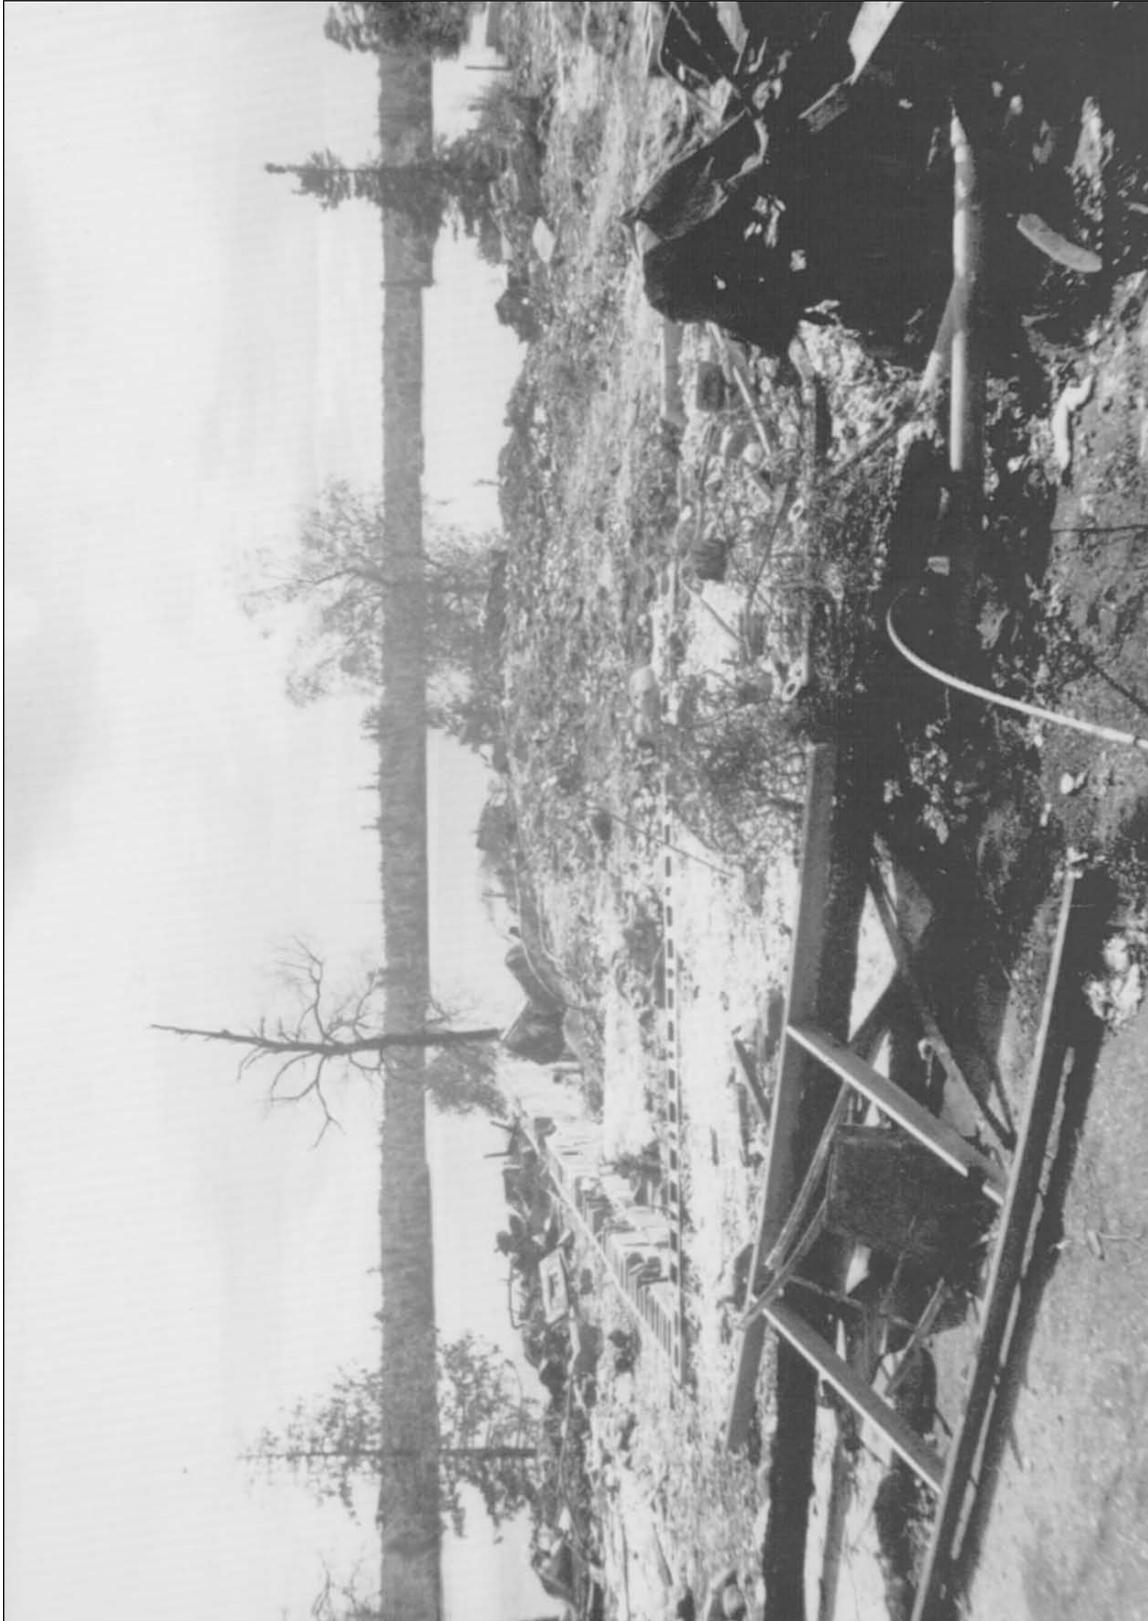
Entire structure was consumed by fire; east and north foundation walls shown here.

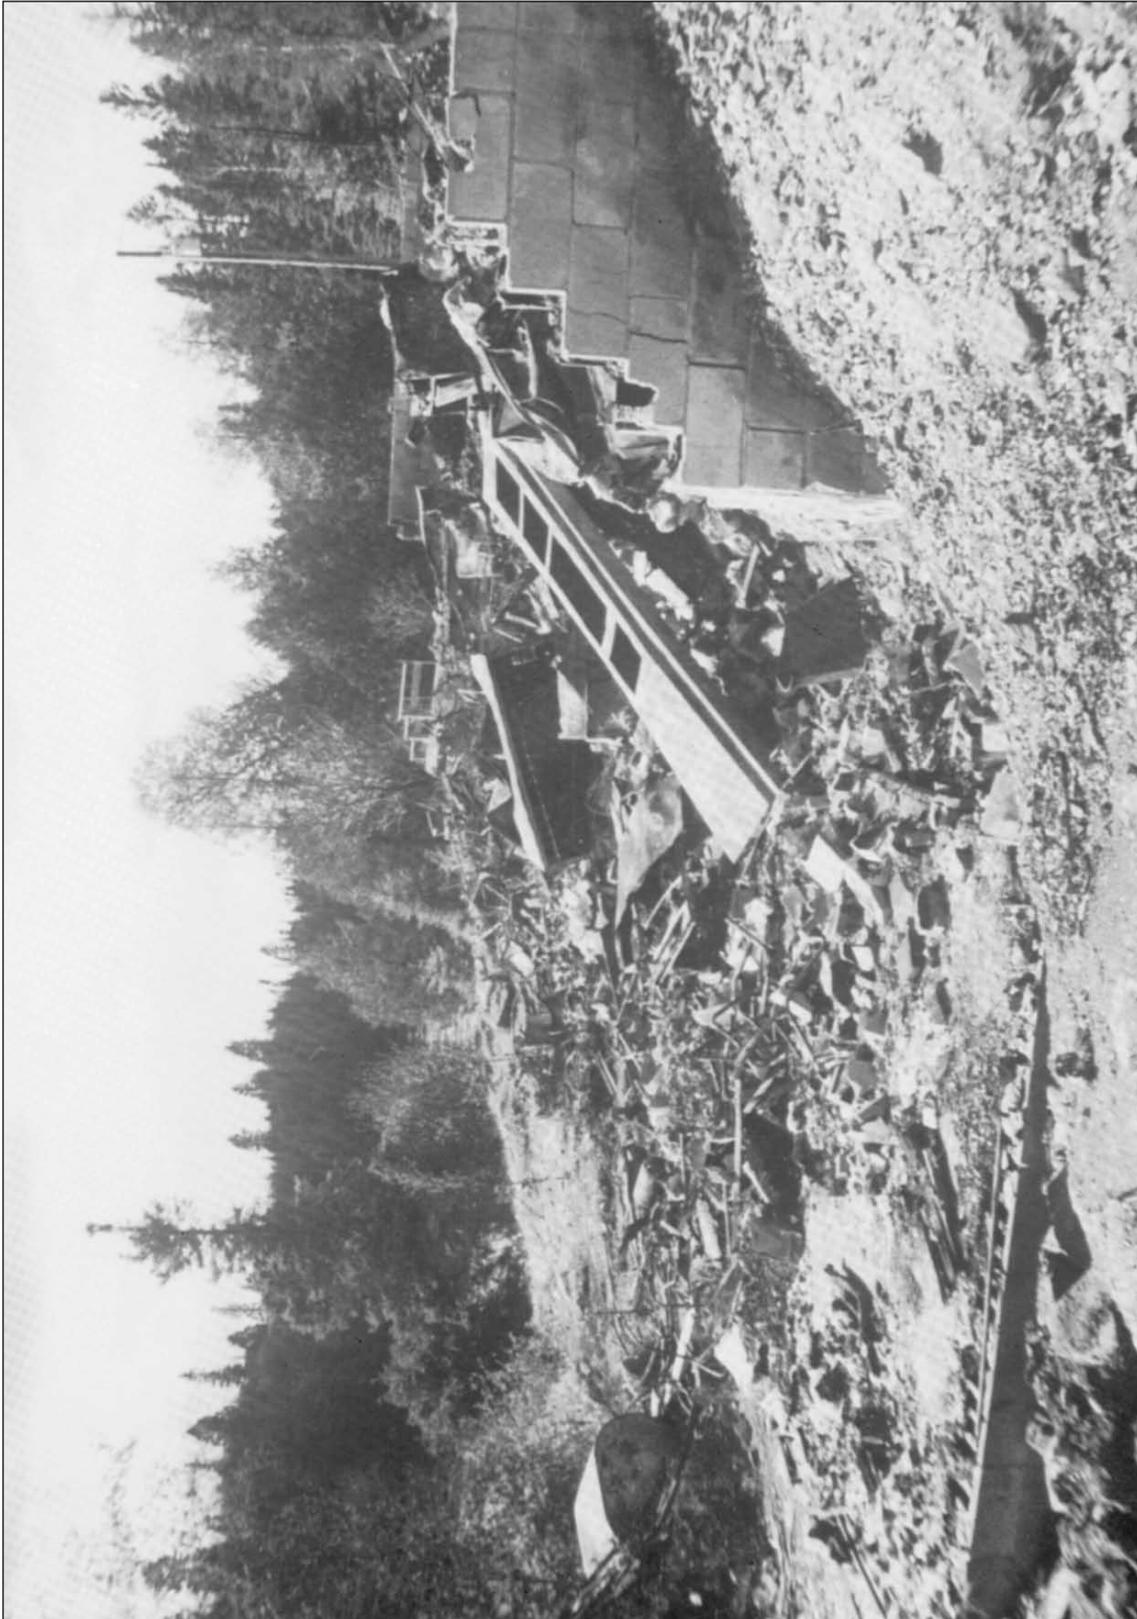
East foundation wall and basement walkout to lake (off photo to left); basement wood frame construction consumed by fire.

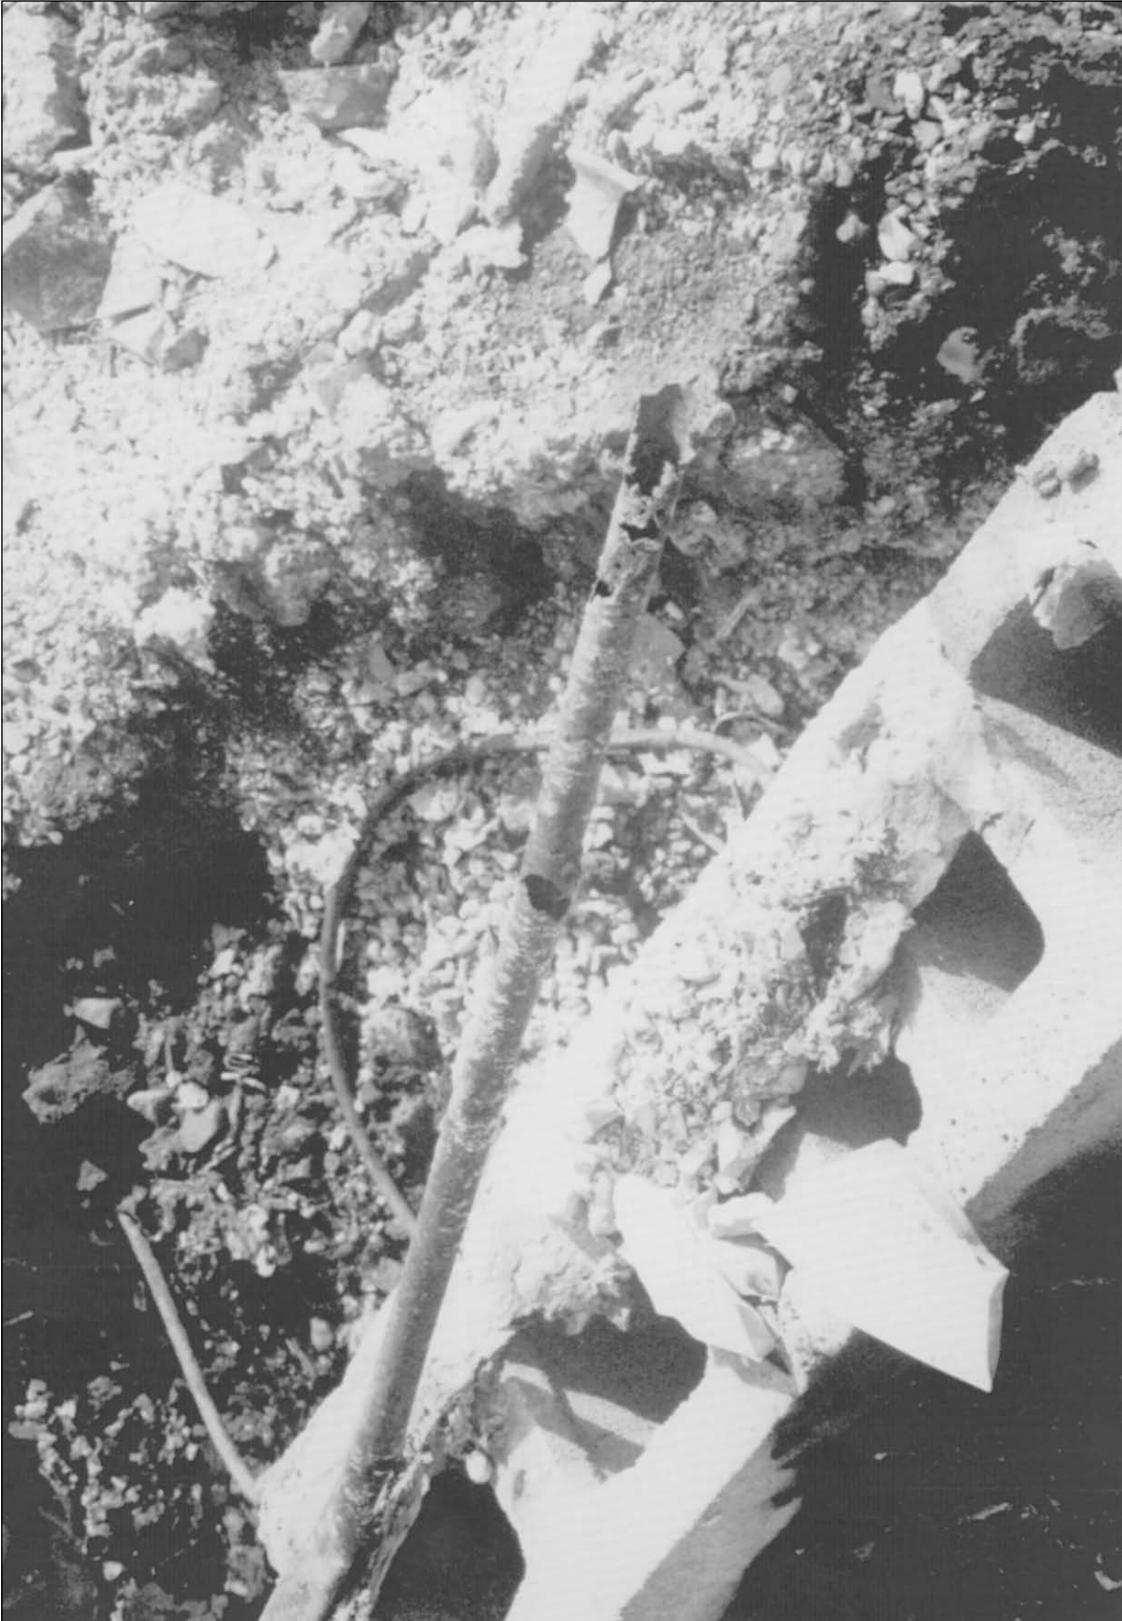
Damage to 3/4-inch copper water pipe from intense heat of the fire.
