U.S. Fire Administration/Technical Report Series

Four Firefighters Killed, Trapped by Floor Collapse

Brackenridge, Pennsylvania

USFA-TR-061/December 1991

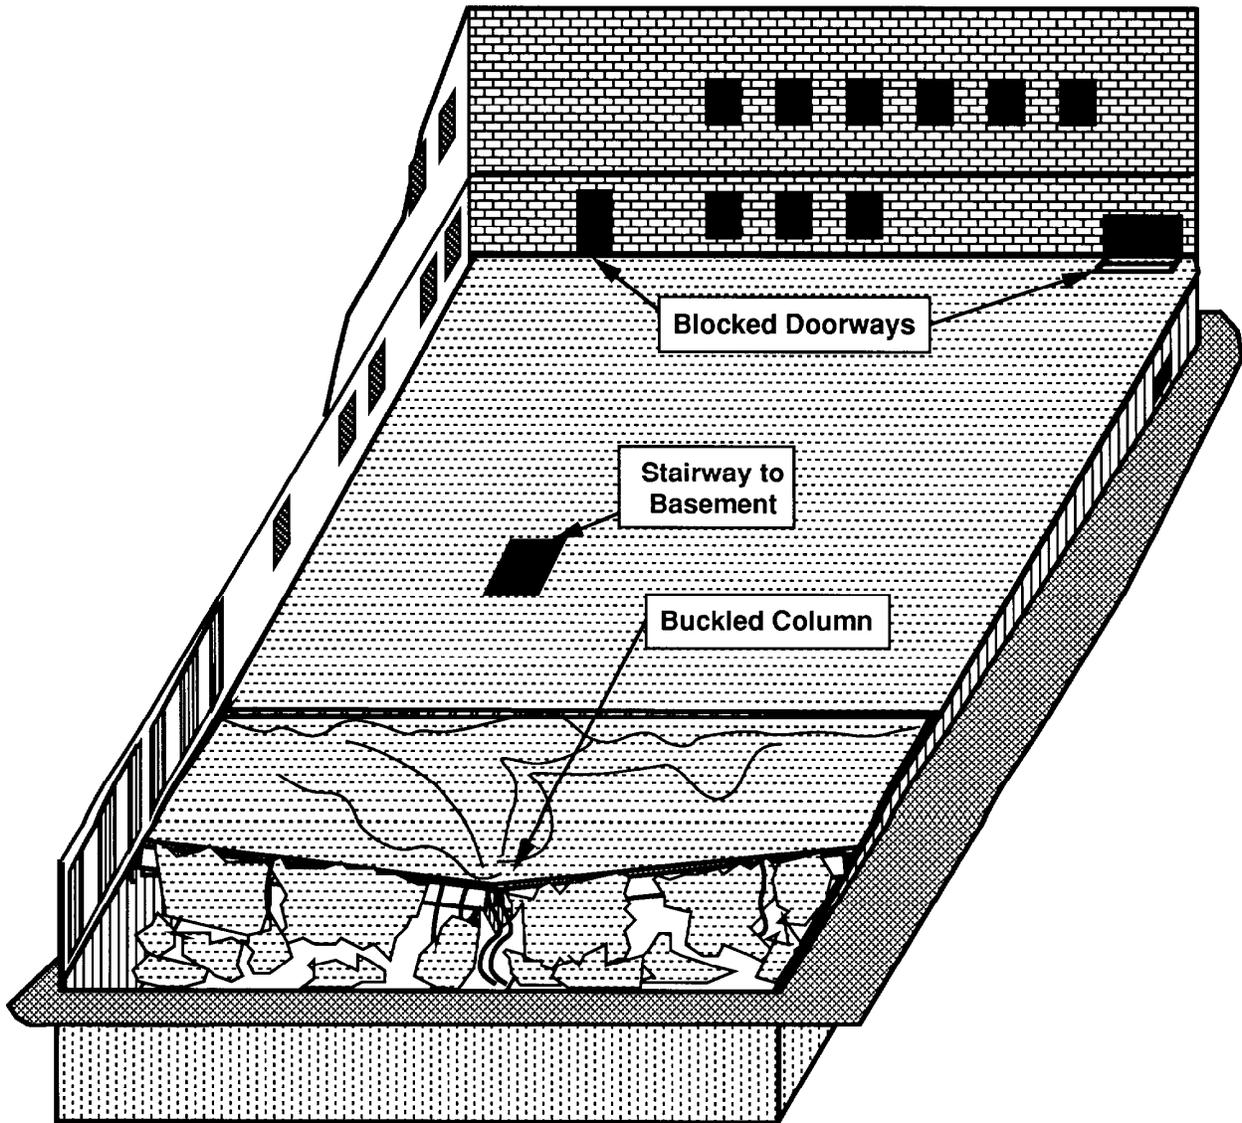
CUT-AWAY VIEW
Showing Floor Collapse

The primary structural collapse was caused by the failure of the steel joists supporting the floor slab above the finishing room. All of the joists between the front wall and the first set of support beams failed and dropped the concrete slab into the basement. Examination of the joists found in the rubble indicates that all were severely warped and twisted from heat exposure. The slab broke near the mid-point of the span and some sections were left hanging vertically from the beams. This created an opening, directly over the fire, extending 15 feet in from the front for the full width of the building.

The middle column supporting the first set of beams was also buckled, although this appears to have been a secondary failure. The buckling of this column caused a secondary slab failure between the first and second sets of beams. The slab in the second bay sloped down toward the opening, with a low point at the center column, but did not drop into the basement. The remainder of the ground floor was not compromised.

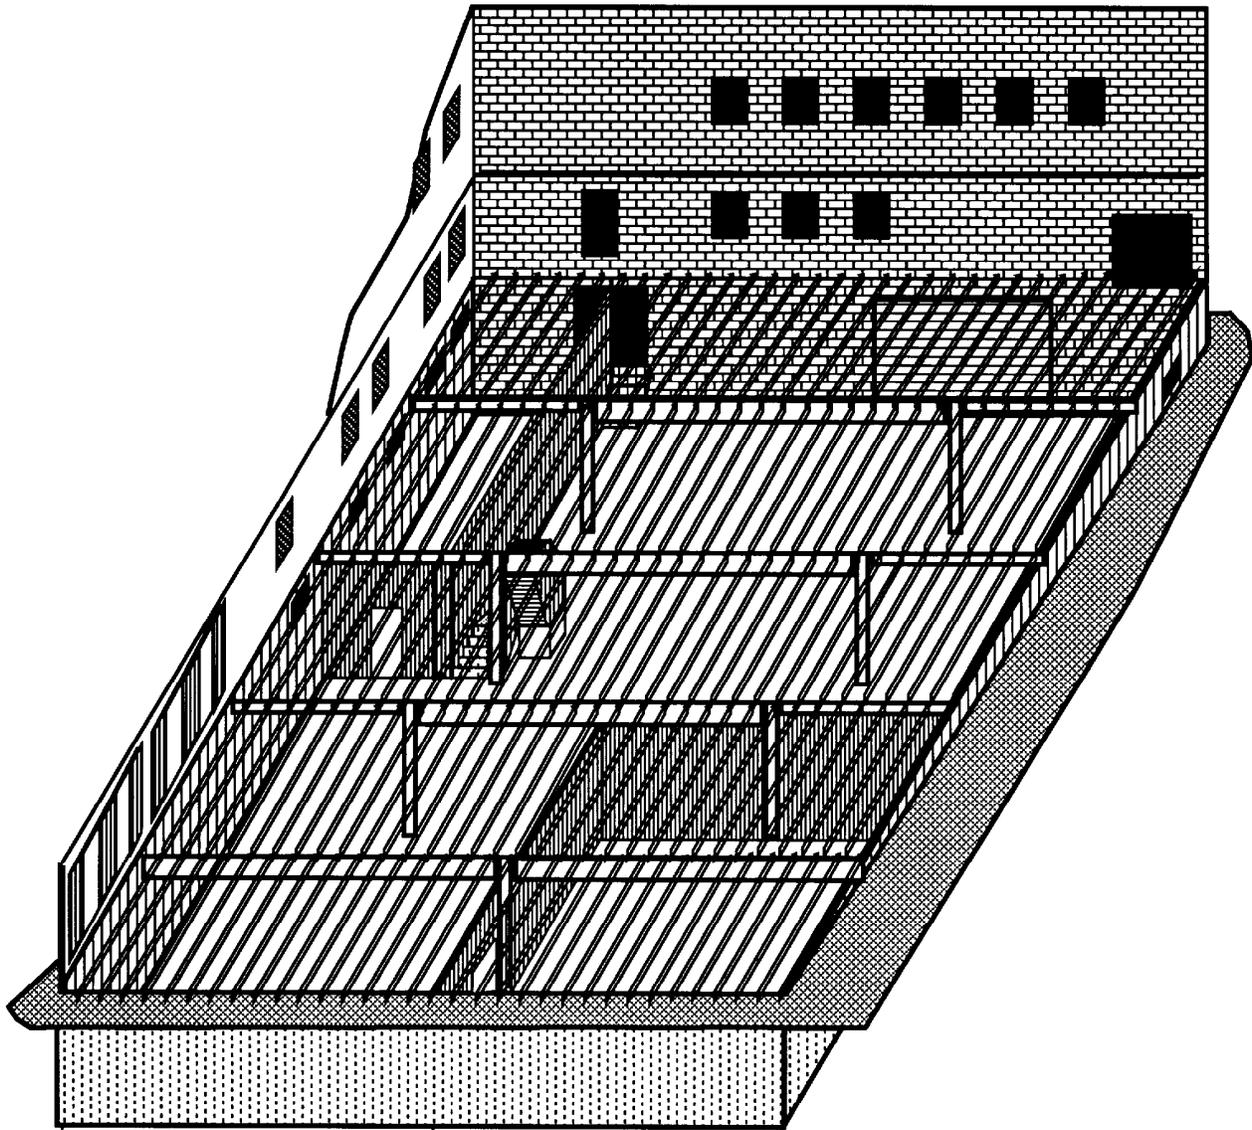
CUT-AWAY VIEW
Showing Ground Floor Joists

The anchorages of some of the joists at the front of the building were severely corroded, particularly in the area under the door leading to the vehicle ramp. These particular joists were so severely corroded that they may not have been able to support a routine load.

The steel joists above the finishing room were directly exposed to fire for a long period of time. The hot floor condition was noted by the first firefighters entering the building, approximately 35 minutes before the collapse occurred, and it is possible that the fire had been burning in the finishing room for an extended period of time before being discovered. The individual joists were probably heated to the point of failure well before the collapse occurred; probably before the fire department arrived. They did not collapse immediately because they were supported by the rigidity of the combined joists and slab assembly and the manner of support at the basement wall.

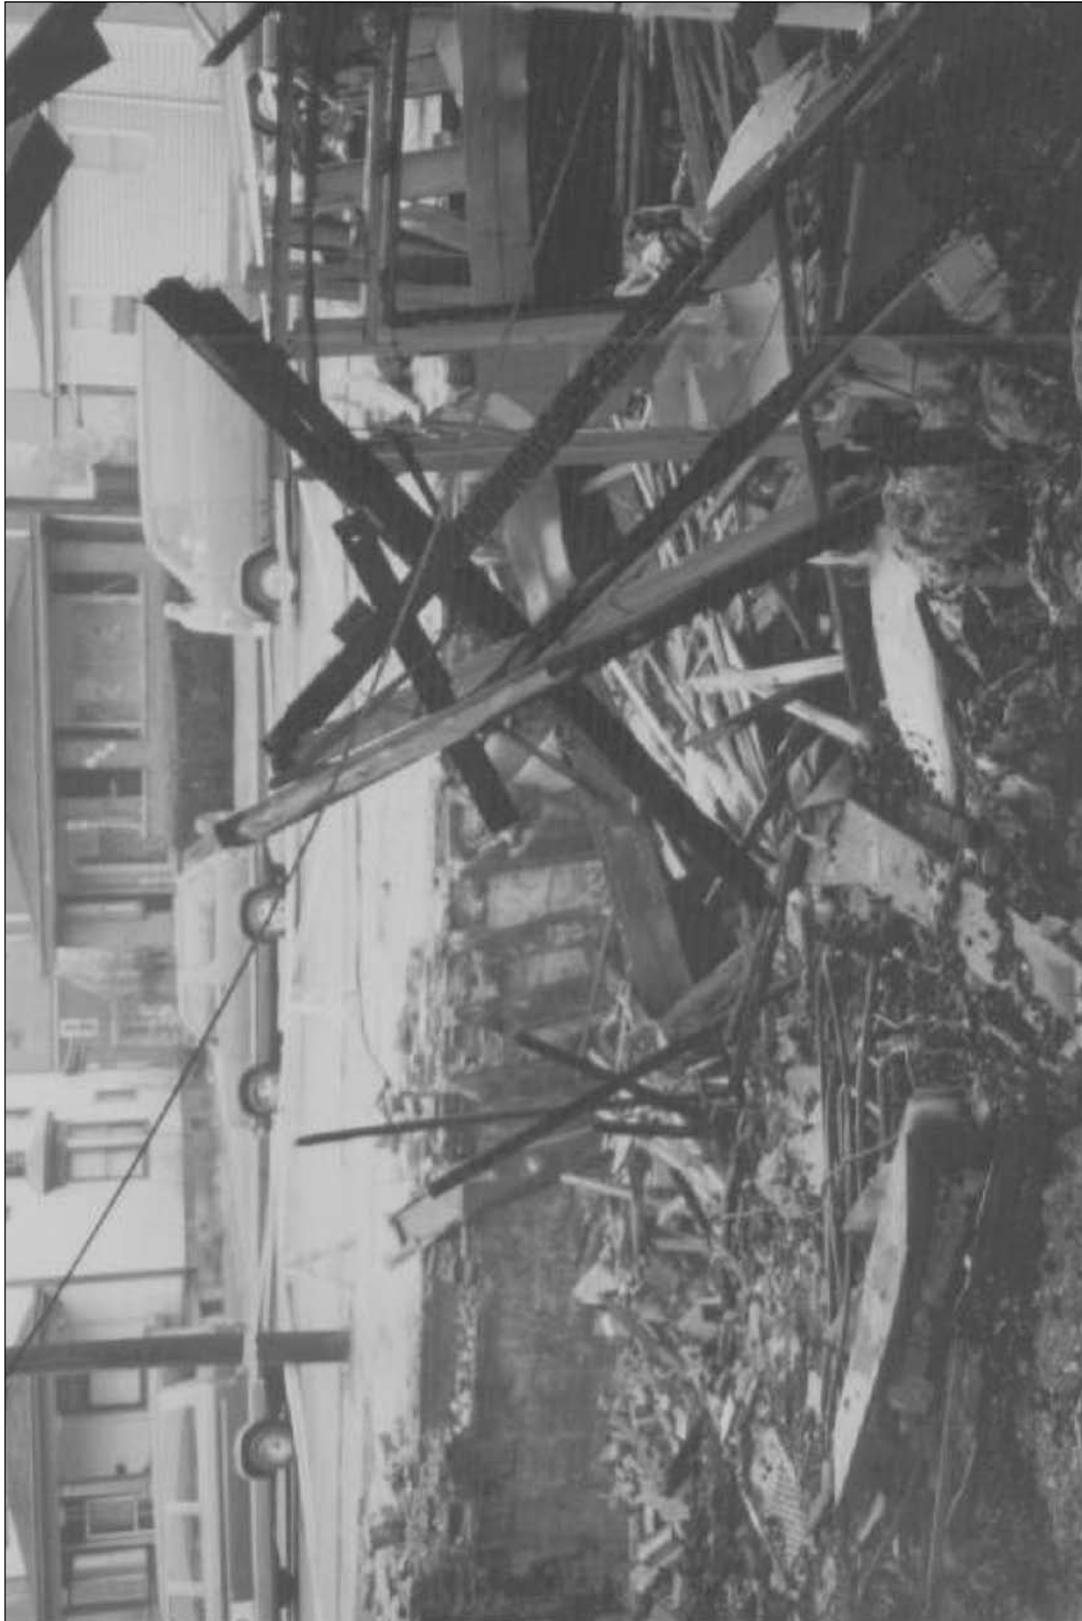
Looking toward Brackenridge Ave. from ground floor, near location where bodies were found. Debris in foreground is from first and second floors and from roof structure. Bent-over ends of floor joists are visible at the point of attachment to the basement wall.

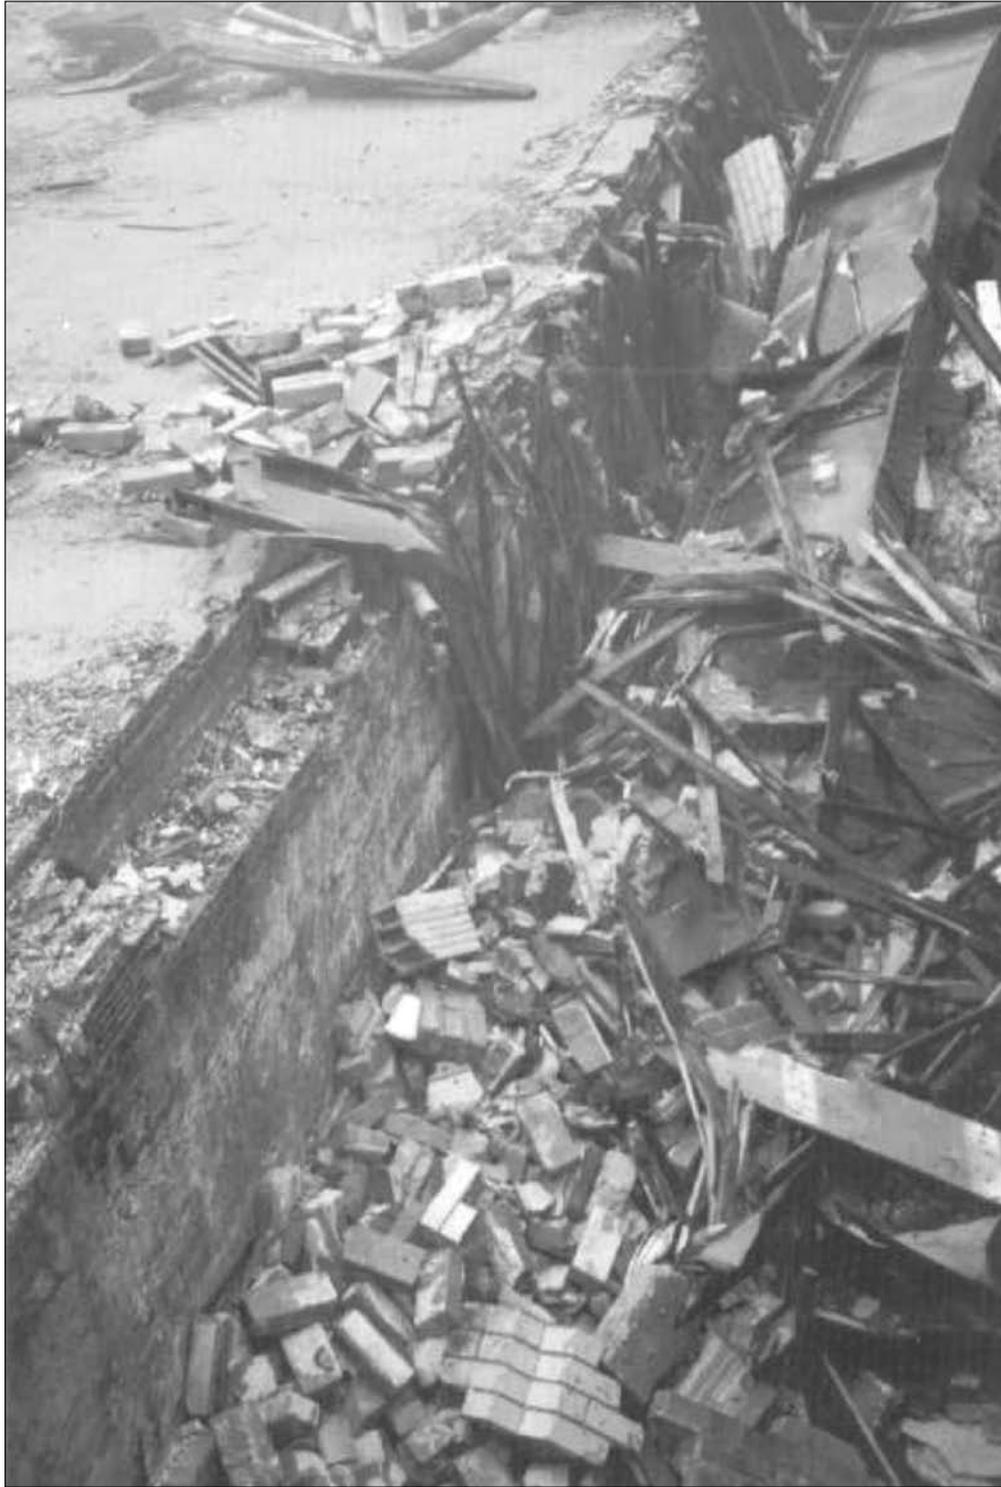
**Point of rigid support for floor joists at front of building. Floor joists rested on concrete basement wall and were held in place by brickwork.
(Steel girder is from roof structure.)**

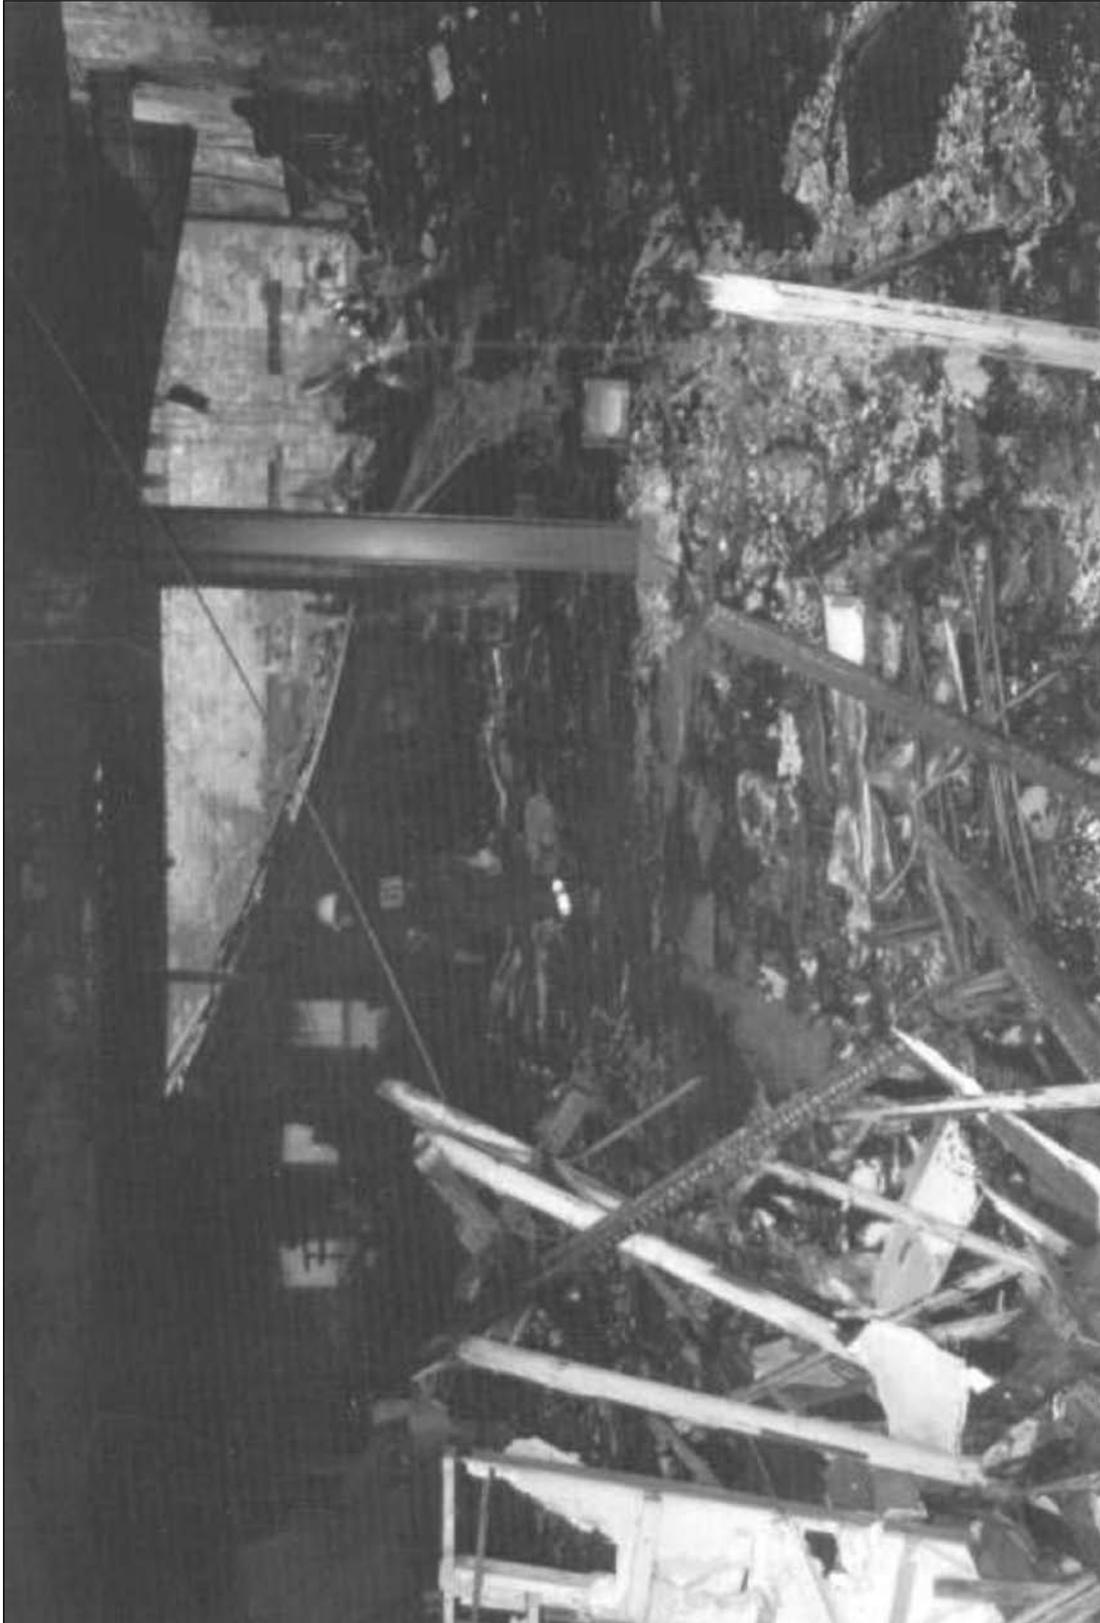
Ground floor area, showing unprotected steel column and ramp to second floor.

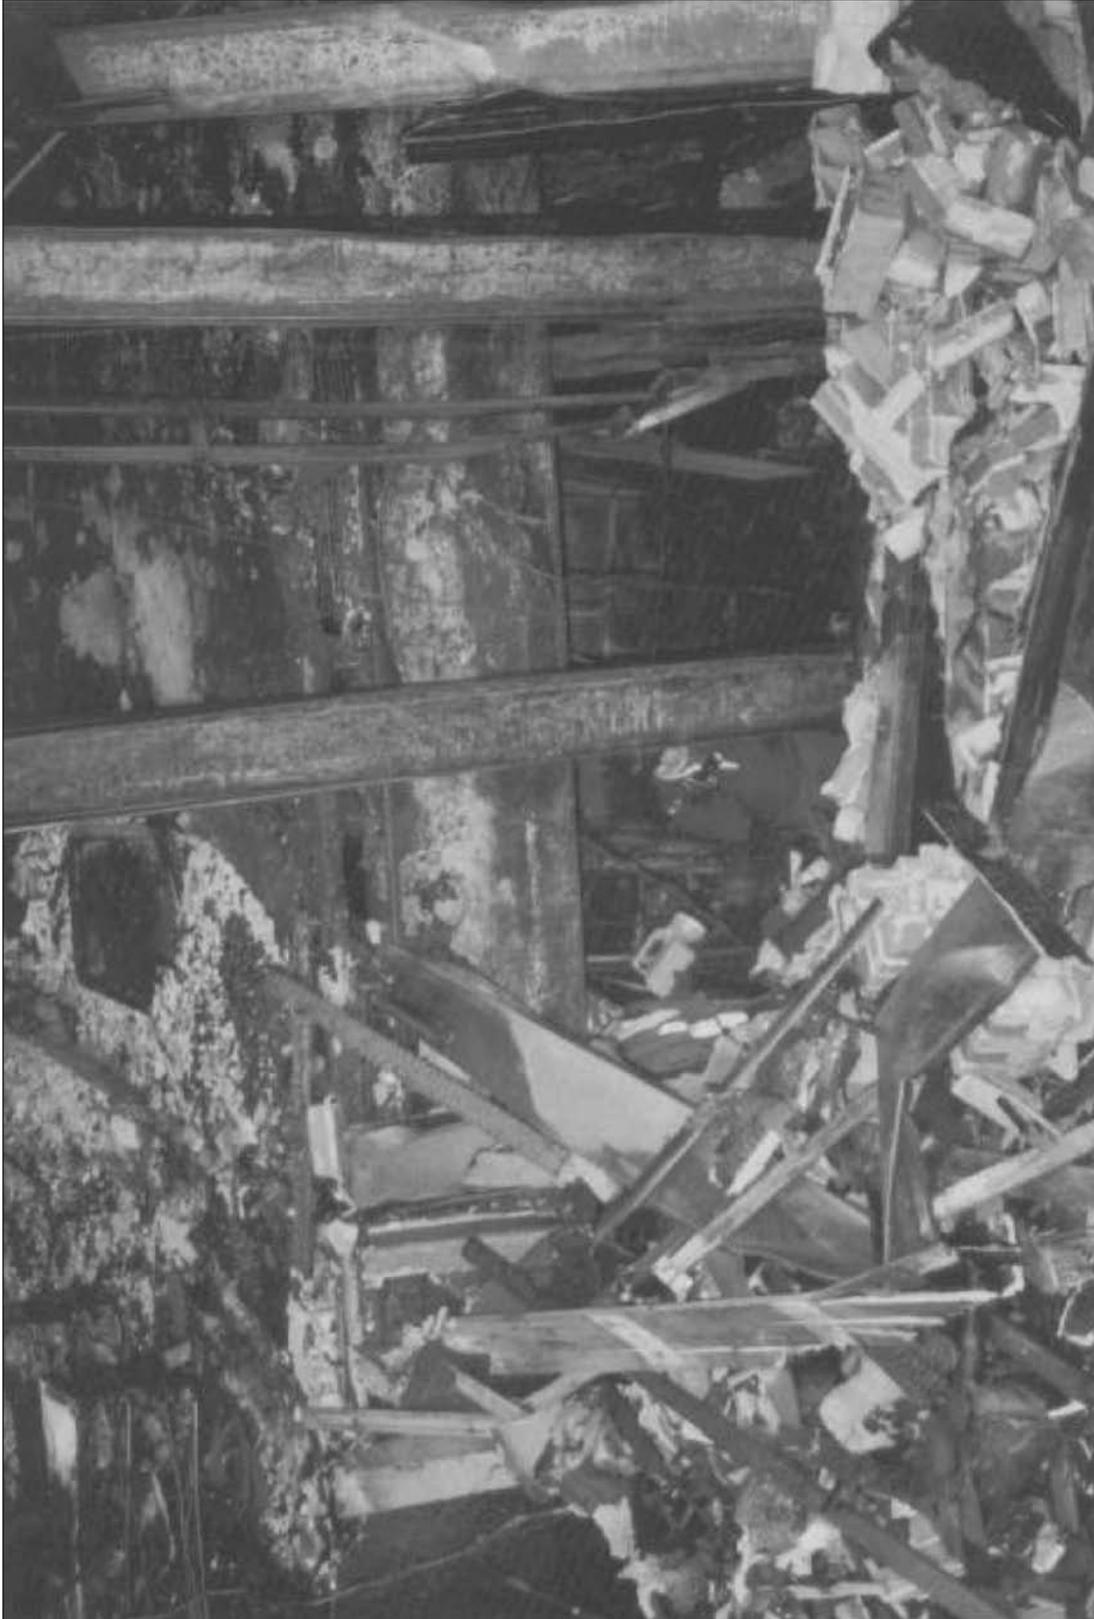
The mass determines the time it will take for a member to be heated to its failure temperature when exposed to a fire. Light gauge members, such as the floor joists in this building, may be vulnerable to collapse with as little as three to five minutes of direct exposure to a fire, while heavier members may take 10 to 20 minutes to reach their failure temperature. Very heavy steel members may survive extended exposure to a fire environment.

**View from sidewalk in front of building (Brackenridge Ave.) looking into basement.
Note thin concrete slab, supported by steel joists resting on steel beams.**

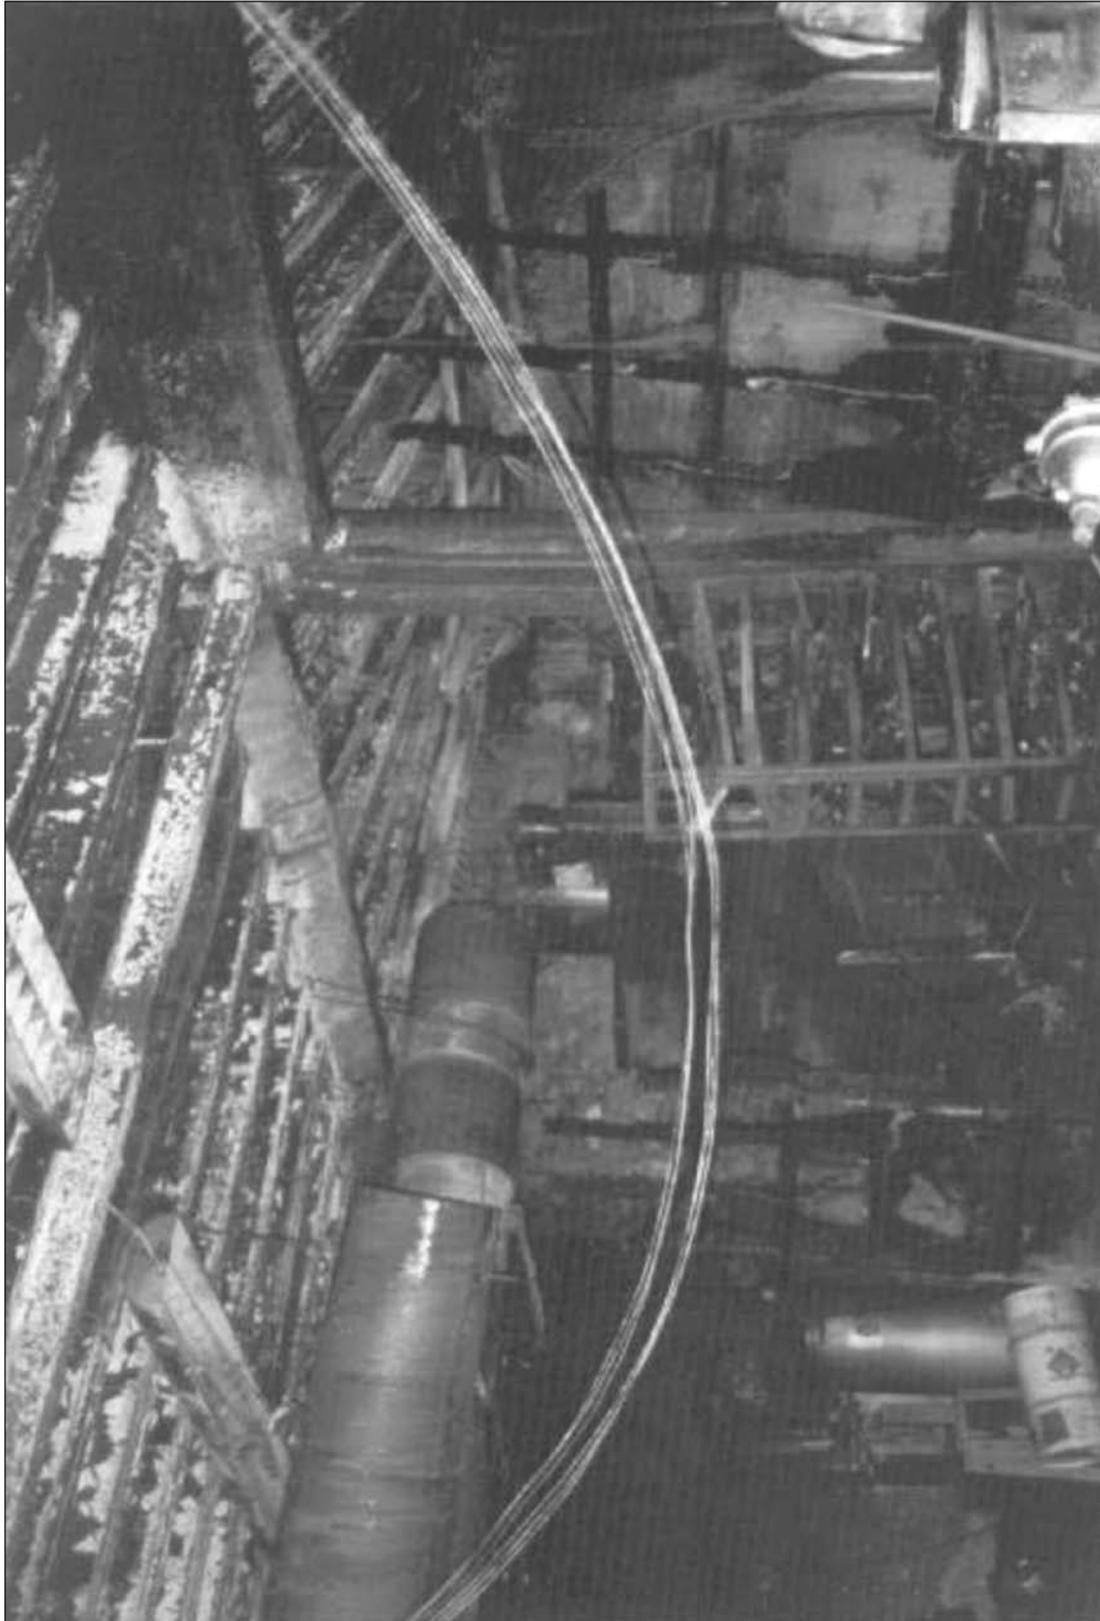
The fire originated in the basement finishing room, which is directly below the front entrance. The investigation indicates that the cause was most likely an accumulation of overspray residue that was ignited by the electric heating unit. The alternative possibility of spontaneous ignition of chemicals used in the room could not be eliminated. The actual time of ignition is believed to have been as long as several hours before discovery. Investigators believe that the fire may have smoldered for several hours and may have gone through repeated stages of flaming and smoldering combustion, limited by the ventilation that was available to sustain flaming combustion.

Partial view of exhaust duct for spray booth air discharges. Rear of metal spray booths and remnants of enclosure wall are visible.

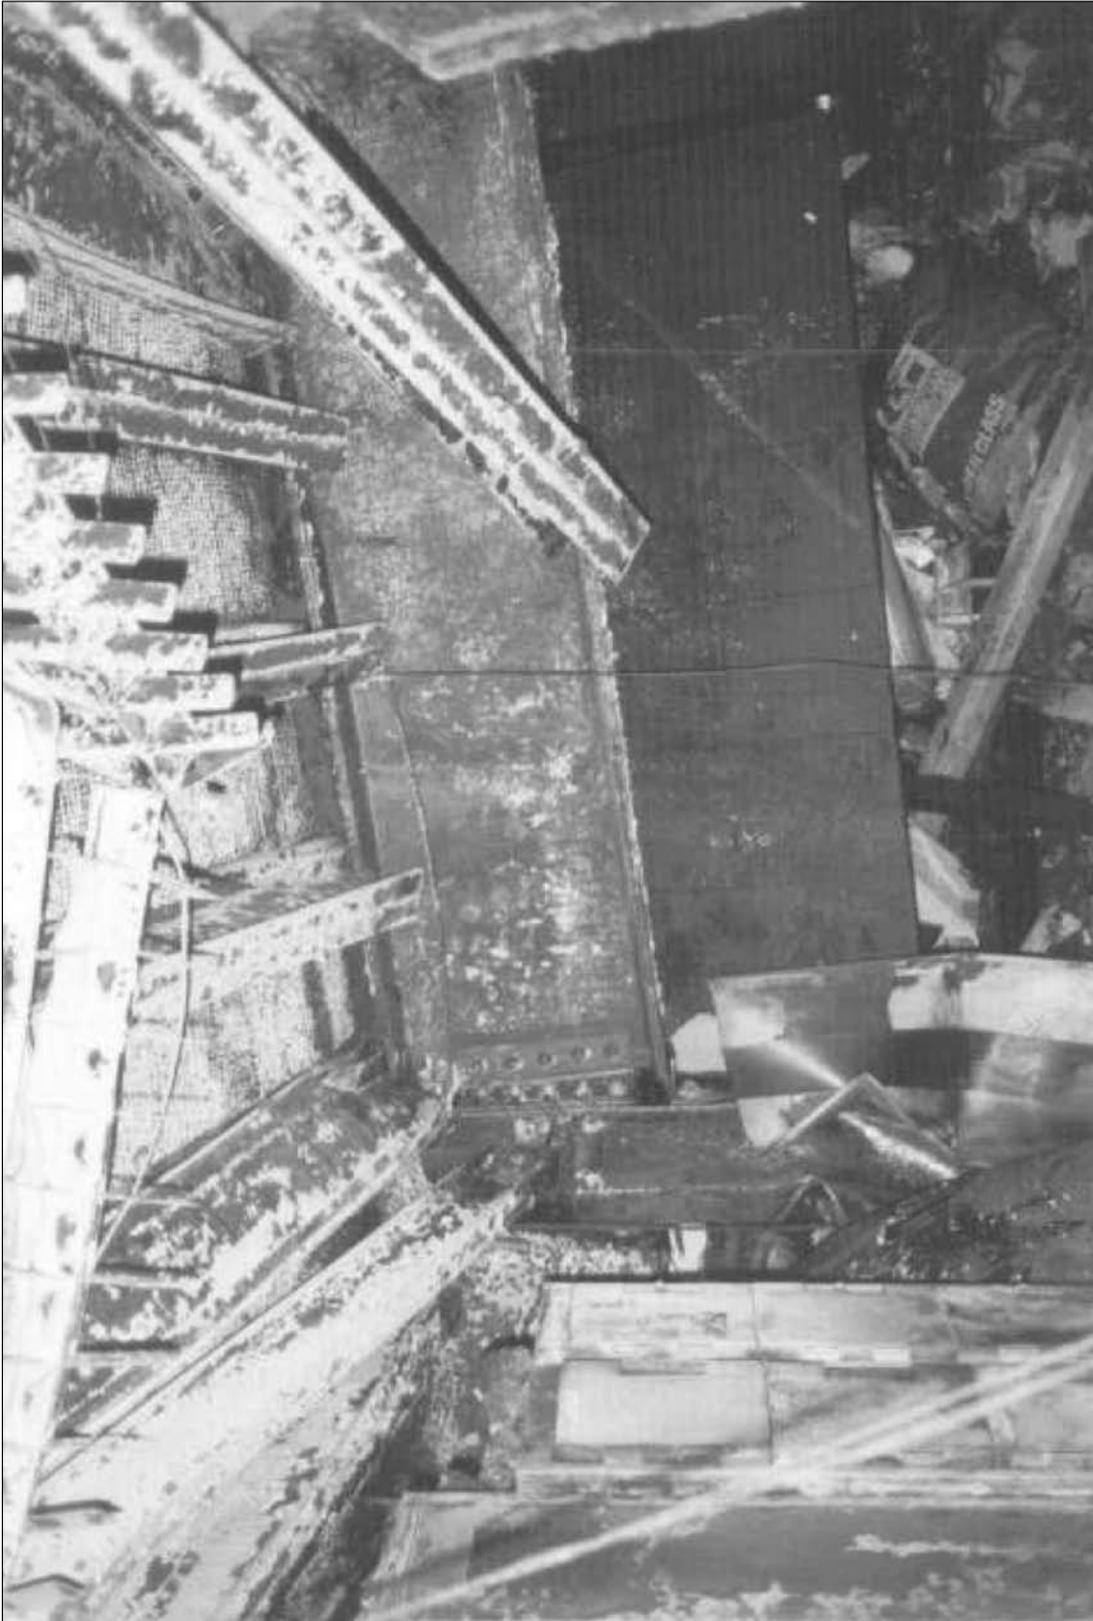
Photo by J. Gordon Routley
Connection between buckled center column and main beam. Note floor section hanging from opposite side of beam.

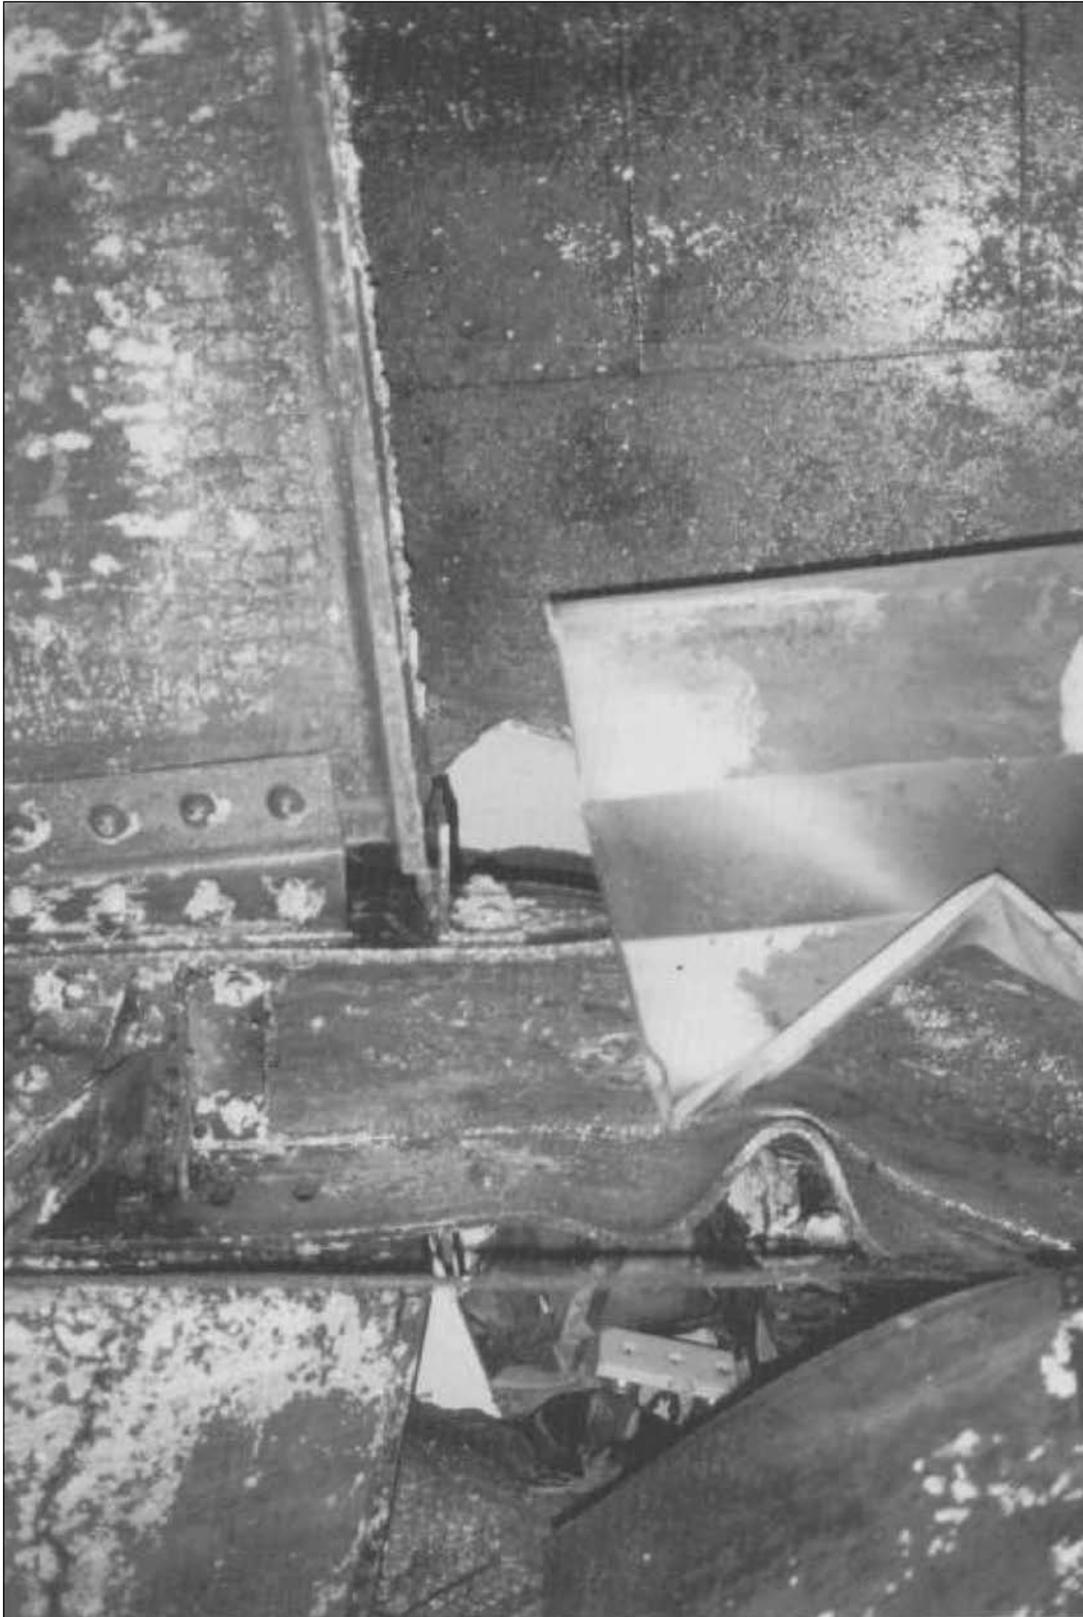
Detail of buckled center column, showing damaged connection of horizontal beam.

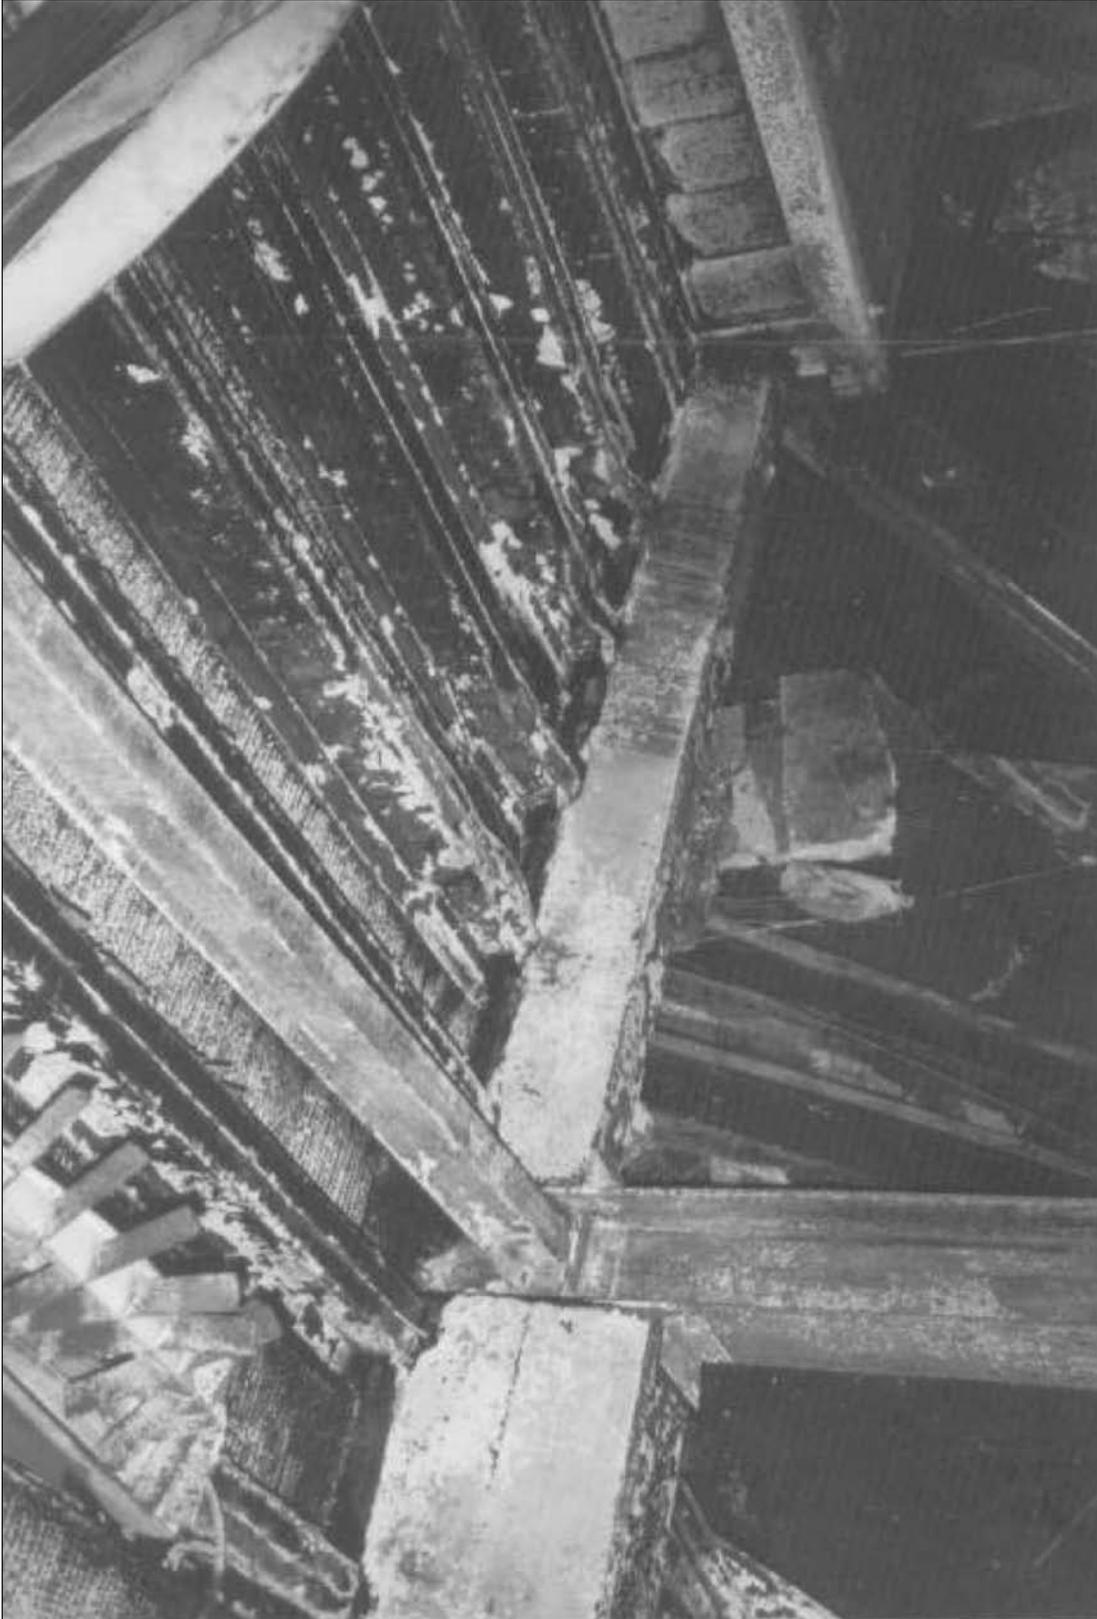
Basement steel beams, encased in concrete, on each side of unprotected column.

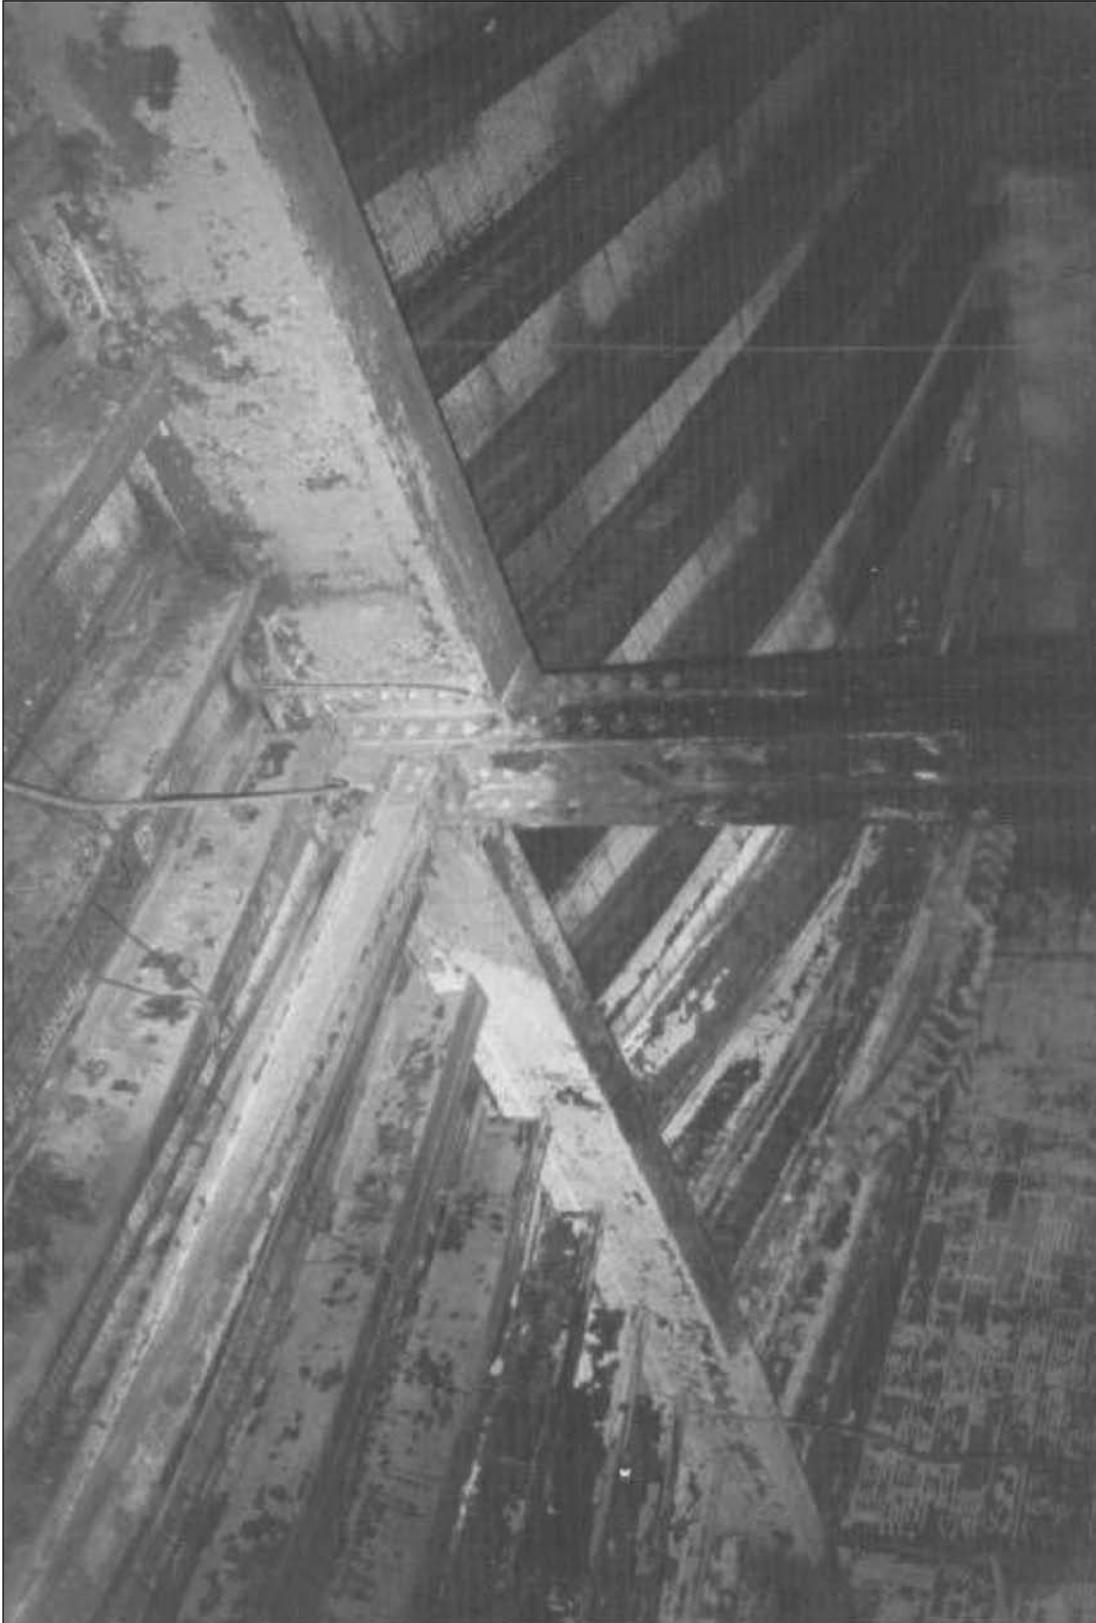
View of unprotected steel supporting second floor. Sag in joists resulted from exposure to the heat of the fire, although this area was not heavily involved in flames.

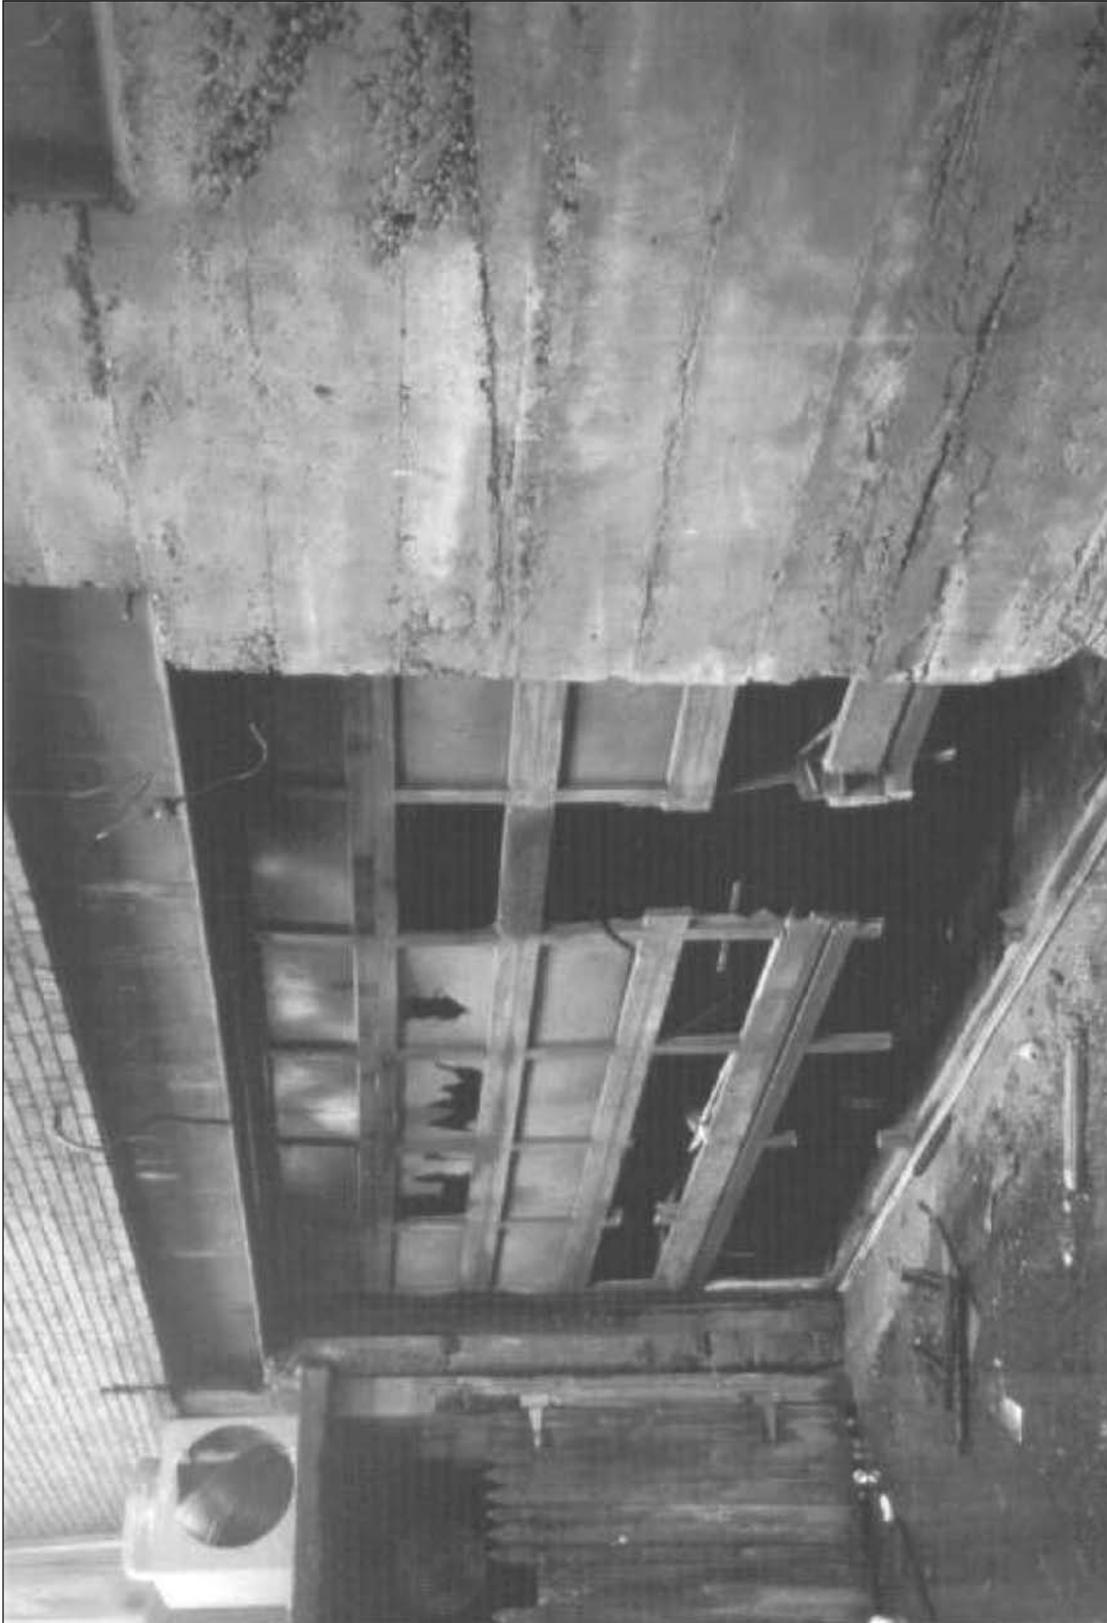
Roll-up door at the rear of the fire building has been cut with circular saws to allow crews to enter the basement. Initial entry by Eureka crew was through the bottom panels – larger opening was made later.
