U.S. Fire Administration/Technical Report Series

# Indianapolis Athletic Club Fire

Indianapolis, Indiana

USFA-TR-063/February 1992

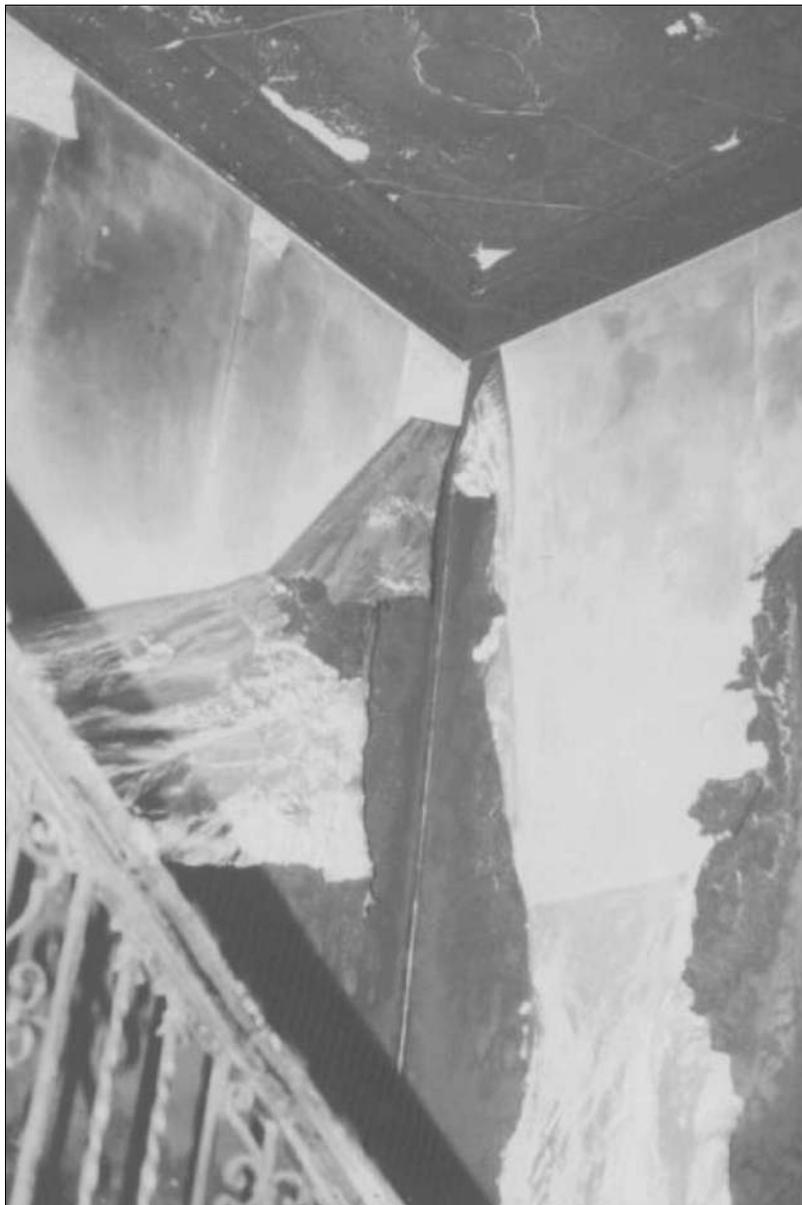
**This view from the monumental stairway looking up toward third floor ceiling shows relatively light damage to the cornice, but heavy damage to the combustibles foil-backed wall coverings.**

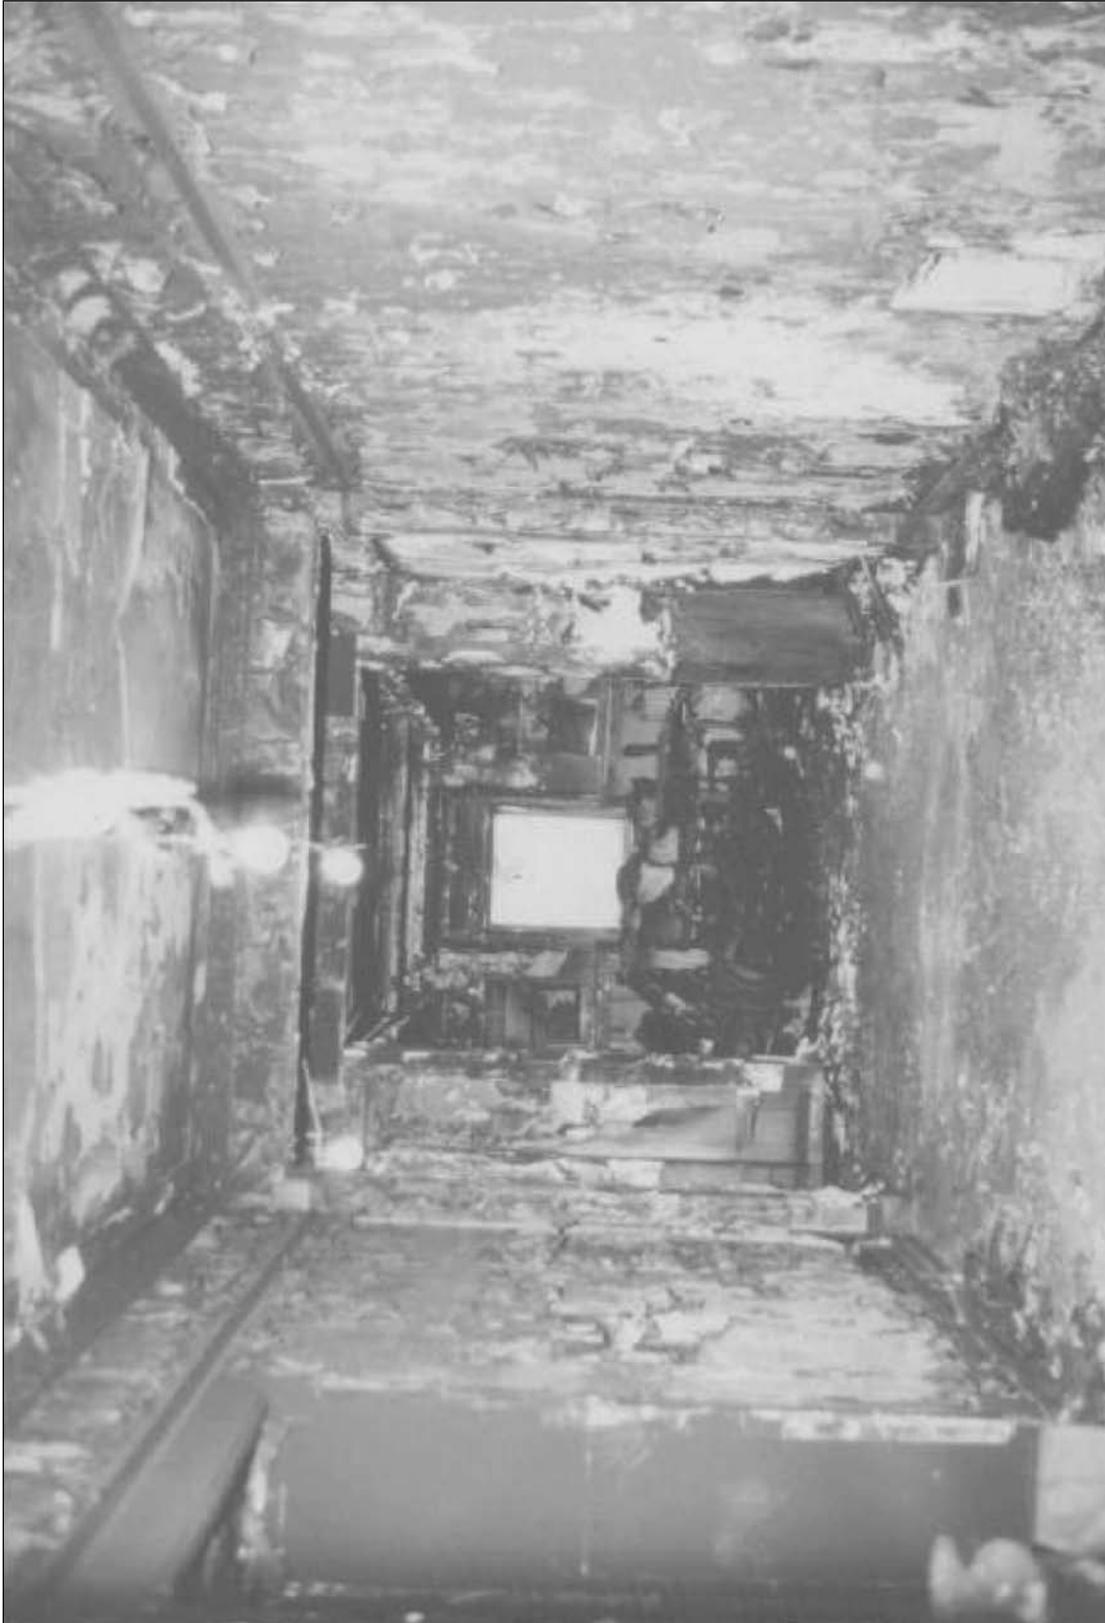
This view of the third floor corridor looking east toward the large dining room shows the extensive damage to combustible wall coverings.

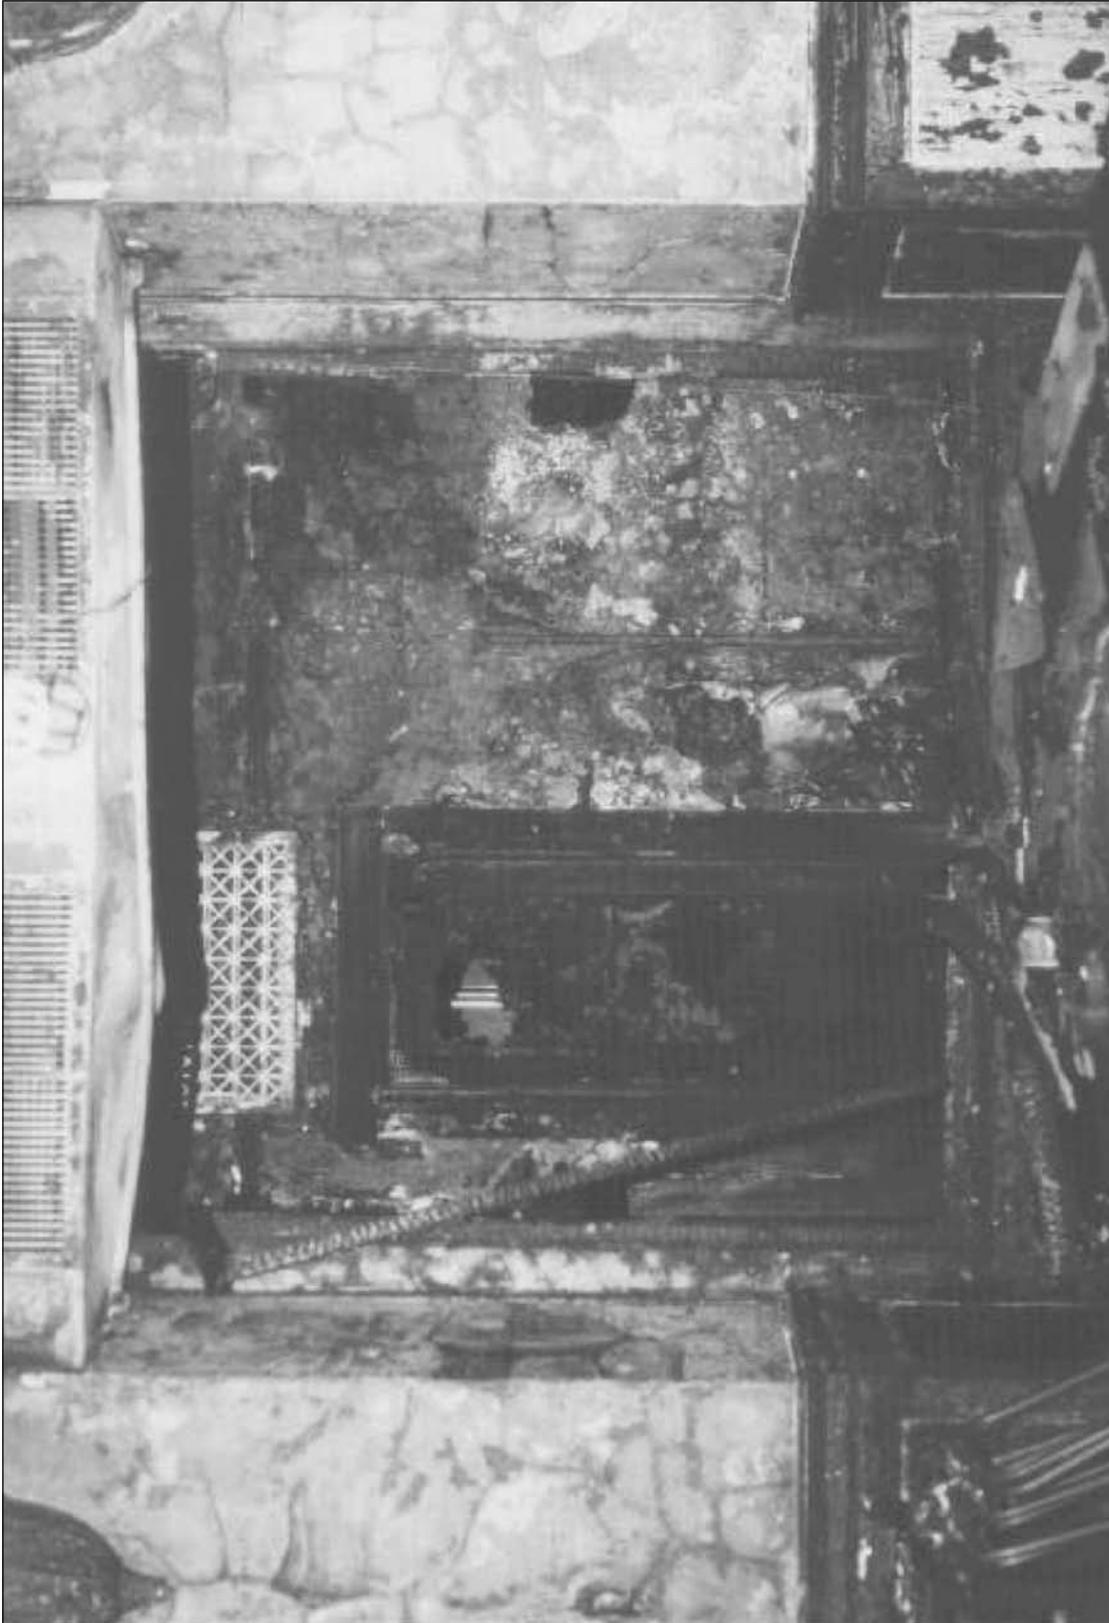
Entrance to ladies room adjacent to the dutch-style service door to the bar (room of fire origin). Note the air return register over the door and the air supply register over the opening to the dining room.

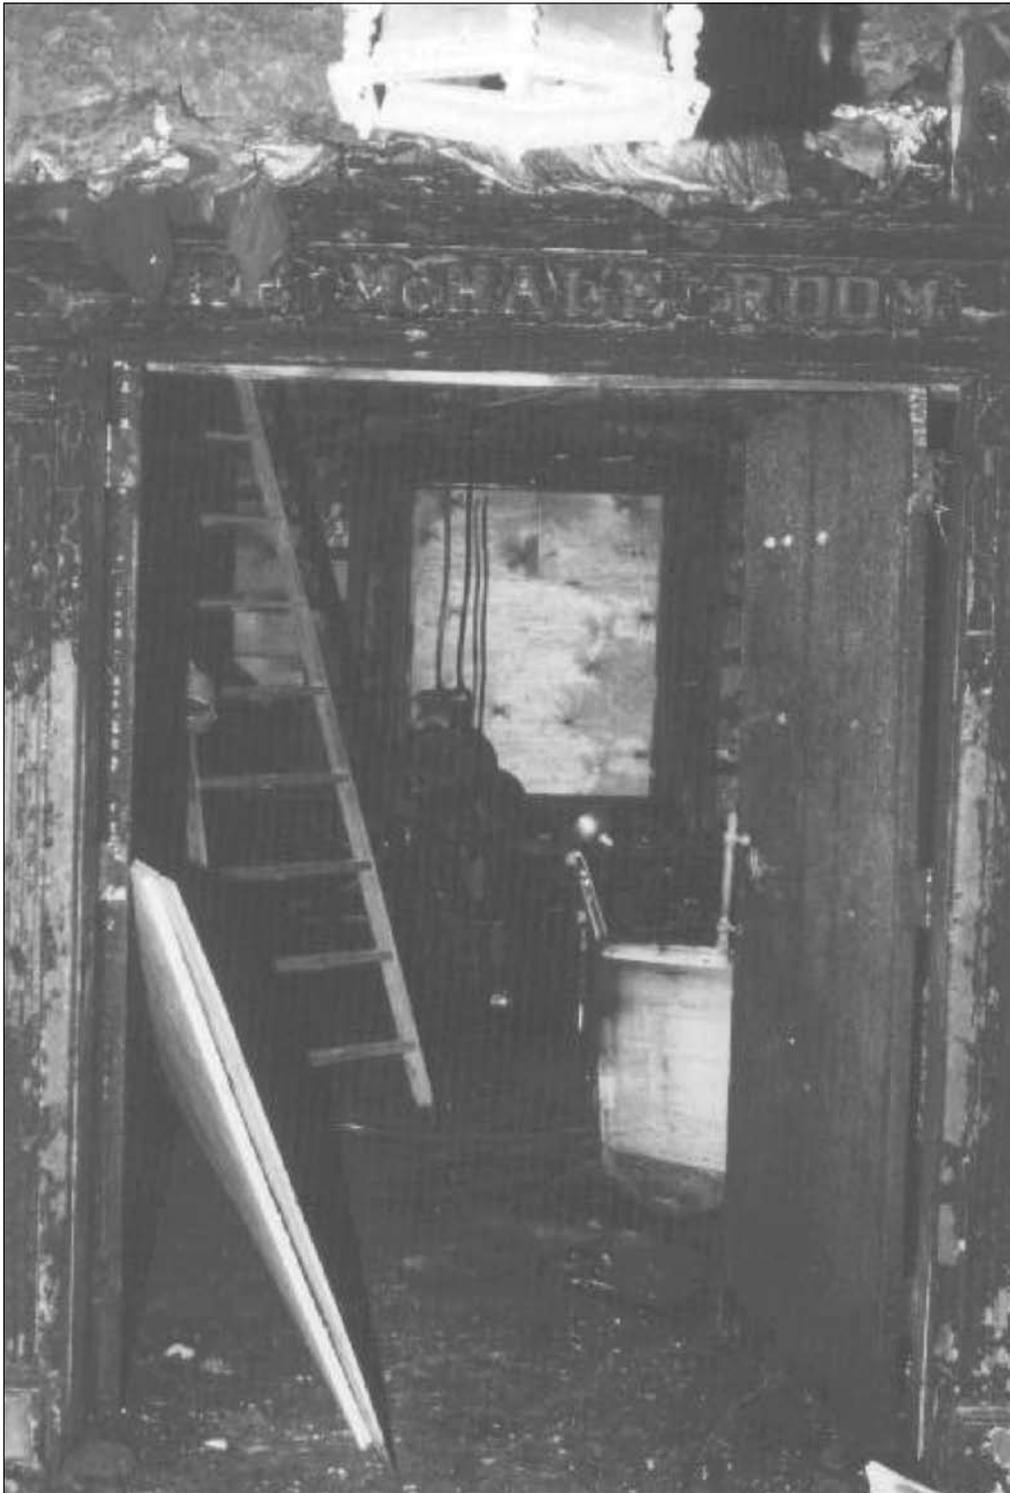
Entrance to the McHale Room looking north from the elevator lobby. Note the fire damage to the wall coverings above the door and the relatively light charring of the door frame.

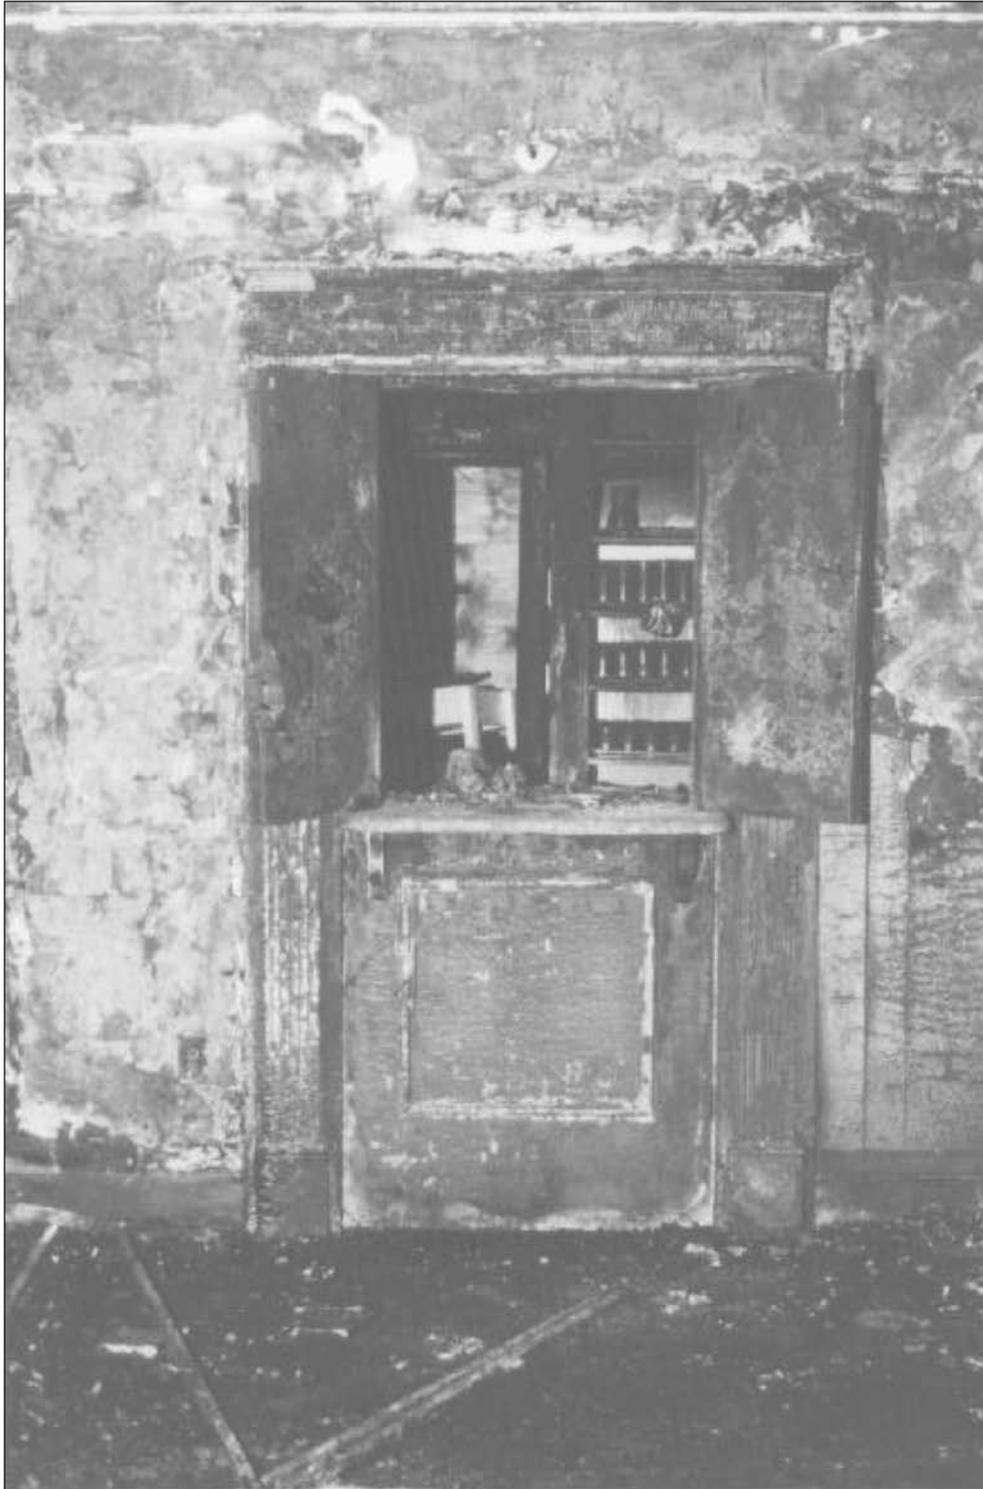
**This view of the dutch-style service door to the bar room shows the deep charring to the door frame above the opening and the plywood paneling on the lower right side of the door opening.**

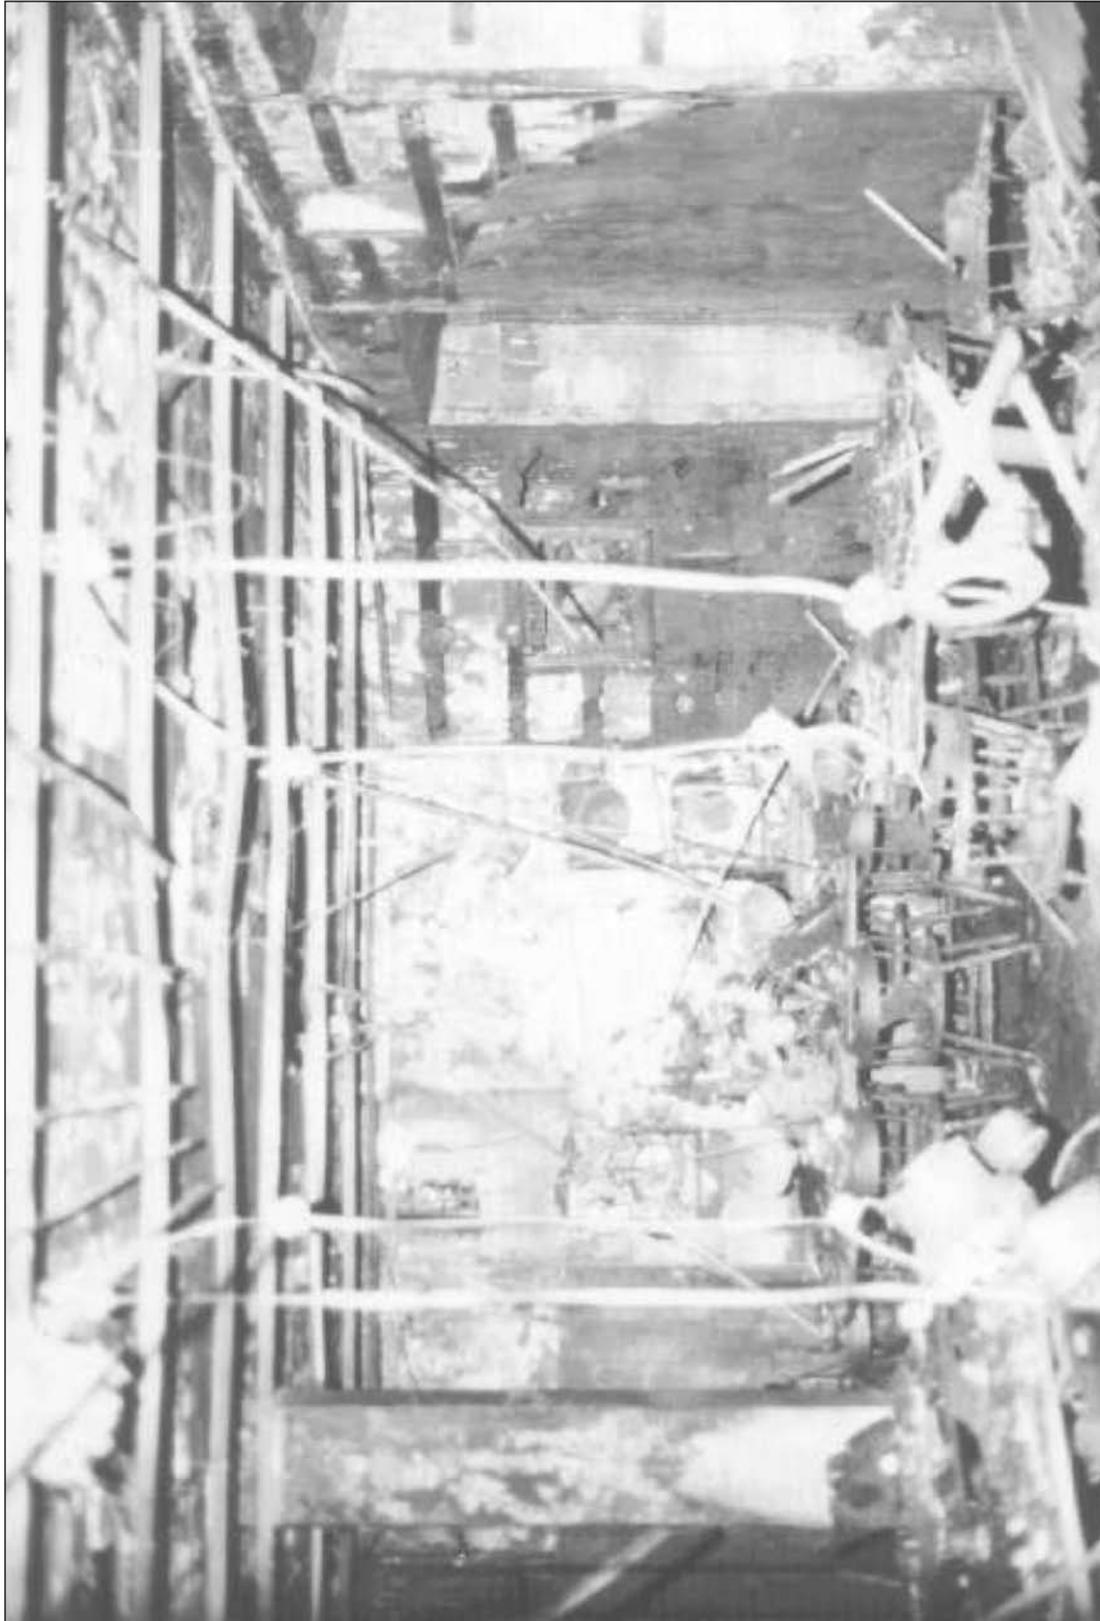
Like the ceilings, wall coverings had been successively replaced and modified. In the bar and McHale Rooms, 1/8-inch plywood paneling was installed on 1-inch by 3-inch furring strips. In corridors and the monumental stair leading from the lobby to the third floor, foil-backed vinyl wall coverings had been installed. The plywood paneling was labeled to indicate it had been tested in accordance with ASTM E84, *Test of Surface Burning Characteristics of Building Materials* and had a flame spread index rating of 150. The *Uniform Building Code* requires that interior finish material covering fire-resistive or noncombustible assemblies be attached directly to the assembly.<sup>5</sup> Installing the paneling on furring strips instead of directly attaching it to the wall surface could be expected to significantly increase the material's flame spread index rating.

The inside of the McHale Room looking west. Shows the use of furring strips under the wall paneling. Much of the paneling at the remote west end of the room remains intact. Also note that the tops of the chair backs are only slightly blistered.

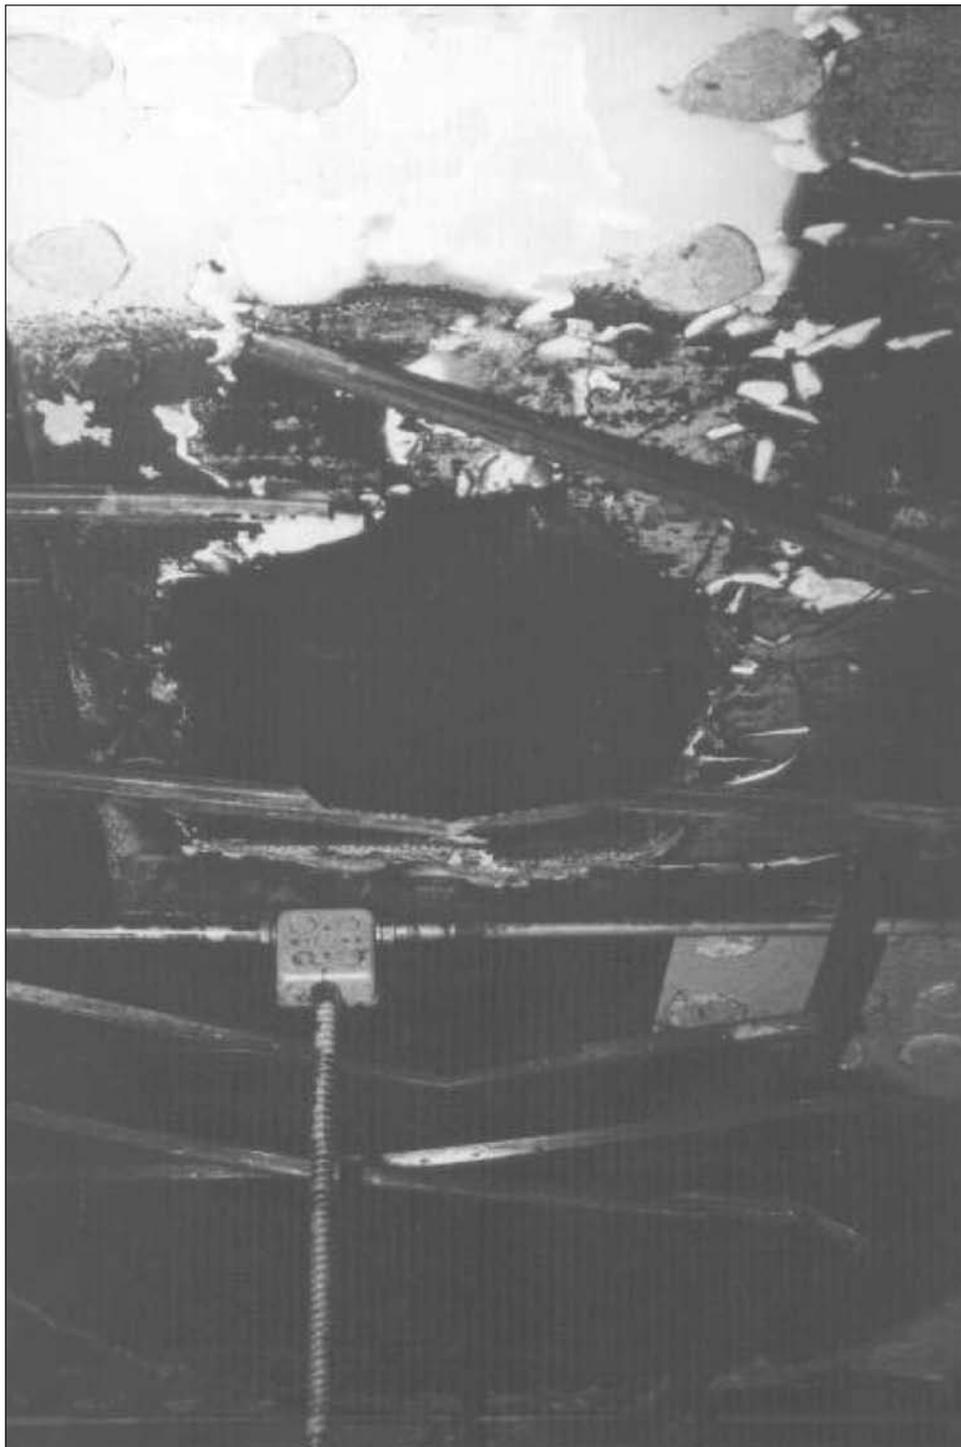
View of opening in suspended ceiling in the McHale Room. Note the charred 1-foot ceiling tiles (at left) glued to the underside of the plaster suspended ceiling and the remnants of the aluminum suspended ceiling frame.

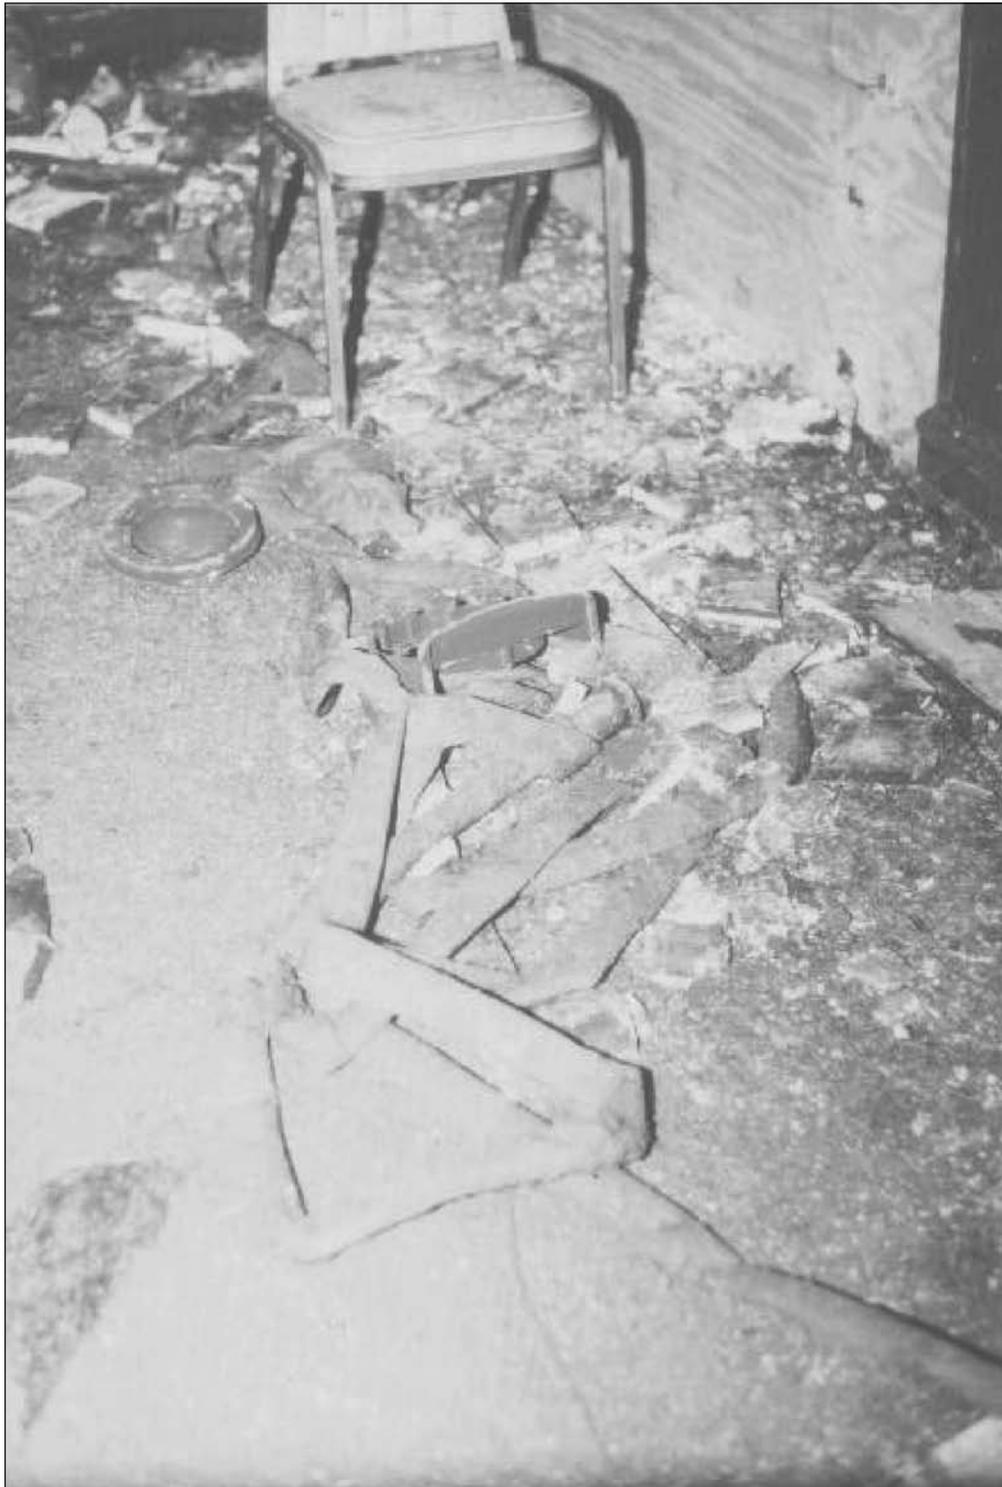
Remnants of occupant use standpipe hoseline used by Engine 7 and Truck 13 firefighters in the initial attack. Note the plastic adjustable-stream fog-nozzle attached to the end (near center of photo).

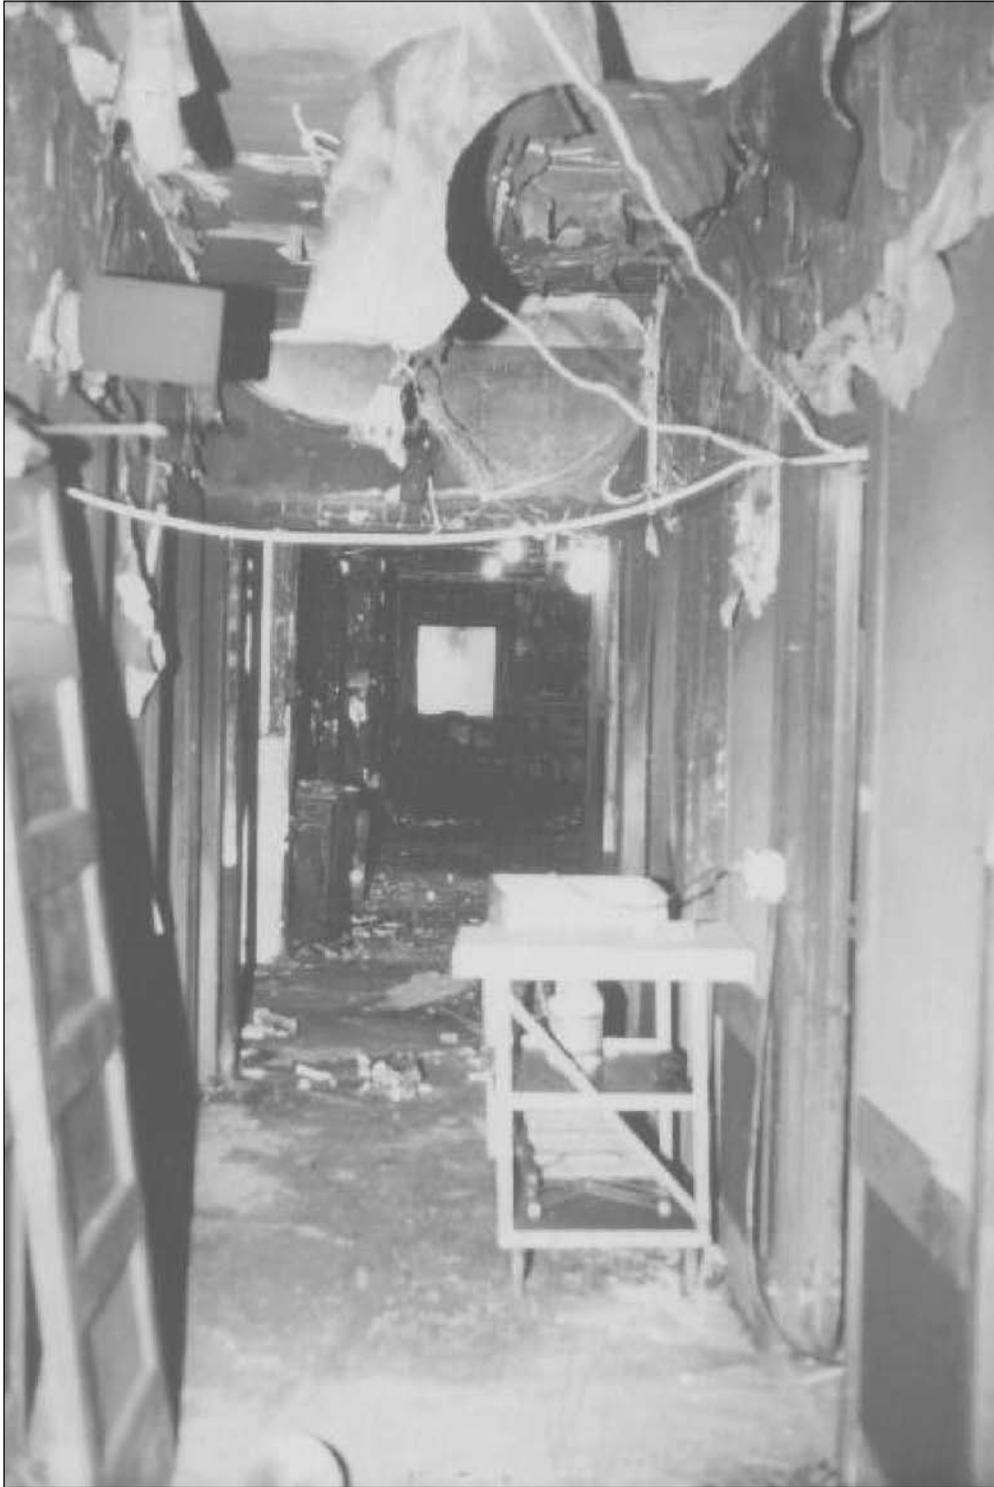
**View of third floor service corridor looking east from standpipe cabinet. Note the relatively minor damage. Most of the damage is confined to wall and ceiling finish materials.**

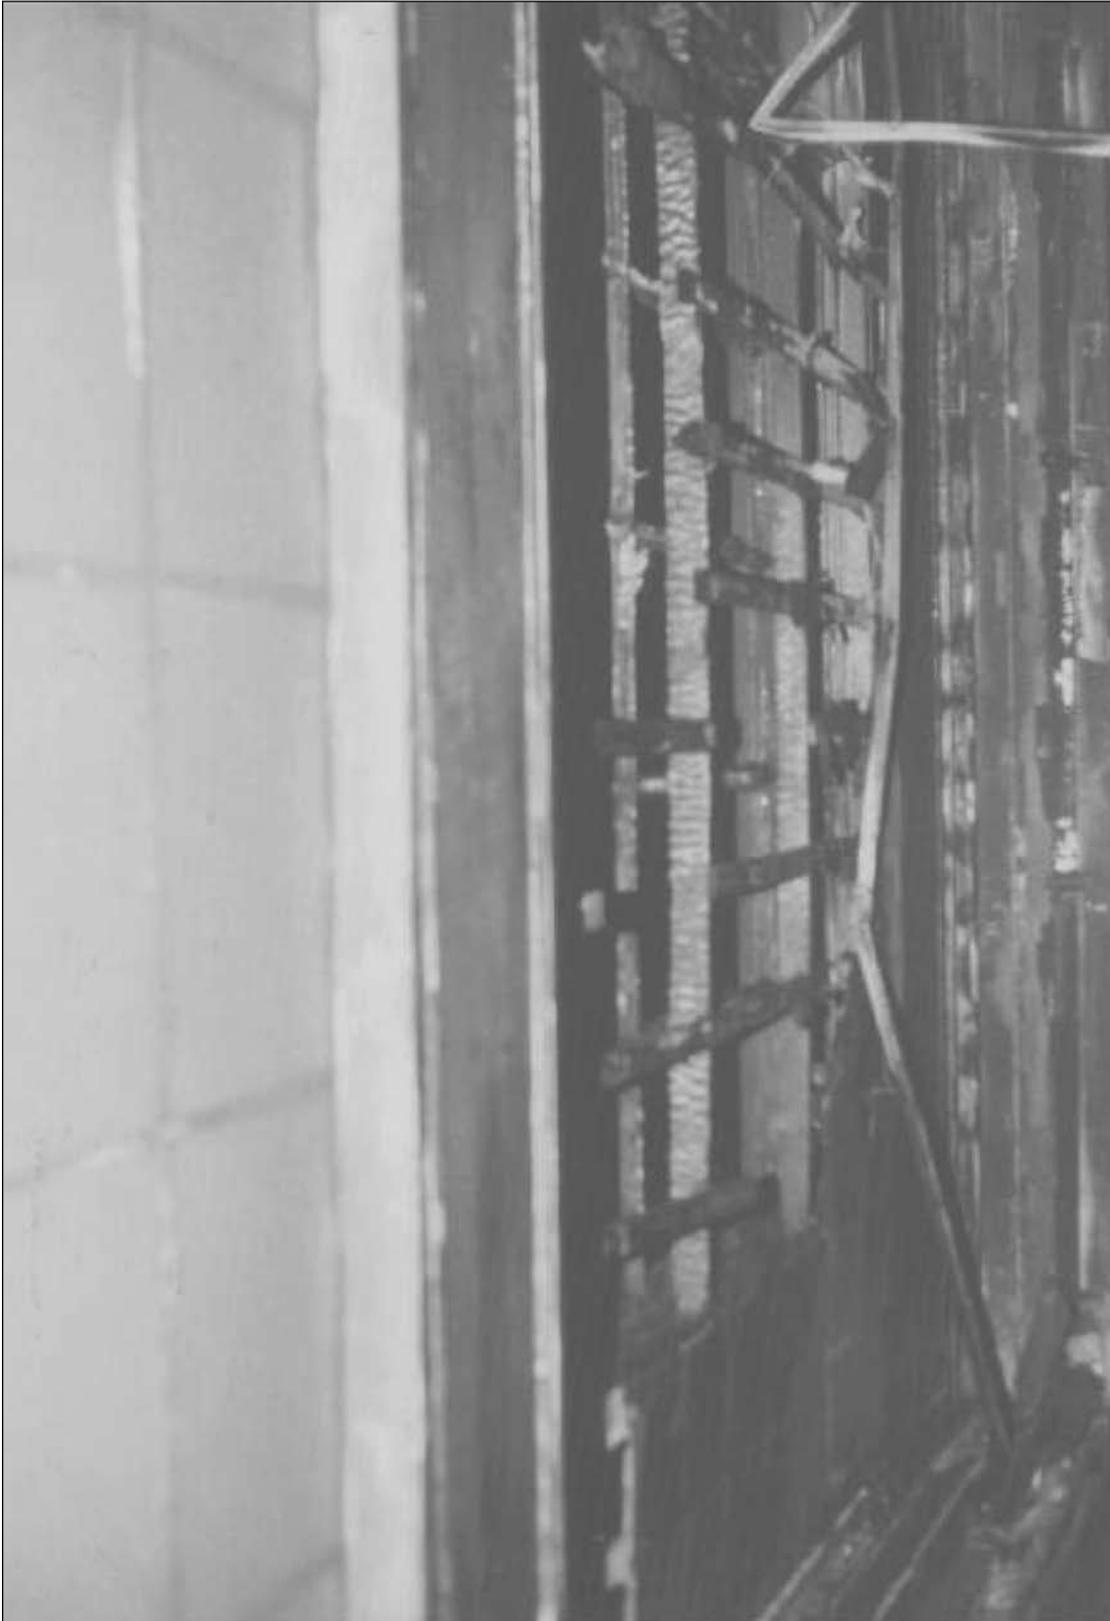
View of suspended ceiling damage above the location in the Grill Room where Captain Spalding was found unconscious and covered in debris.

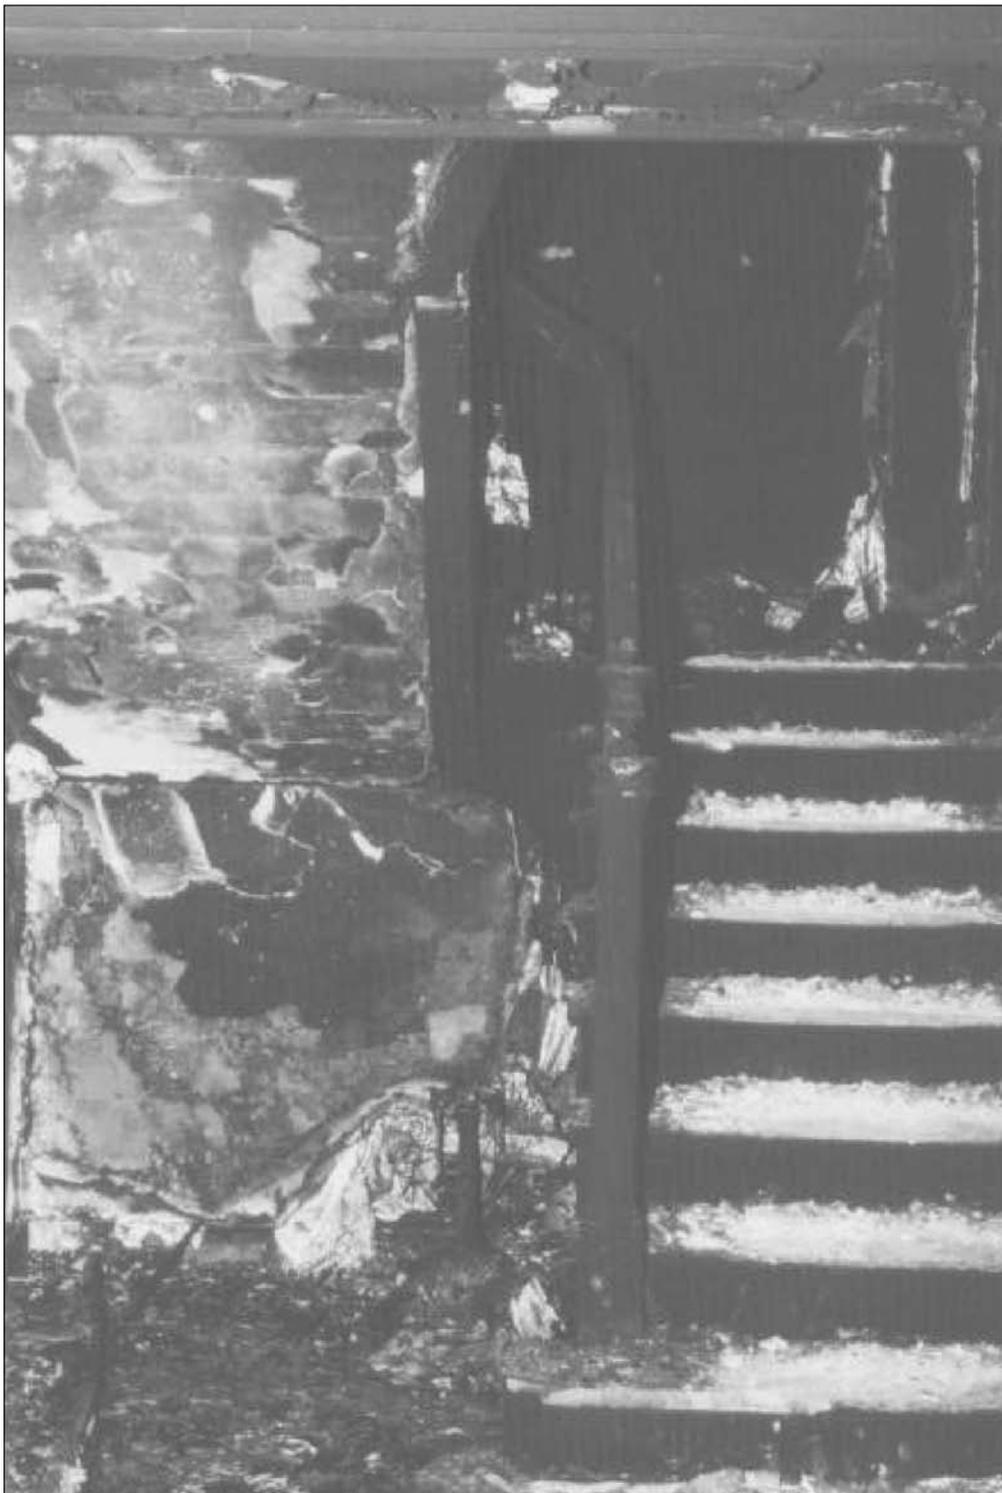
View of east stairway connecting third through ninth floors. This stairway was open on the third floor (shown here) and the fourth floor permitting the stairway to fill with smoke and the fire to spread vertically to the fourth floor.

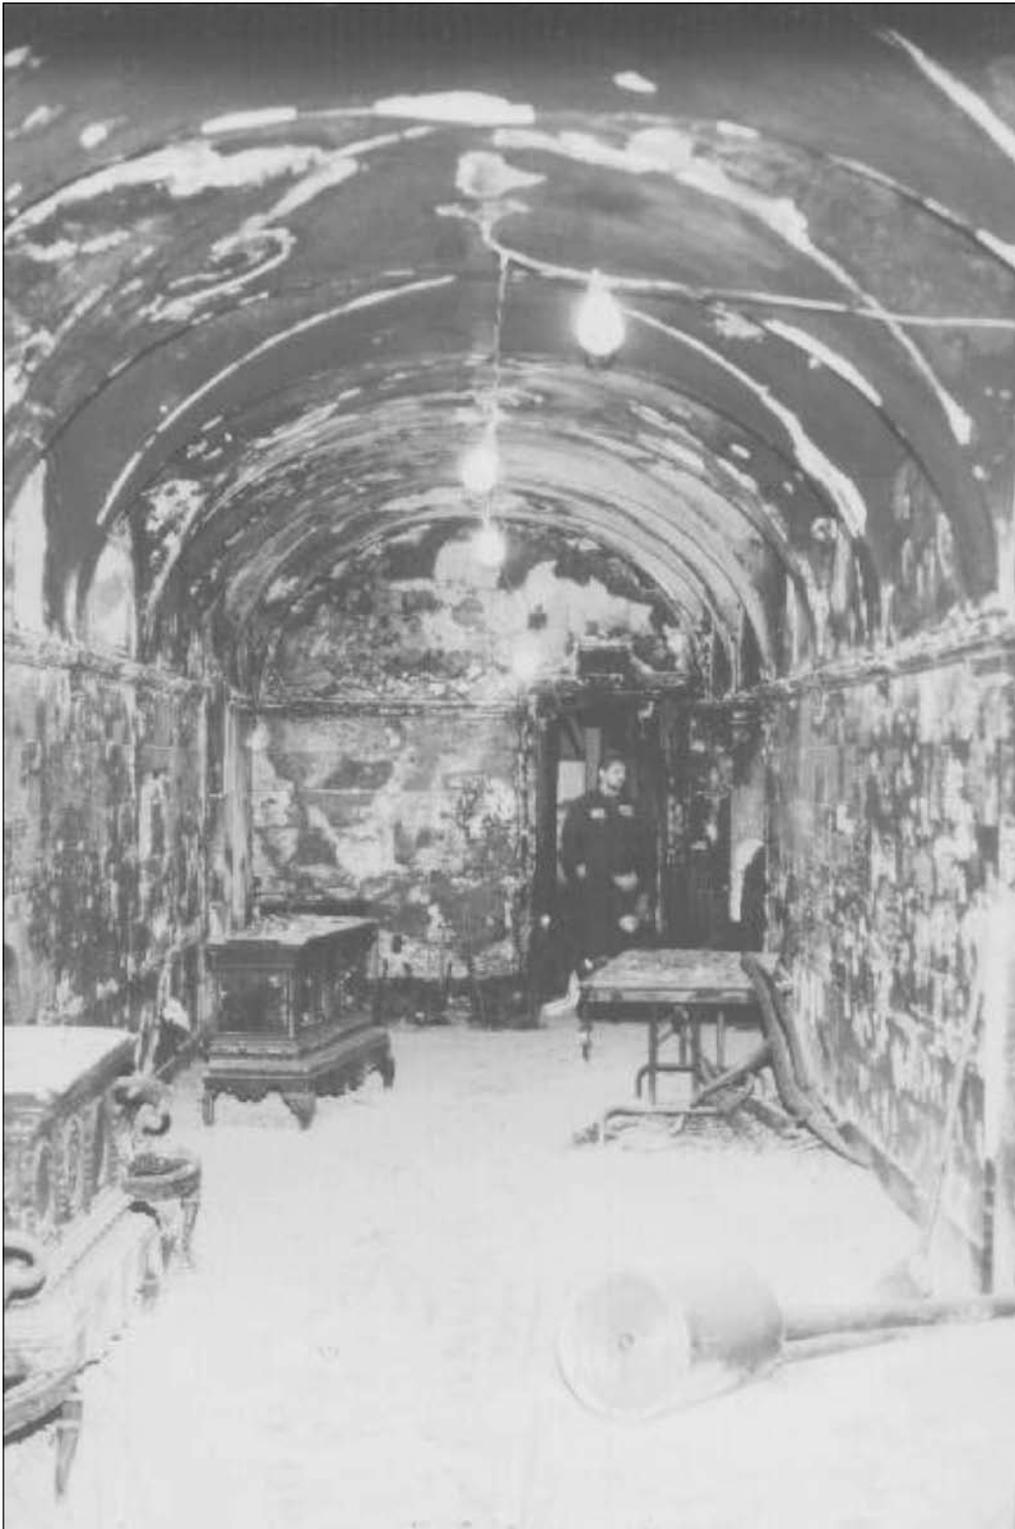
View of fire damage in the fourth floor corridor looking west toward the center of the building.

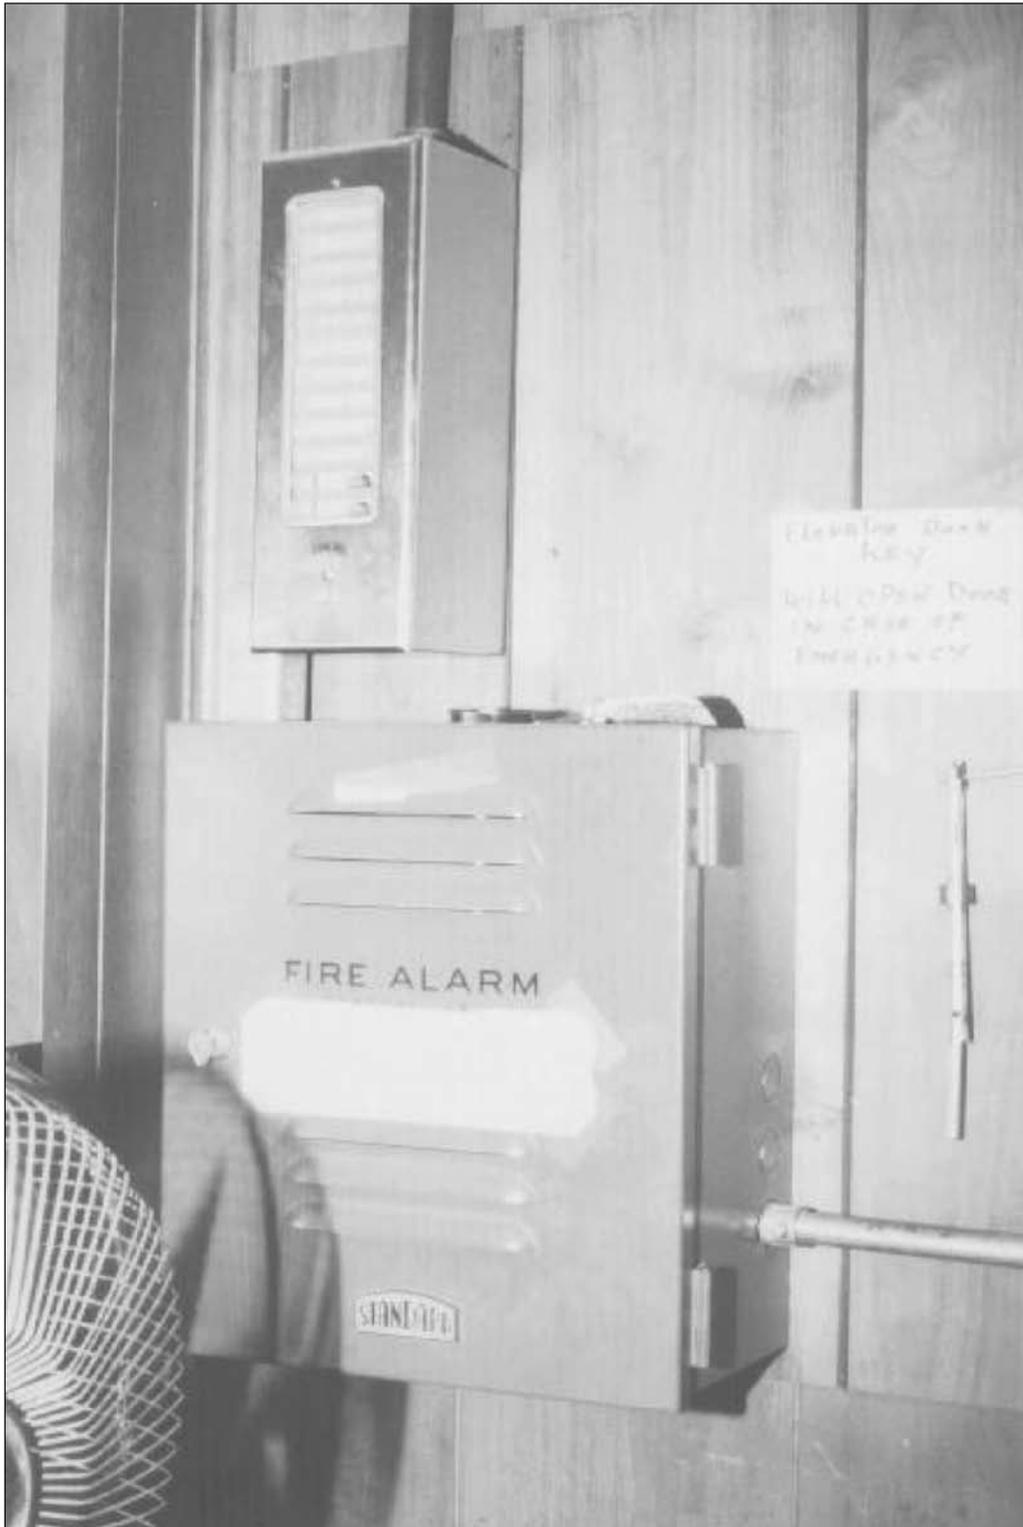
Manual fire alarm system cabinet and tabular fire alarm enunciator above.  
This system provided power to the fire alarm signals on all floors.

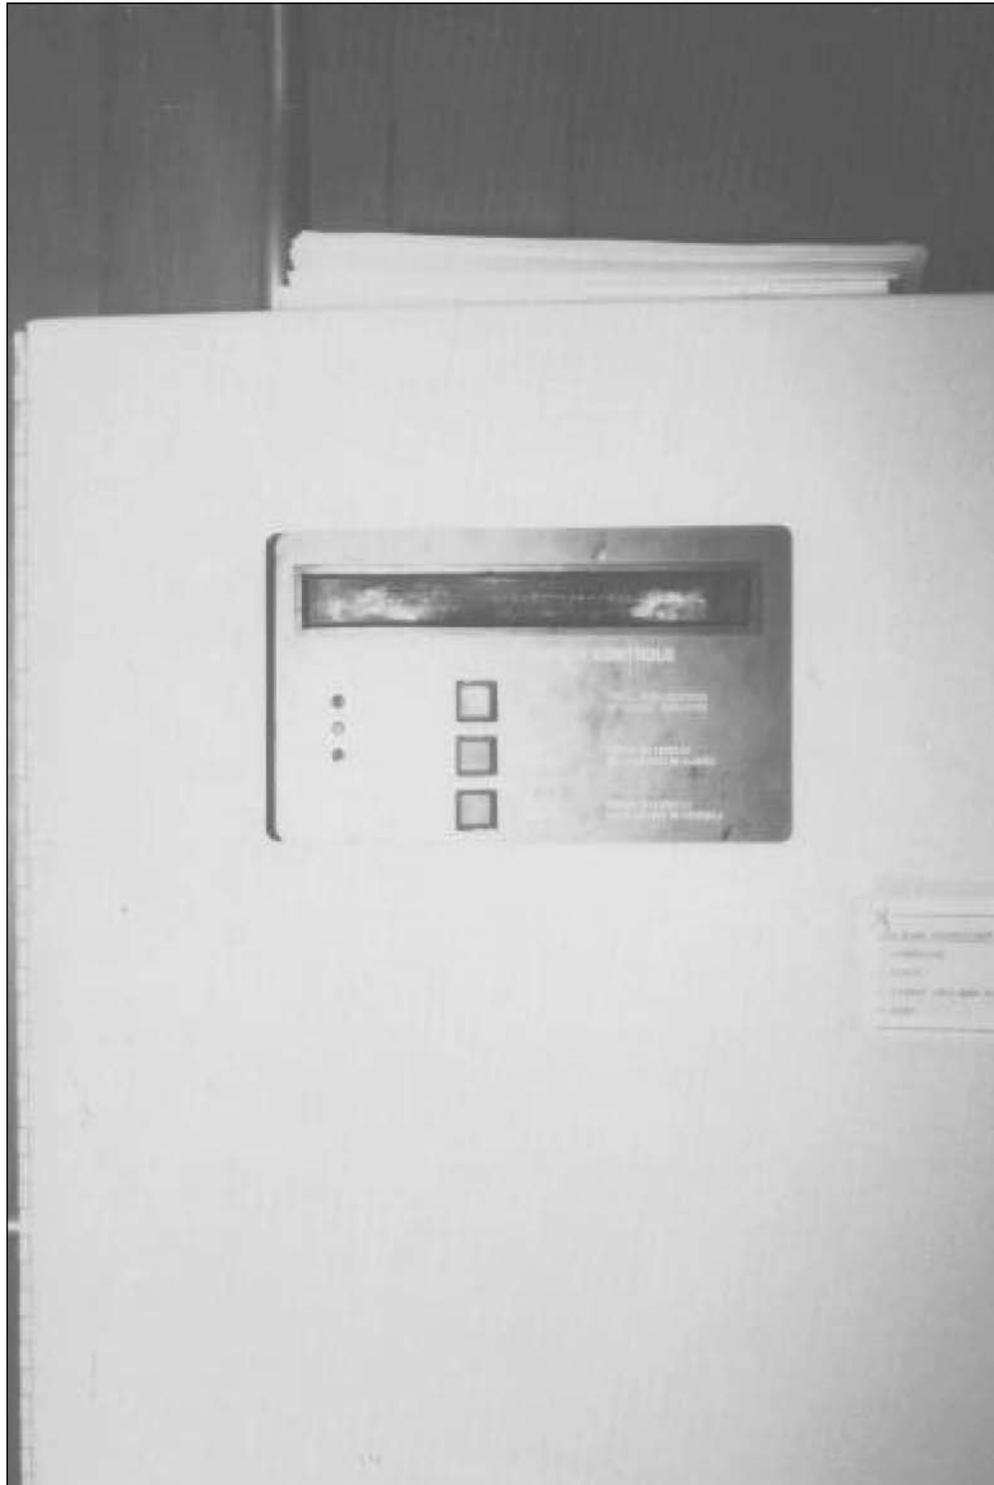
**Analog addressable smoke detector control unit. This unit powered and supervised the in-room and basement smoke detectors, as well as monitoring the conventional-zoned control units which powered the corridor smoke detectors.**
