# Ten Fatality Board and Care Facility Fire

Detroit, Michigan

USFA-TR-066/June 1992

This is Report 066 of the Major Fires Investigation Project conducted by TriData Corporation under contract EMW-90-C-3338 to the United States Fire Administration, Federal Emergency Management Agency.

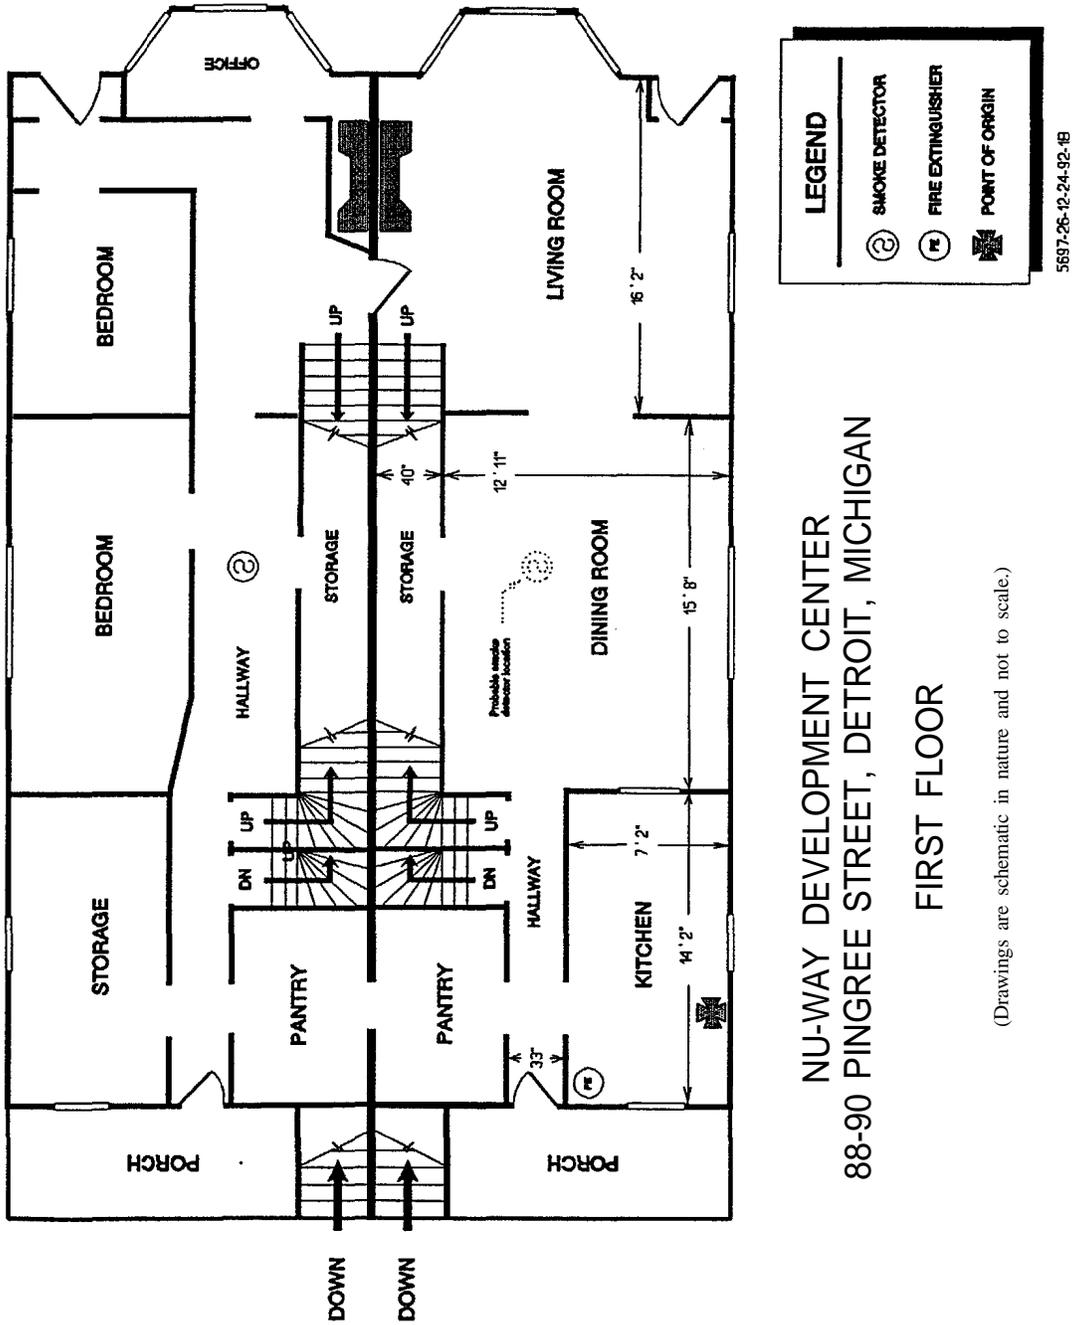
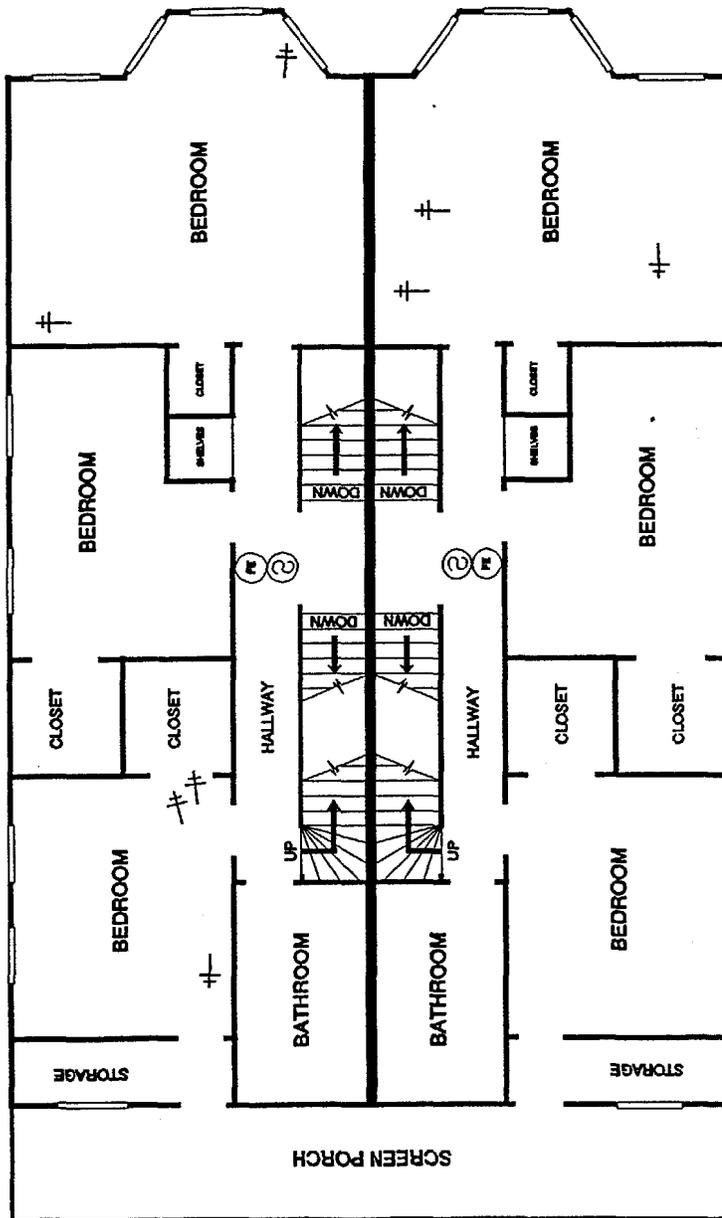
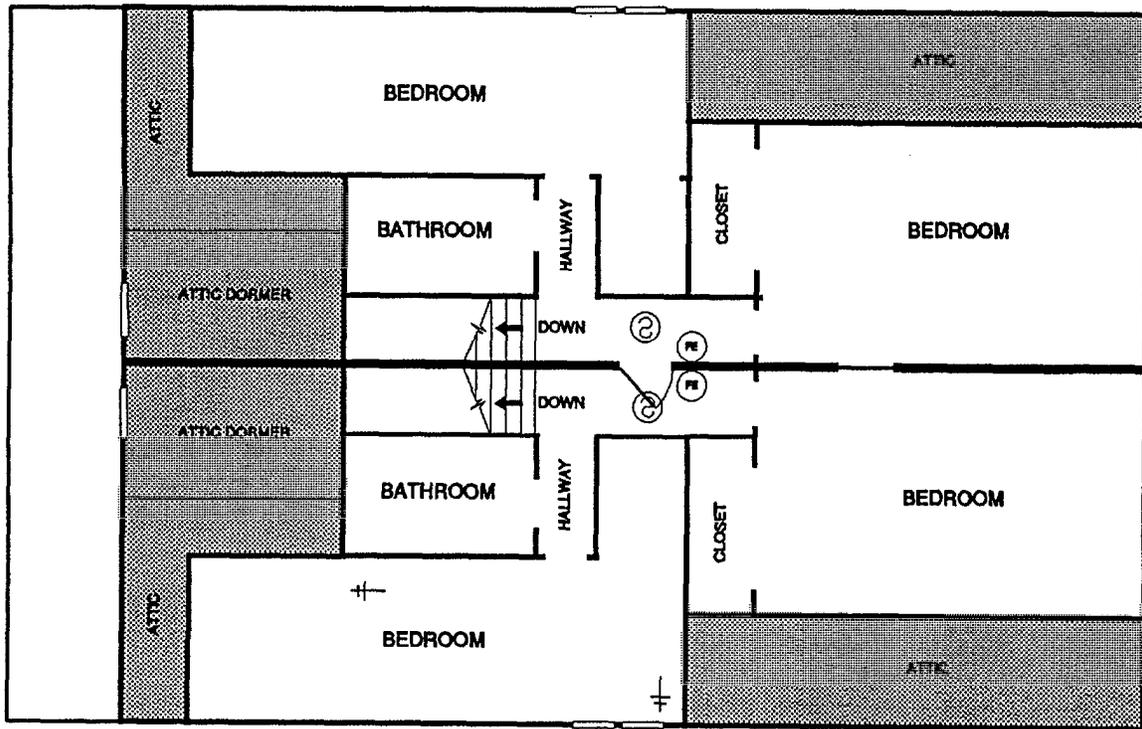
## Floor Plans and Area Map

The floor plan in Appendix A shows the locations of the victims. They were distributed throughout the building. The same number of victims was found on the east side as the west side and in the front part of the building as the rear. Eight of the victims were found on the second floor and two on the third floor.

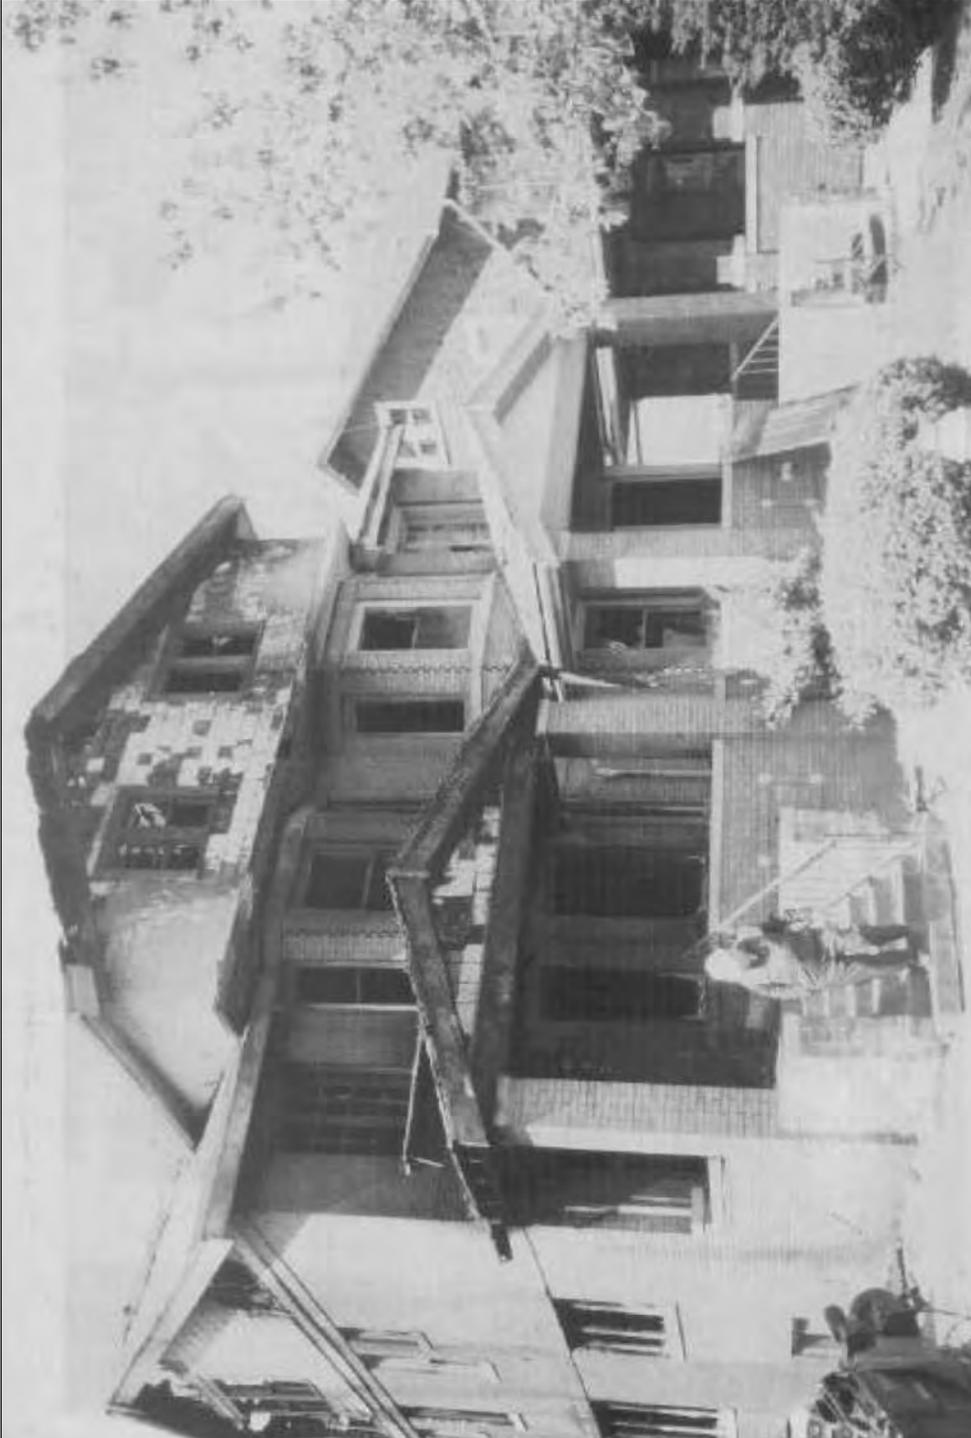
Exterior of 88-90 Pingree Street (structure faces south). Firefighters found fire showing from the first floor west and front, with heavy smoke showing from the second and third floors.

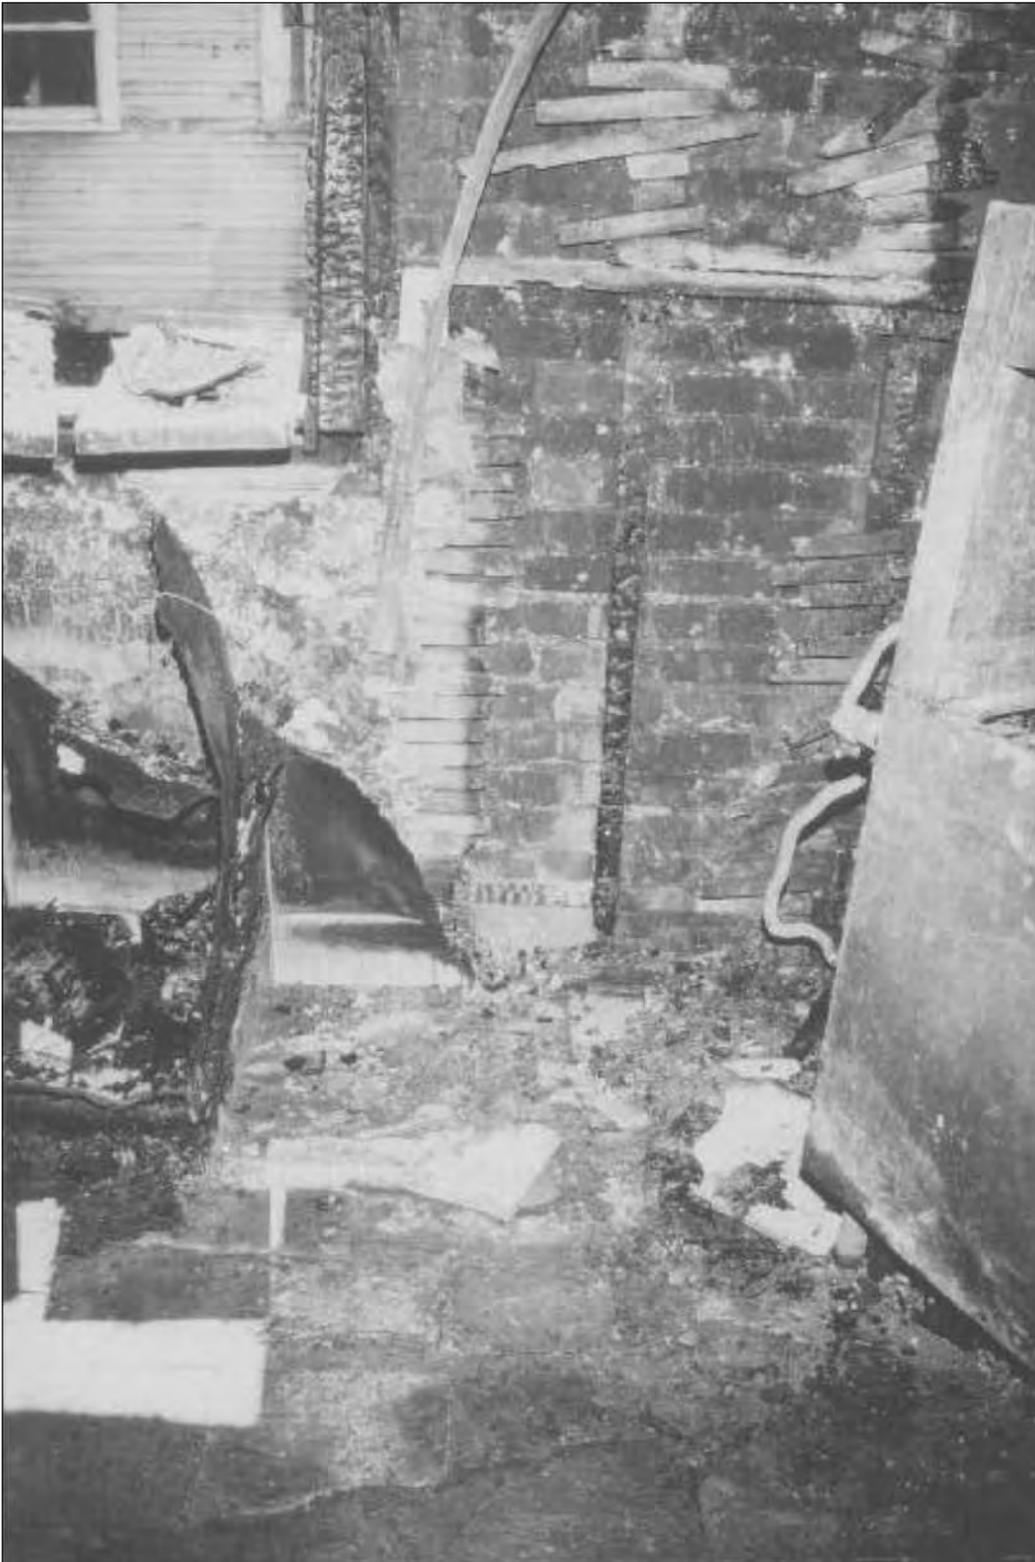
Detroit fire investigators believe the fire started when carelessly discarded smoking materials ignited trash in a kitchen waste receptacle. Investigation revealed that the fire started in the kitchen near the floor between the stove and kitchen counter on the east side of the room. (For floor plans, see Appendix A.) A distinctive V-shaped burn pattern was clearly evident on the outside wall adjacent to this area pointing to the likely point of origin. Combustible interior finish on this wall likely provided additional fuel as the fire grew and spread. Other combustibles, including containers of cooking fat on a shelf directly above the point of origin, probably became involved allowing the fire to grow rapidly. The quantity and configuration of fuel and the relative remoteness of the room of origin from the occupied portions of the building permitted the fire to grow significantly before it was detected.

Point of origin in kitchen showing evidence of low burn near the baseboard.

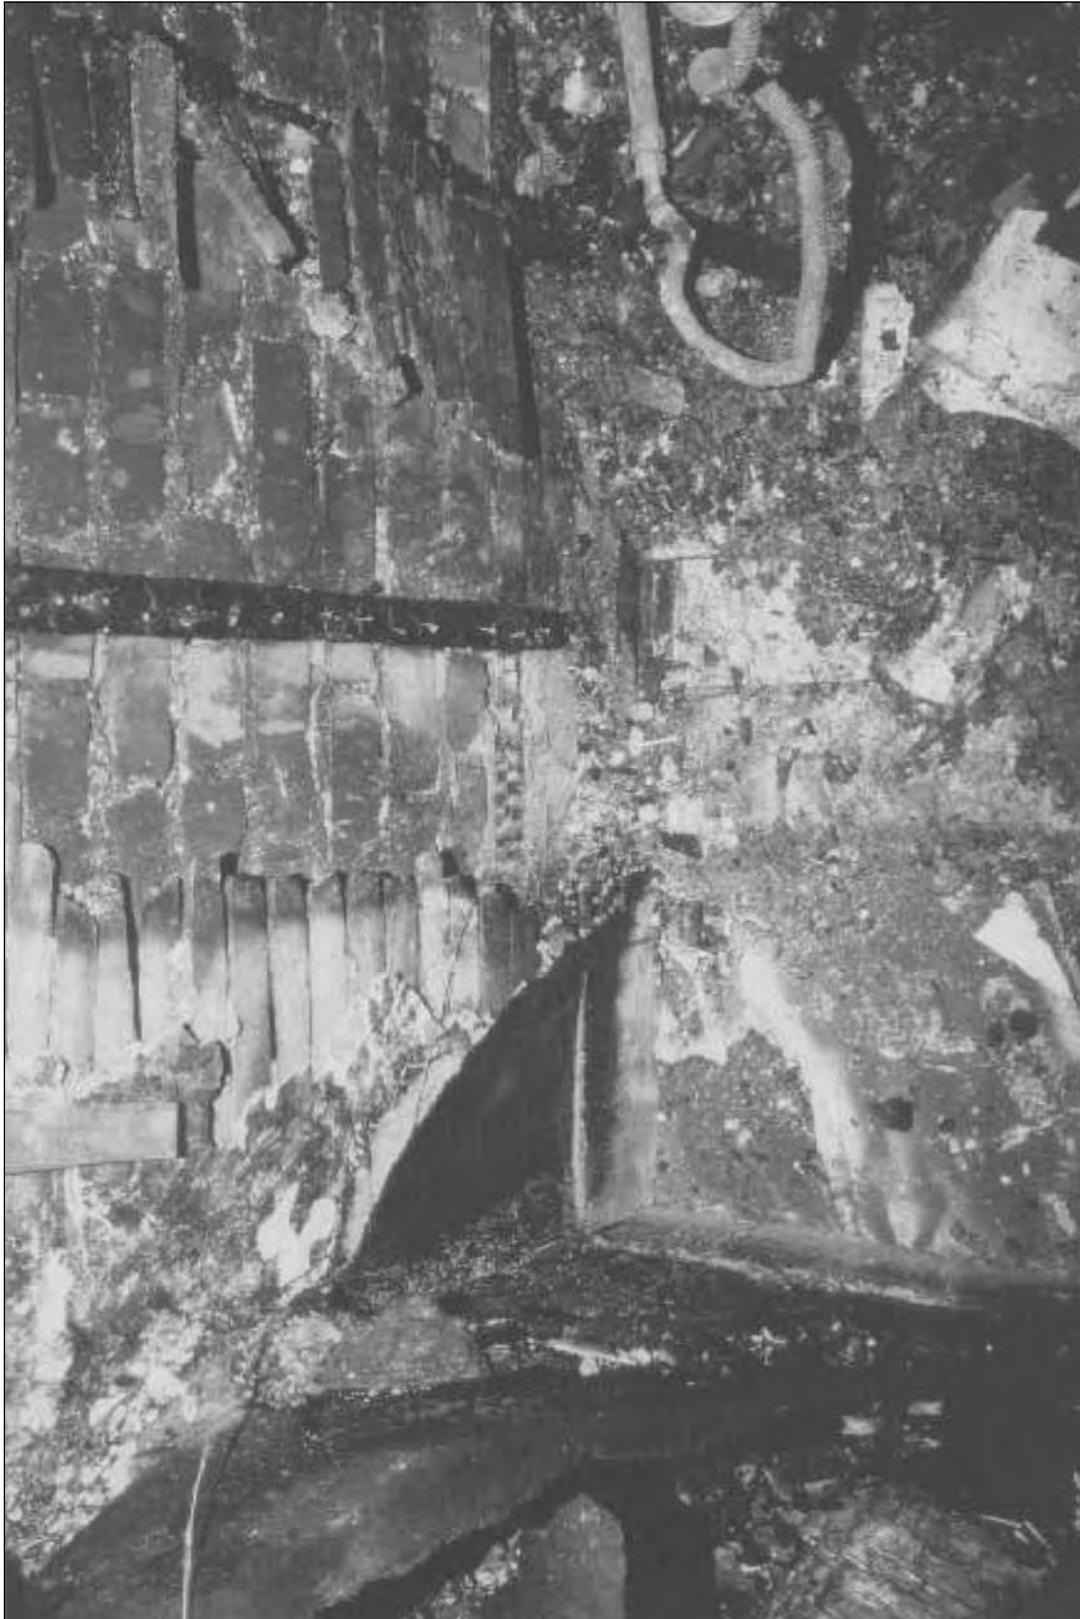
Close-up of the point of origin. A small triangular section of the particle board installed over the plaster and lath remains in the lower center portion of the picture.

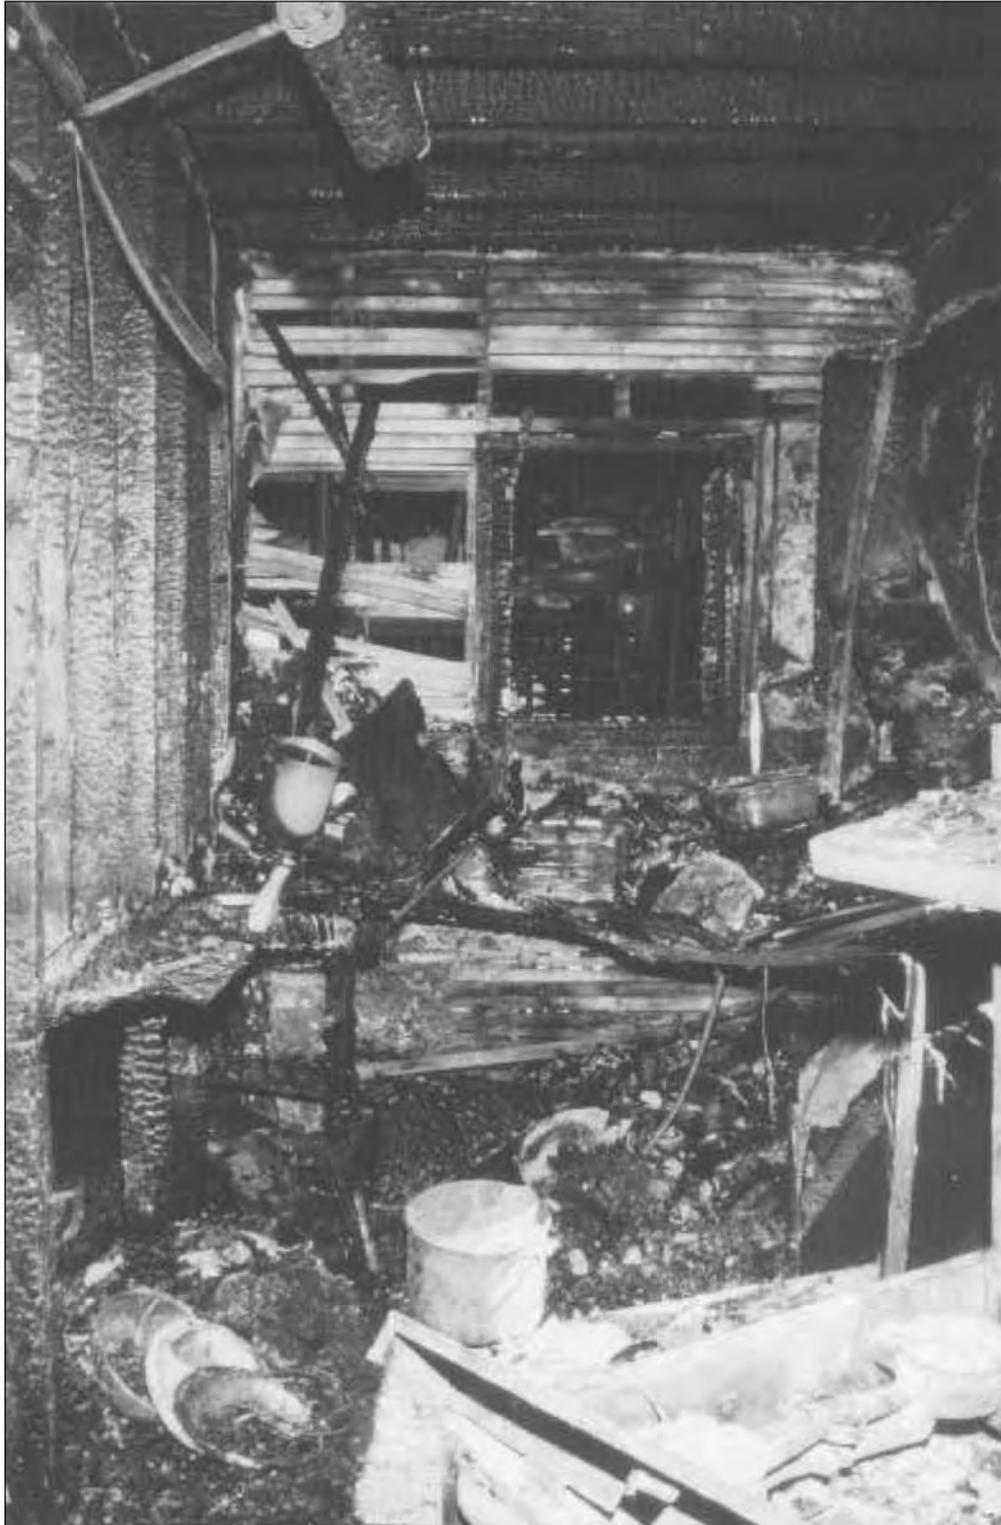
View from the kitchen looking south through the pass-through window into the dining room. The fire was observed through this window by Mr. Fluckes and Mr. Gregory.

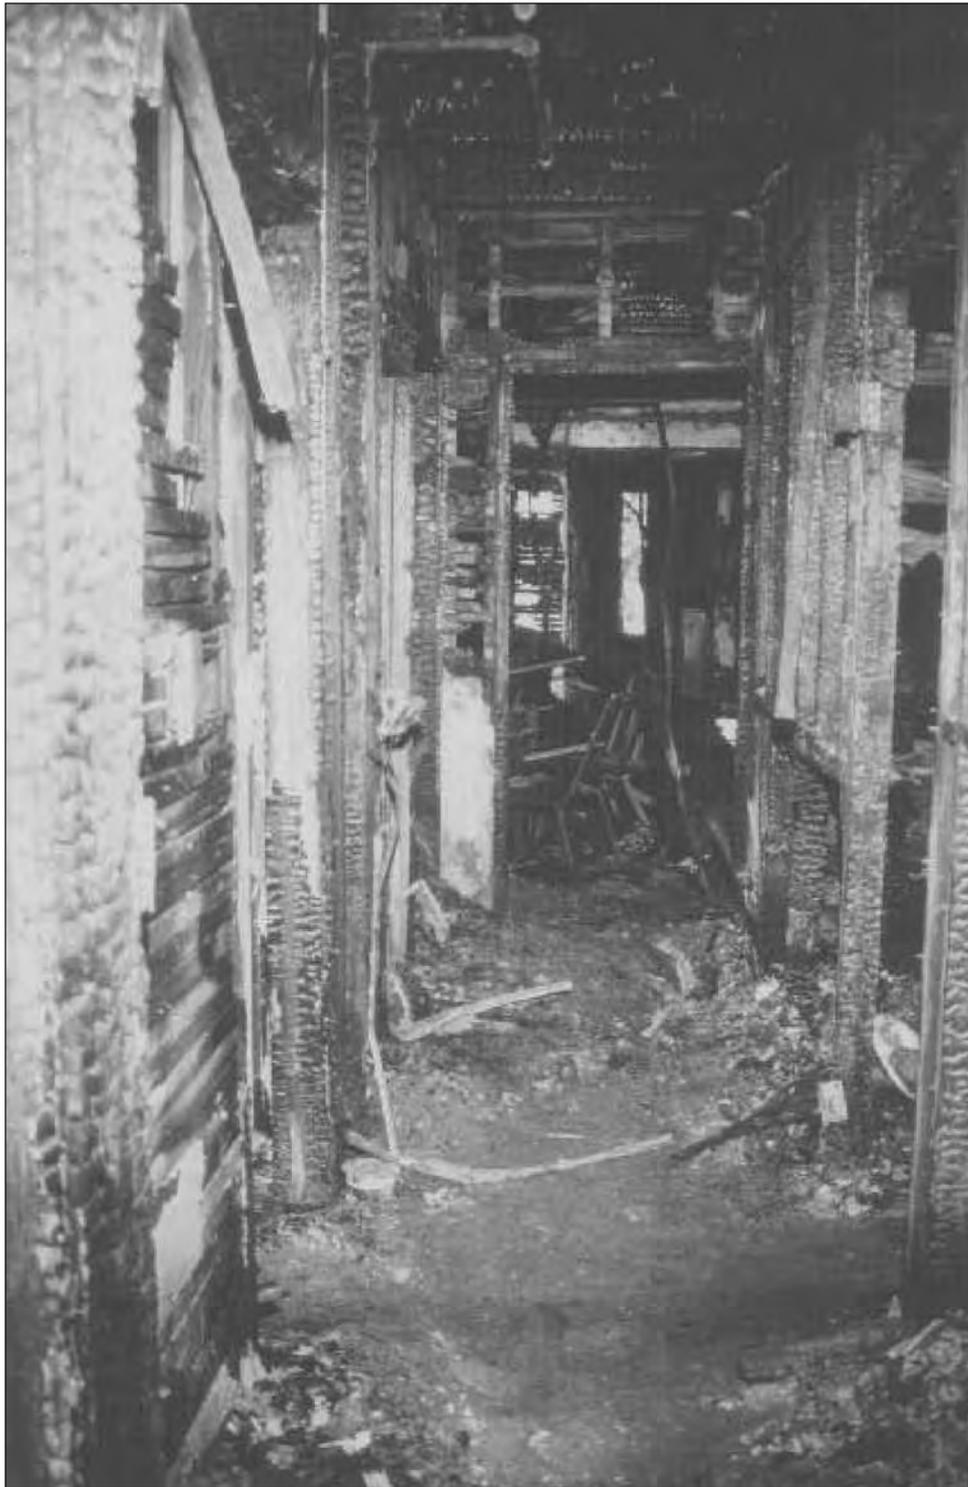
**View looking south down the rear corridor adjacent to the kitchen showing heavy damage to the wall studs near the floor level. Also visible through the door opening at the south end of the corridor is heavy fire damage in the dining room.**

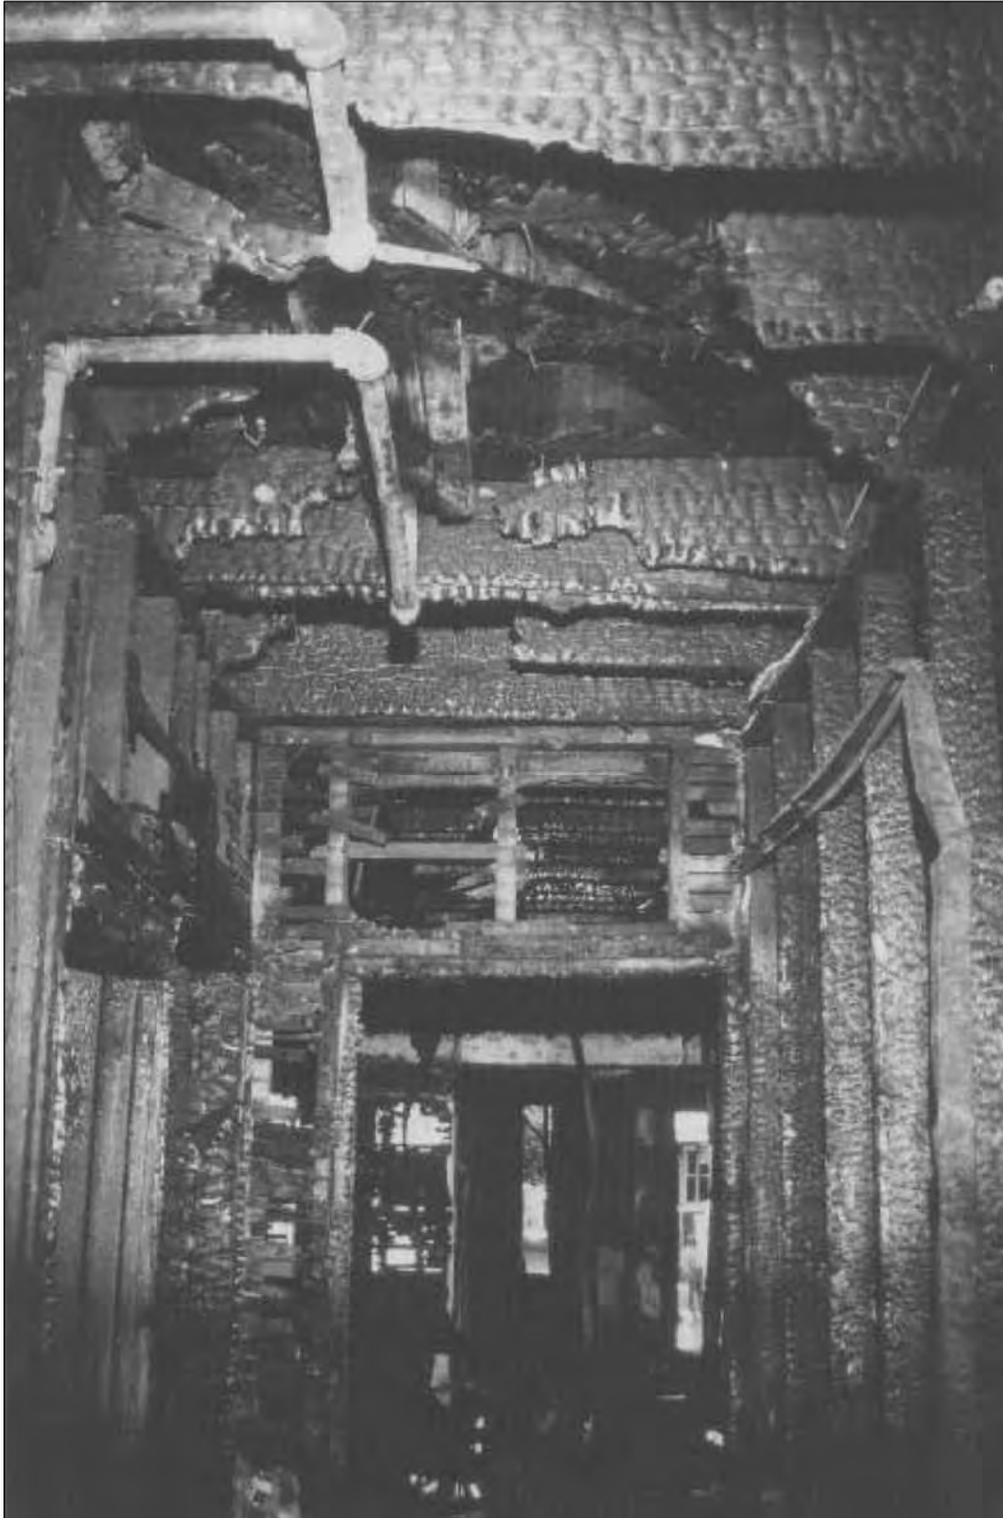
Close-up of fire damage to the ceiling area in rear corridor next to kitchen. Pipe penetrations were one avenue of fire and smoke spread to the second floor.

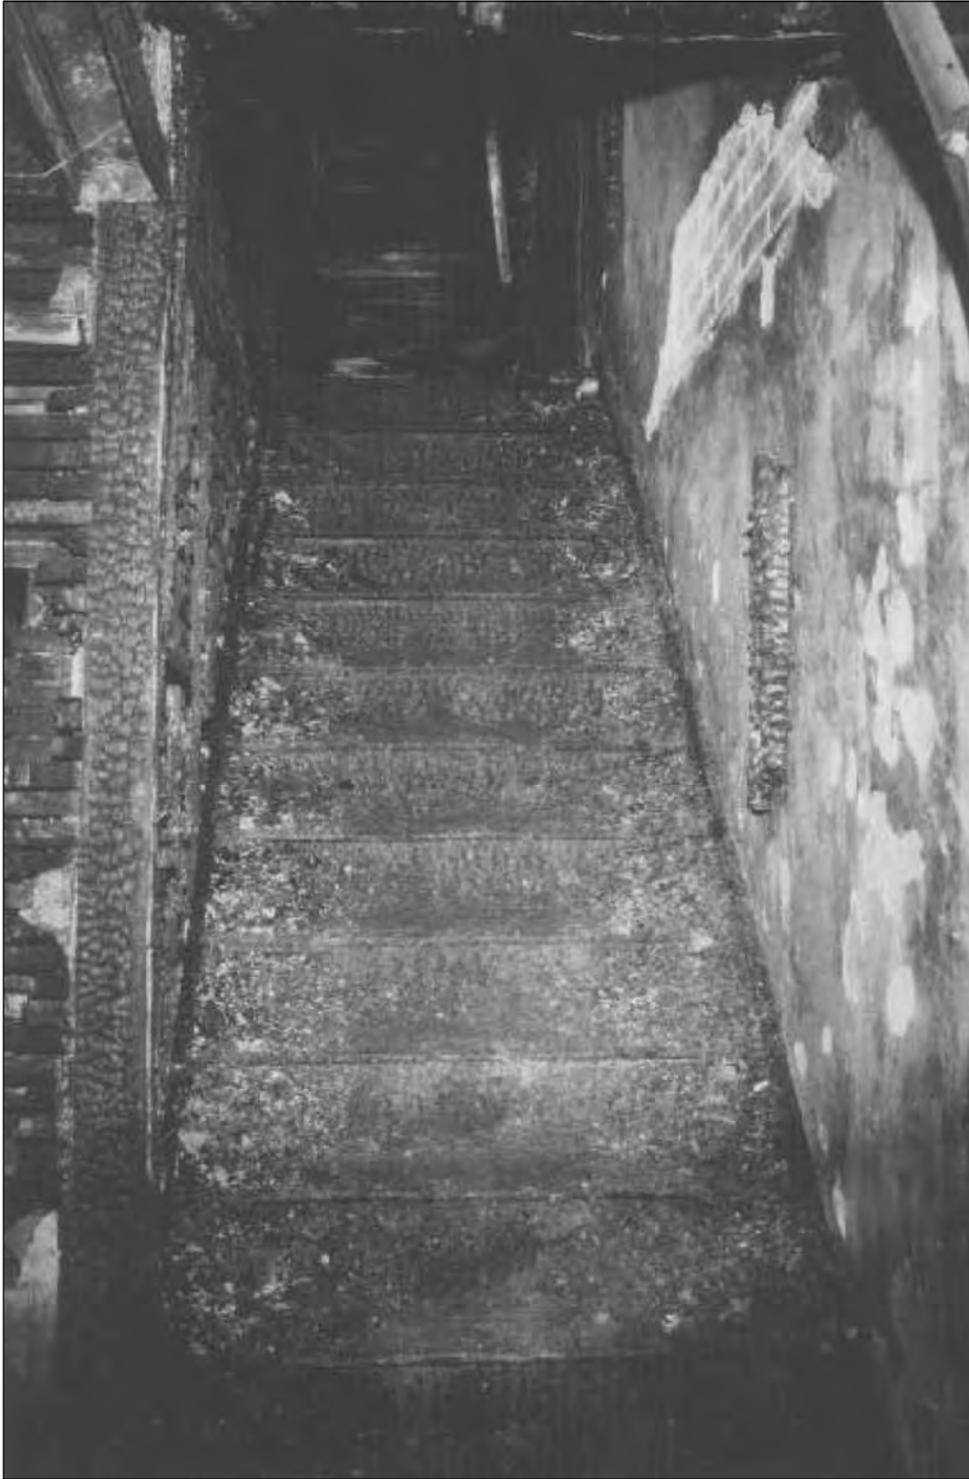
**West stairway leading from the first floor living room to the second floor shows extensive charring to the stair risers, evidence of intense radiant heat exposure as the fire spread vertically cutting off the egress path.**

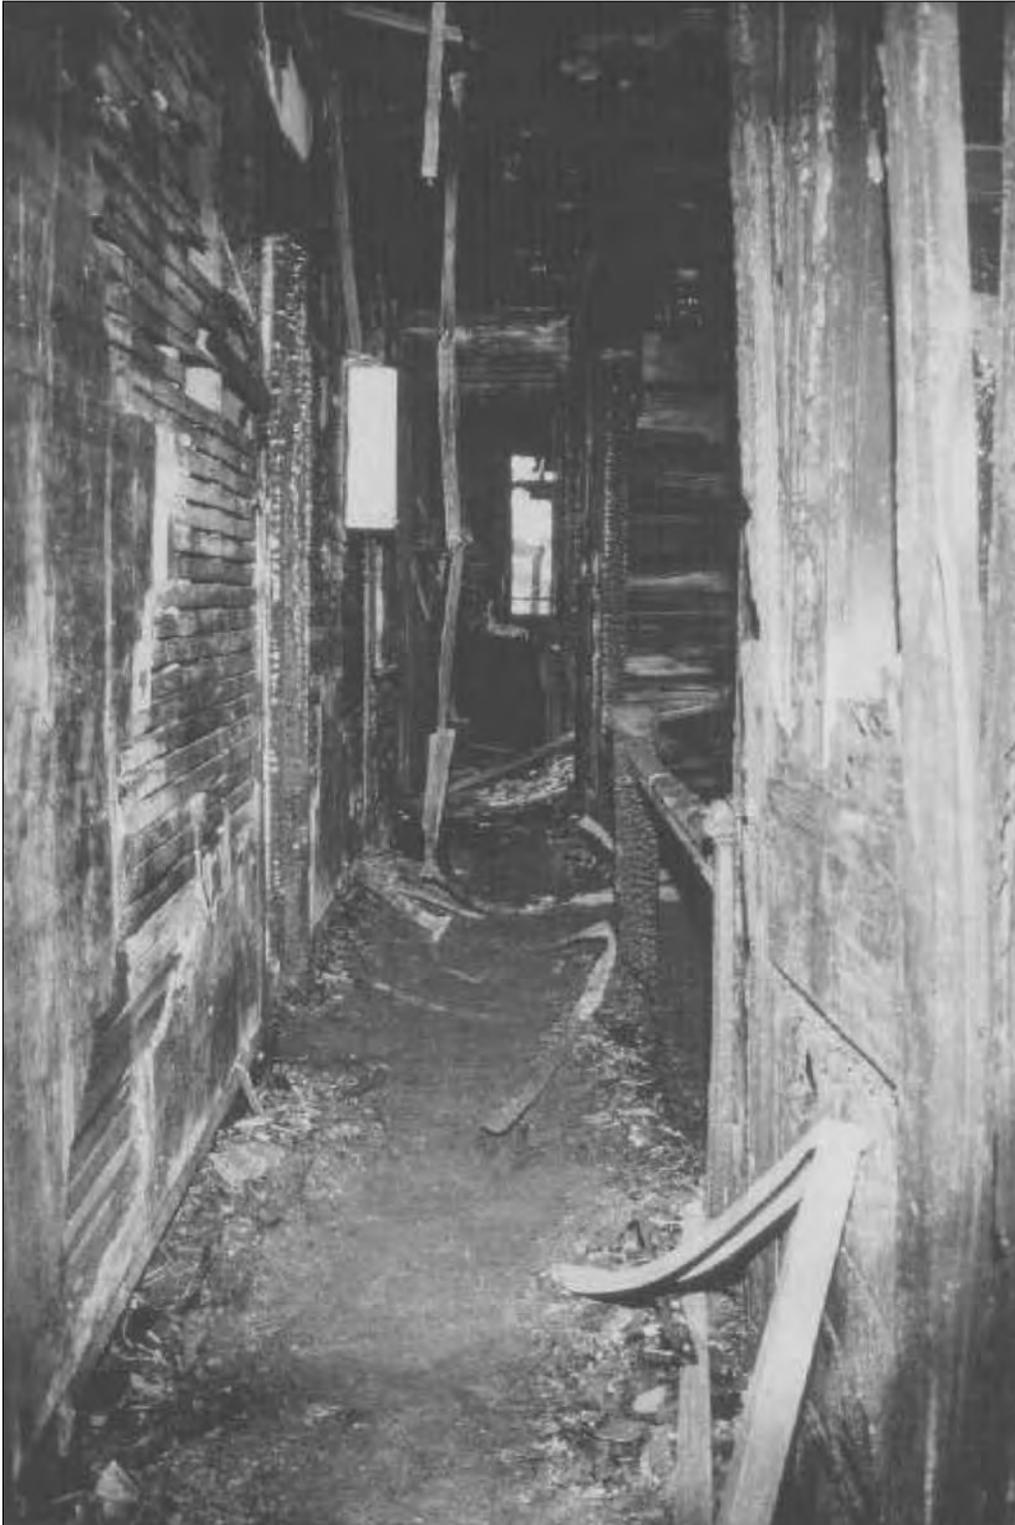
Second floor west corridor looking south shows the heavy fire damage resulting from vertical fire spread via the front stairway.

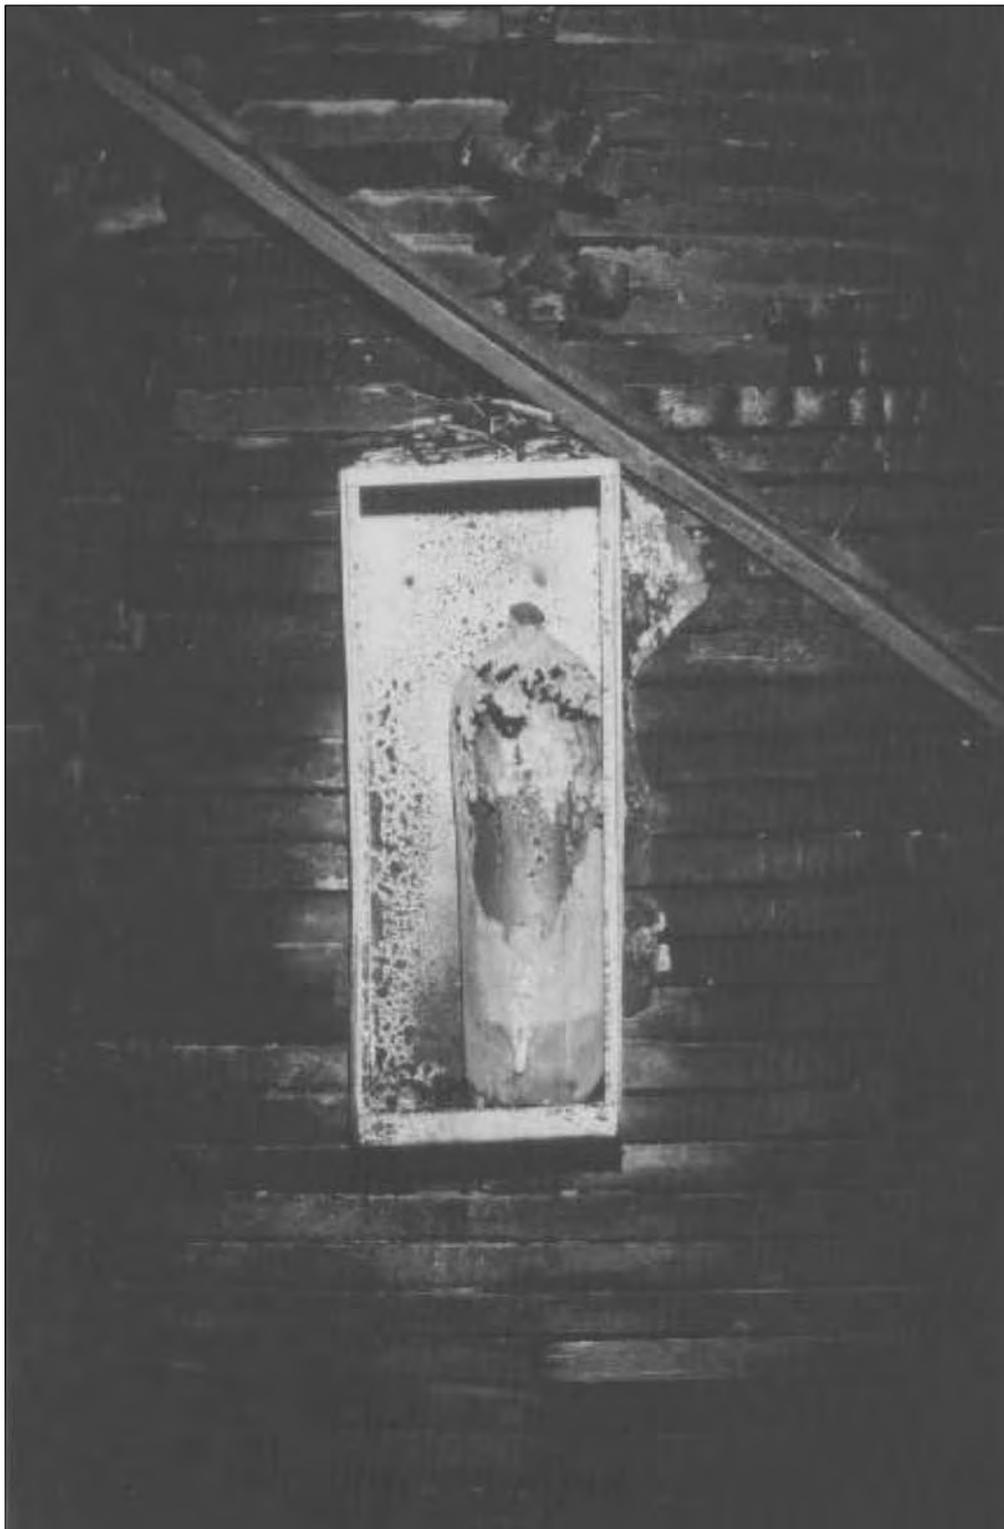
The remains of a melted aluminum fire extinguisher shell in a cabinet on the second floor west side.

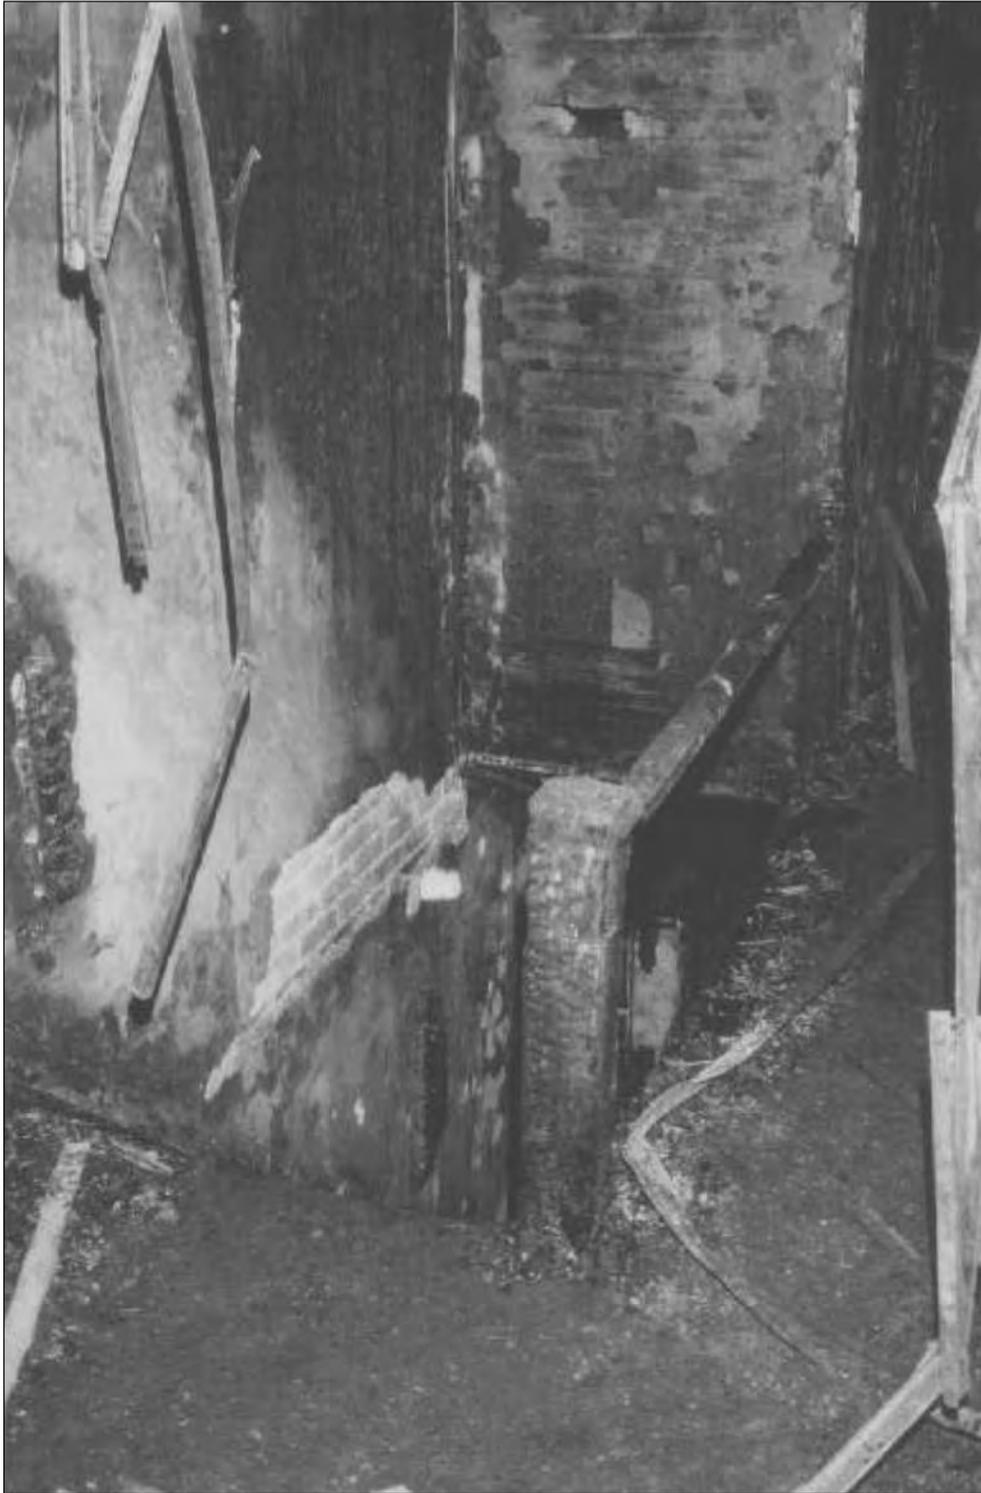
West side rear stairway looking down from second floor. Extensive charring and plaster spalling provide evidence of the fire spread which cutoff access to both the front and rear stairways.

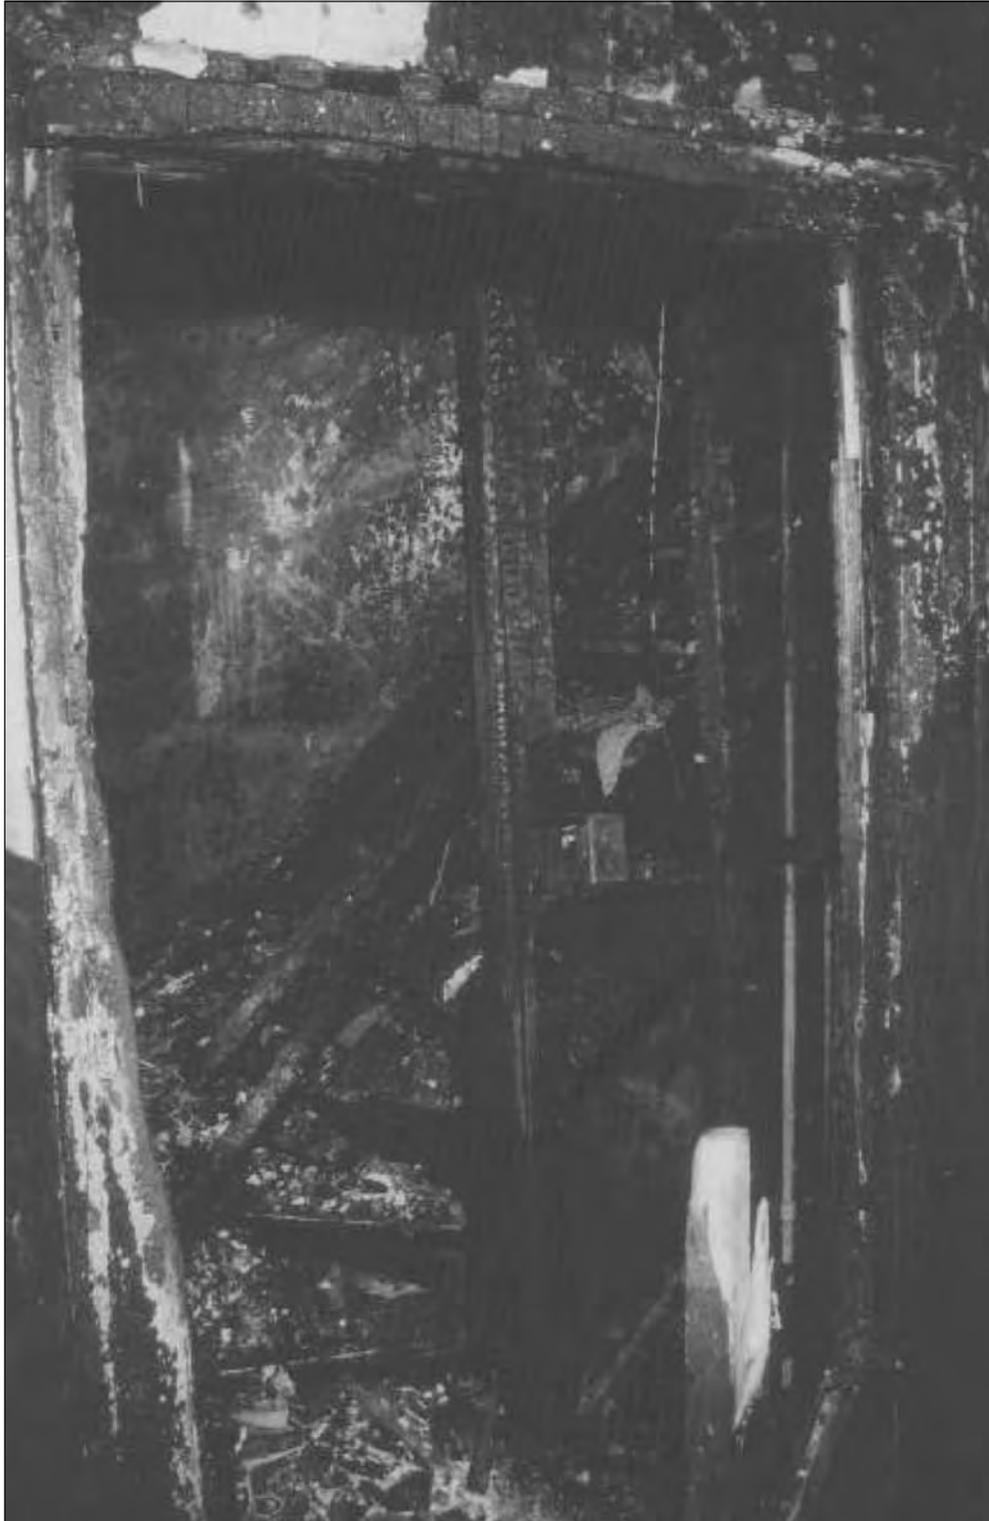
View of west side stairway leading to the third floor. Once again, heavy fire damage to the door lintel and framing indicate that fire spread via this route was extensive.

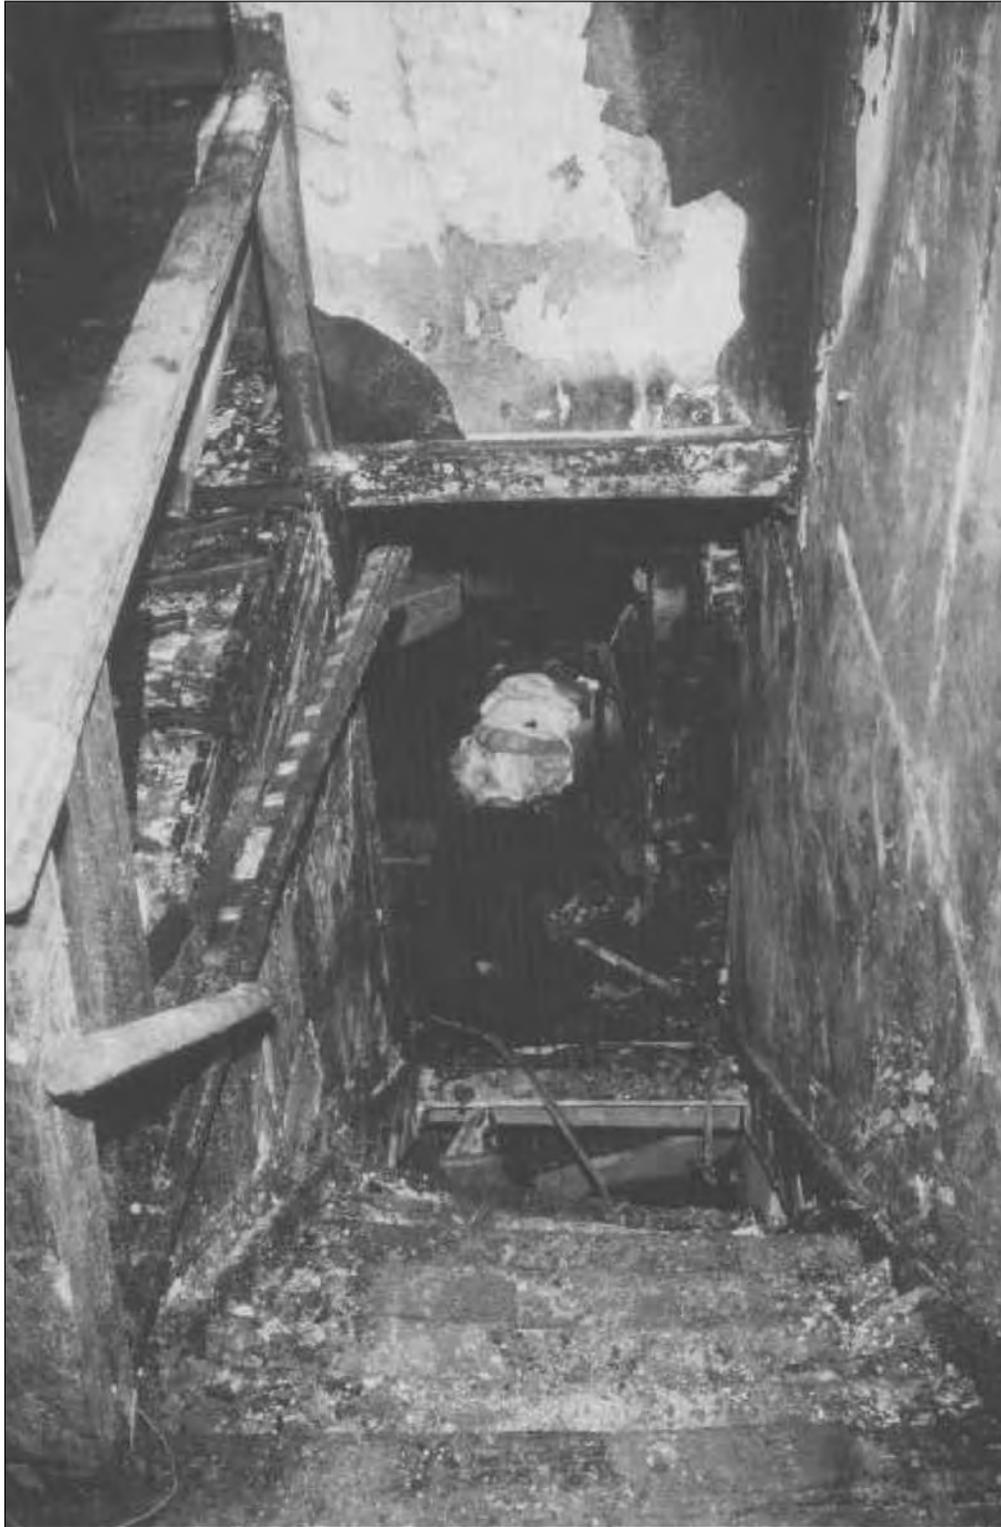
View of east side front stairway looking down from second floor. Although heat damage is slightly less intense here, evidence of extensive heat and smoke spread is clear.
