Wood Truss Roof Collapse Claims Two Firefighters

Memphis, Tennessee

USFA-TR-069/December 1992

Investigated by: J. Gordon Routley

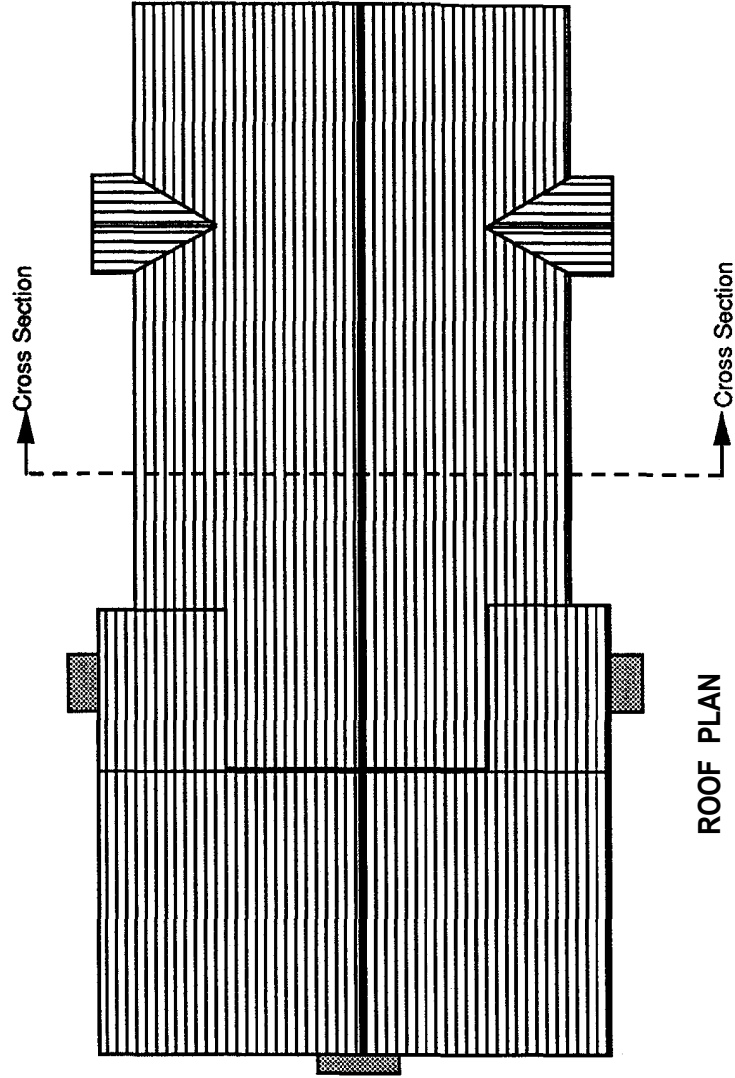
ROOF PLAN

The fire appears to have traveled along the underside of the roof, following the peak from east to west. The tops of all of the trusses were completely burned away for approximately 12 to 18 inches below the top connection point and could not be retrieved from the rubble. All of the lower connections could be located and most were still intact. The depth of char varied from almost full depth on the remnants of the higher members near the center of the span to almost no sign of burning on the lower and outer sections.

All of the top and bottom chords had splices near the mid-span points on each side of the trusses and most of these splices had failed, dropping the center section all the way to the floor, while the ends only rotated on their wall supports.

Many of the gusset plate connectors had failed, either by completely disengaging from the wood or by allowing one or more of the members to work free from a connection point. At the higher points the wood was charred beyond the depth of penetration of the gusset plate points, leaving empty pits in the charred wood where the gusset plates had been attached. As noted previously, virtually all of the top connection points were completely burned away. Some of the kingpost members were charred to a depth of more than 1/2-inch before the remaining unburned wood had broken; the diminished cross section of unburned wood fractured when it was unable to carry its load. (This would account for the “snap” sound reported by some of the firefighters just before the roof caved in.)

The depth of char on the roof materials decreased with distance toward the outer walls (downslope) from the mid-point. After the fire was extinguished, most of the plywood roof decking remained intact, except for approximately five feet on either side of the mid-point, still supported on top of the outer walls. The remaining unburned plywood was so thin, however, that there was obvious sag between trusses.

The roof collapse can be directly attributed to failure of the top connection points of the trusses, where the kingpost meets the top chord sections. It cannot be determined precisely which truss failed first and whether the gusset plates came loose from the top connection or the kingpost snapped and pried the gusset plates loose. The top connection is a critical point in each truss and its failure would result in the failure of that truss. It appears that several trusses failed in rapid succession – almost simultaneously following the first. All of the trusses would have been close to the point of failure and unable to support any additional load, so the load shift that occurred with the first failure probably caused several more trusses to collapse.
