U.S. Fire Administration/Technical Report Series

New York City Bank Building Fire: Compartmentation vs. Sprinklers

New York, New York

USFA-TR-071/January 1993

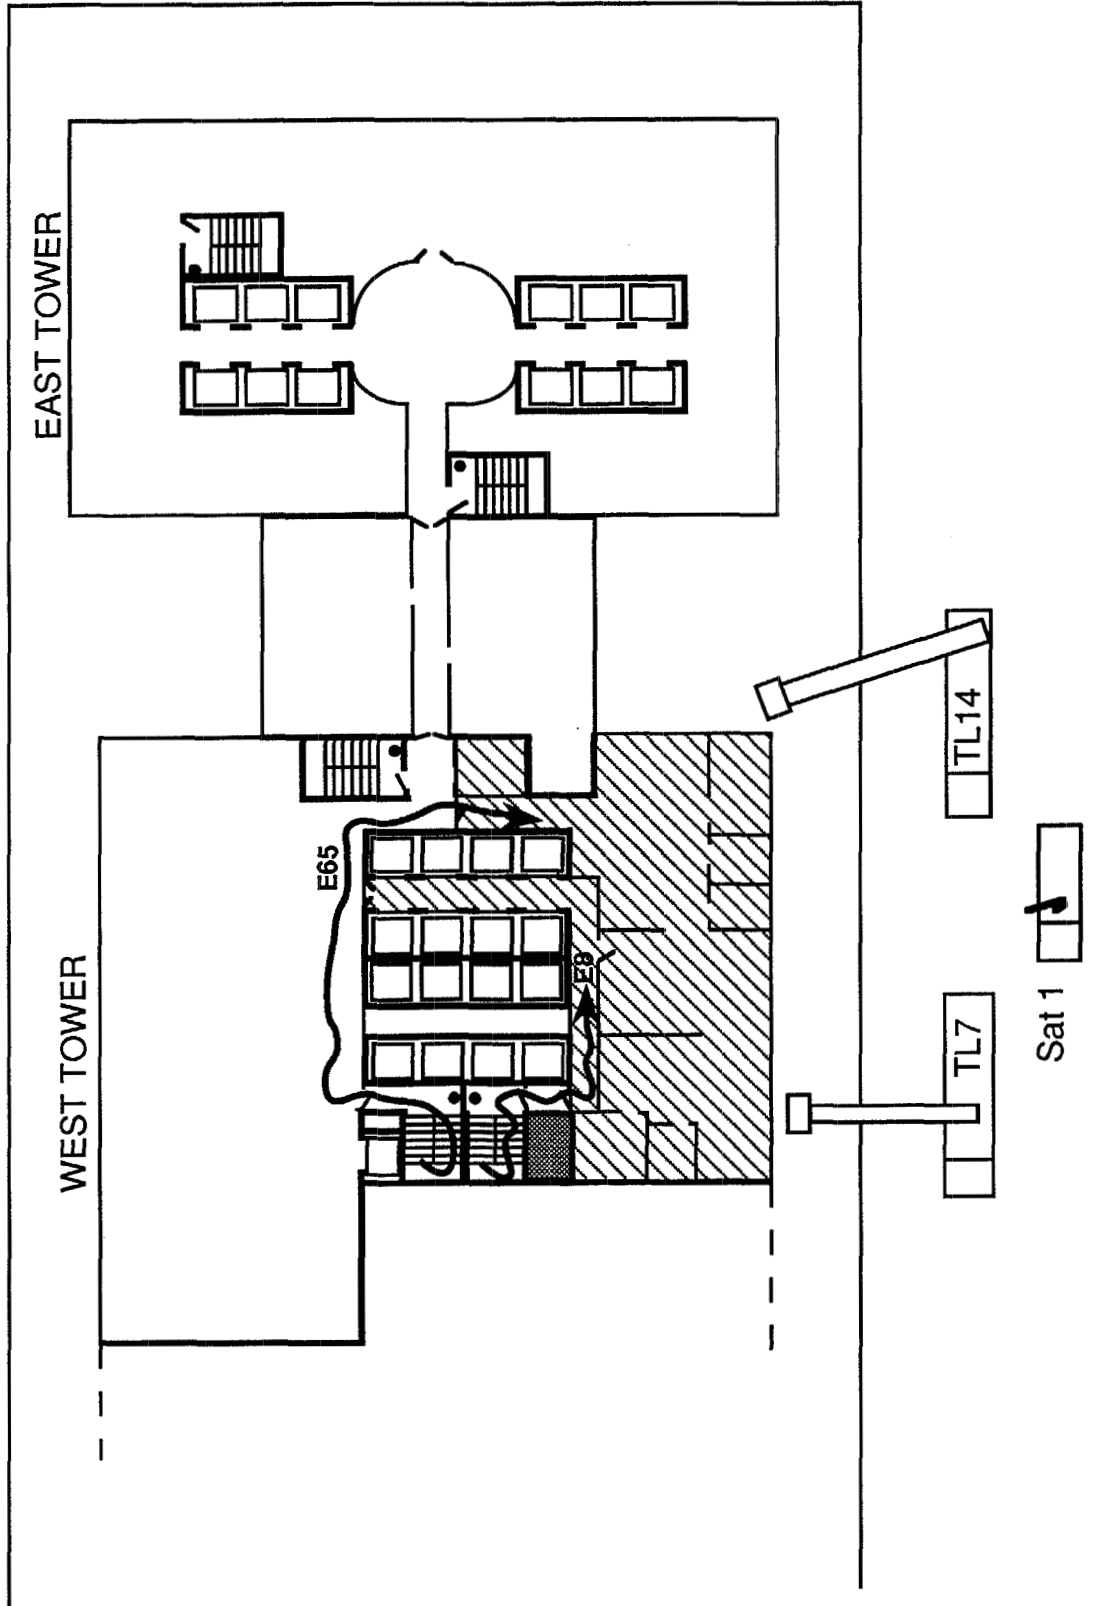
**BANKERS TRUST BUILDING
FIRE ATTACK PLAN**

Shaded Area = Fire Involvement

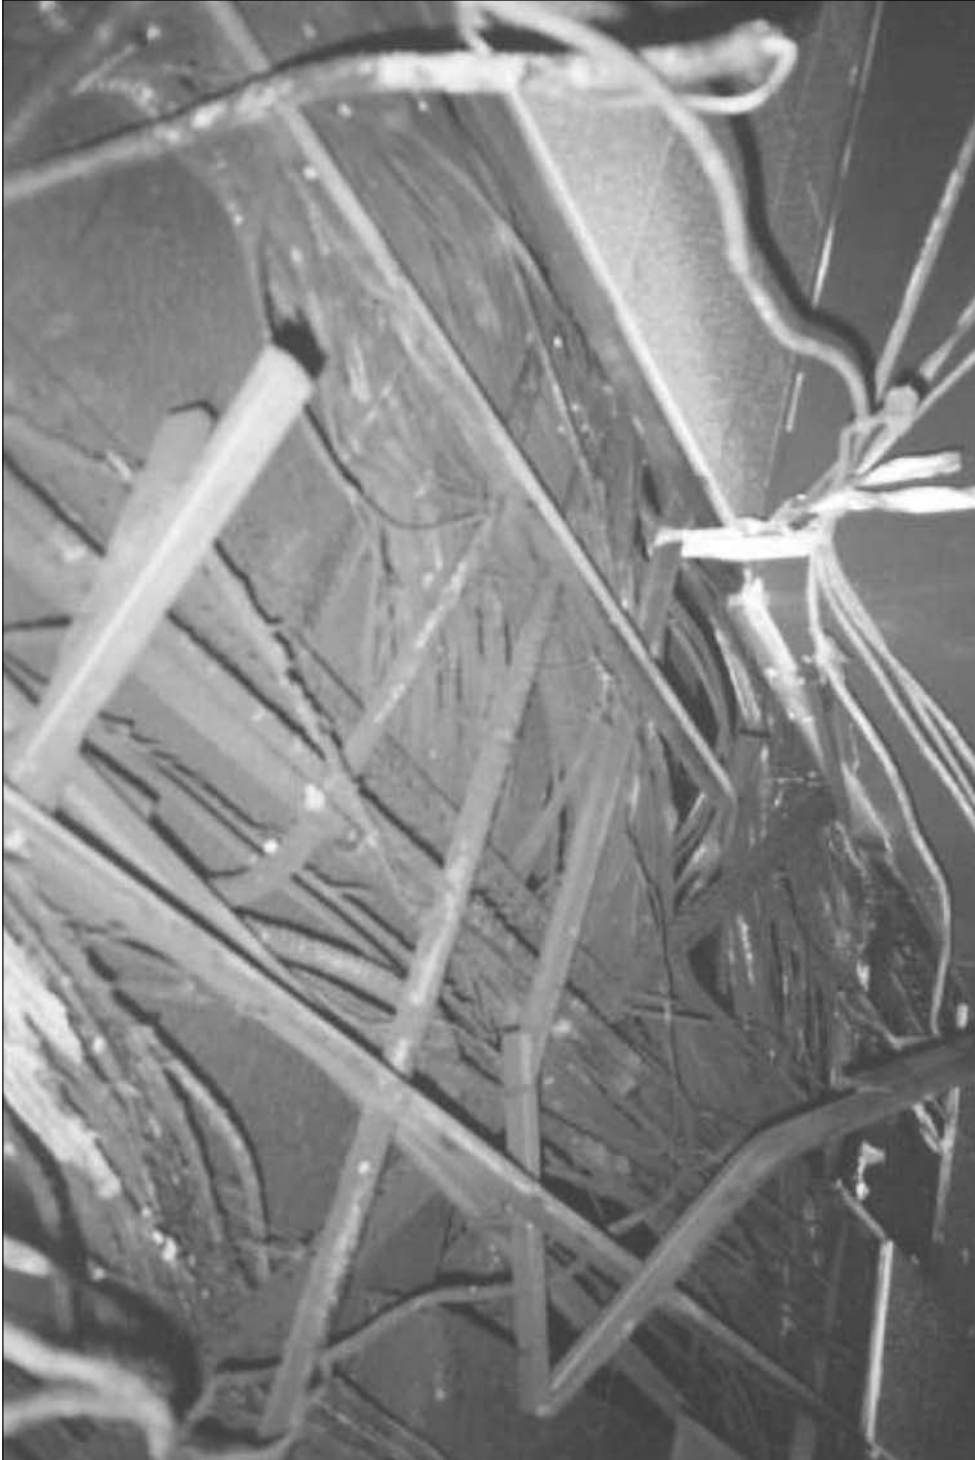
Fuel Load in Ceiling Plenum – The space above the ceiling in the fire area and adjacent areas was used for electrical wiring and communications cables. The amount of communications wiring in this type of occupancy is often a problem. It appears that over the years the amount of communications wiring in the plenum has grown, as old runs have been replaced by new wiring, but the old cables were not removed. The fuel load provided by the insulation on the wires contributed to the fire origin and intensity. The cable runs also made it impossible to fully seal the openings in fire separation walls above the ceilings, allowing smoke to migrate from one compartment to another and contributing to the secondary damage.

Photo shows the accumulation of combustible wiring that was in the ceiling plenum on the sixth floor at the edge of the fire area.

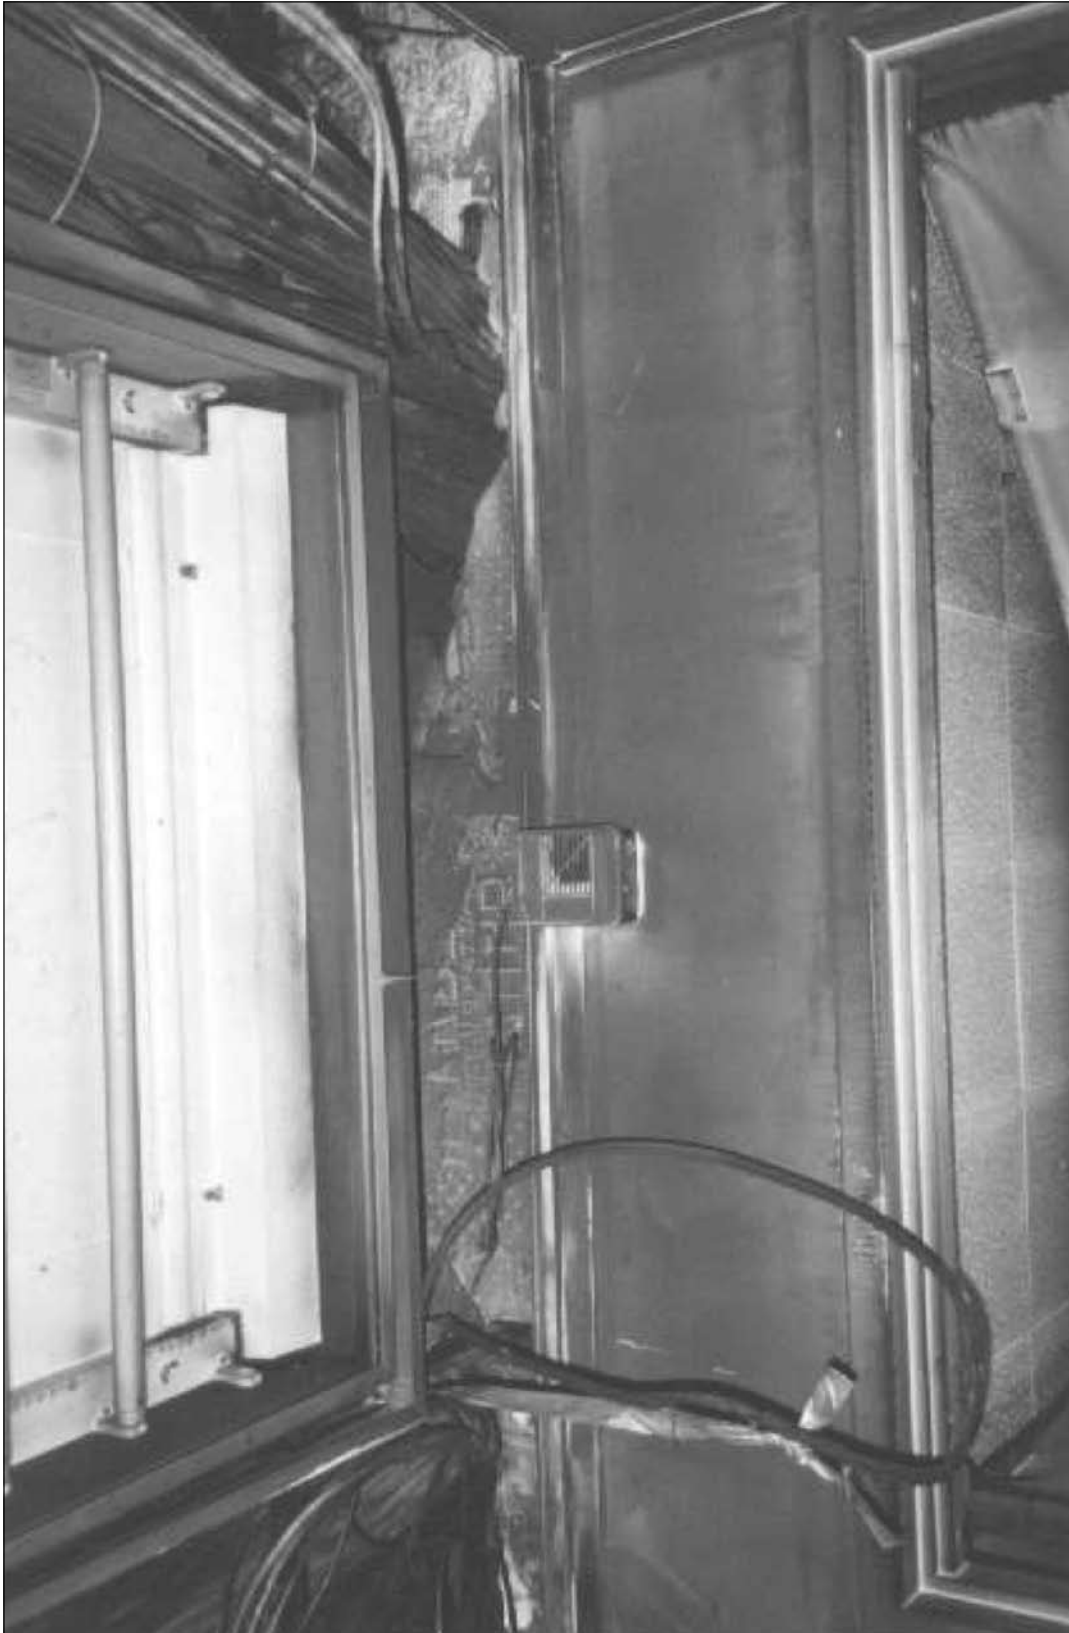
View of the ceiling plenum at the fire division wall shows the accumulation of electrical and communication wiring that penetrates the interior fire division wall above the doorway on the sixth floor.

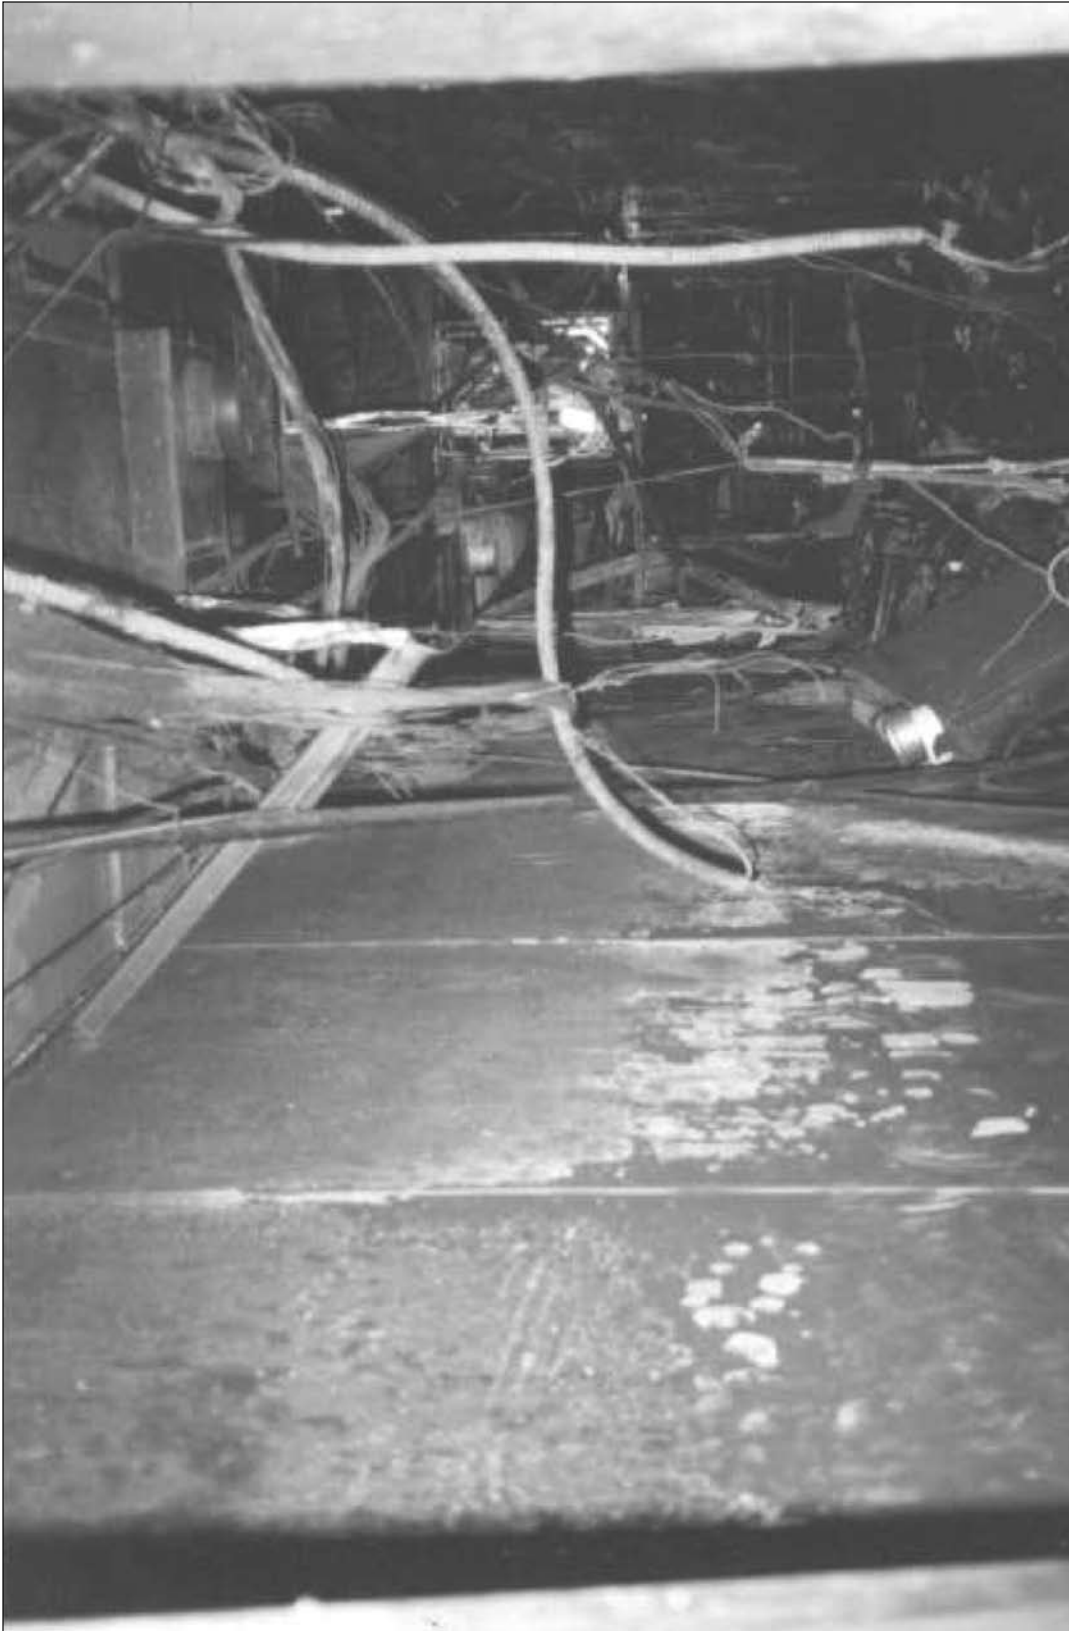
Corridor on the sixth floor where Engine 65 attempted to advance a 2 1/2 inch attack line.

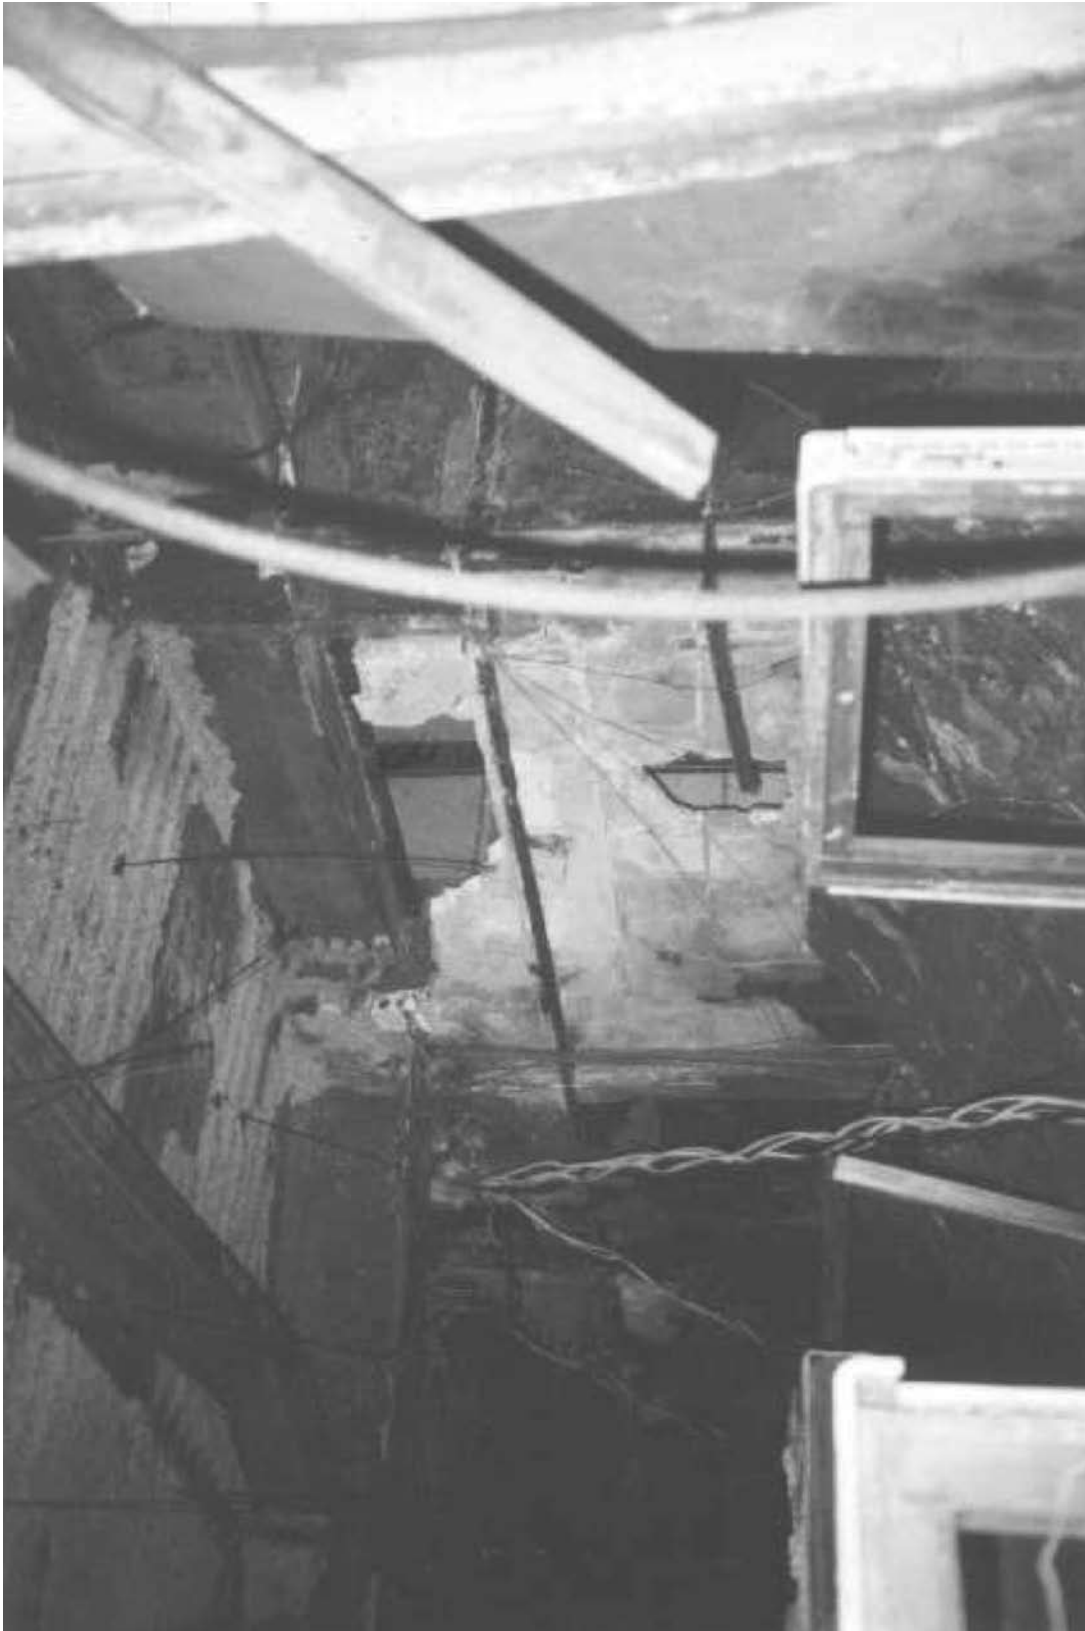
The master streams also punched a hole in the block wall enclosing the elevator shafts, directly opposite the windows, causing the blocks to fall on top of the elevator cars that were parked at the lobby level. Water runoff damaged most of the lower floors of the west tower. Electrical and telephone systems in the west tower were disrupted and needed major repairs.

Area on the sixth floor showing penetration into the elevator shafts caused by the high pressure master streams.

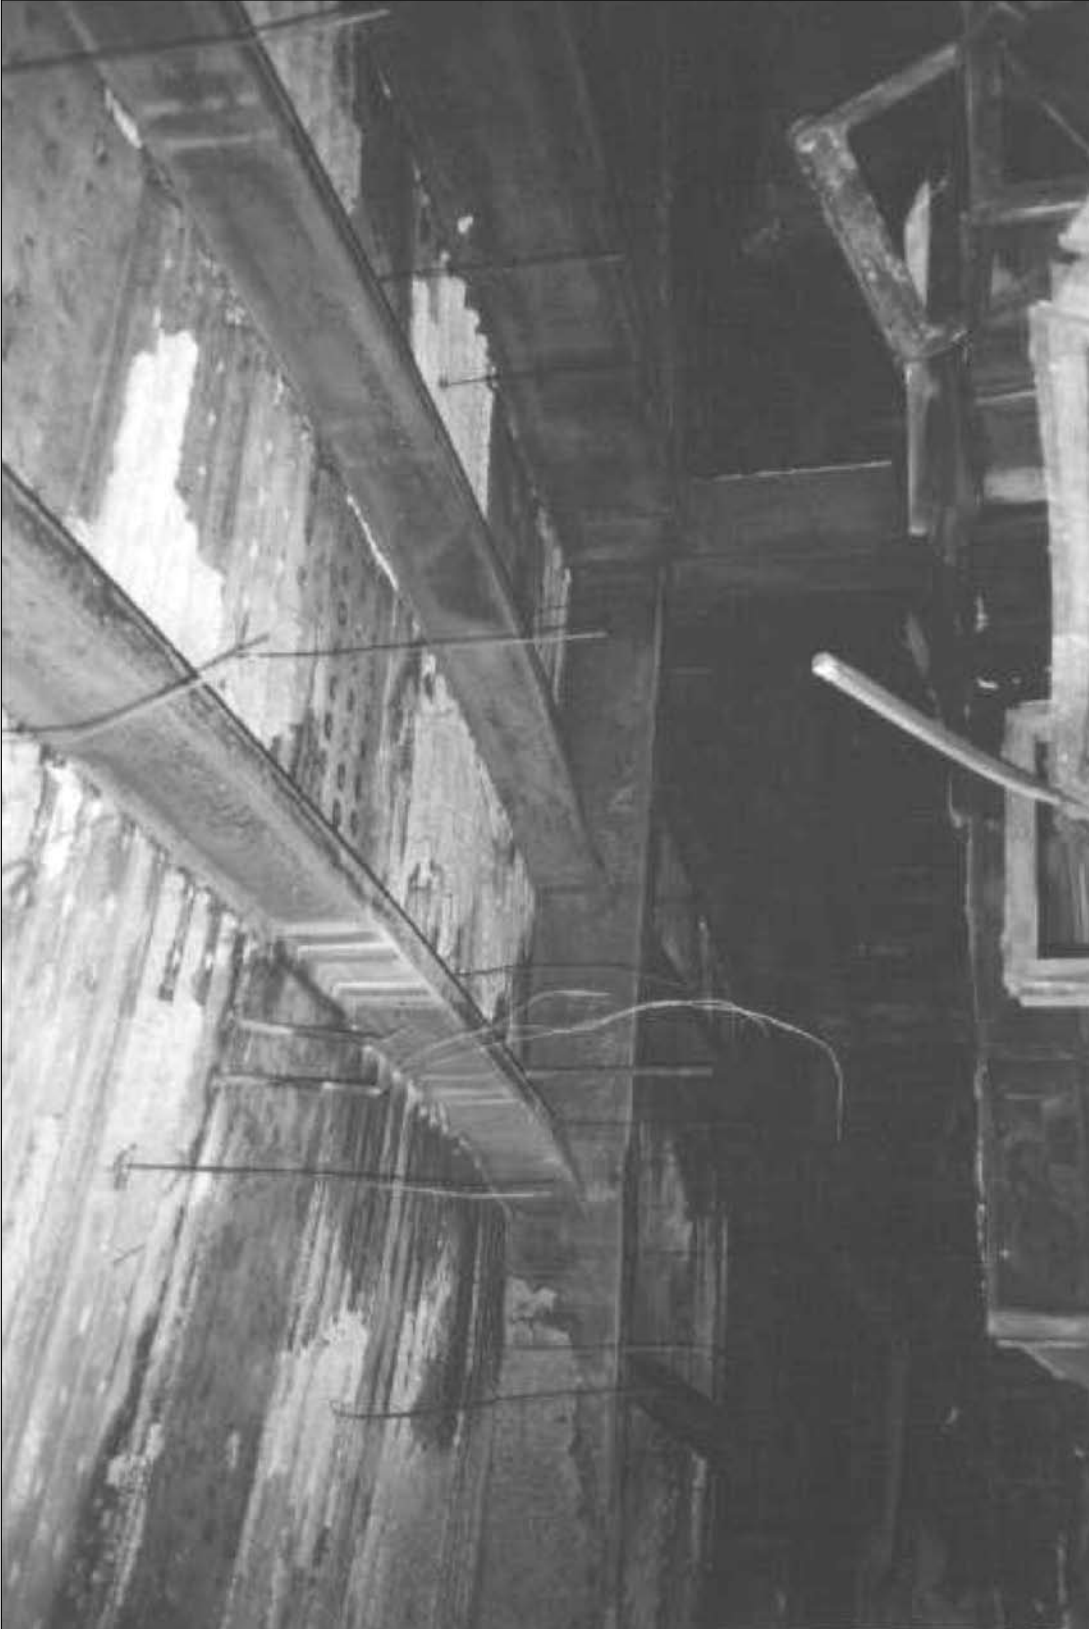
Most of the structural damage was confined to the underside of the seventh floor assembly. There was minor warping and sagging of the steel beams and larger girders, as well as sagging of the steel Q-deck between the beams. One of the smaller beams was detached from the supporting girder at one end of its span, apparently from the force of a master stream hitting it while it was heated. The deformation of the deck was most pronounced along the joints where fire had been observed extending through to the seventh floor; a variation in the floor level of three to six inches remained after the fire.

Close examination after the fire was completely extinguished showed there was no damage to the columns or girders and the structural deformation of the floor assembly was relatively minor. Several floor sections and a few beams would need to be removed and replaced to repair the structure. This was similar in nature to the damage that was observed in the highrise office building fires in Los Angeles and Philadelphia, although the extent of the damage in Philadelphia was much greater.

On the sixth floor, this view shows that virtually all the asbestos fireproofing was washed off the steel that was exposed to water streams. Photo also shows the deflection of the beams and floor deck above due to heat.

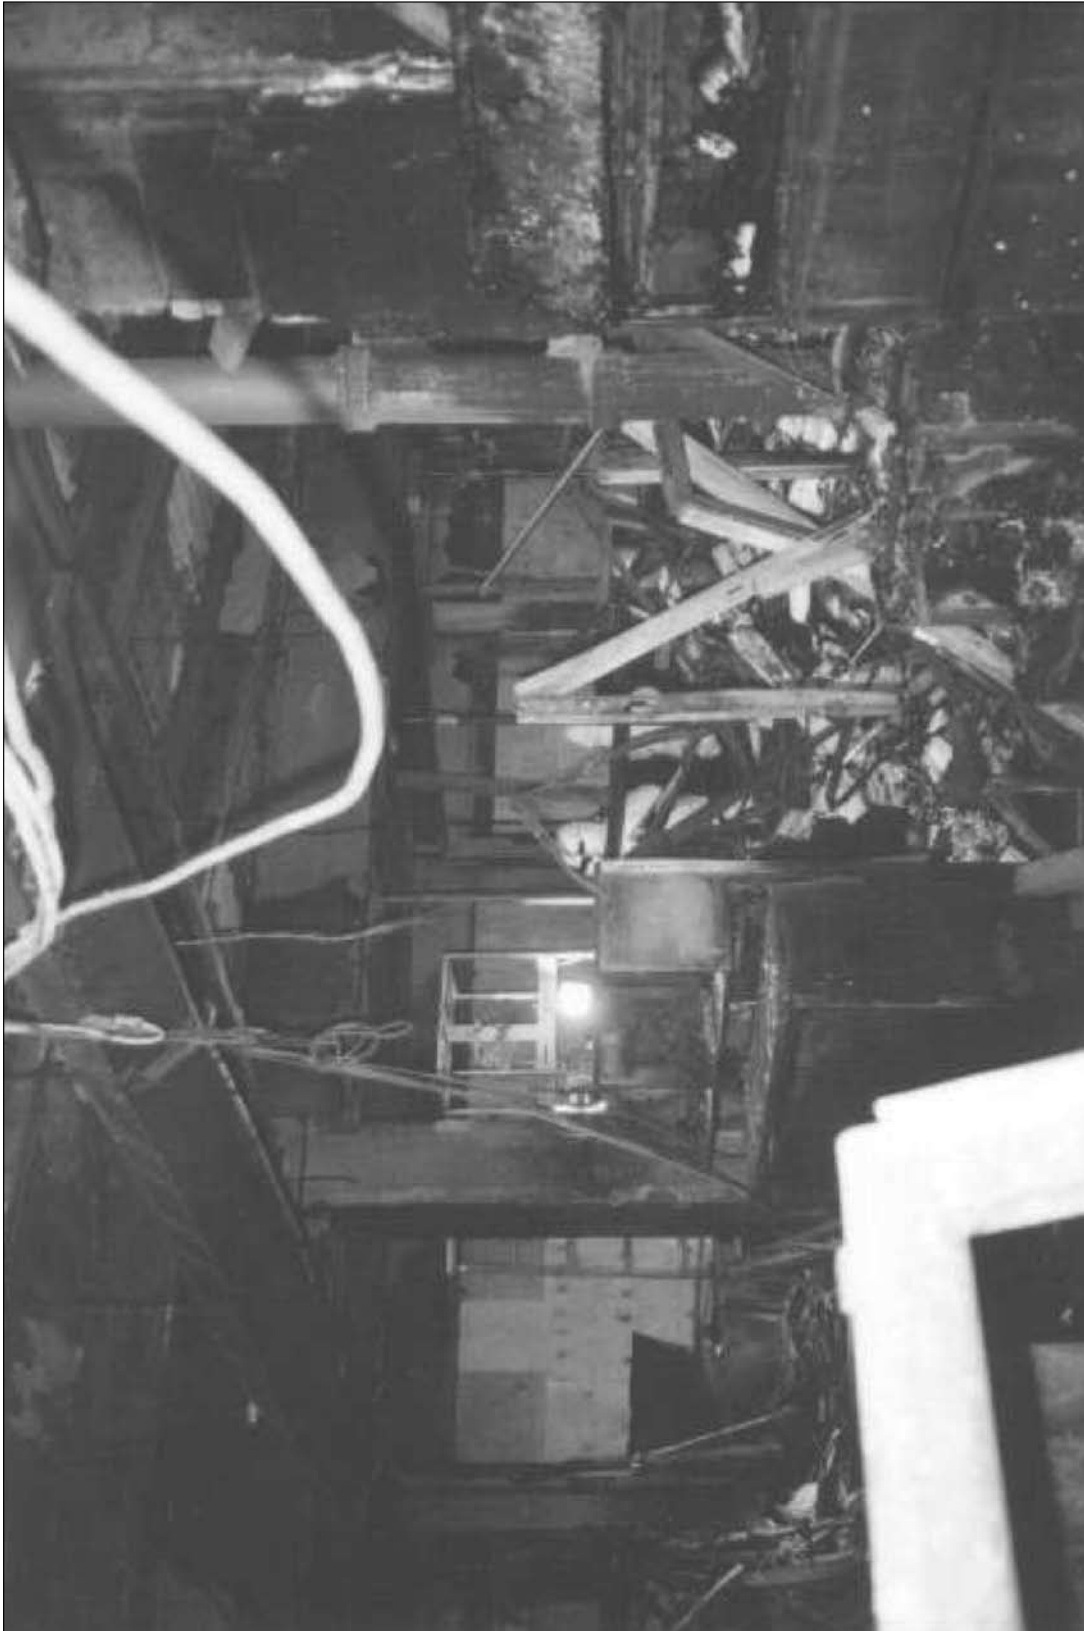
The direct fire damage on the sixth floor included destruction of all contents on the south half of the west tower and heavy heat and smoke damage on the north half of the same tower. A smaller area directly above was involved on the seventh floor and there was minor fire extension into the eighth floor. Most of the remainder of the sixth floor of both towers was heavily damaged by smoke, although the area separation doors kept the flames out of the east tower and limited the heat damage.

The main fire area on the sixth floor looking toward the windows on the 48th Street side of the building. Note the degree of fire damage to contents and exposure of the structural steel above the ceiling.

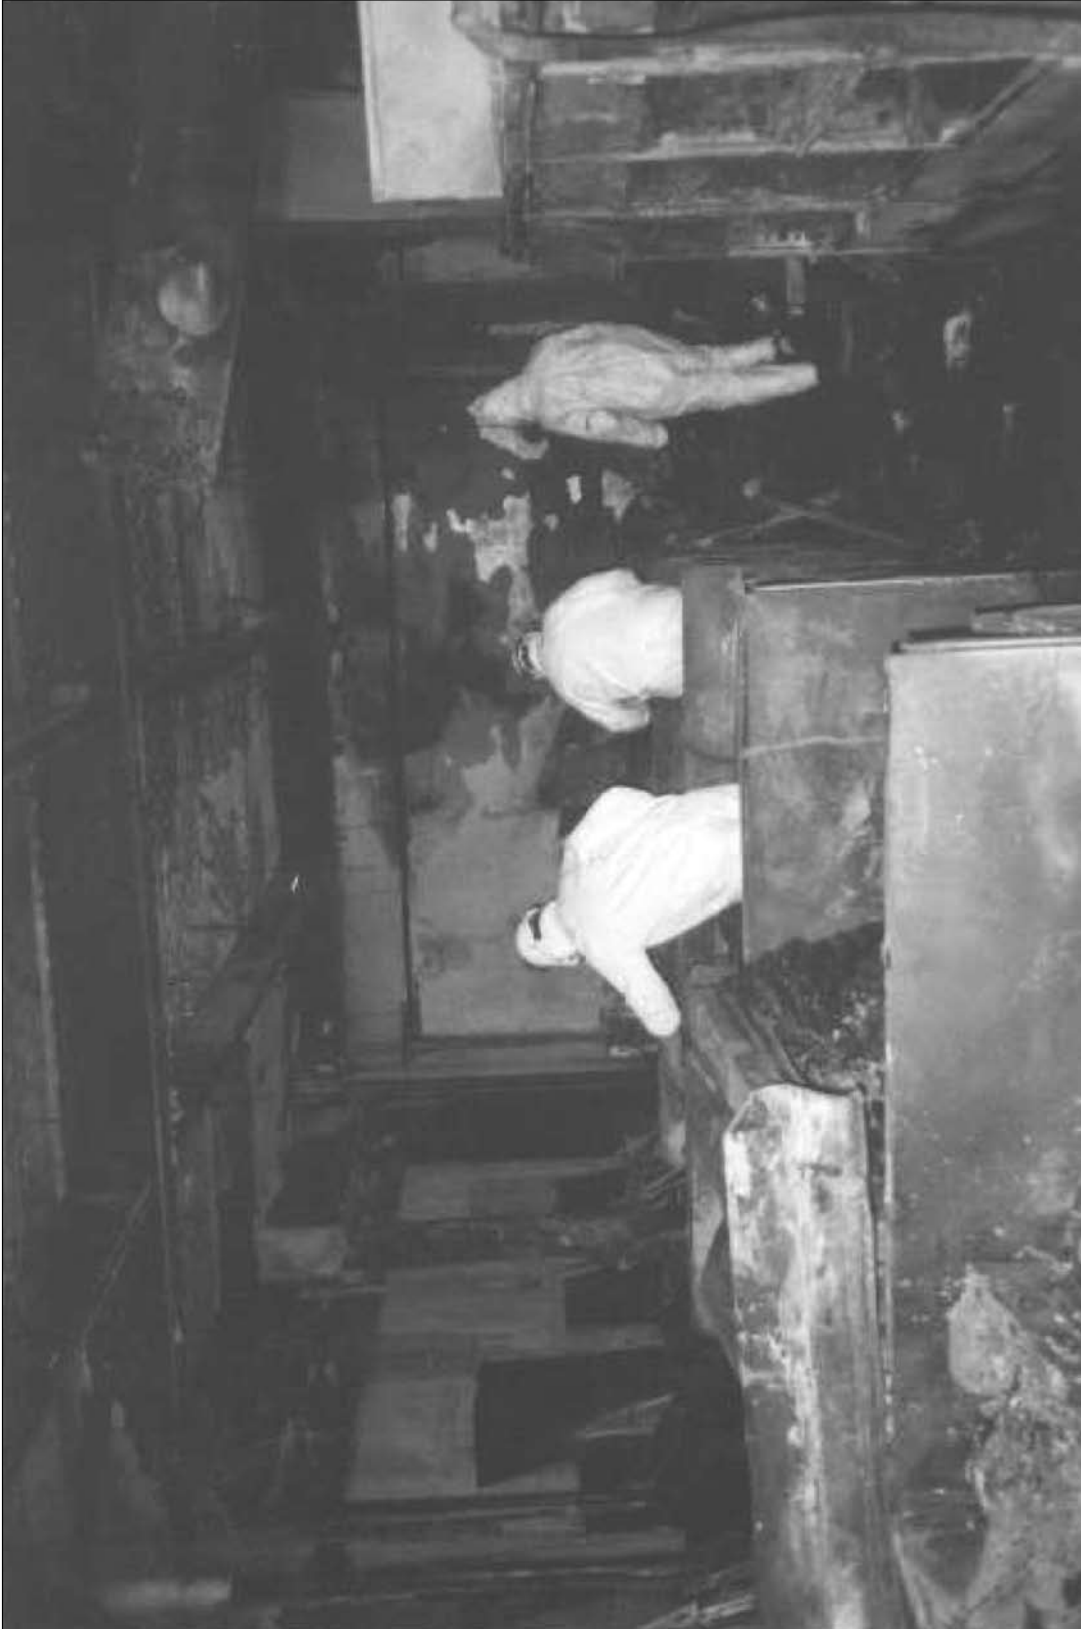
The asbestos problem continued through the investigation stage. Investigators could not enter the fire area to determine the cause and origin of the fire until the asbestos problem had been addressed. The building owners brought in an asbestos removal and decontamination contractor to remove the free asbestos from the fire area and from the rest of the building; however, it was three days before investigators were able to enter the area wearing respirators and protective ensembles.

Investigators working in the area of fire origin wearing protective clothing due to asbestos contamination.
