U.S. Fire Administration/Technical Report Series

New York City Bank Building Fire: Compartmentation vs. Sprinklers

New York, New York

USFA-TR-071/January 1993

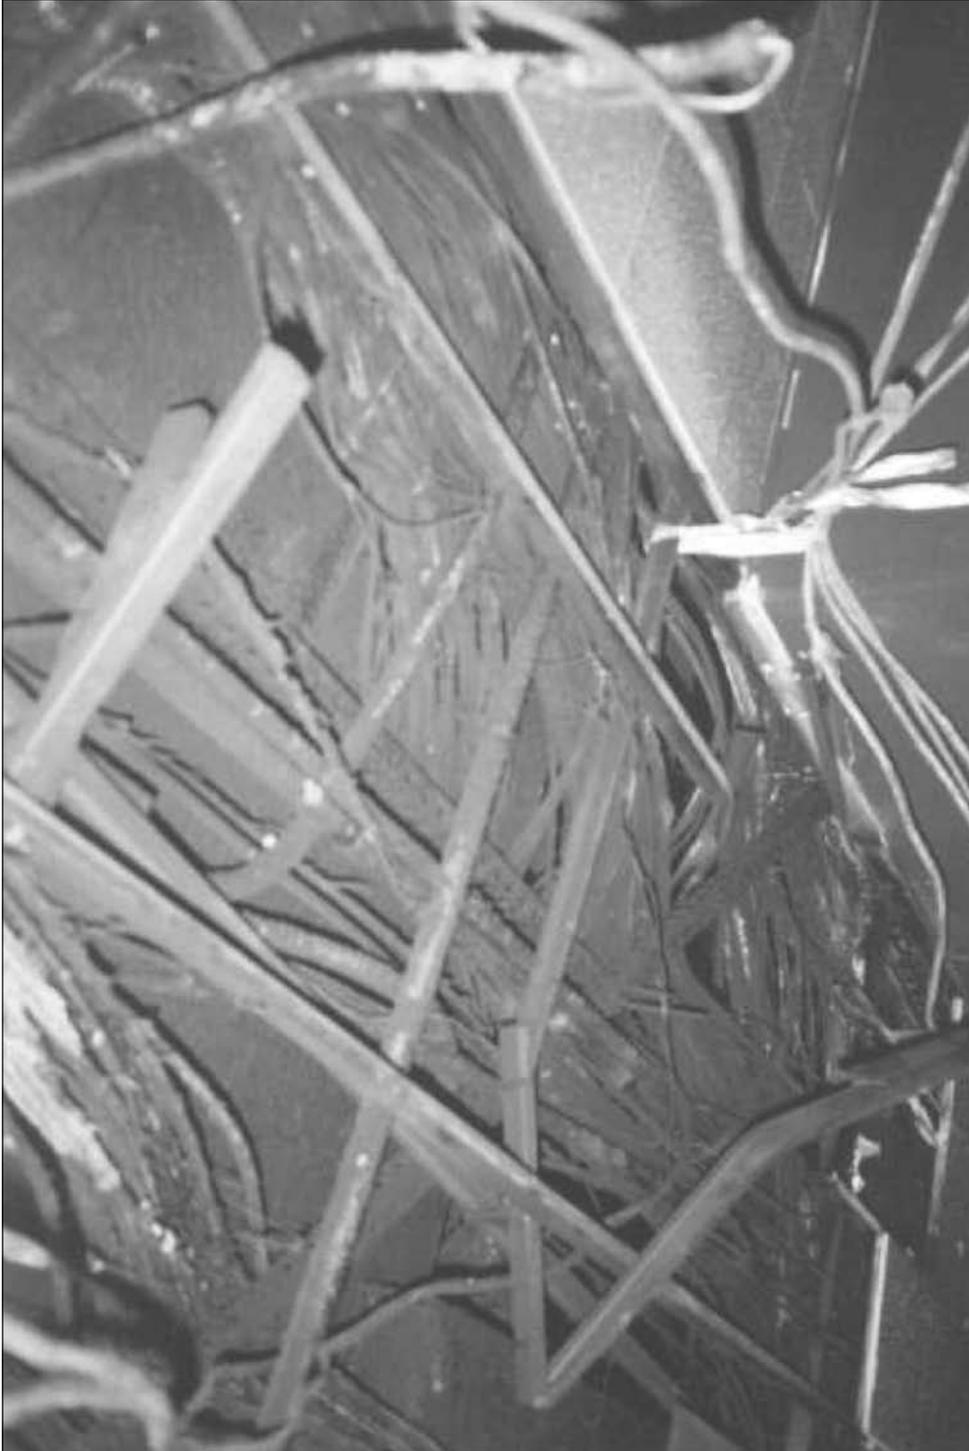
Photo shows the accumulation of combustible wiring that was in the ceiling plenum on the sixth floor at the edge of the fire area.

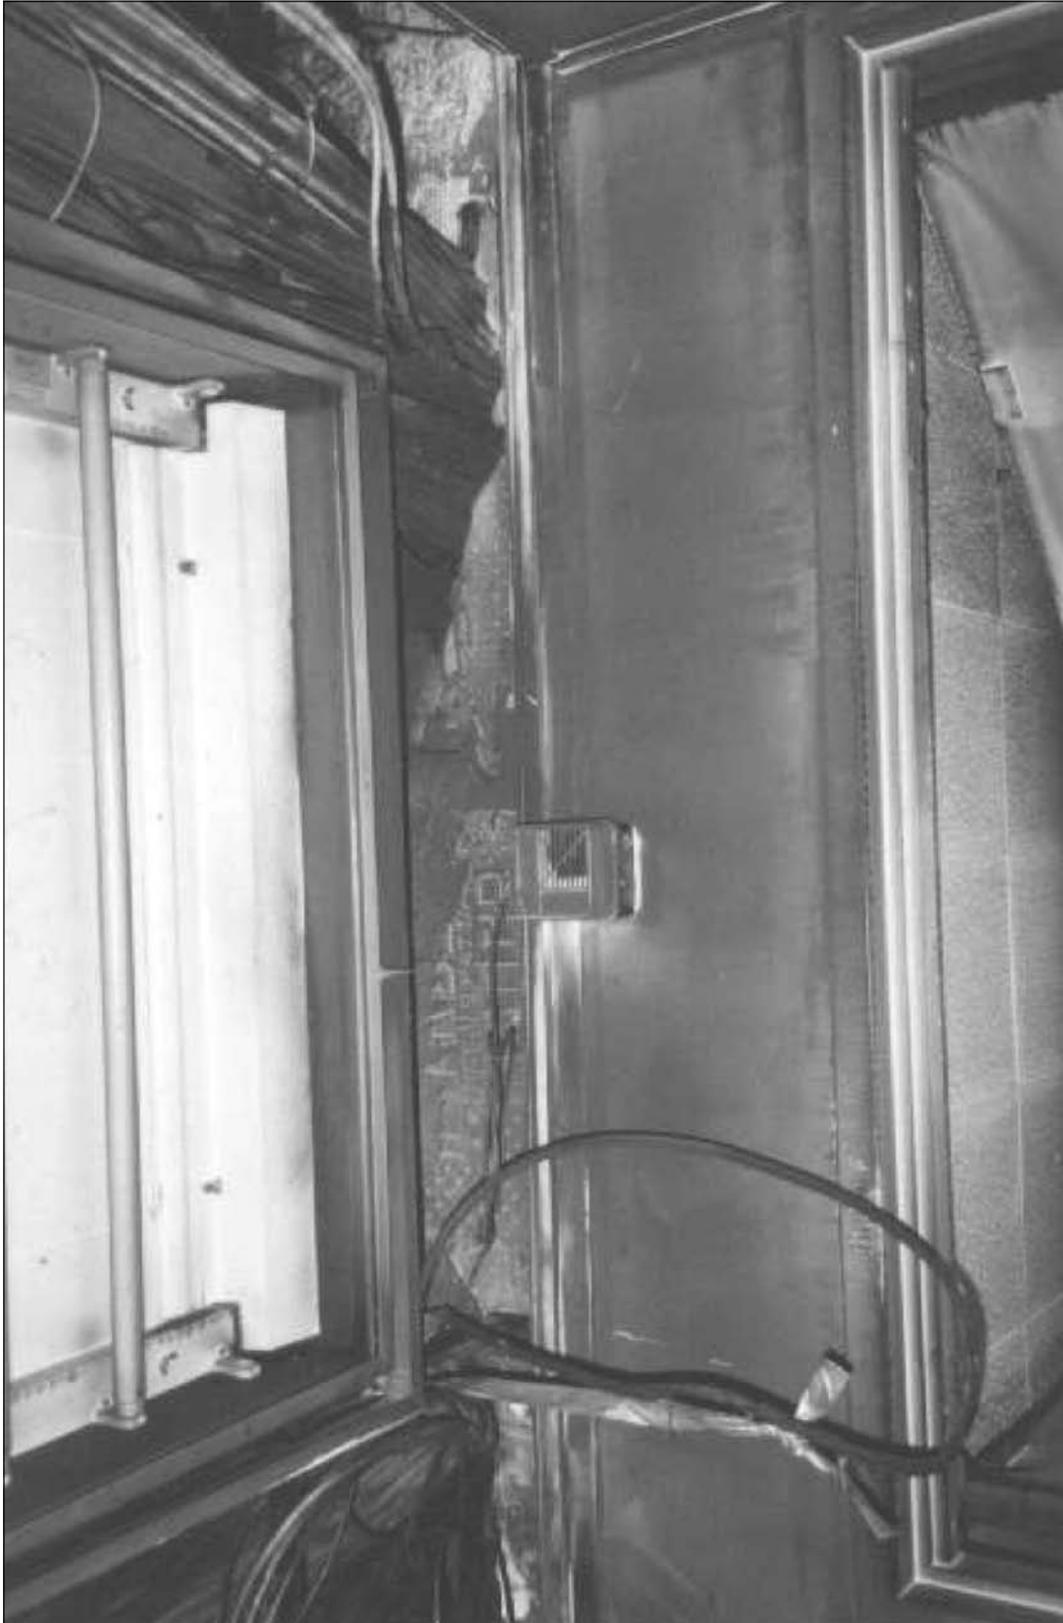
Fuel Load in Ceiling Plenum – The space above the ceiling in the fire area and adjacent areas was used for electrical wiring and communications cables. The amount of communications wiring in this type of occupancy is often a problem. It appears that over the years the amount of communications wiring in the plenum has grown, as old runs have been replaced by new wiring, but the old cables were not removed. The fuel load provided by the insulation on the wires contributed to the fire origin and intensity. The cable runs also made it impossible to fully seal the openings in fire separation walls above the ceilings, allowing smoke to migrate from one compartment to another and contributing to the secondary damage.

View of the ceiling plenum at the fire division wall shows the accumulation of electrical and communication wiring that penetrates the interior fire division wall above the doorway on the sixth floor.

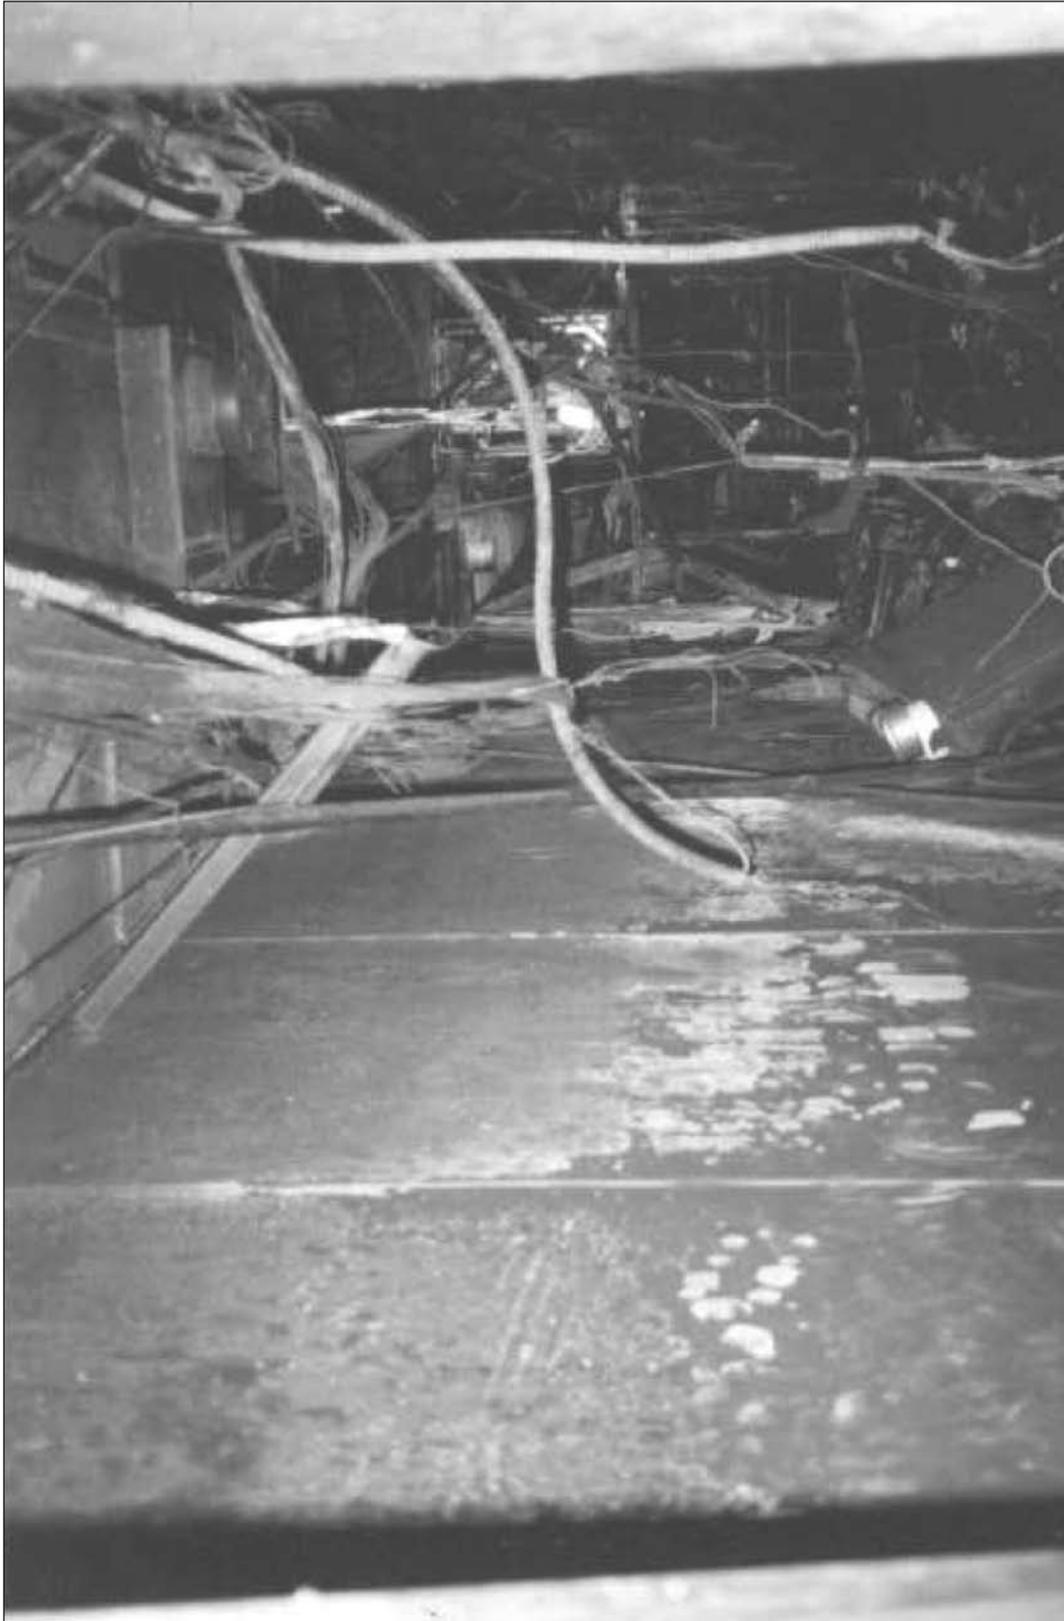
Corridor on the sixth floor where Engine 65 attempted to advance a 2 1/2 inch attack line.

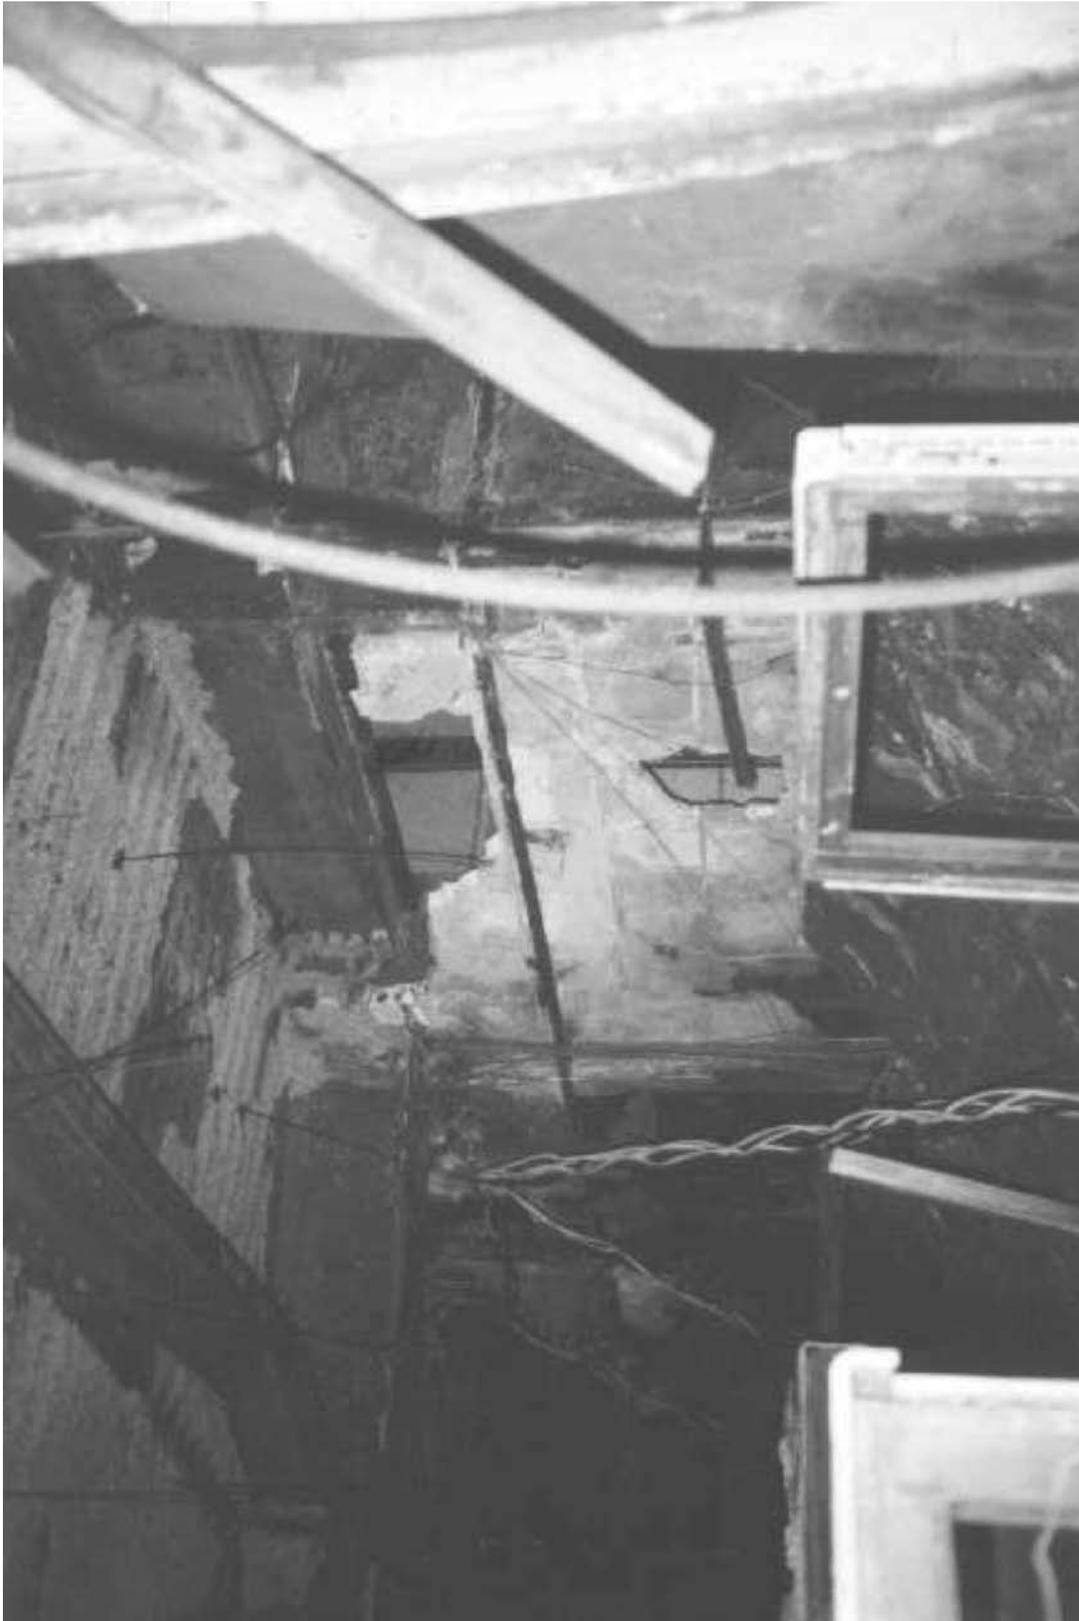
The master streams also punched a hole in the block wall enclosing the elevator shafts, directly opposite the windows, causing the blocks to fall on top of the elevator cars that were parked at the lobby level. Water runoff damaged most of the lower floors of the west tower. Electrical and telephone systems in the west tower were disrupted and needed major repairs.

Area on the sixth floor showing penetration into the elevator shafts caused by the high pressure master streams.

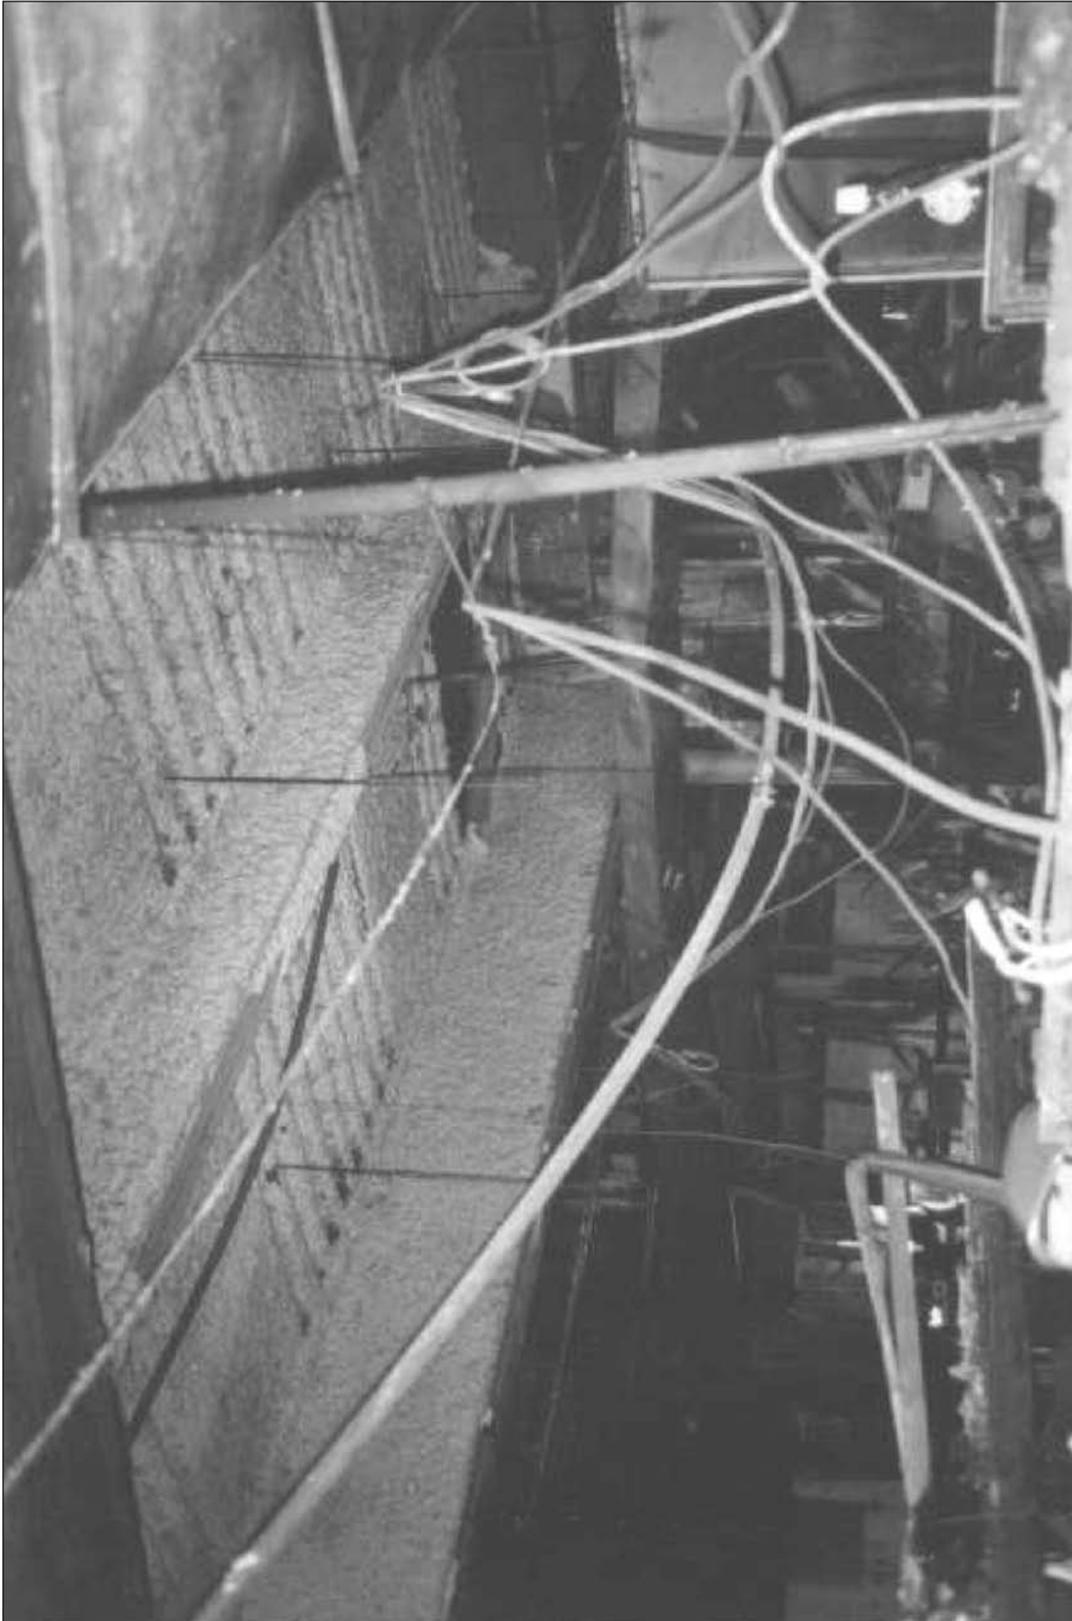
On the sixth floor, this is a view of the structural steel from the underside showing where the sprayed on asbestos fireproofing material remained attached to the steel in an area that was not exposed to water streams.

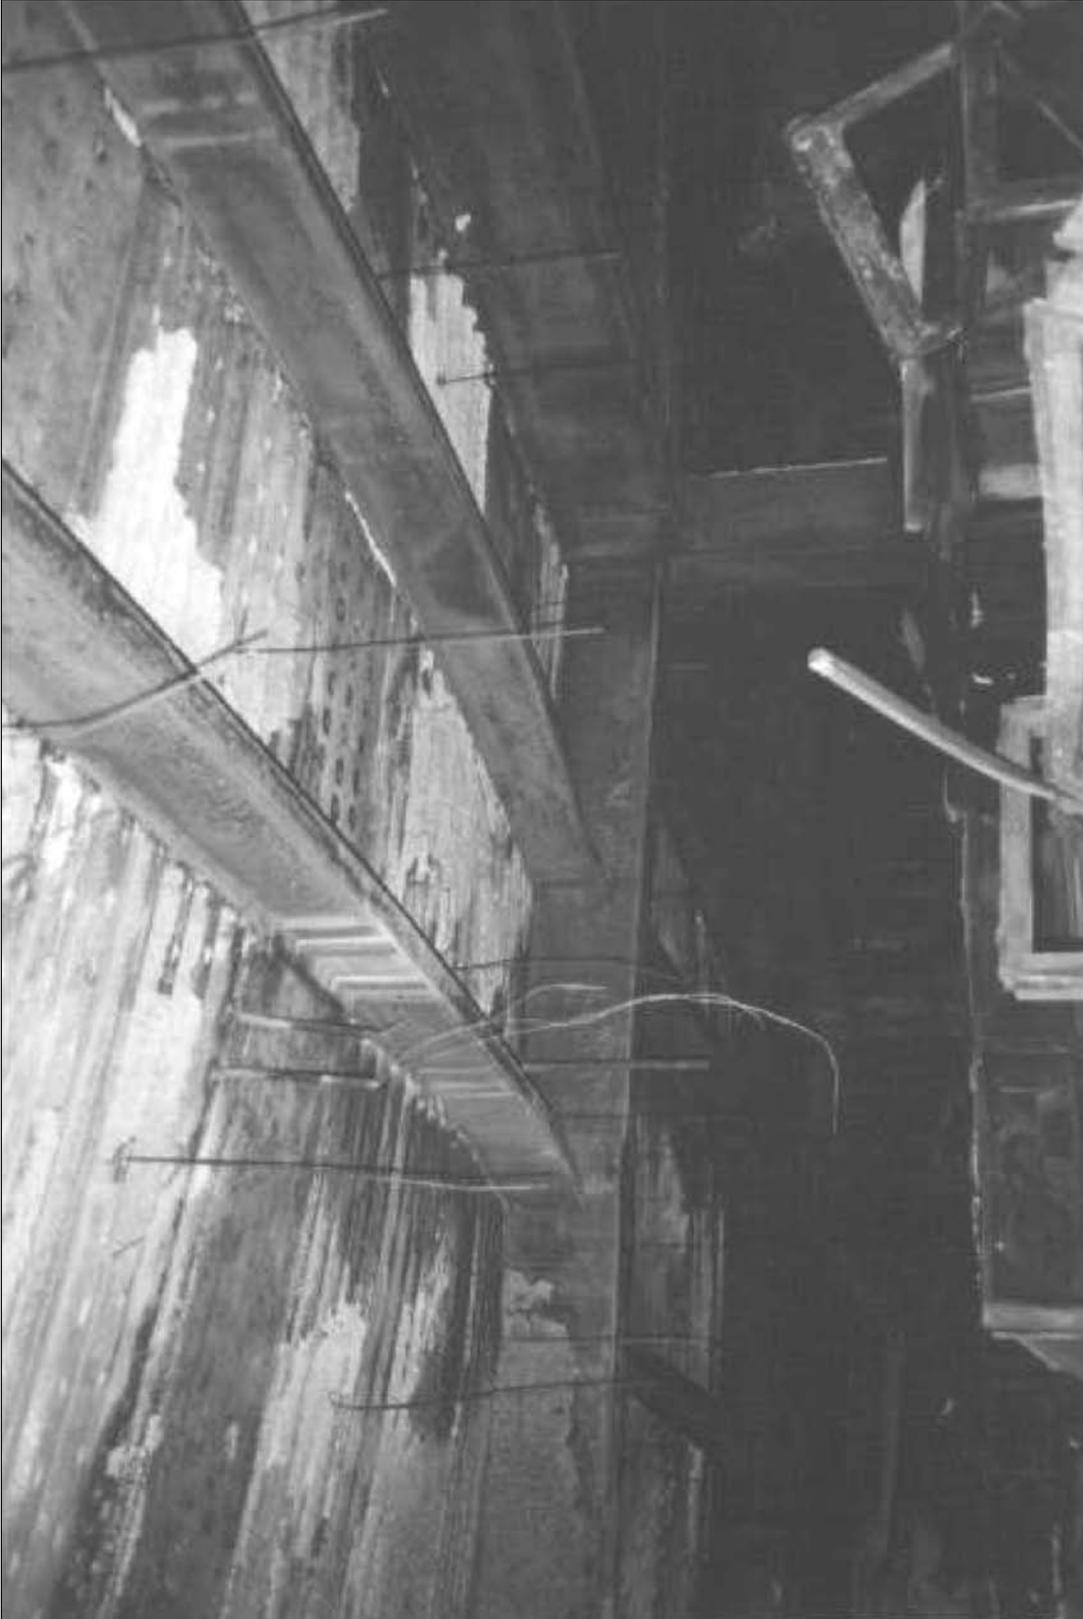
Most of the structural damage was confined to the underside of the seventh floor assembly. There was minor warping and sagging of the steel beams and larger girders, as well as sagging of the steel Q-deck between the beams. One of the smaller beams was detached from the supporting girder at one end of its span, apparently from the force of a master stream hitting it while it was heated. The deformation of the deck was most pronounced along the joints where fire had been observed extending through to the seventh floor; a variation in the floor level of three to six inches remained after the fire.

Close examination after the fire was completely extinguished showed there was no damage to the columns or girders and the structural deformation of the floor assembly was relatively minor. Several floor sections and a few beams would need to be removed and replaced to repair the structure. This was similar in nature to the damage that was observed in the highrise office building fires in Los Angeles and Philadelphia, although the extent of the damage in Philadelphia was much greater.

On the sixth floor, this view shows that virtually all the asbestos fireproofing was washed off the steel that was exposed to water streams. Photo also shows the deflection of the beams and floor deck above due to heat.

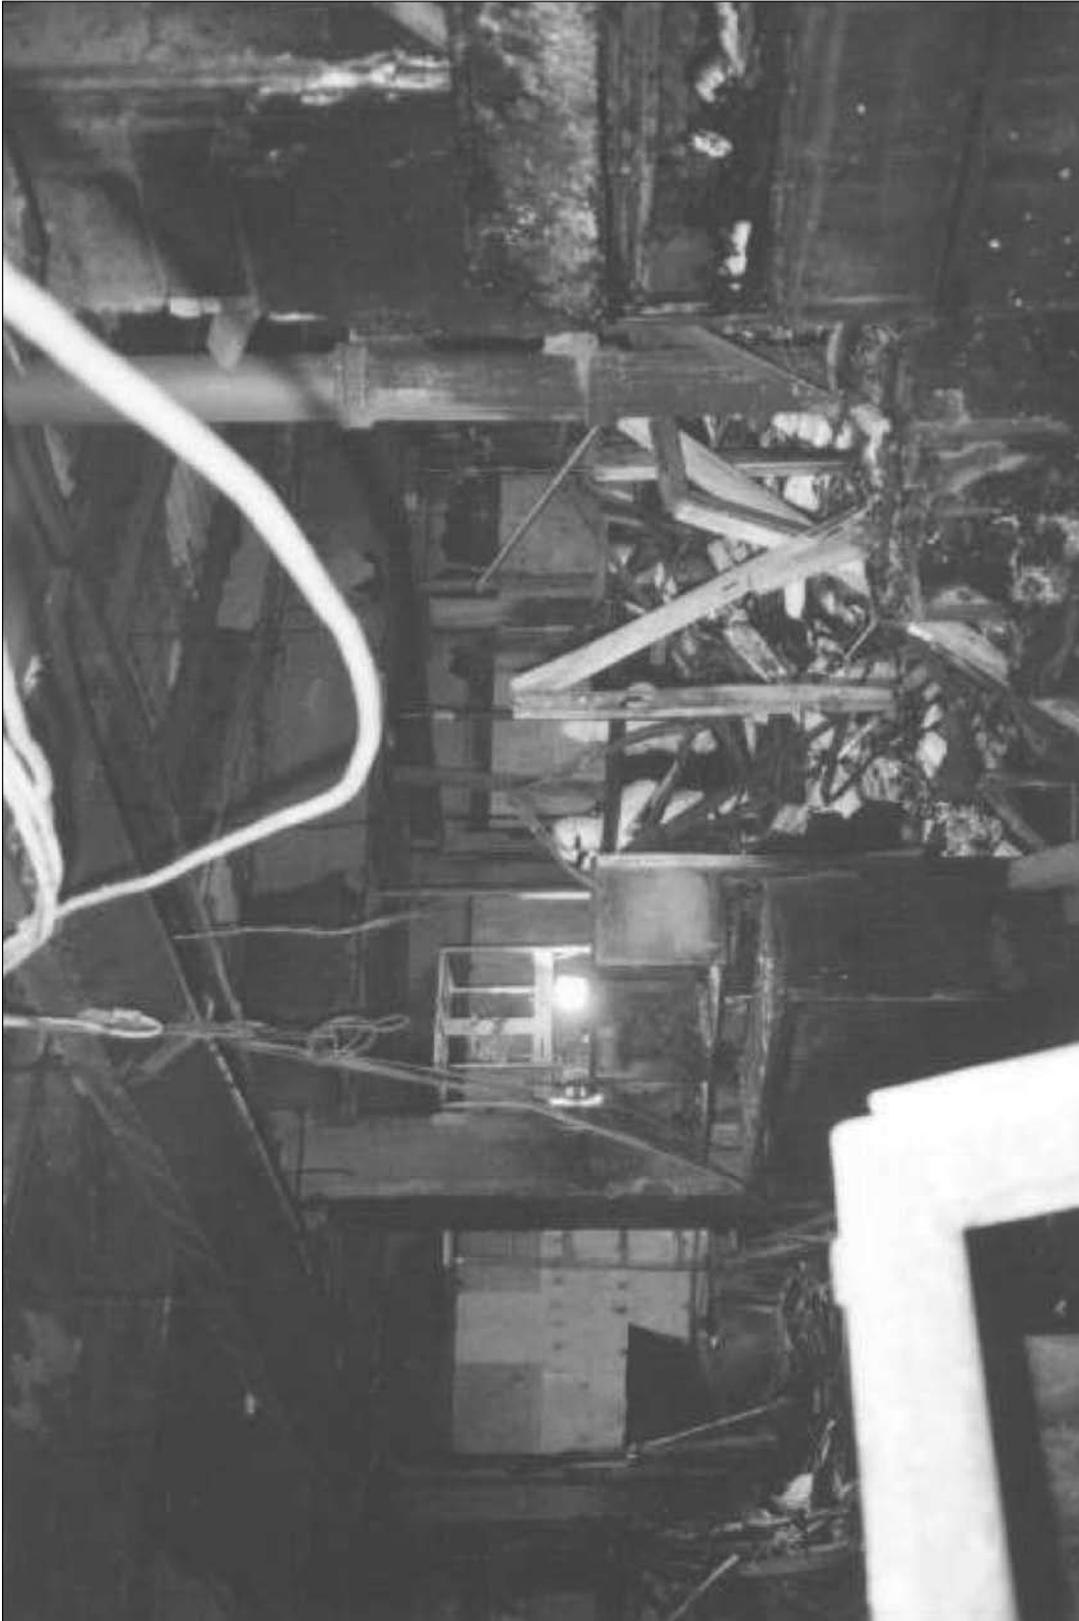
The direct fire damage on the sixth floor included destruction of all contents on the south half of the west tower and heavy heat and smoke damage on the north half of the same tower. A smaller area directly above was involved on the seventh floor and there was minor fire extension into the eighth floor. Most of the remainder of the sixth floor of both towers was heavily damaged by smoke, although the area separation doors kept the flames out of the east tower and limited the heat damage.

The main fire area on the sixth floor looking toward the windows on the 48th Street side of the building. Note the degree of fire damage to contents and exposure of the structural steel above the ceiling.

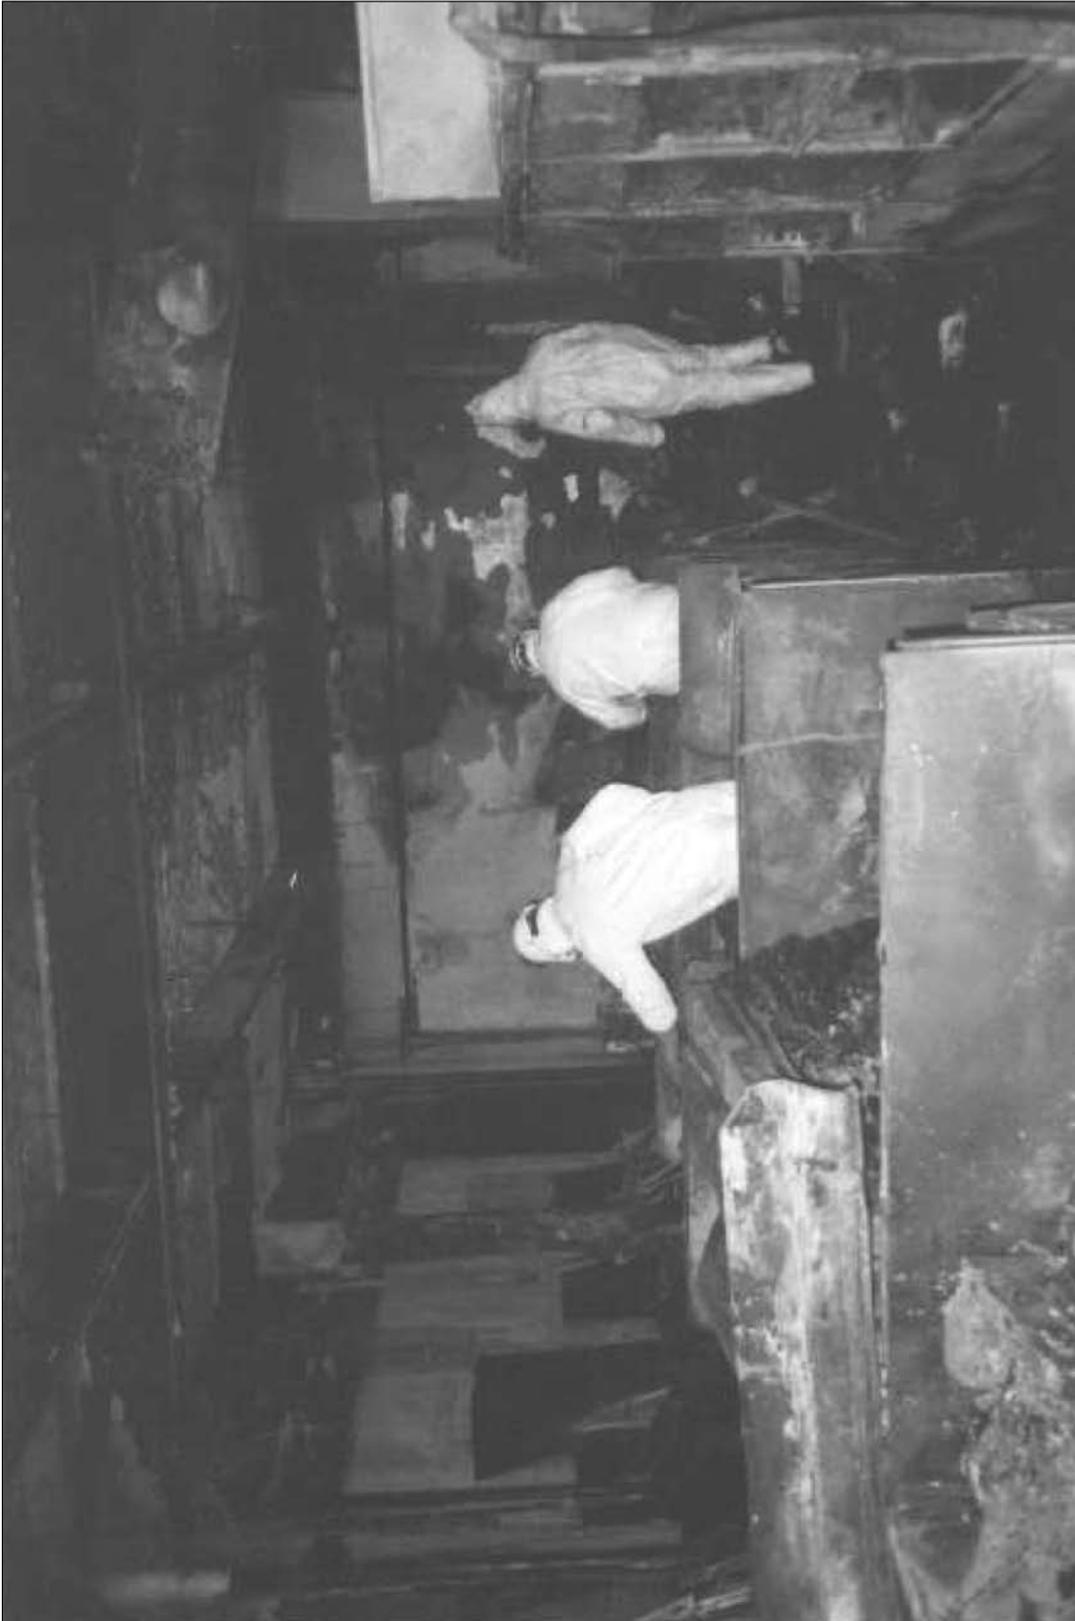
The asbestos problem continued through the investigation stage. Investigators could not enter the fire area to determine the cause and origin of the fire until the asbestos problem had been addressed. The building owners brought in an asbestos removal and decontamination contractor to remove the free asbestos from the fire area and from the rest of the building; however, it was three days before investigators were able to enter the area wearing respirators and protective ensembles.

Investigators working in the area of fire origin wearing protective clothing due to asbestos contamination.
