# Two Firefighter Deaths in Auto Parts Store Fire

Chesapeake, Virginia

USFA-TR-087/March 1996

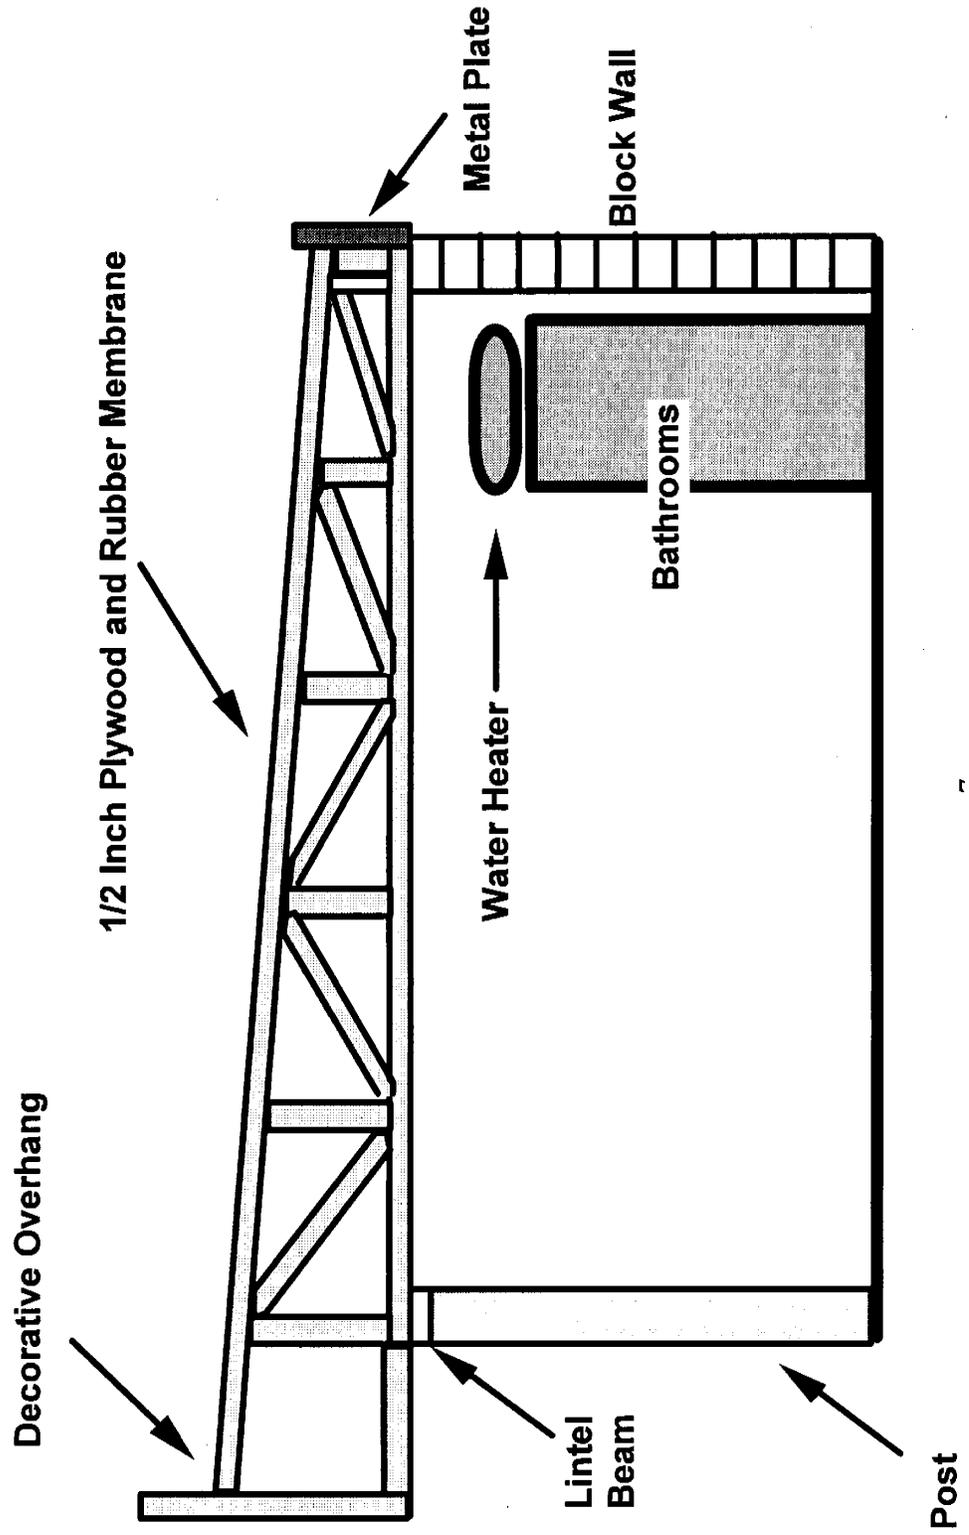
Figure 2  
ADVANCE AUTO PARTS STORE  
Dissection of the truss roof as viewed from front to back  
of the building.

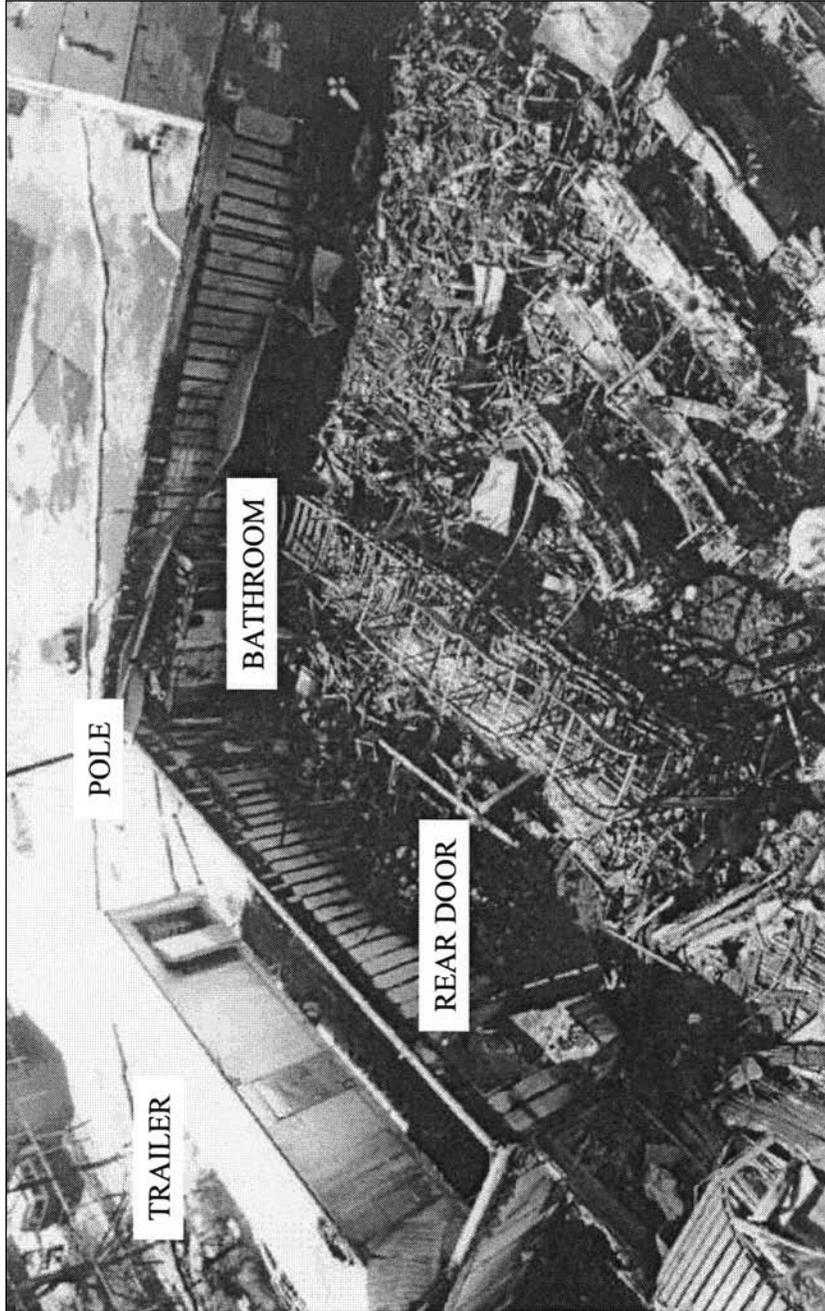
An elevated view of the rear of the store, showing (1) the door in the rear where the firefighters entered with the 1 3/4 attack line; (2) the trailer that blocked the view of the rear entrance; (3) the location of the utility pole; and (4) the employee bathrooms where the fire was originally discovered. (Photo courtesy of the NFPA).

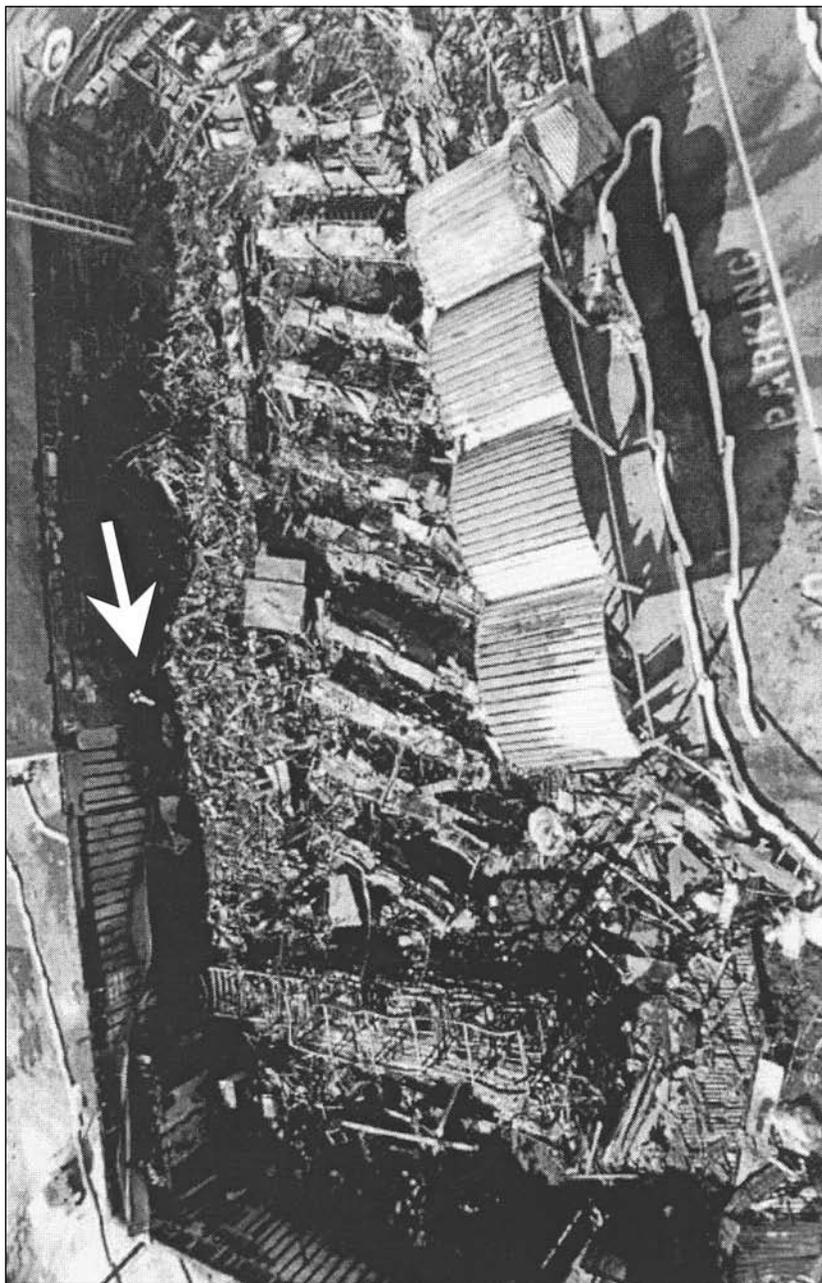
Photo of interior of the store from an elevated position on side two. The white cross (arrow) indicates where both firefighters were found. (Photo courtesy of the NFPA).

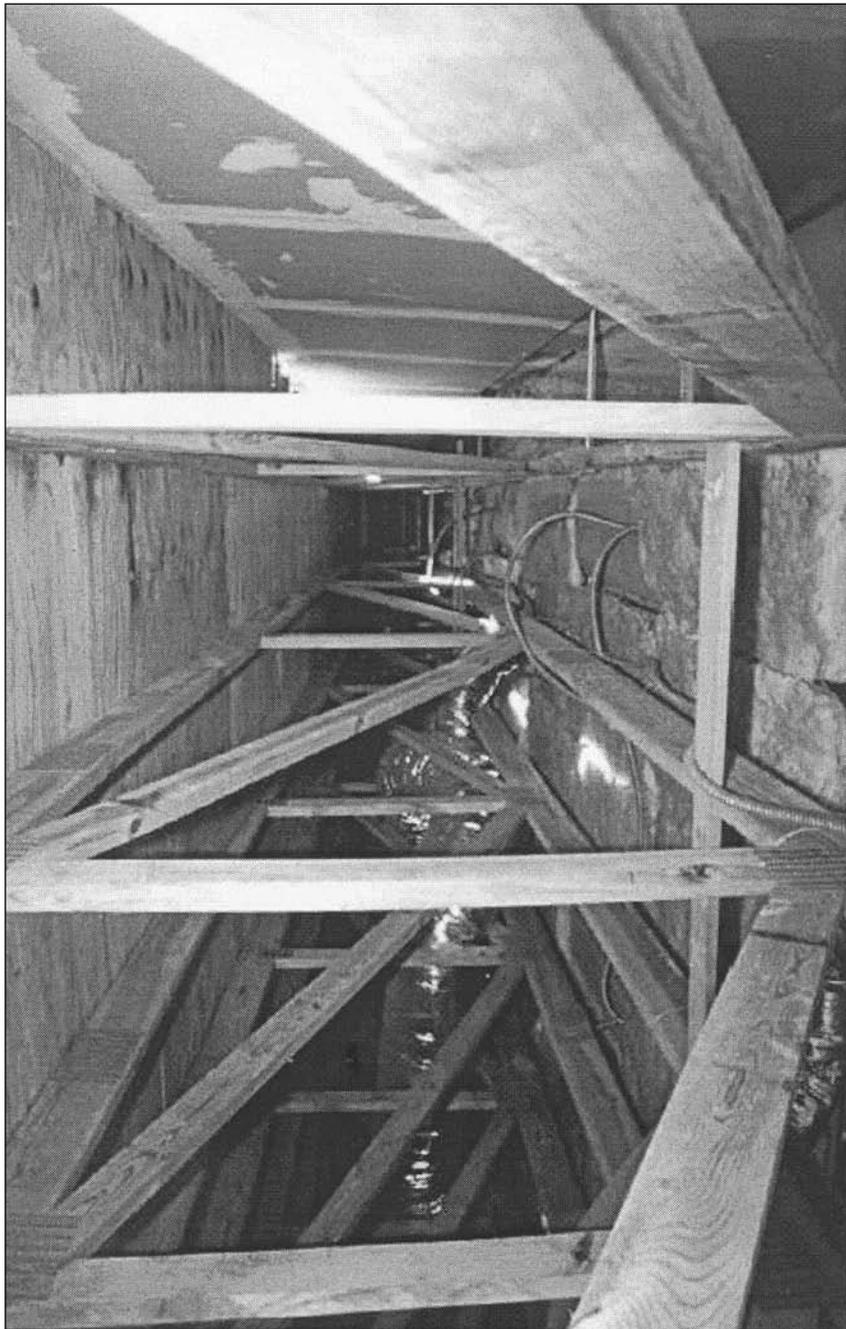
**The truss loft area in another part of the Indian River Shopping Center. (Photo courtesy of NFPA).**

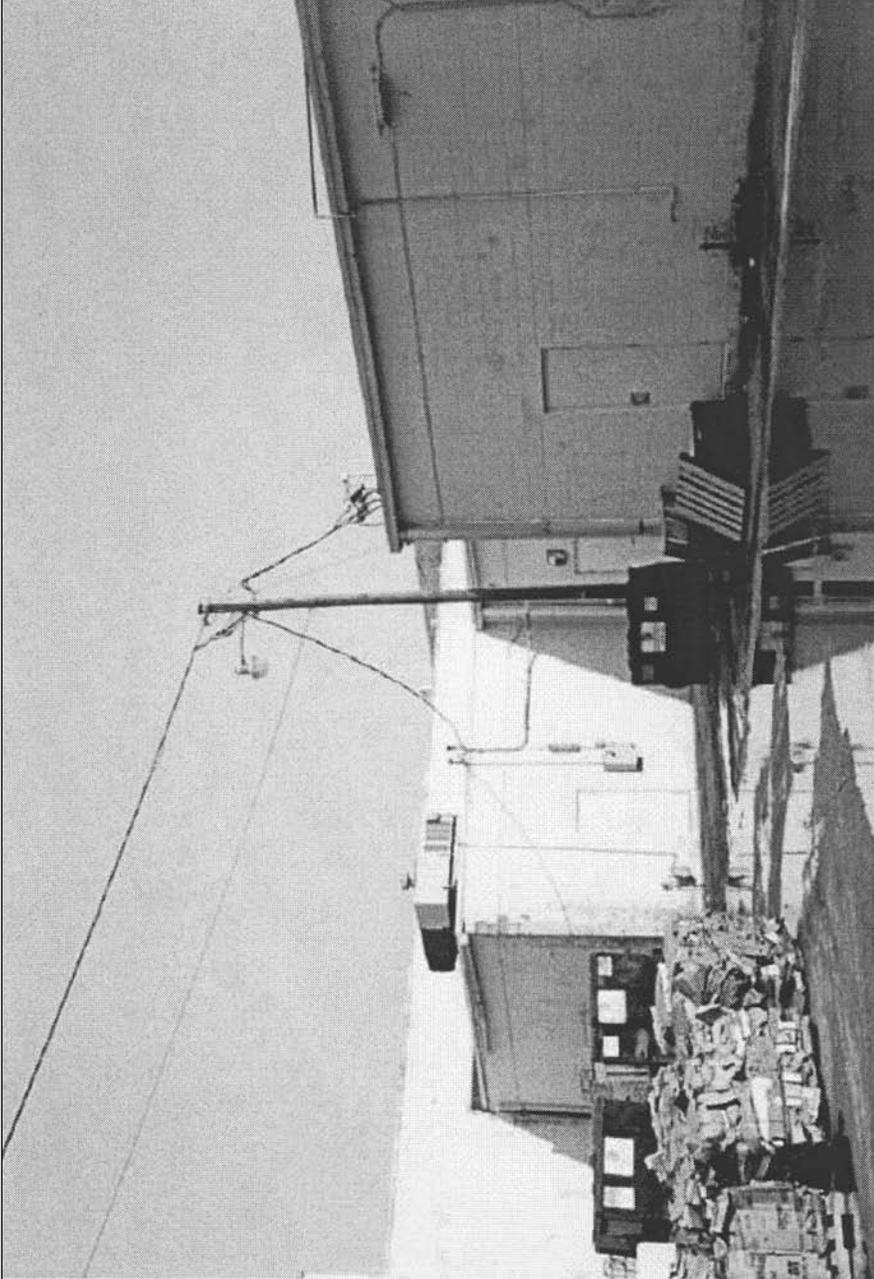
The fire was caused by the electrical short created when the power company truck struck the power line to the building. Investigation by the City of Chesapeake Electrical Inspector after the fire revealed that the meter contained wiring that appeared to have been tampered with and did not comply with the electrical code. Several connections at the meter had been doubled-lugged, connecting multiple wires to single terminals. Additional investigation by Virginia Power revealed that the building may have been improperly grounded, leading to numerous hot connections when the short circuit occurred. The main fuse did not trip at the breaker panel and the wiring on all three air handling units had been fused. This probably resulted in the ignition of multiple spot fires in the truss loft above the store.

Utility pole connecting power to a meter at the rear of the Indian River Shopping Center.  
(USFA file photo).

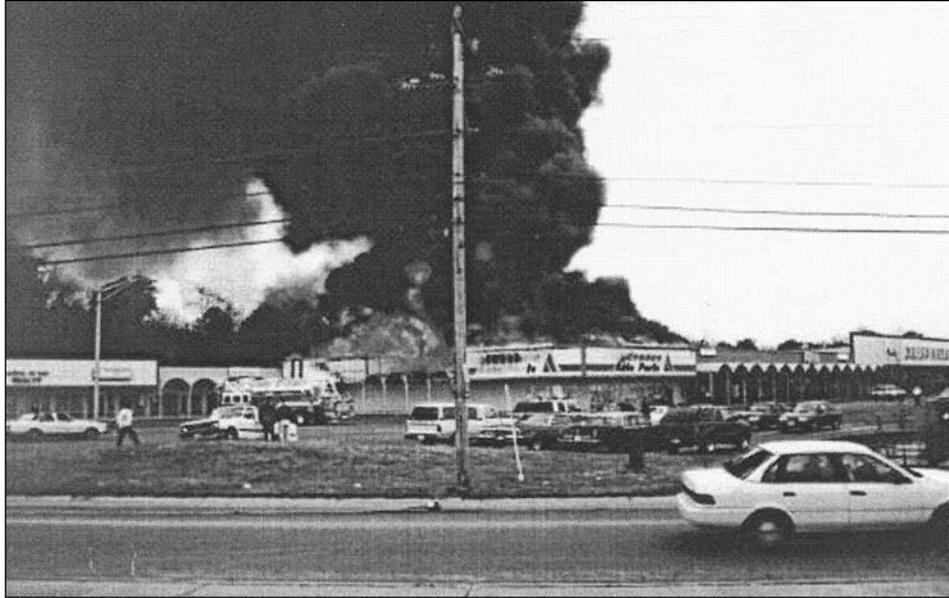
**Ladder 2 is shown in its initial position on side two. Time of the photo is estimated between 11:50 and 11:52 a.m. (Photo courtesy of Chesapeake Fire Department).**

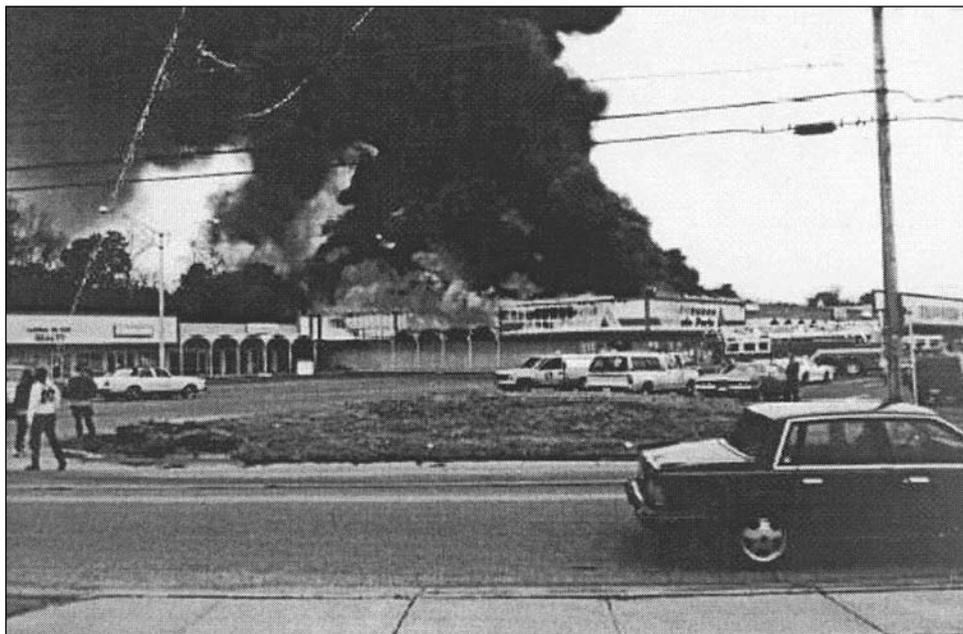
**Ladder 2 is shown in position on side one. Time of the photo is estimated at 11:52 a.m. The supply line in the front of the picture is from Engine 1. (Photo courtesy Chesapeake Fire Department).**
