# Five Fatality Residential Motel Fire

Thornton, Colorado

USFA-TR-104/January 1997

# **Five Fatality Residential Motel Fire Thornton, Colorado**

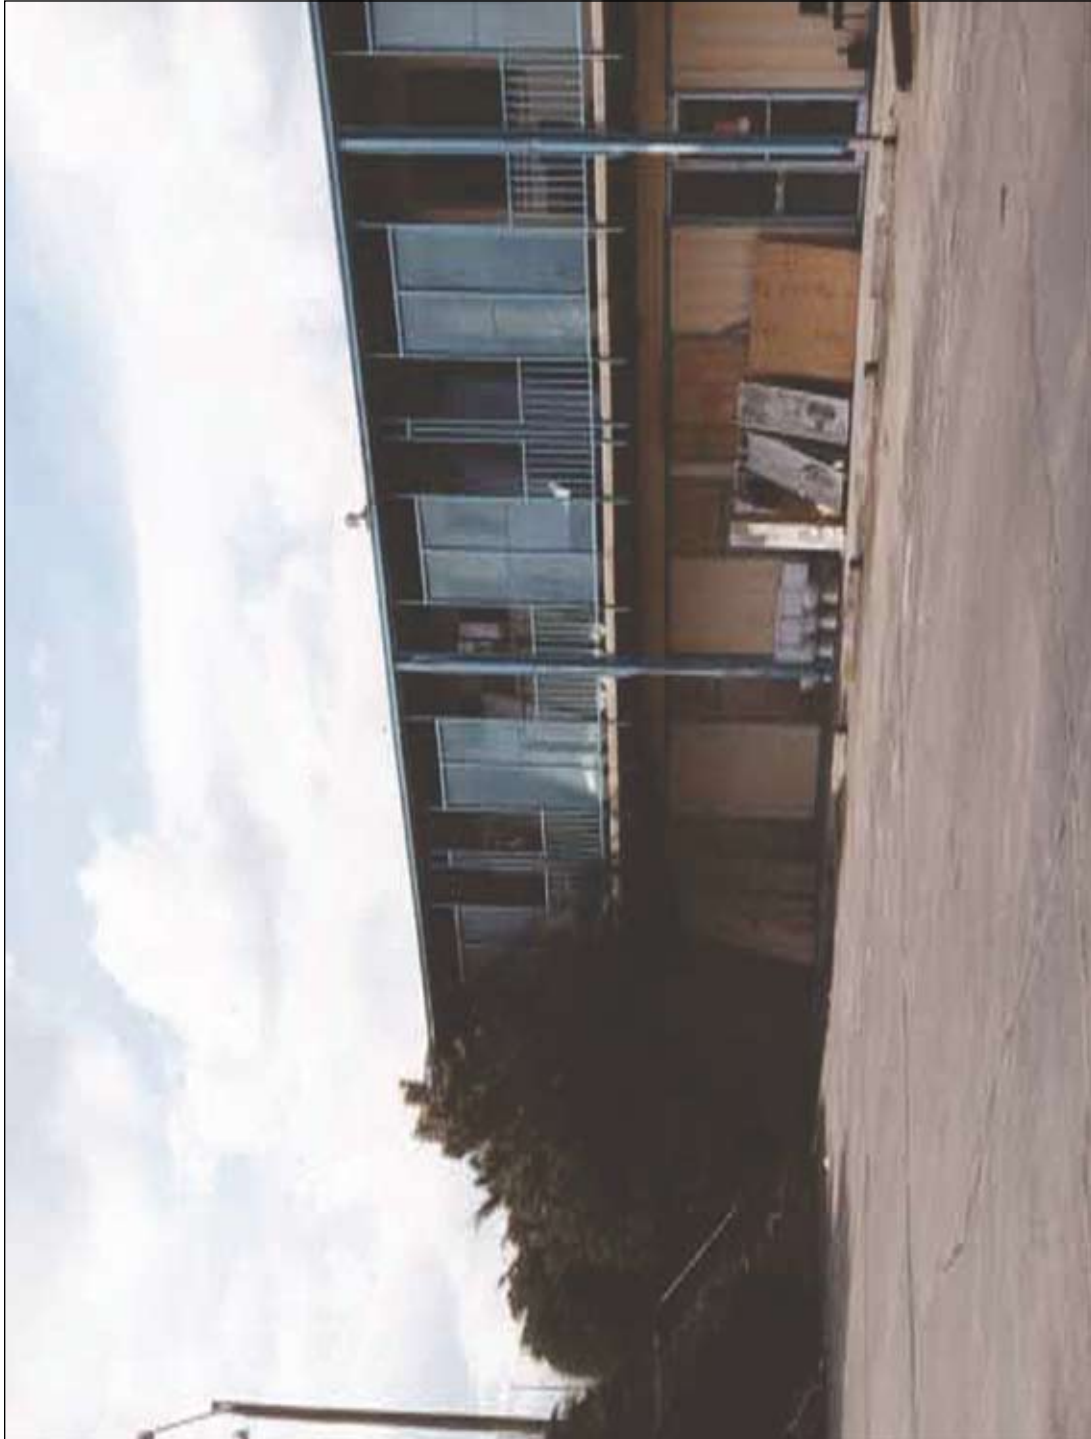
**Photo 1. Southwest corner of the front wing looking northwest. The 100 level, commercial and offices, and the 200 level guest rooms are shown. The pine tree shields the entrance to the stairway and storage closet which was the point of origin.**

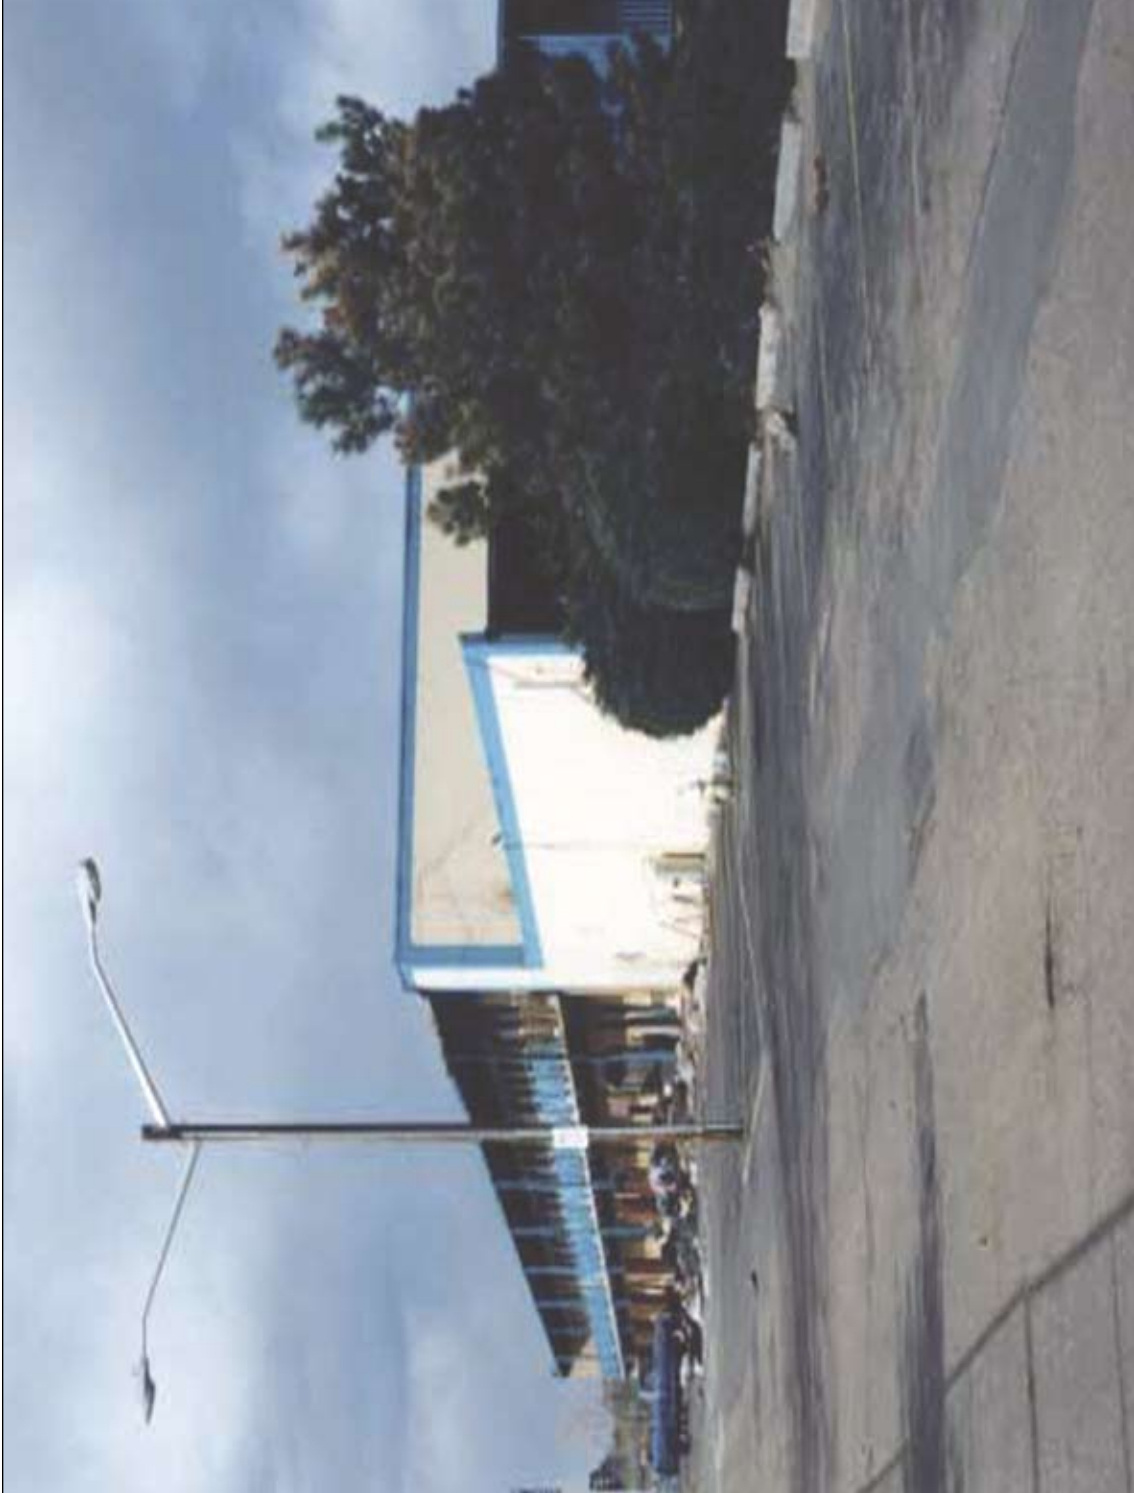
Photo 2. The west side of the property looking north. This is the 200 and 300 level guest rooms of the west wing and the end of the front wing. Engine 67 used the fire hydrant to the right of the light pole.

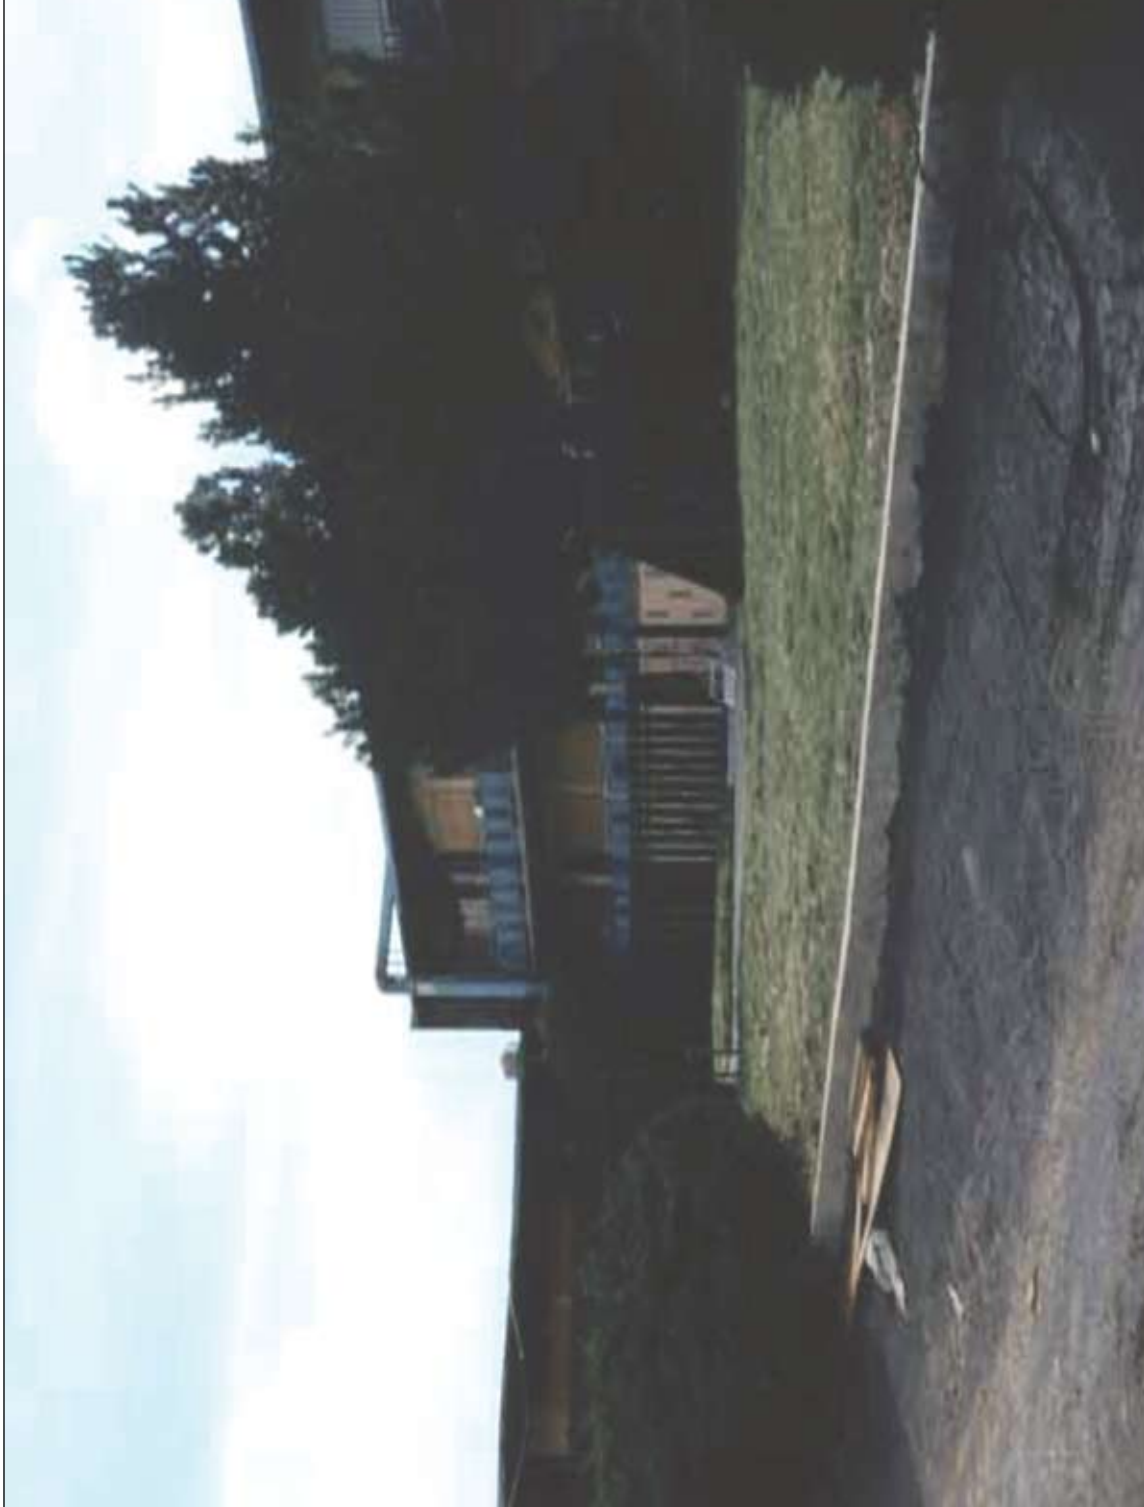
Photo 3. The inside corner of the junction between the front and west wings; part of the U shape. This illustrates all three levels of the property and the grade change.

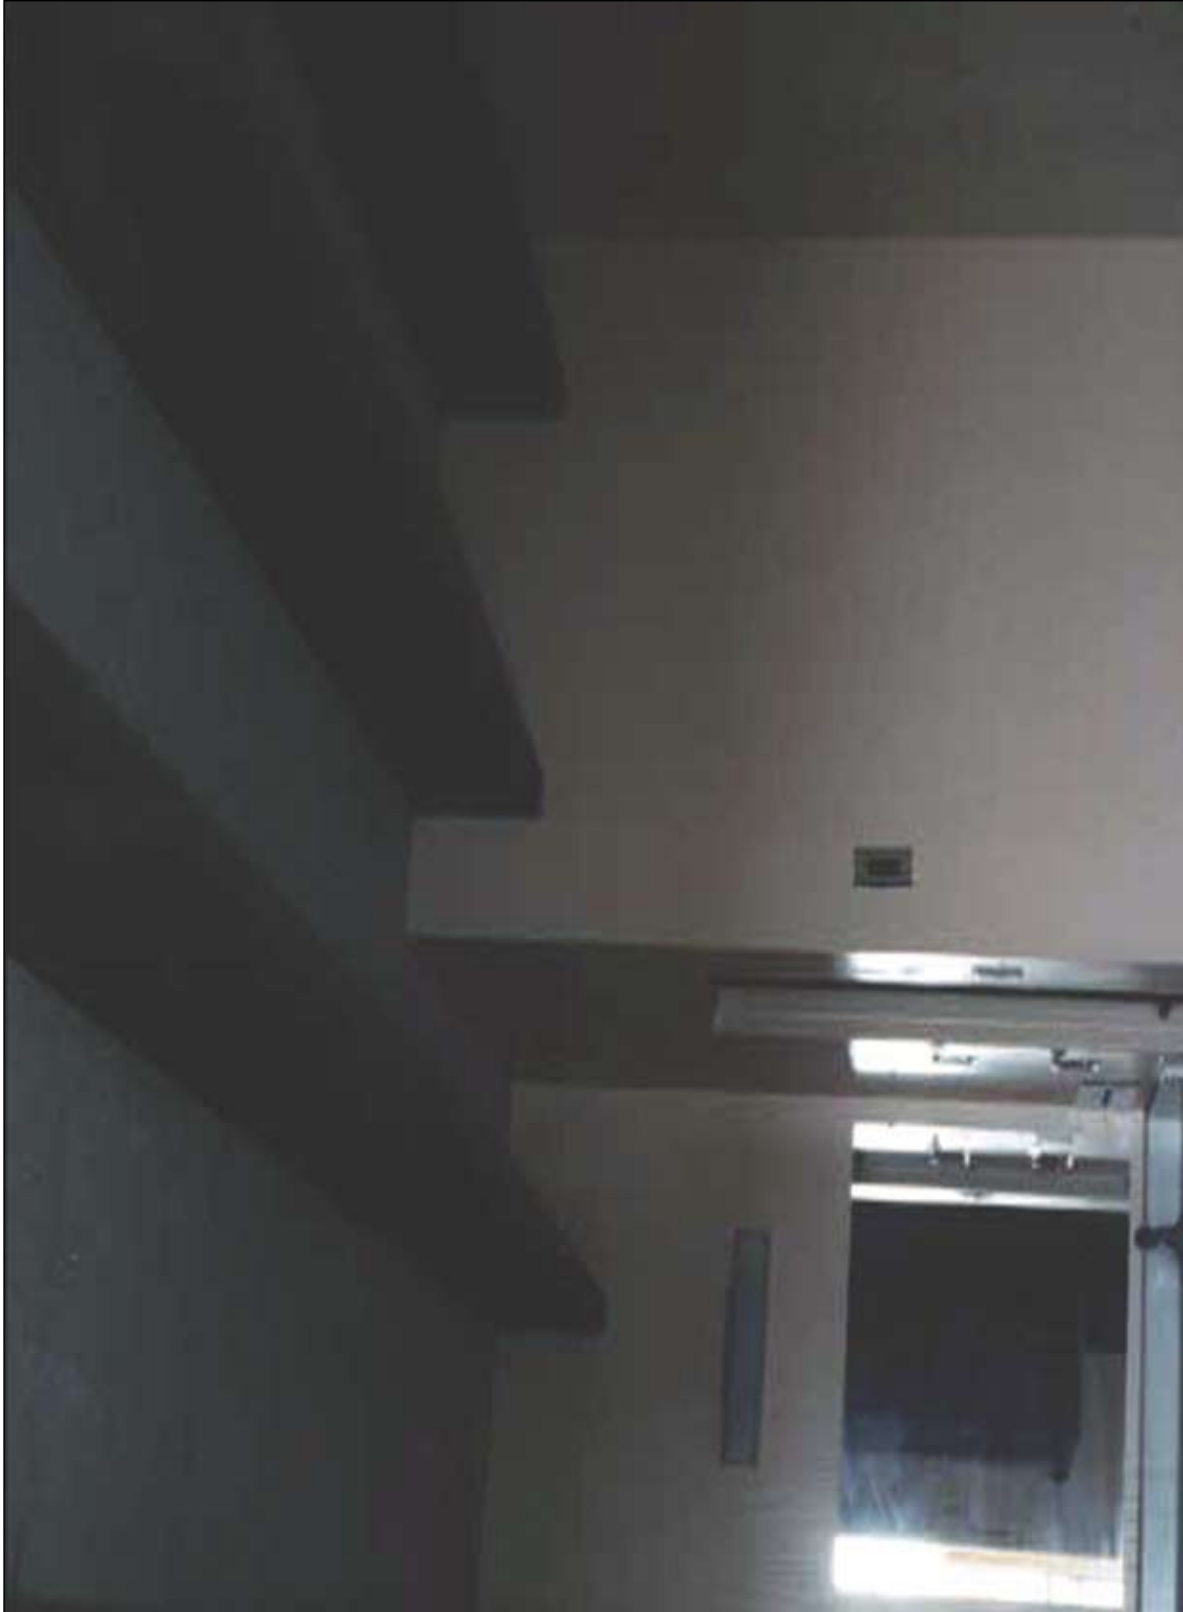
On the first floor of each wing, parallel masonry block walls formed the lower part of a two story utility chase between back to back guest rooms. These block walls supported the second floor in the middle of the building. This floor consisted of concrete on Tectum board<sup>1</sup> which was supported by 4 x 12-inch wood beams about 34 inches on center. (See photograph 4.) The beams rested on the chase and outside walls.

Photo 4. Typical guest room ceiling, bathroom, and sink of the utility chase wall.

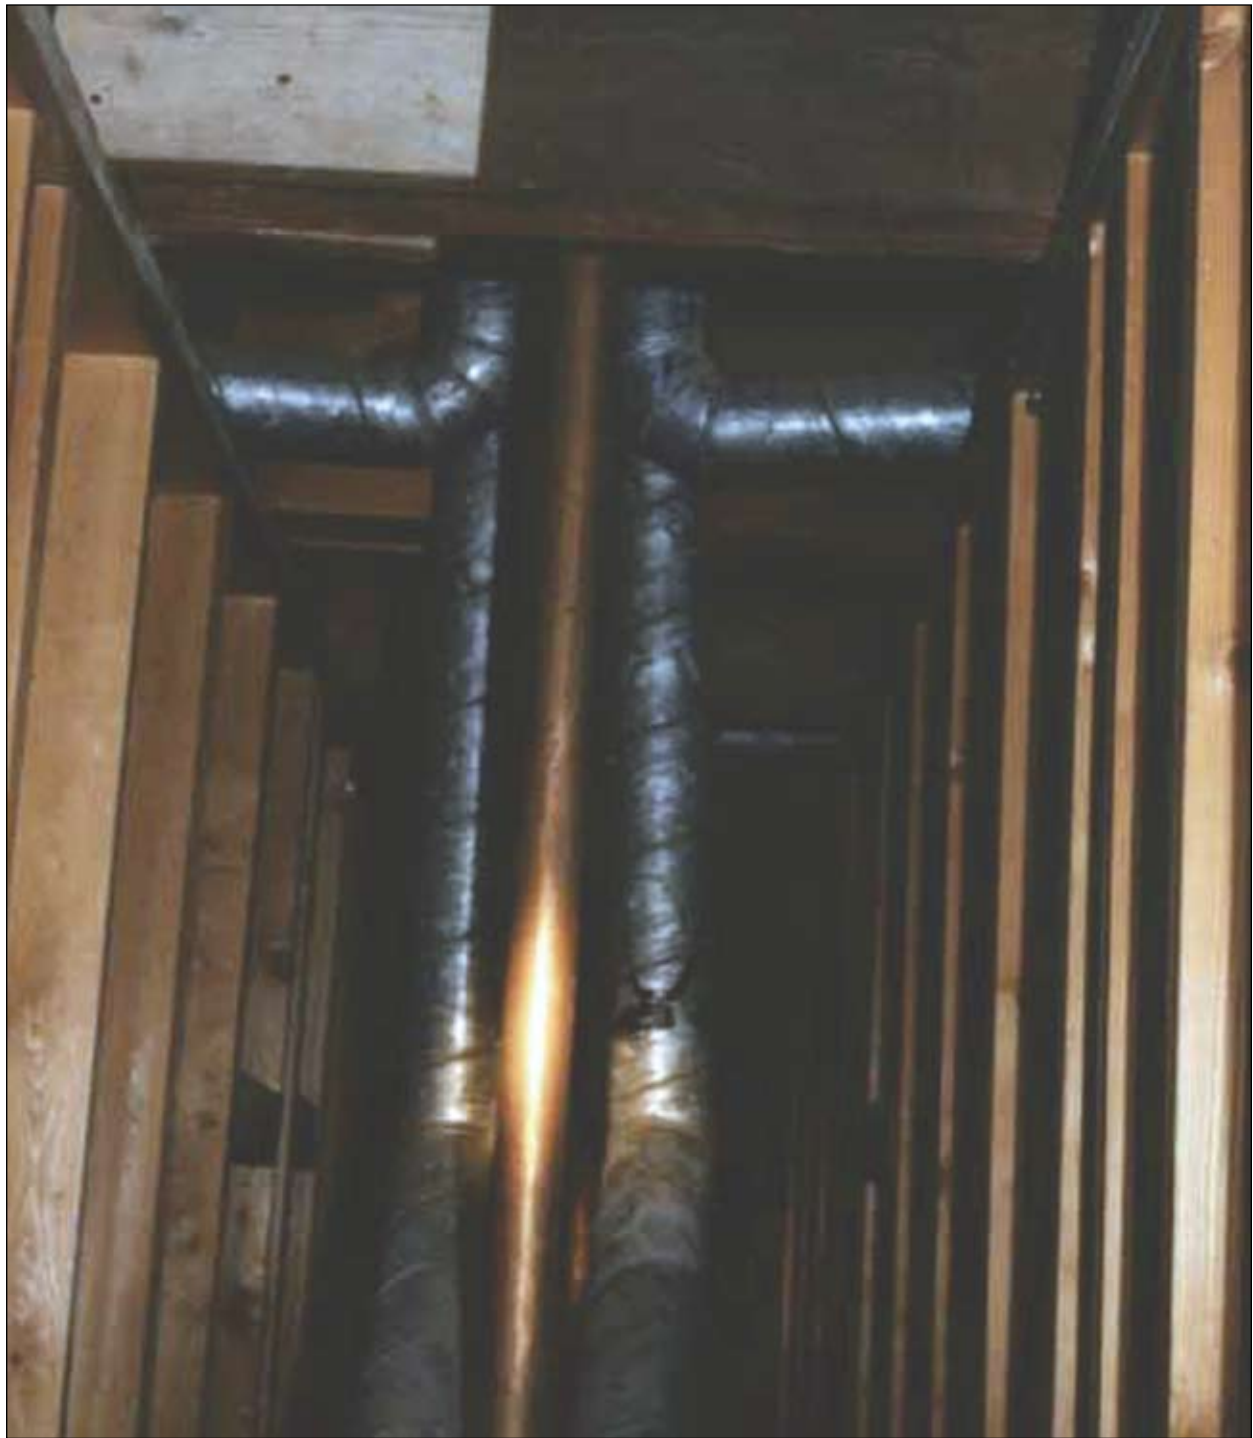
On the second floor, the utility chase was constructed of parallel 2 x 4-inch wood stud walls covered only on the guest room side only with drywall. (See photograph 5). The chase walls formed the center support for the 4 x 12-inch wood roof beams which were spaced about 34 inches on center. The beams held up a light weight roof consisting of Tectum board<sup>1</sup> covered with a hot mopped asphalt built-up gravel topped roof covering. (See photograph 6.)

The utility chase was not smoke or fire stopped either vertically or horizontally within the chase. In addition, the chase was not separated by fire resistance rated construction from the guest rooms. Even the first floor hollow concrete block walls were not completely separated from combustible concealed spaces in the guest rooms. On the second floor, the wood studs were exposed in the utility chase providing a fuel source for the fire to move horizontally inside. As the wood studs failed, or the fire found openings in the gypsum board wall, the fire was able to enter the guest rooms, especially where fuel was available in the room near the utility chase wall. Several guest rooms were gutted by fire in this manner. The recognition of combustible concealed spaces is an important part of the pre-incident plant process. Fire companies or fire protection staff need to carefully investigate the building's construction and physical arrangement to identify potential concealed spaces. The more difficult task is developing and implementing actions to mitigate construction deficiencies such as lack of smoke and fire stopping, exposed combustible materials or lack of fire resistance rated separations.

**Photo 5. The interior of the utility chase between rooms showing the second floor wall construction and the wood beams supporting the roof.**

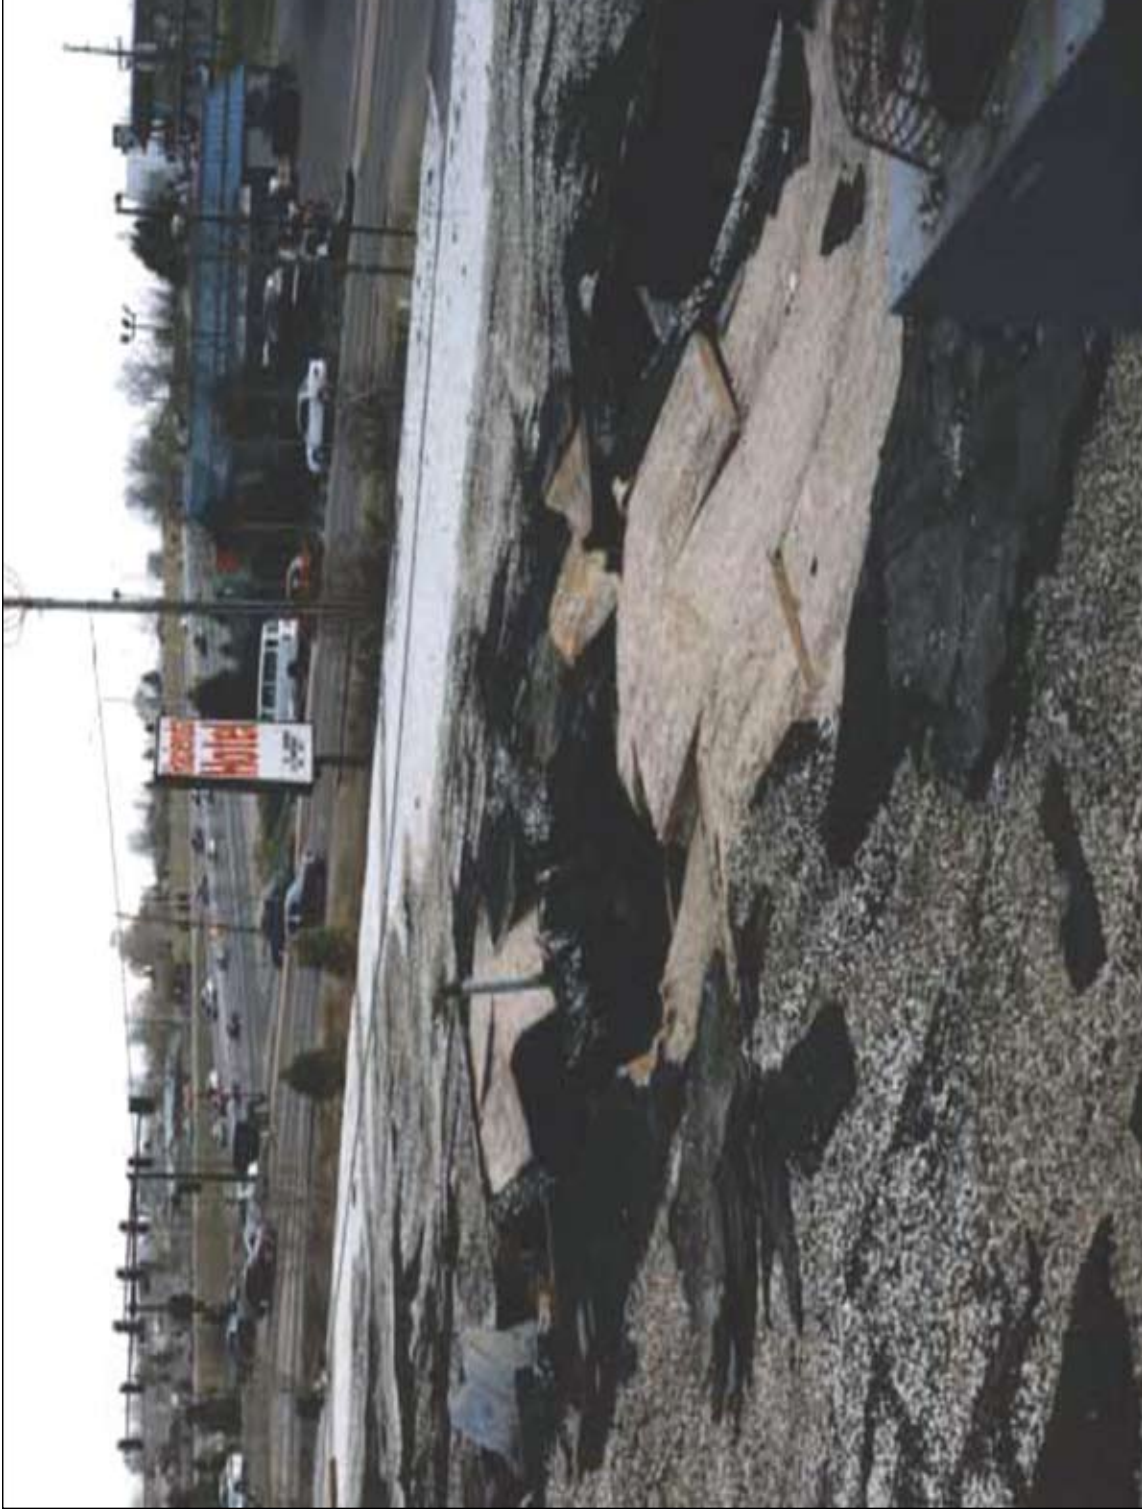
Photo 6. Roof over the front wing. The collapsed area is above the utility chase. The roof construction of Tectum board, built-up roofing, and gravel topping is illustrated.

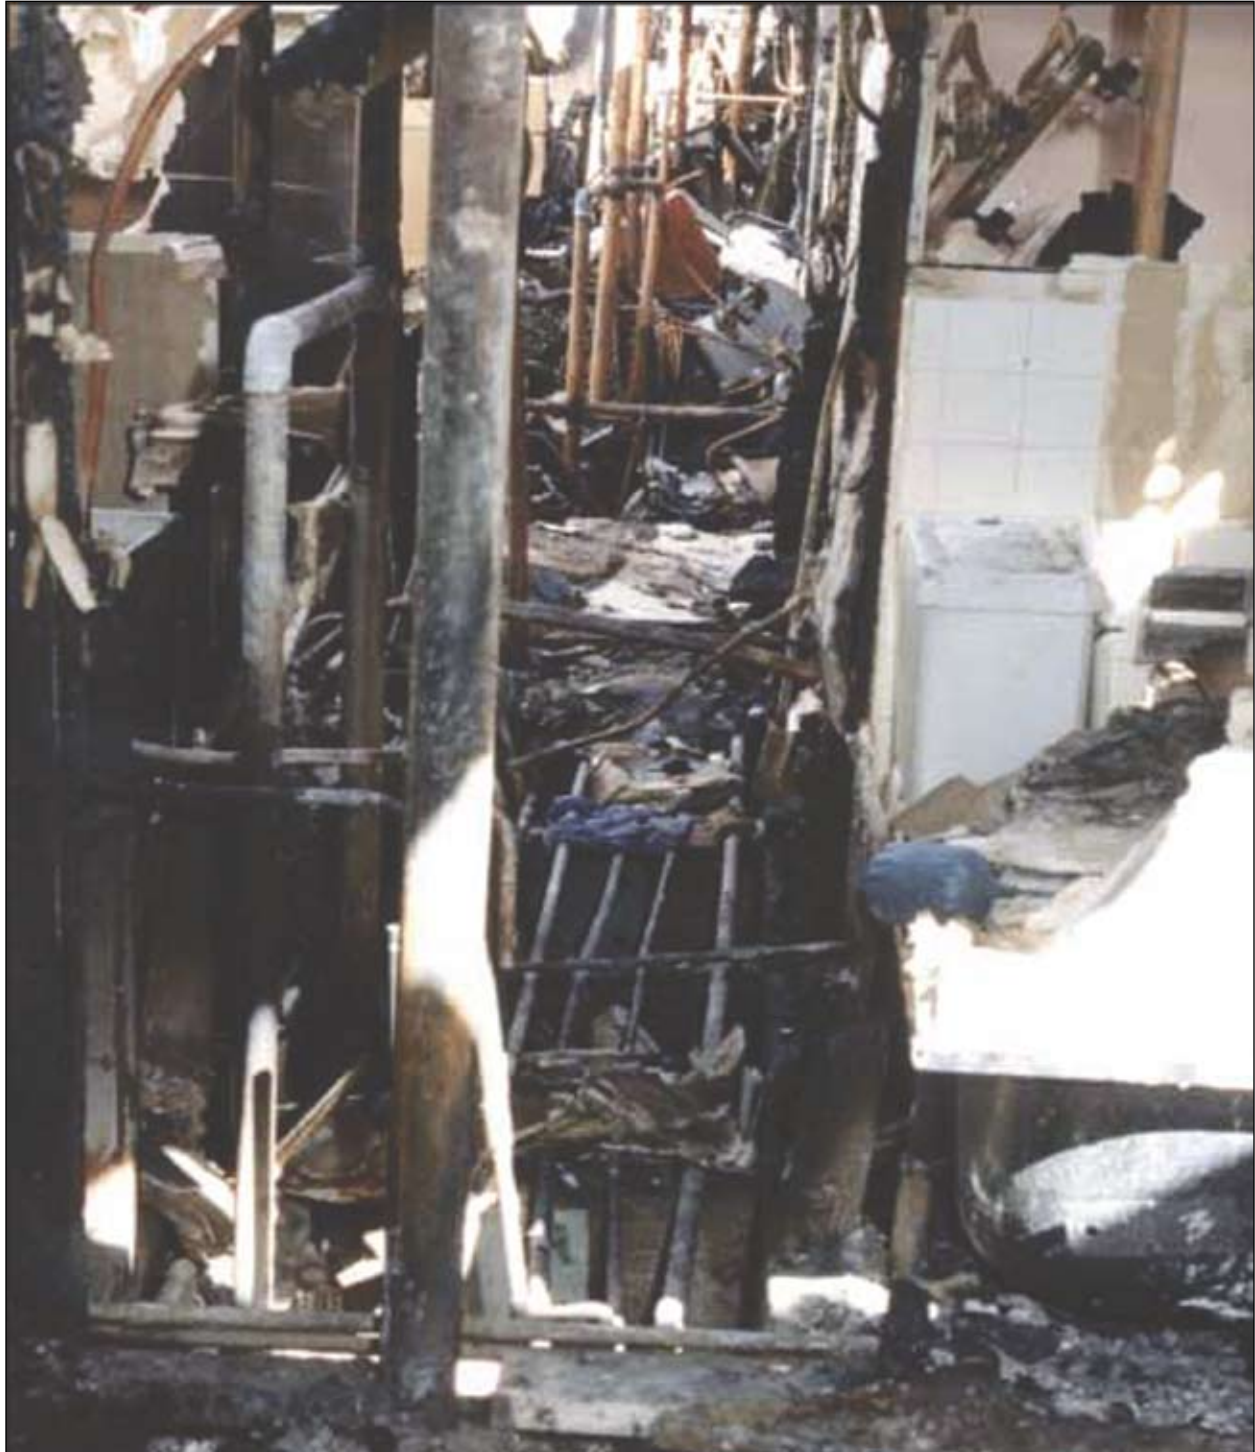
While the fire was essentially contained to the front wing, it was burning within the entire length of the utility chase. The fire broke out of the chase at several locations on the first and second floors. Inside the utility chase, the exposed 2 x 4-inch wood studs were heavily damaged the entire length and the studs near the west end were totally consumed by the fire. This resulted in the roof collapsing over almost the entire length of the chase. Partial roof collapse also occurred over Rooms 219 to 222 and at the rear (by the utility chase) of Rooms 208 to 211. The fire entered several rooms on the second floor, consuming most of the rooms' contents. Yet adjacent rooms were not heavily damaged.

**Photo 7. The west end of the utility chase in the front wing. Room 222 is to the left and Room 211 to the right. The second floor utility chase walls were burned away.**

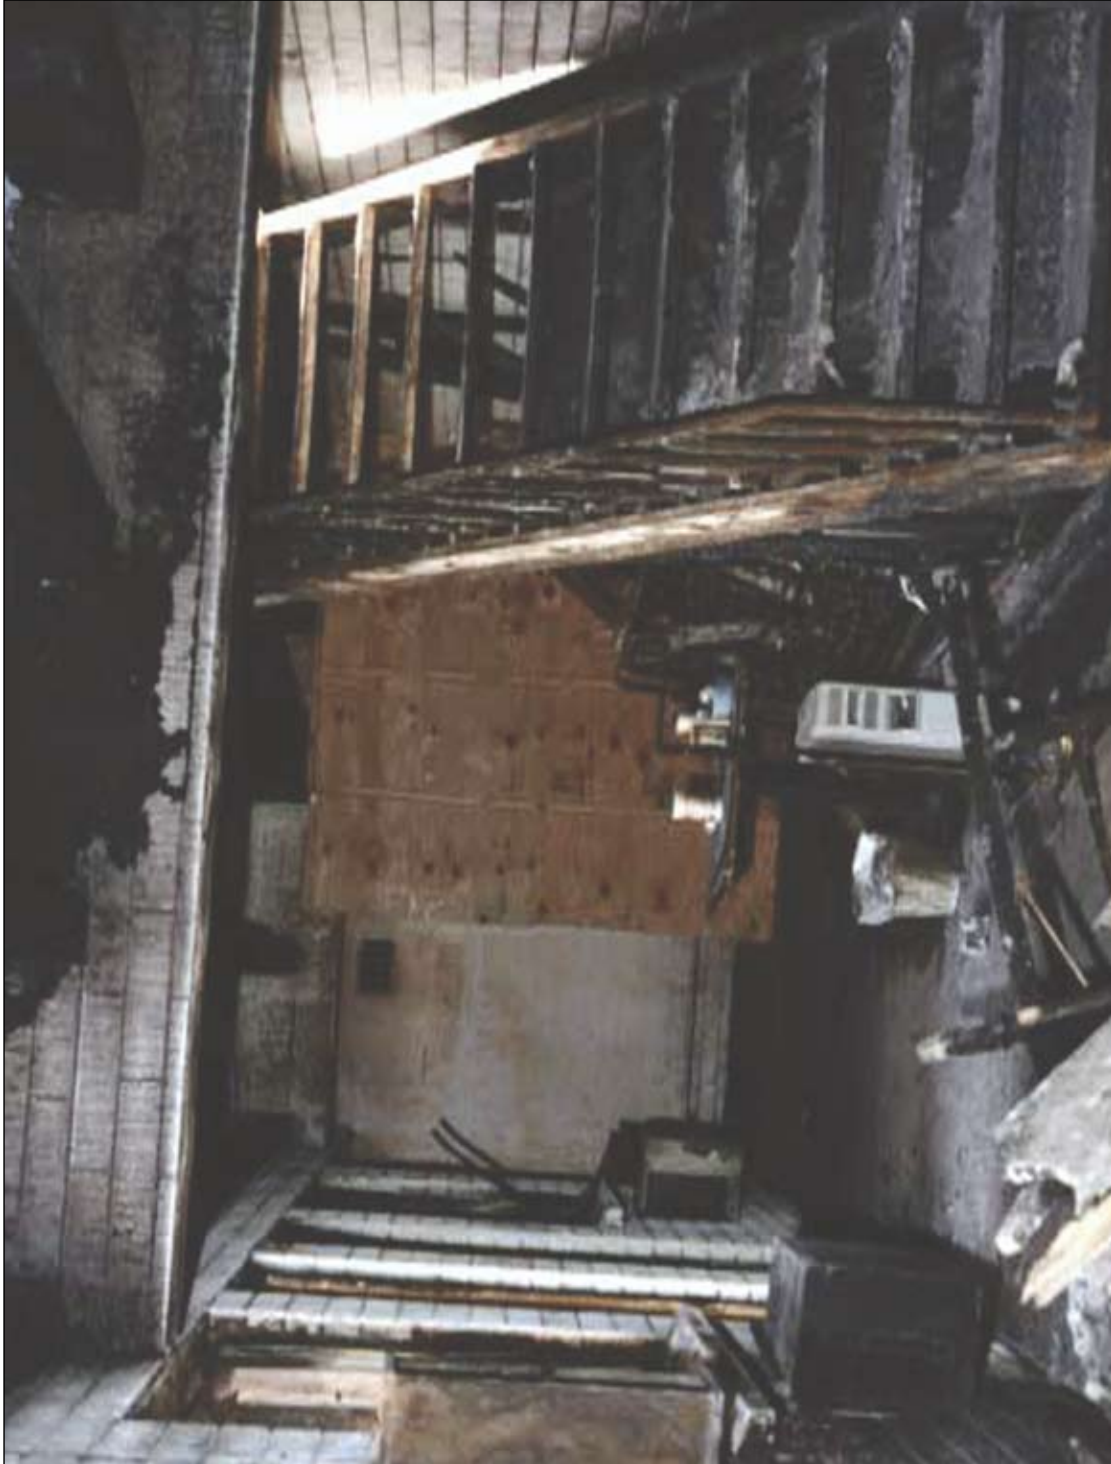
Photo 8. The 200 level breezeway area outside of Rooms 220 to 222 looking west. The open stairway to the 300 level is on the right. Under the stairs is another storage room whose wood stud and gypsum board walls were destroyed by the fire.

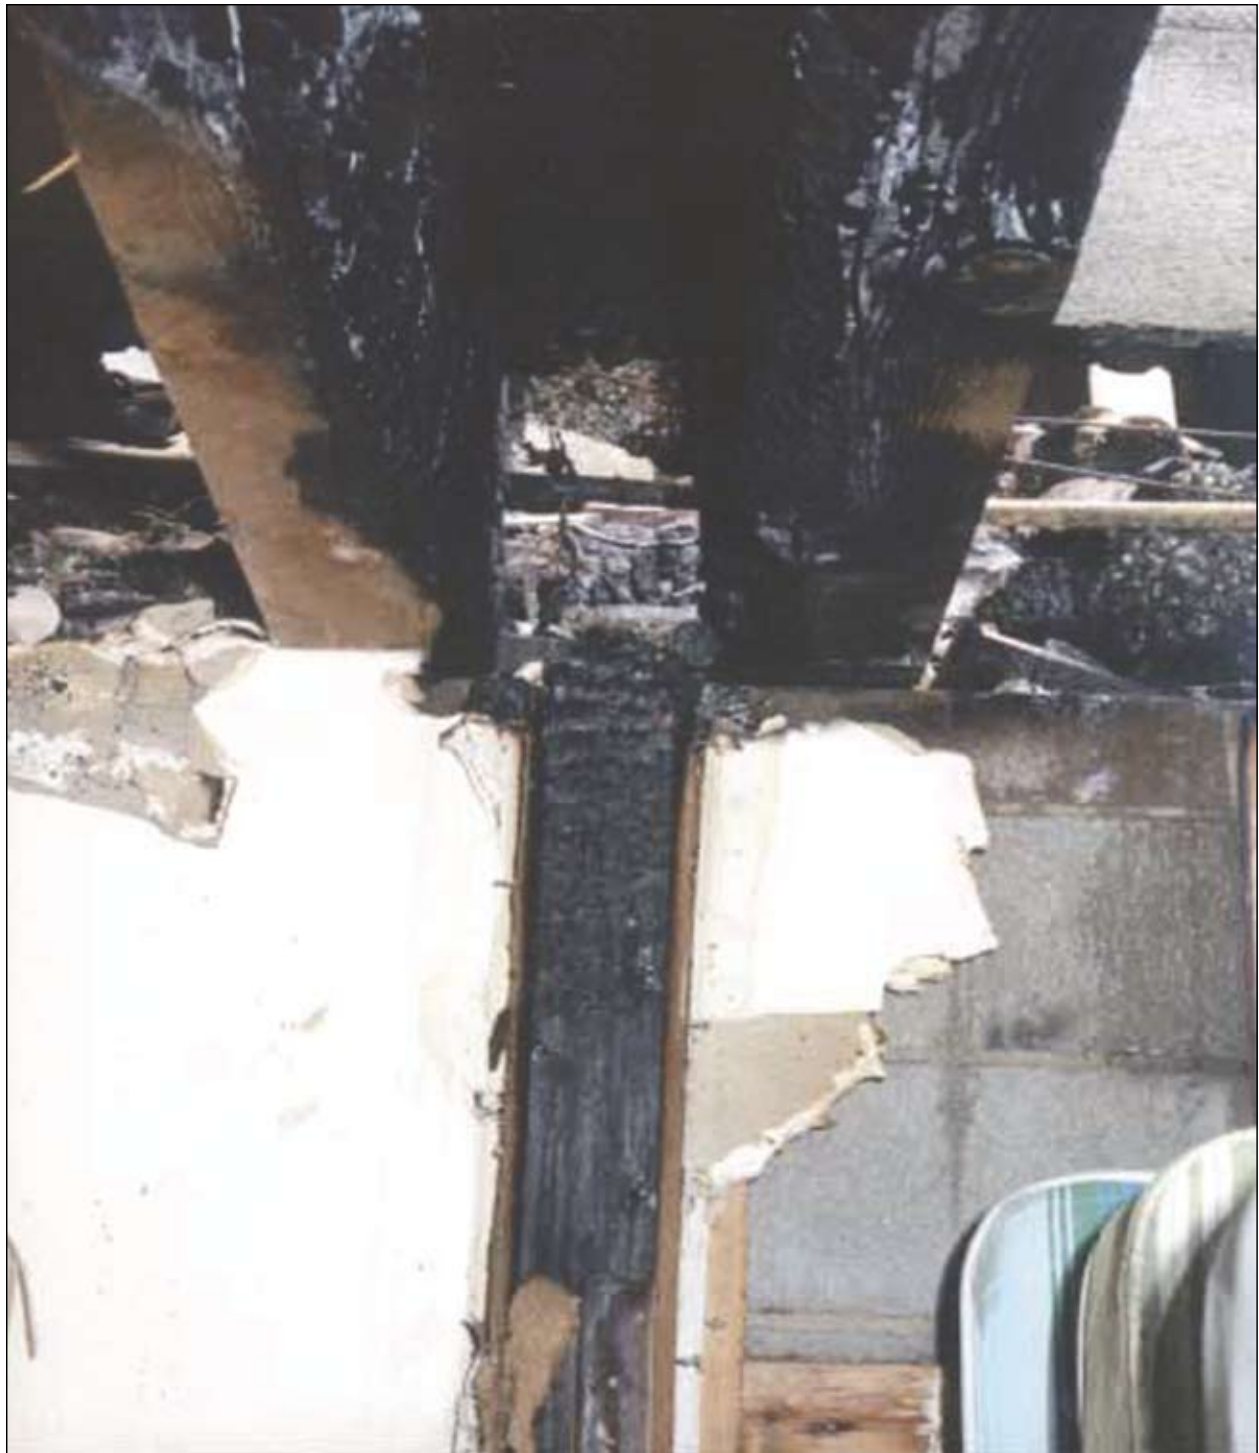
On the first floor north side, the fire followed along the wood construction in the separator walls between rooms, consuming the 2 x 4-inch wood studs from the inside out.

**Photo 9.** A separation wall between 100 level guest rooms that was burned from the inside out. The parallel wood beams formed the top of the wall and the communication to the utility chase is at the back.

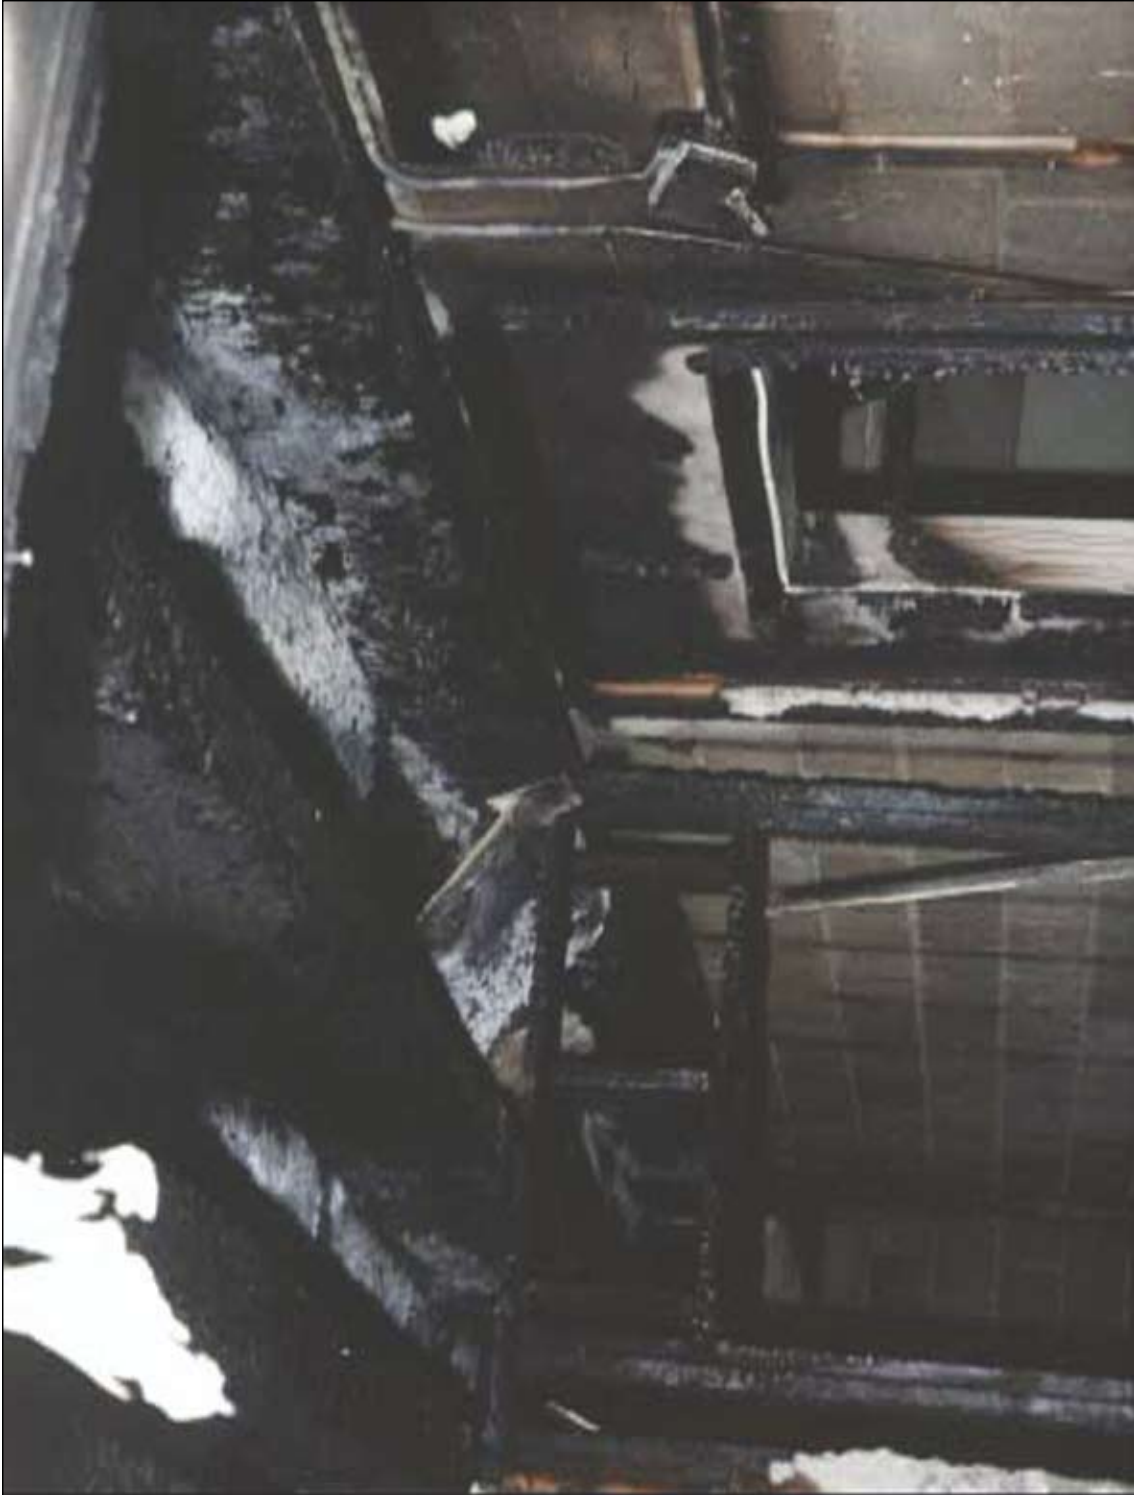
Photo 10. The top of the door frame for the 100 level closet determined to be the point of origin. The open stairway to the 200 level is to the top left off the photograph.

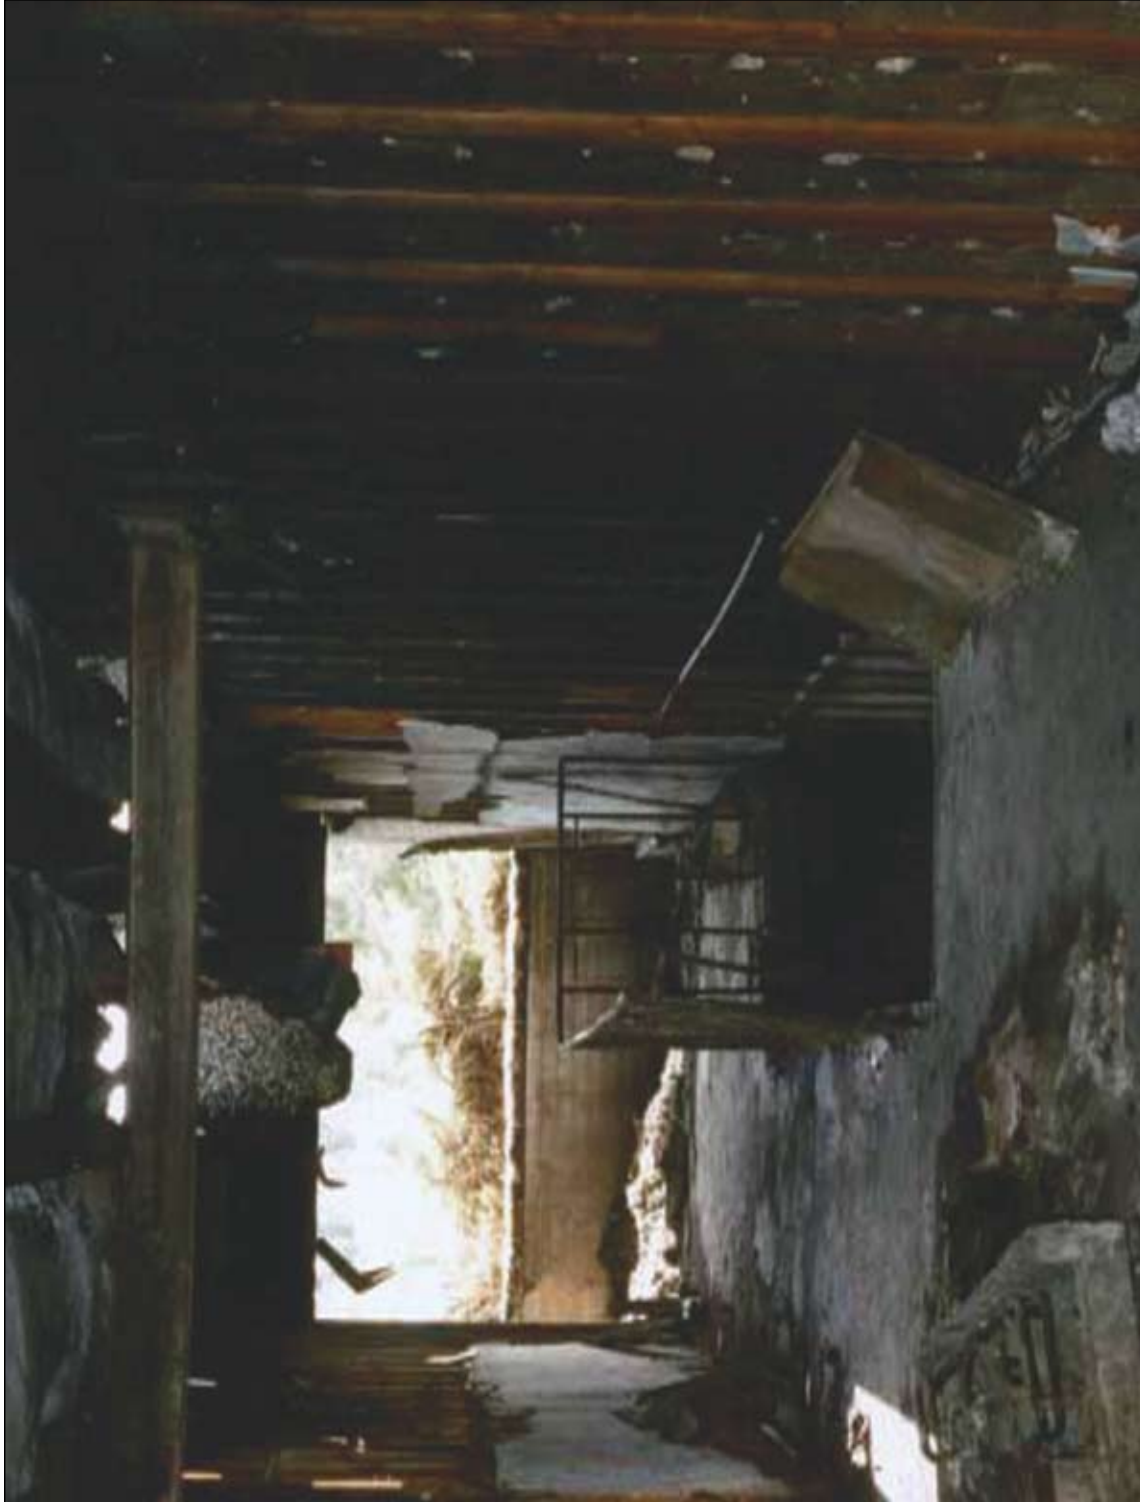
Photo 11. The top of the open stairway from the 100 level looking south. A glass in aluminum frame wall enclosed this area just before the partial height brick wall in the background. Room 222 is to the left.
