U.S. Fire Administration/Technical Report Series

Old Buckingham Station

Chesterfield, Virginia

USFA-TR-105/May 1995

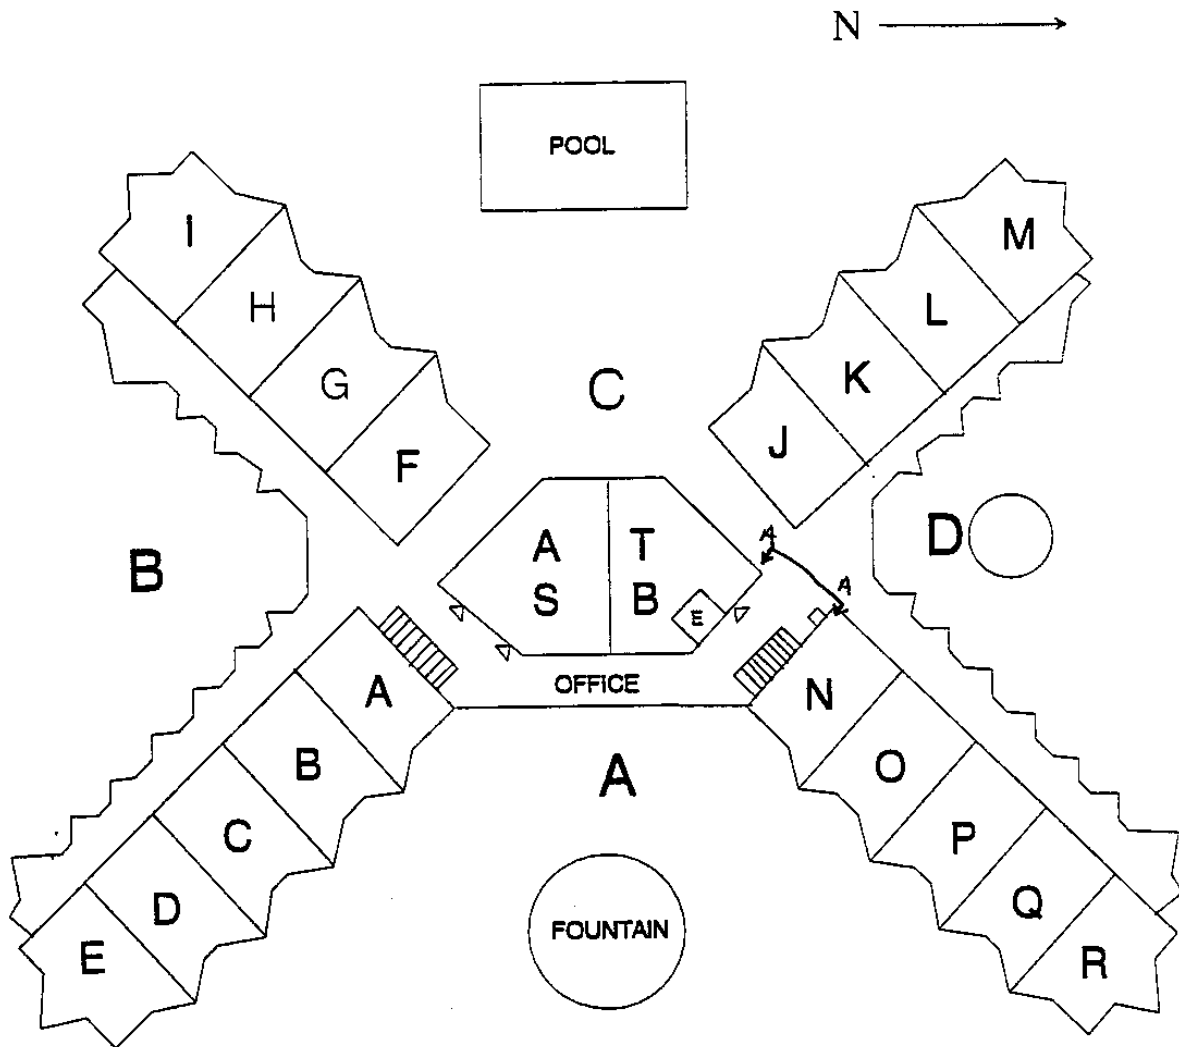
Lodge Building

Fire investigators determined that the fire began on the second floor in a covered walkway between the northeast wing and the center core, just outside of apartment 2J. (See Appendix B for location.) The cause was identified as an exterior light fixture that had been inverted from its usual operating position by one of the occupants and then wrapped with a flannel shirt to reduce the light intensity into their bedroom. The fixture's incandescent bulb was enclosed by a clear plastic globe. By inverting the fixture, the vent holes, which were intended to remove heat from the 60-watt bulb, were out of position and the plastic globe in combination with the flannel shirt held in the heat. This eventually resulted in the ignition of the shirt and the light fixture's plastic globe. The fire spread to the vinyl plastic siding and to the wooden stairway.

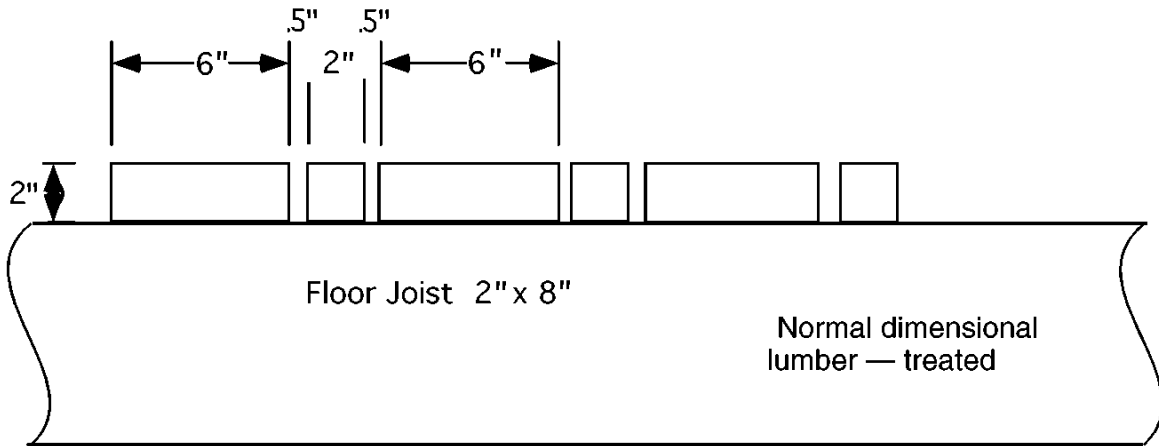
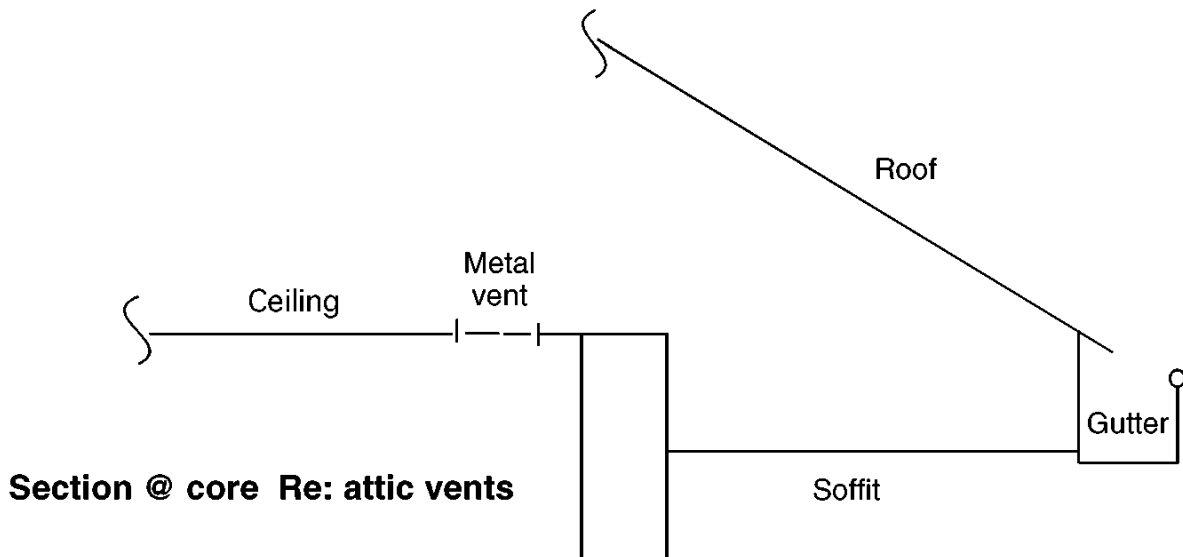
Construction Details

The floors were 2 x 4 parallel cord trusses 18 to 24 inches deep supporting a plywood sub-floor that was topped with a thin (about 1-inch) layer of lightweight concrete. Gypsum board ceilings were attached directly to the bottom cords of the truss. The roof was constructed of a chip board deck over peaked wood trusses made from 2 x 4 and 2 x 6 members. The truss span was approximately 40 feet with a peak height of 13.5 feet and an 8/12 pitch. The roof contained a ridge vent and continuous soffit vents were provided around the perimeter of the building. (See Appendix C for soffit vent details.)

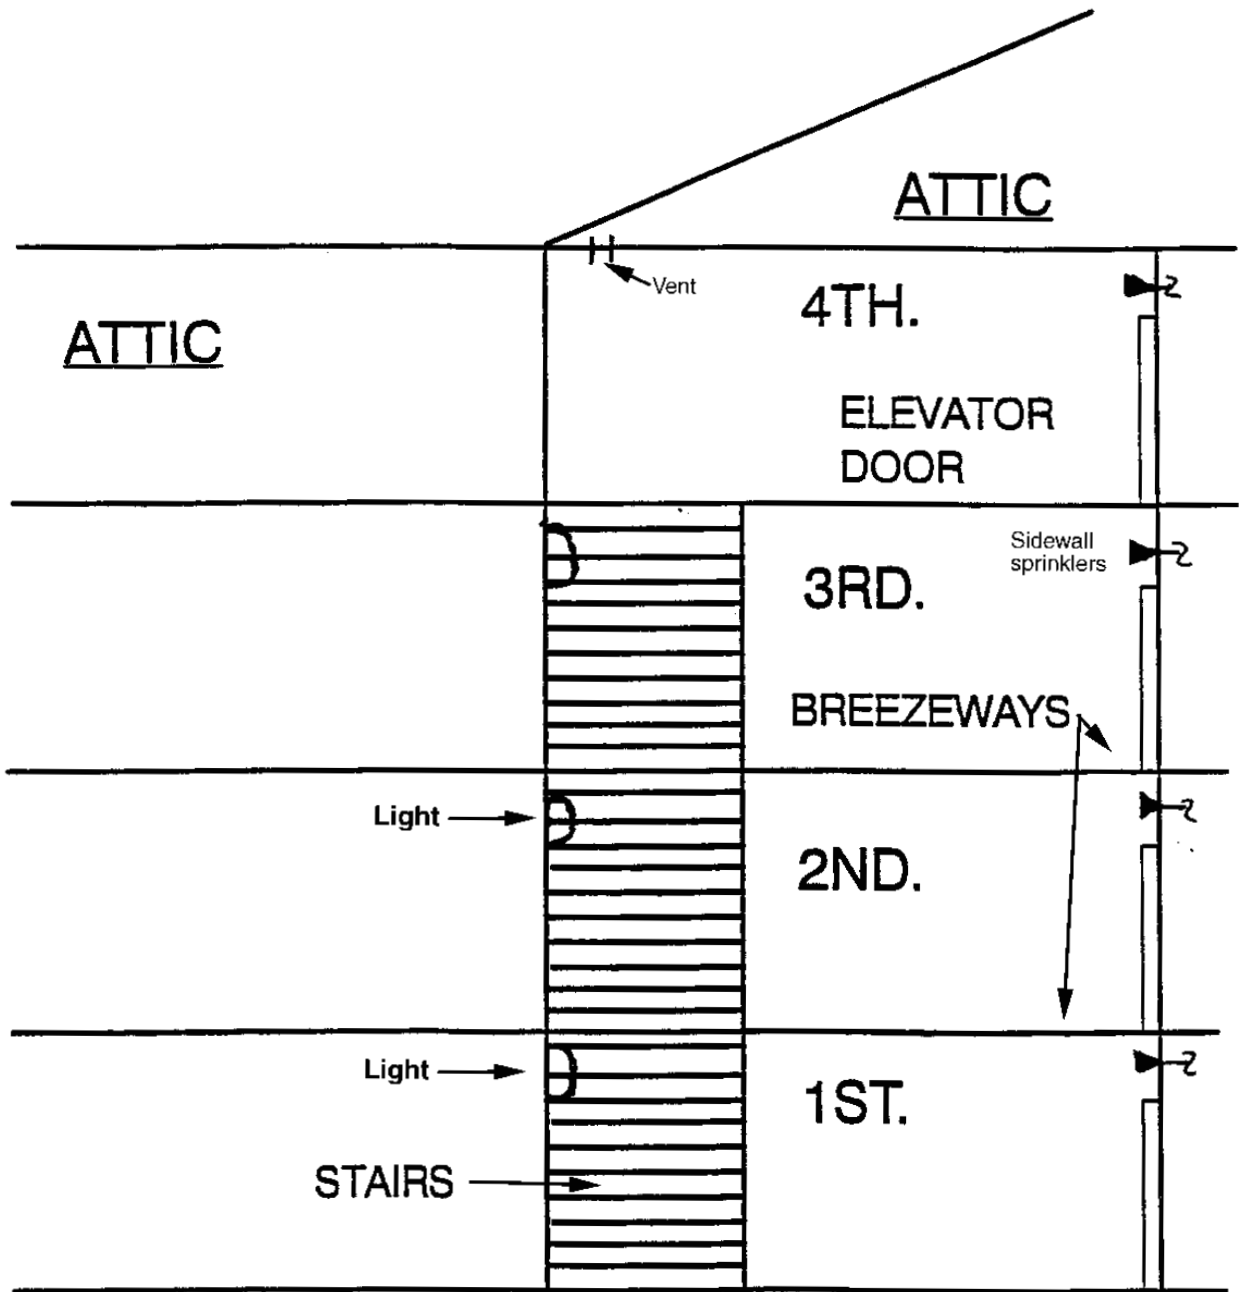
Section at Core Walkway, Lodge Building

The siding fire quickly moved up the nearby open, wooden stairway before the sidewall sprinkler on the wall opposite the light fixture was able to operate. (See appendix E for Section Drawing.) The fire continued to burn upward until it reached the ceiling of the fourth floor open walkway. At this point it entered the combustible attic through a vent opening at the outside perimeter of the ceiling. The soffit vents in the fourth floor core area were located inside, rather than outside, the perimeter support beam for the roof. This design contained the heat and flames at the fourth floor ceiling and allowed them to pass through the vent into the unprotected combustible attic. Once in the attic, the fire was out of reach of the exterior sprinkler heads.

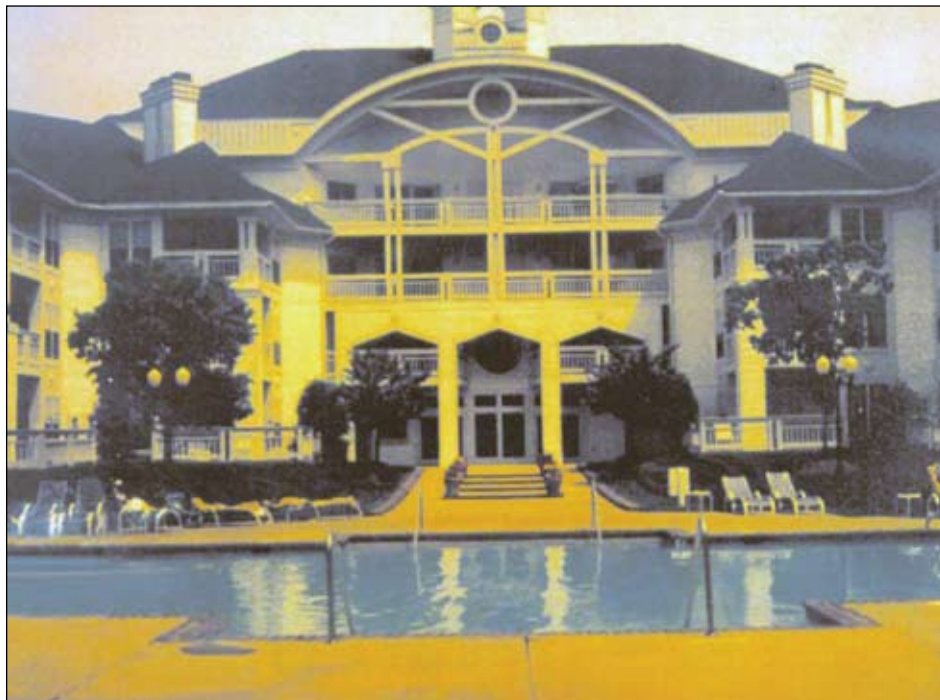
Photo 4. The rear or swimming pool side of the four story core building before the fire. The fire started on a second floor breezeway on the left side of this photograph.

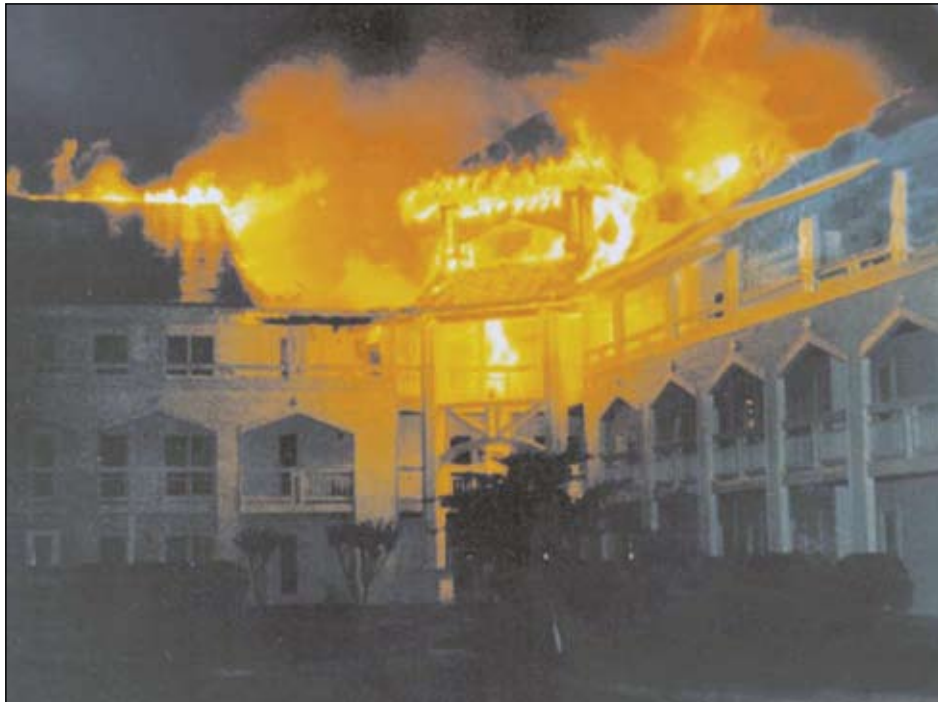
Photo 5. Fire involvement in Sector D (North side) as units were preparing to operate in this sector. The fire was well-established in the attic, third floor walkway, and fourth floor.

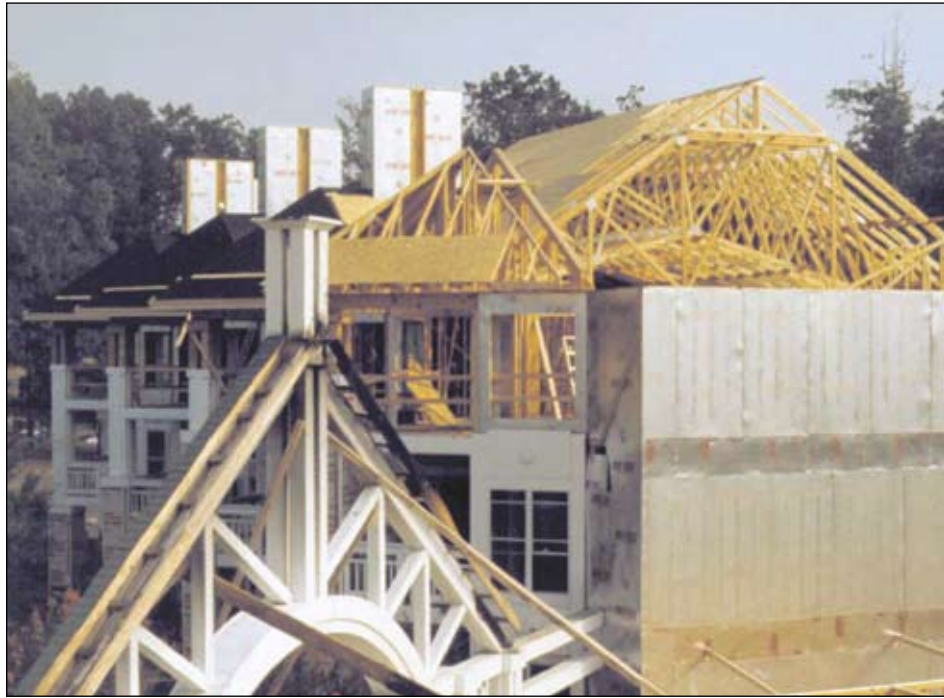
Photo 7. The remains of the front archway and the repairs and reconstruction underway for the wing in Photograph 6. The attic trusses and exterior sheathing materials are illustrated.

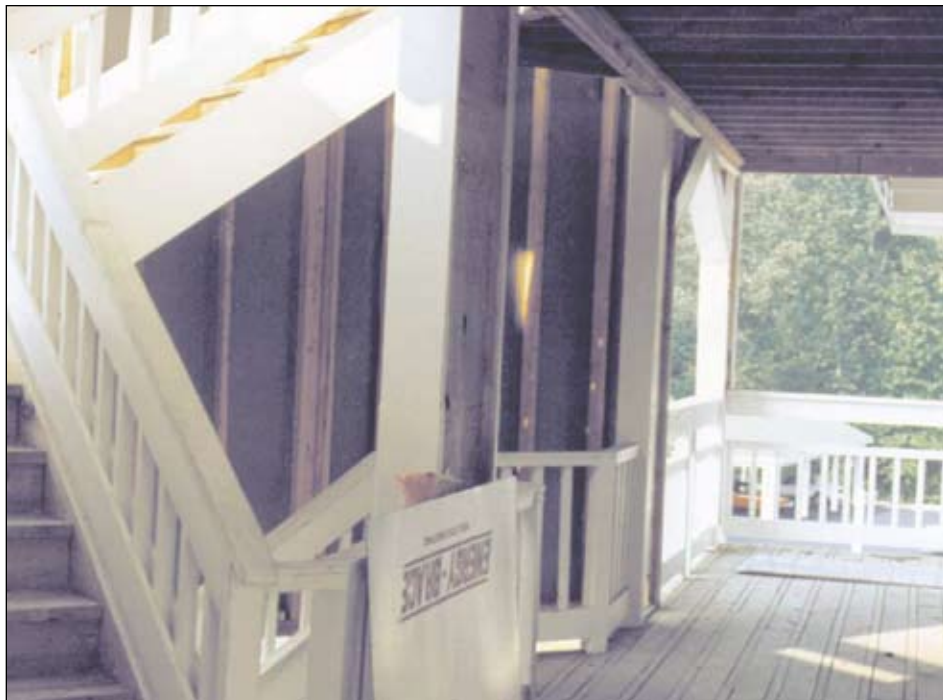
Photo 10. The stairway and exterior walkways used throughout the building. Note the gaps in the walkway to allow water to drain and the piece of thin exterior sheathing leaning against the stairway.

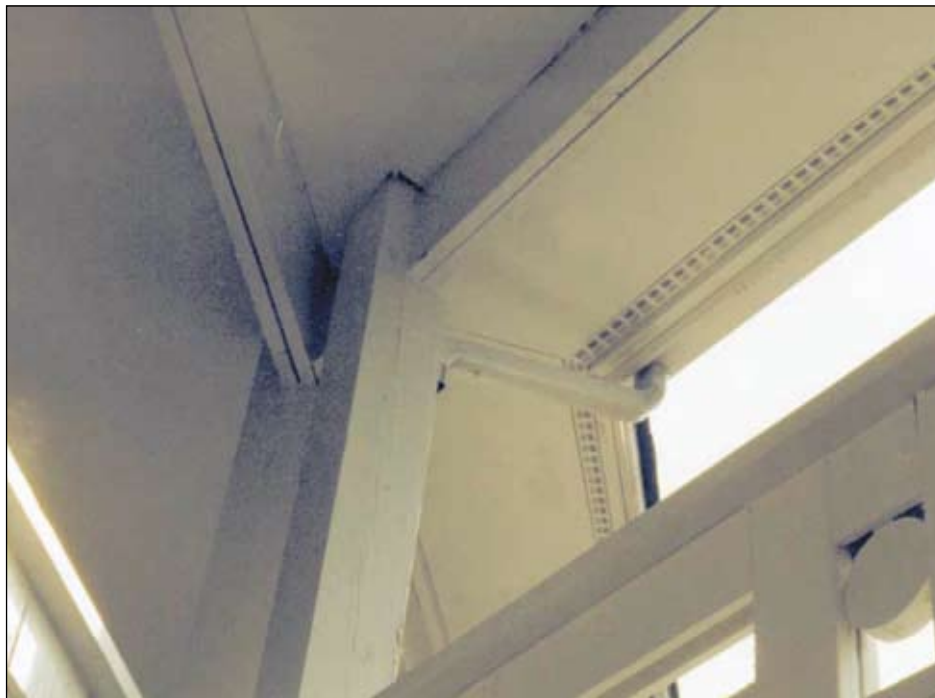
Ventilation Openings into Attic	Air vent openings at the building eaves permitted the fire to easily access the unprotected combustible attic space.
Fire Spread	The open combustible corridors and balconies and lightweight exterior wall finish supported rapid vertical and horizontal fire spread.
Delayed Fire Reporting	The exterior point of origin and time of ignition combined to cause a long delay in the discovery and reporting of this fire.
Access Limitation	The main body of the fire was on the side of the structure with restricted access. Swimming pool, fencing, and lack of roadways delayed the fire department's attack on this side.

Photo 11. Typical eave line vents installed around the perimeter of the building. The fire is believed to have entered the attic through these vents.

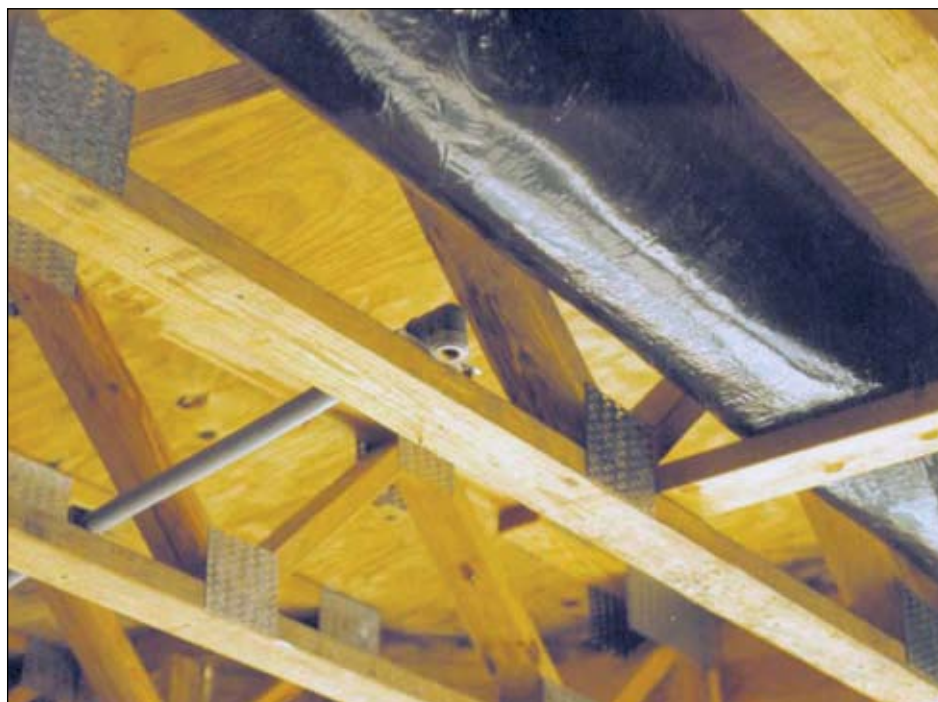
Photo 12. The parallel cord wood floor trusses used in the original construction and a polybutylene automatic sprinkler line.
