# Sprinklered Records Storage Facility

Chicago, Illinois

USFA-TR-106/October 1996

**Sprinklered Records Storage Facility**  
**3033 North Knox Avenue**  
**Chicago, Illinois**  
**October 29, 1996**

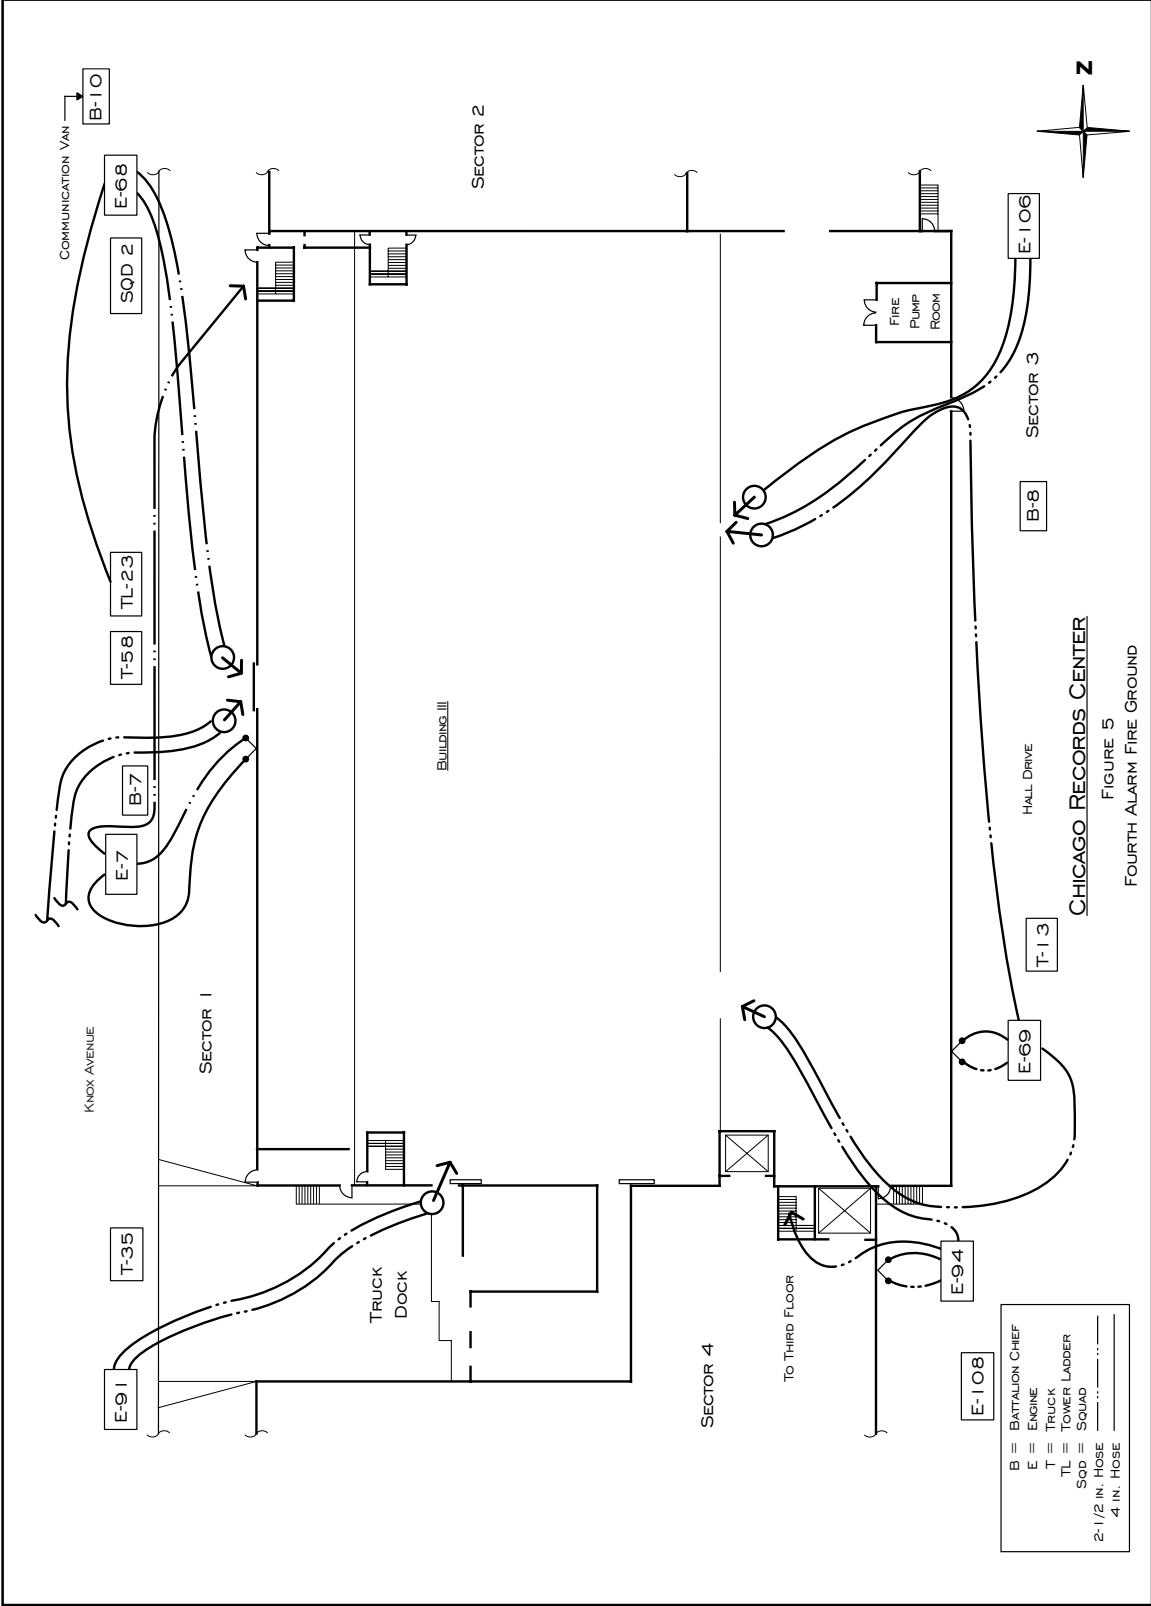
CHICAGO RECORDS CENTER  
FIGURE 5  
FOURTH ALARM FIRE GROUND

A fourth alarm was requested at 3:37 p.m. by the Fire Commissioner. This alarm brought four additional engines to the scene. These companies provided rotation for on-scene personnel who had been working for nearly two hours. Command personnel felt that the fire was contained to the fire separation area, barring any significant structural collapse. Such a collapse was not expected as the conditions at the masonry separations did not appear to be deteriorating. (See Appendix A, Figure 5.)

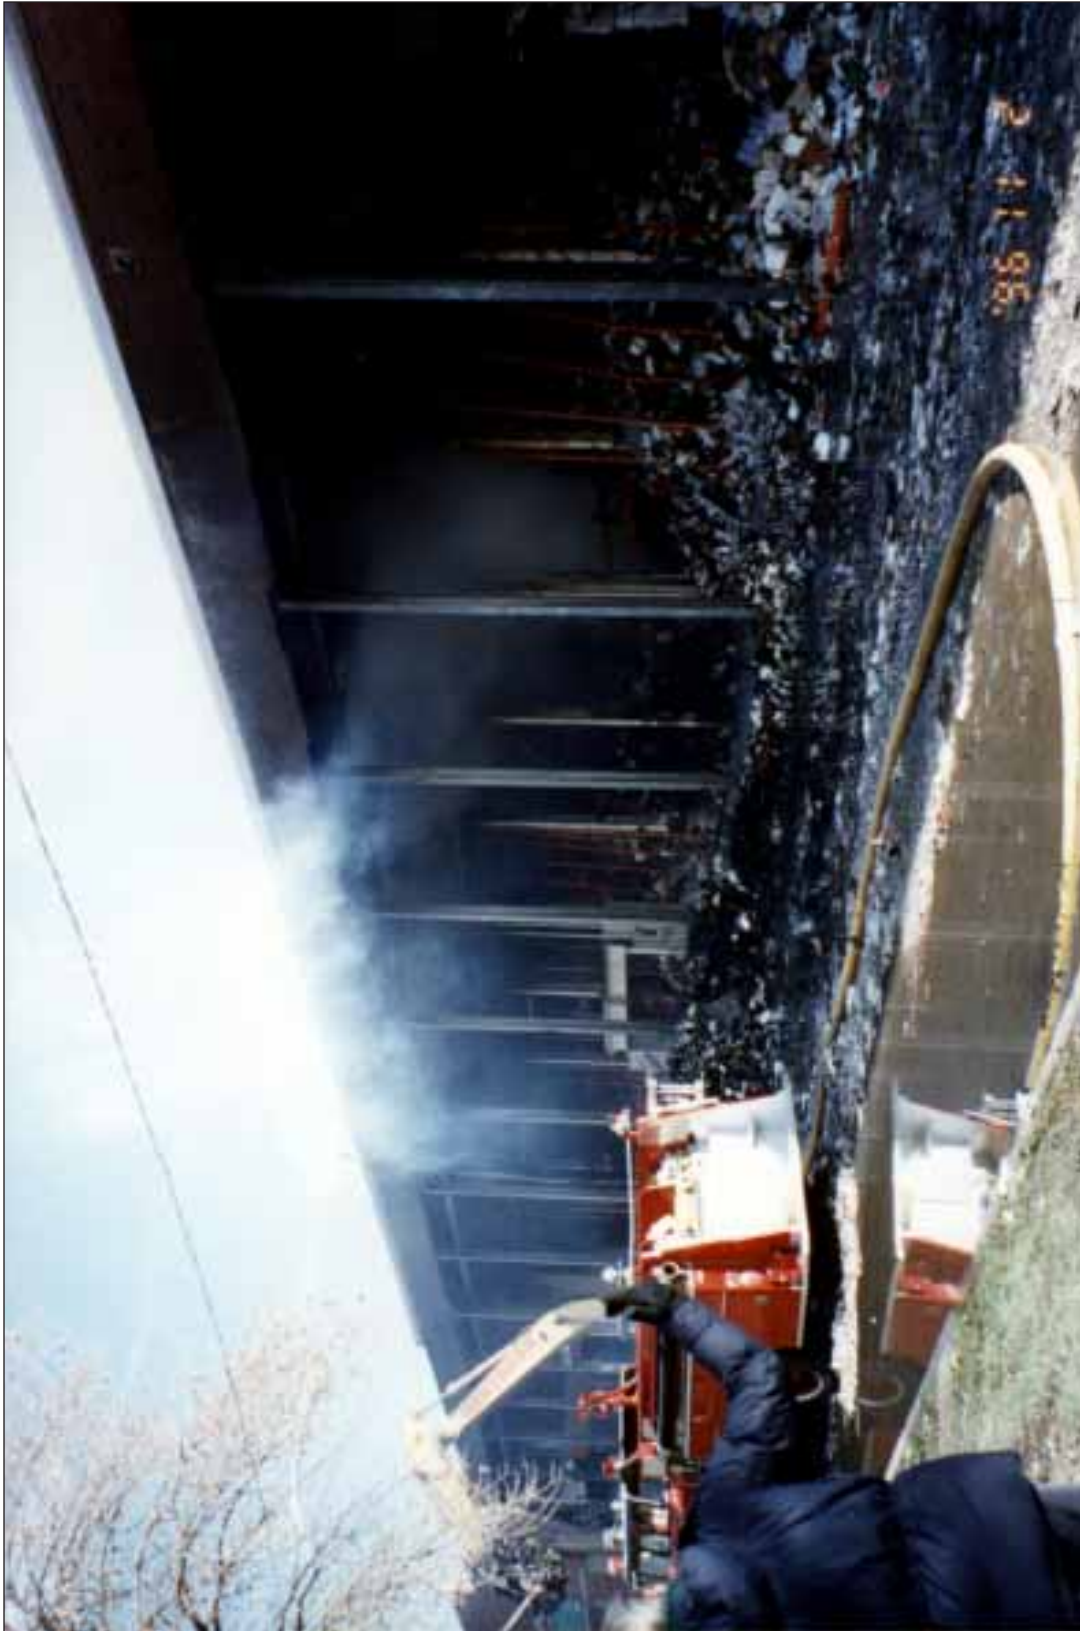
Photo 1. Knox Avenue and the front of Building III several days after the start of the fire during overhaul. The west street curb line is at the bottom left corner.

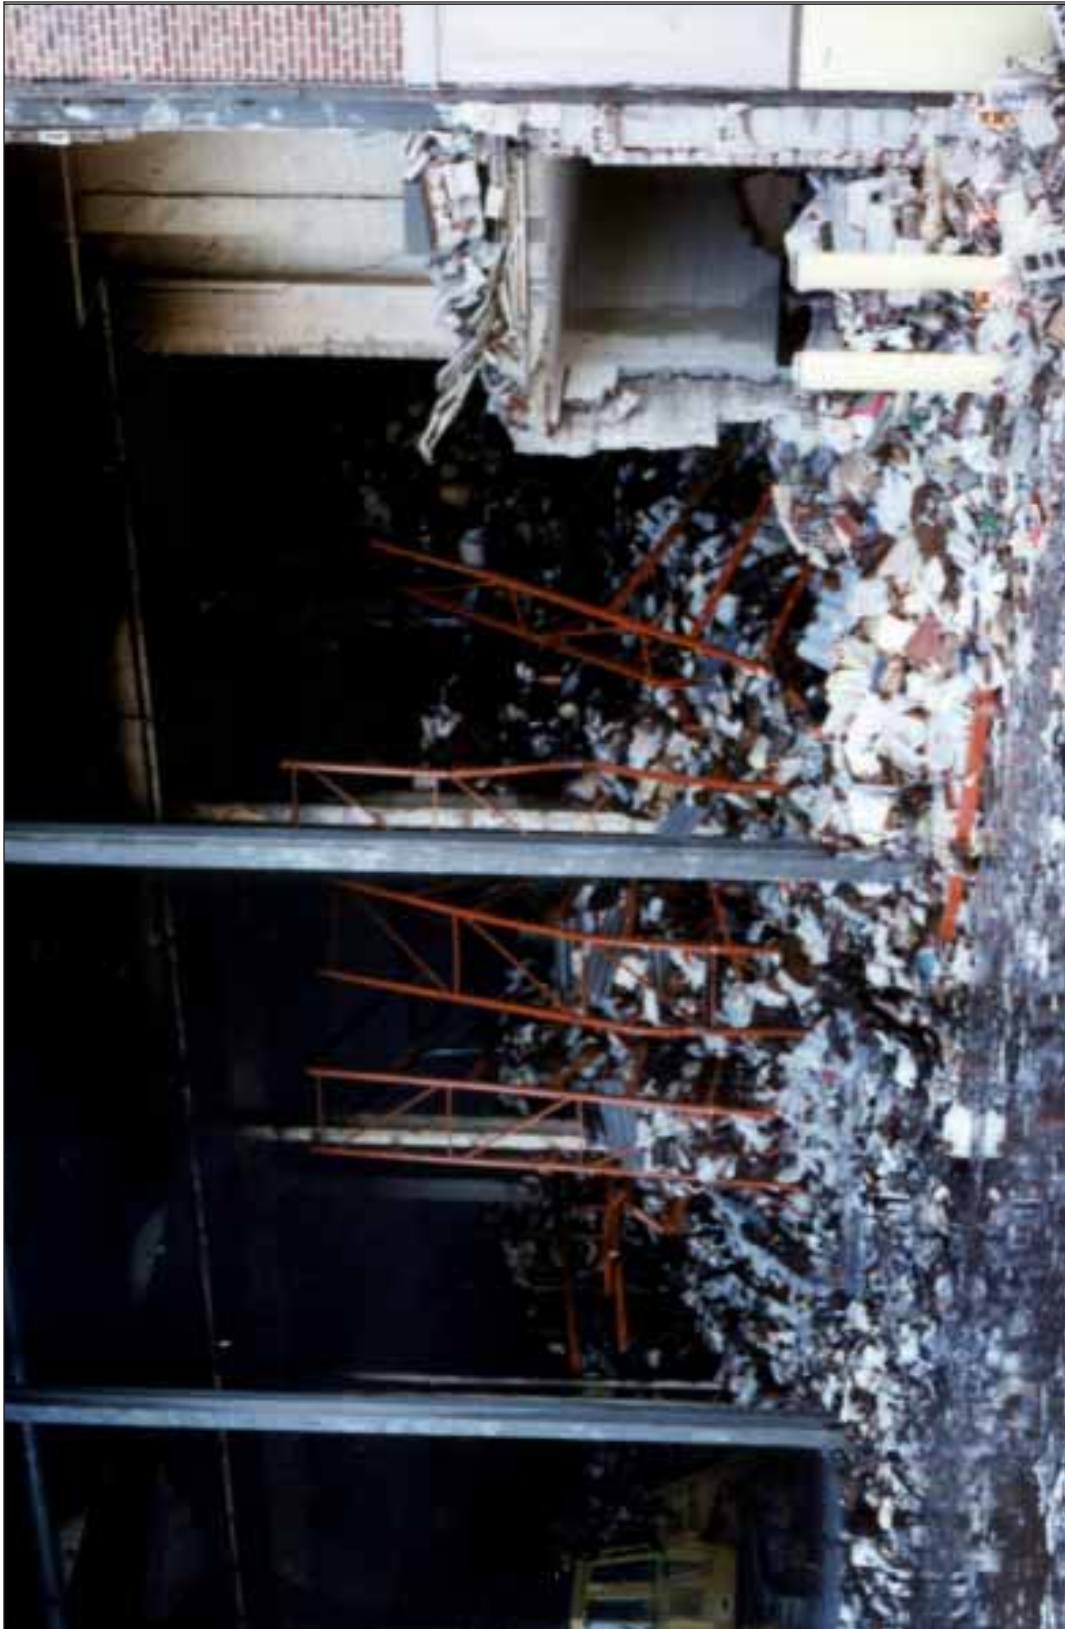
Photo 2. Typical of the rack collapse, record box failure, and documents filling the aisles. The brick-faced, hollow concrete block front wall was removed on the night of the fire.

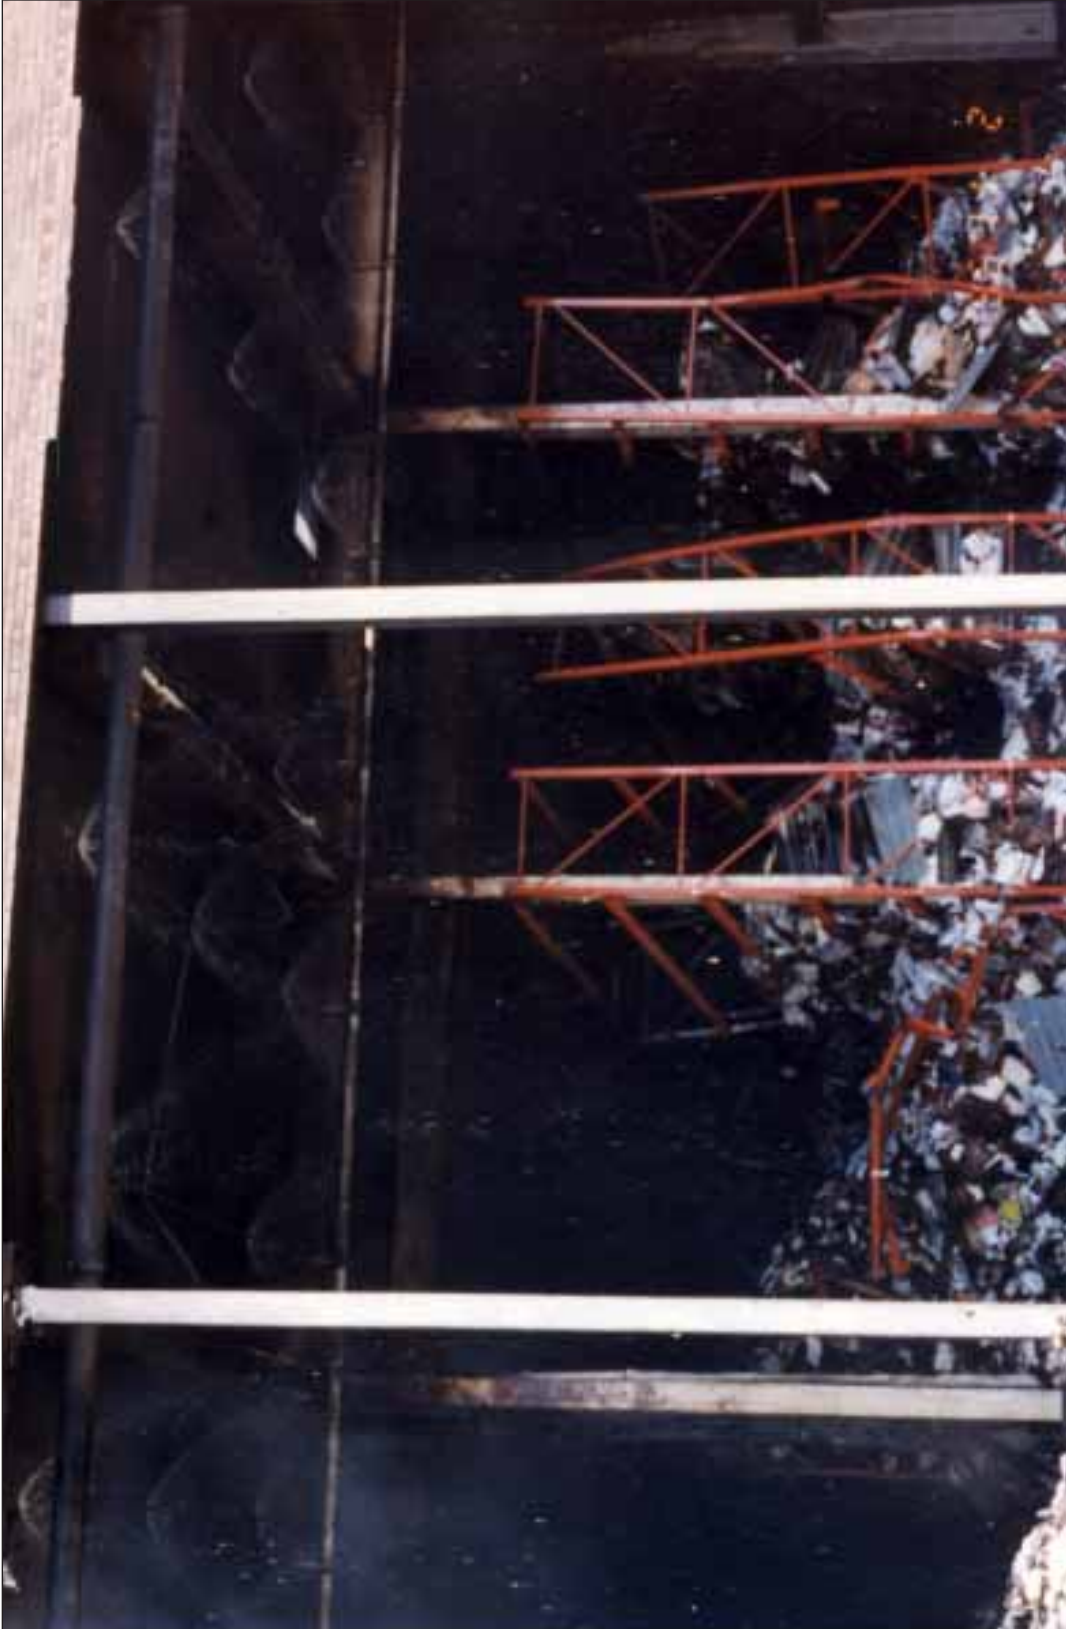
Photo 3. Racks and operating overhead automatic sprinklers near the northwest corner of Building III. Complete and partial collapse of the storage racks, shelves, and contents.

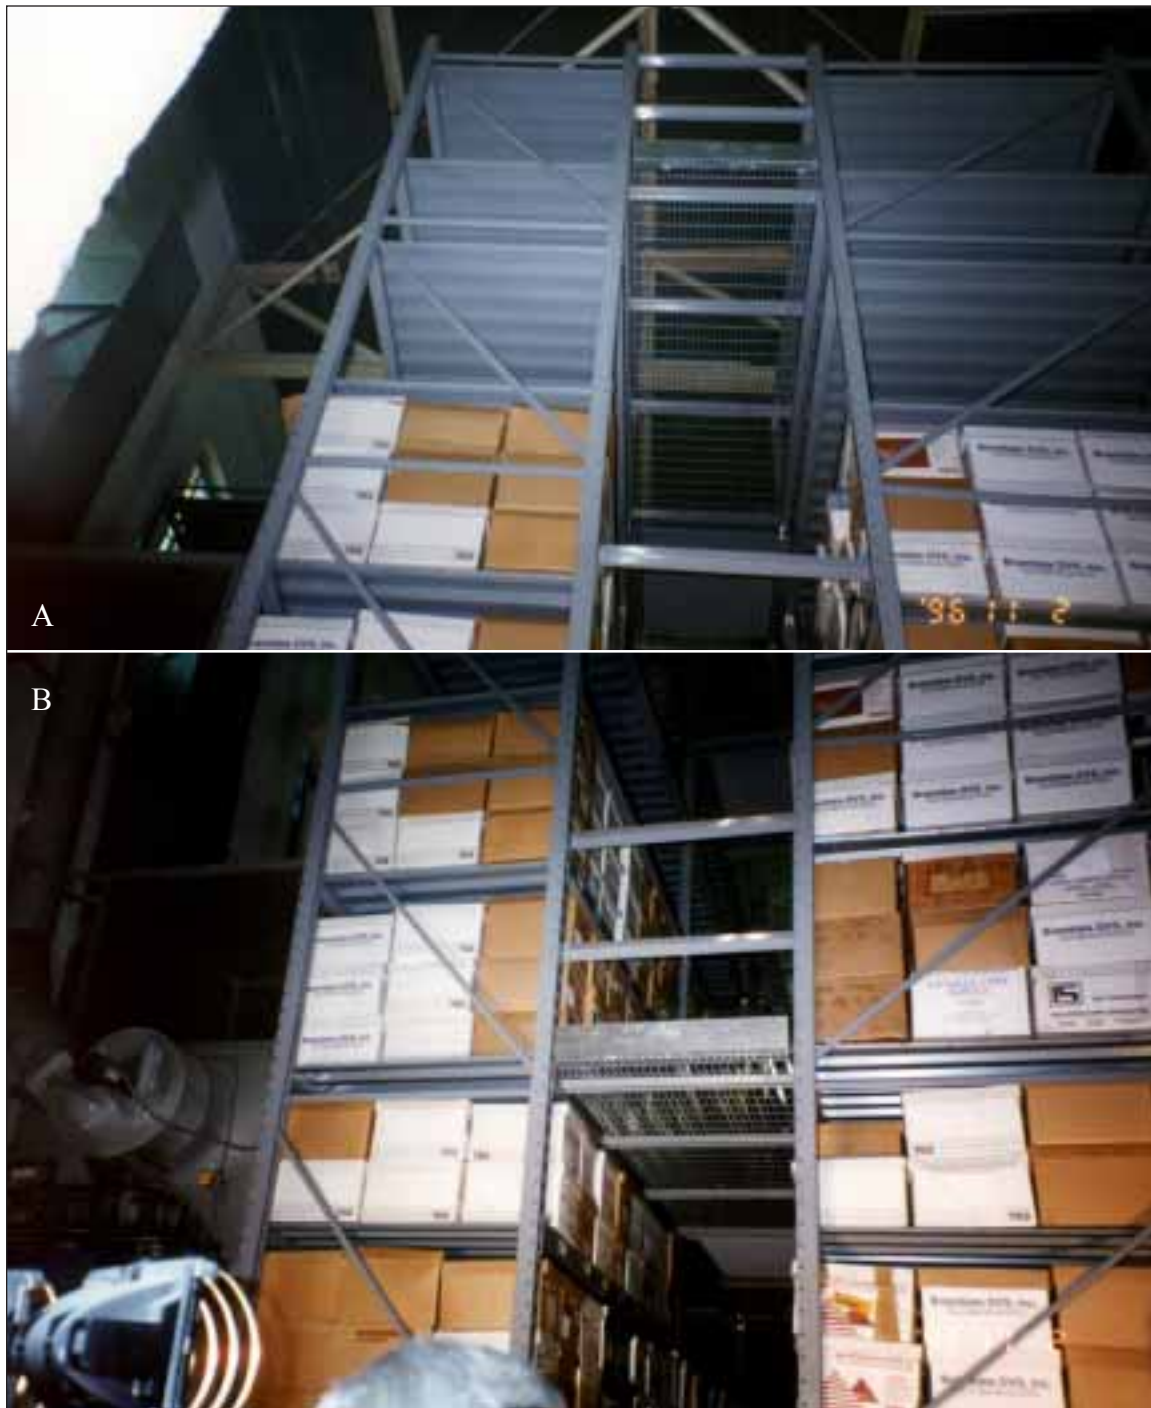
Photo 4. A and B. The shelving and records storage arrangement in the adjacent compartment to the east of the fire compartment. Taken from the floor, the two levels of elevated, grated walkways and the building's roof are depicted.

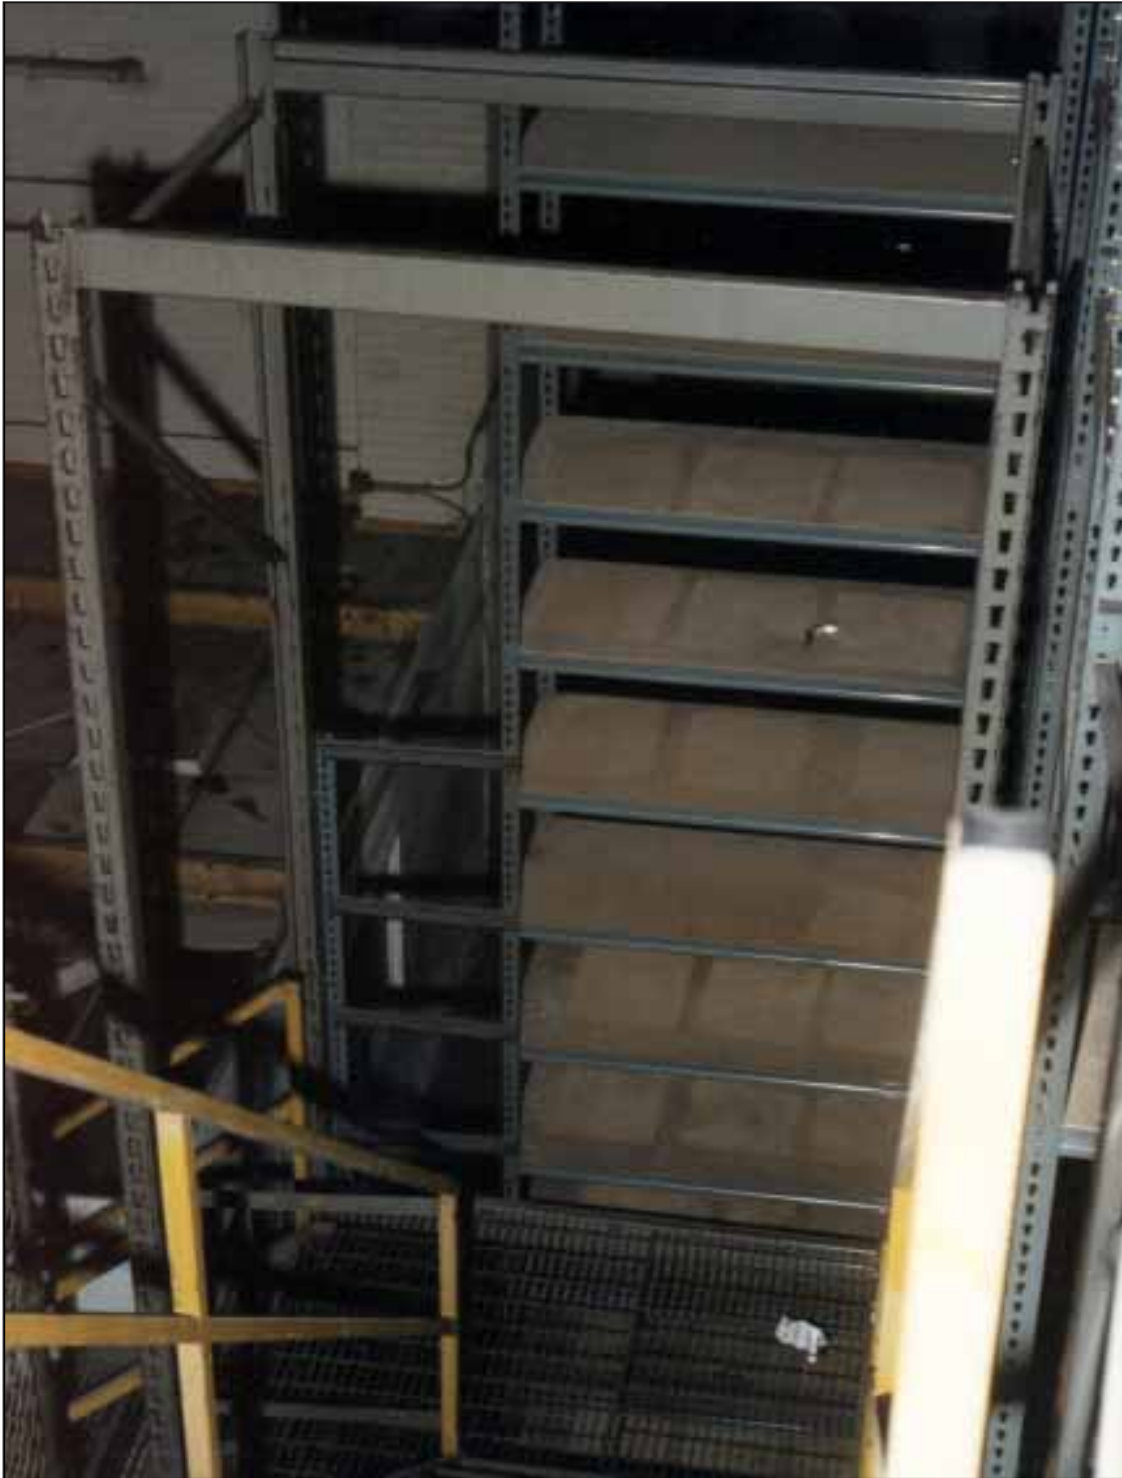
The use of tall racks with grated intermediate walkways is not recommended by NFPA No. 232A. Rather, full floors with fire resistance ratings are recommended to limit the extension of fire travel and to reduce the number of records subject to destruction or damage in a single fire. Where tall

Photo 5. Looking down from the top walkway gives a different perspective to the storage arrangement in the adjacent compartment to the east. Note the solid shelves, unprotected steel racks and typical access stairs.

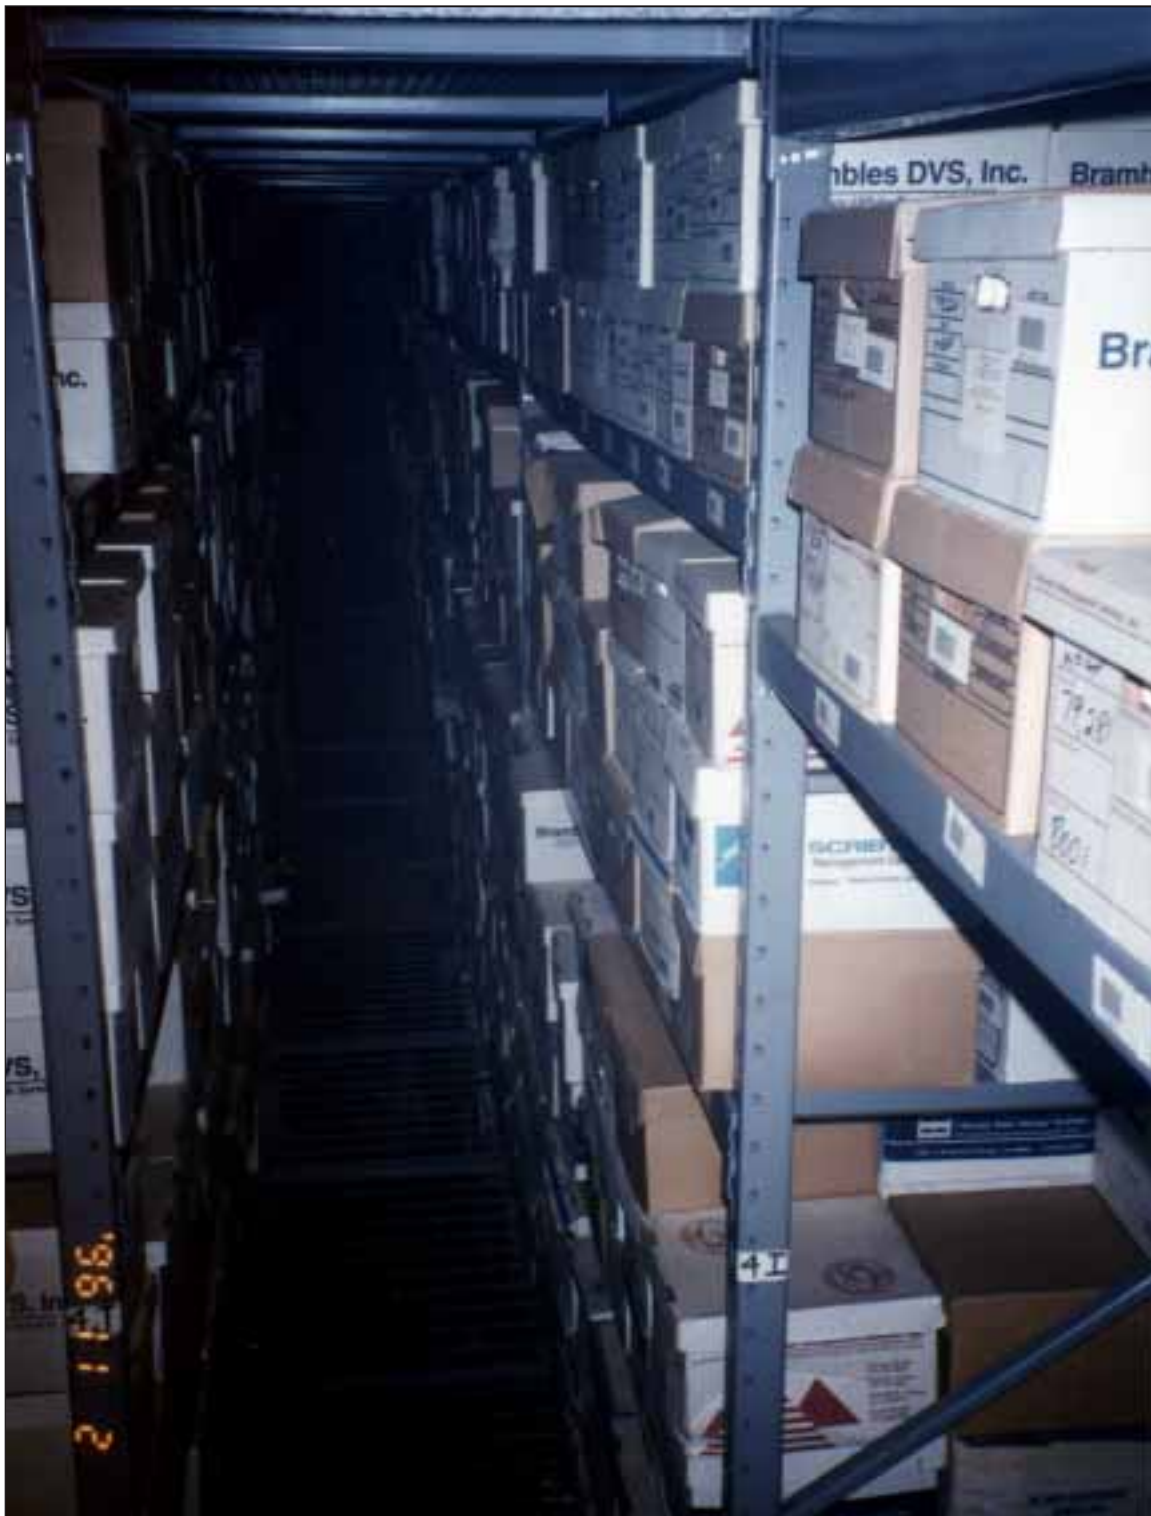
Photo 6. An intermediate level storage aisle with records boxes in place. The size and style of the storage boxes varied by section.

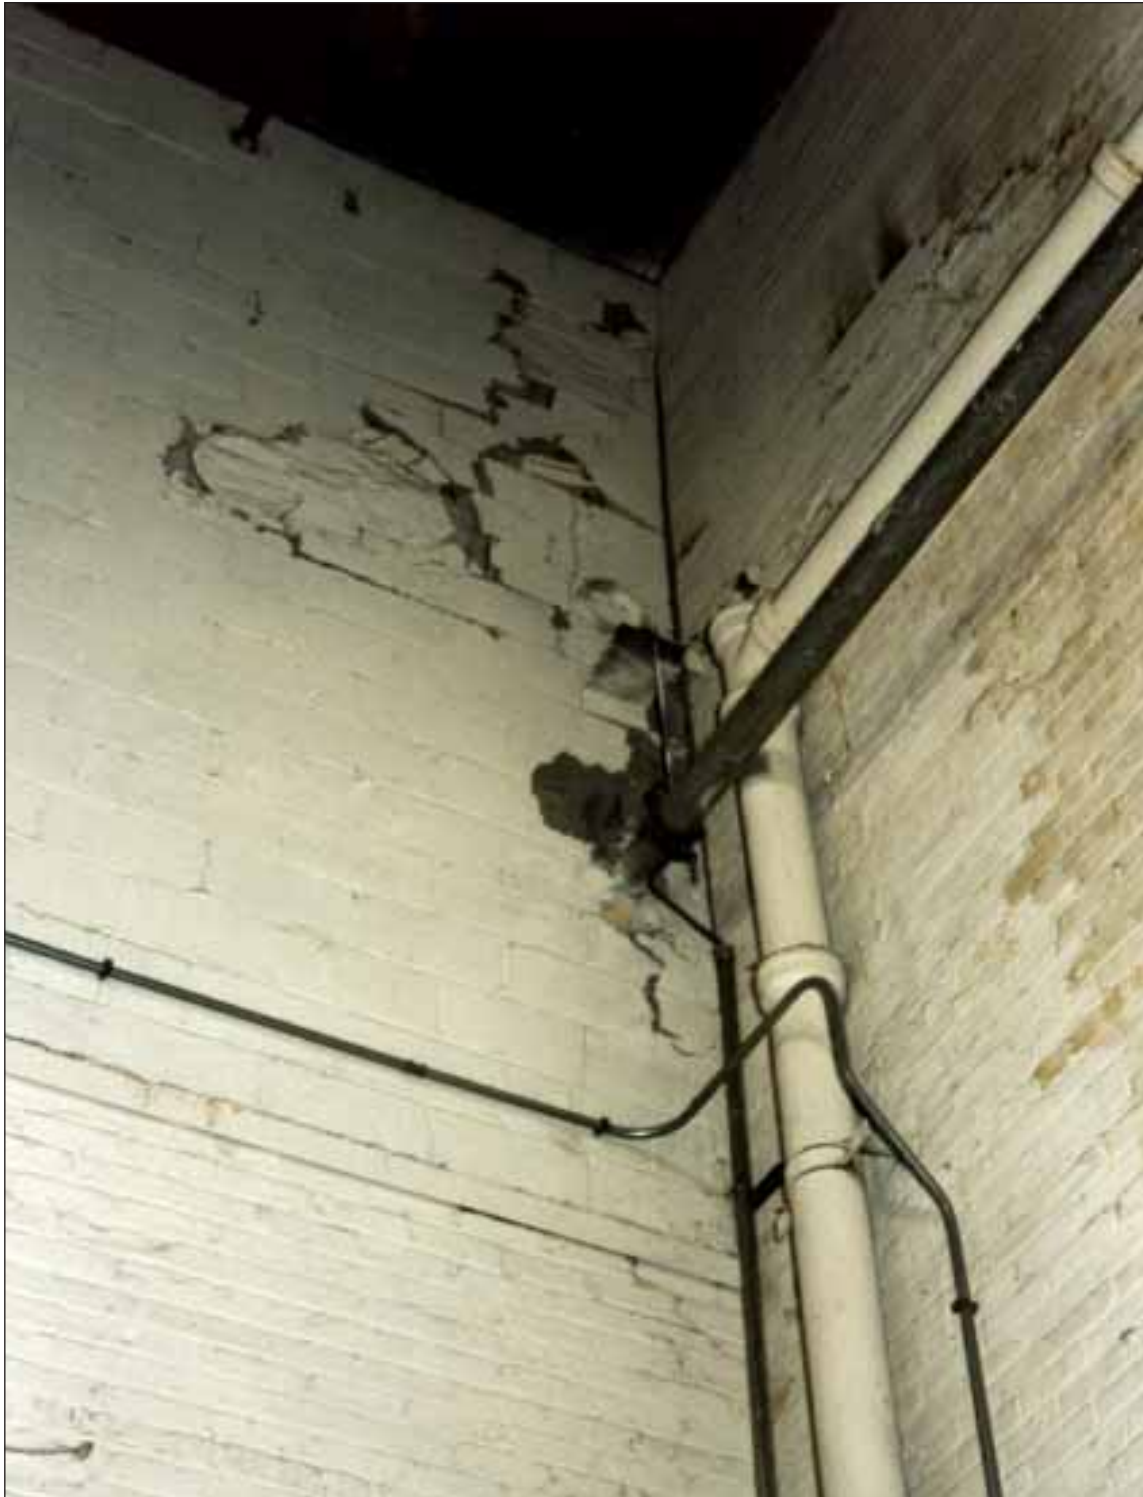
The adjacent building construction to the north was noncombustible was masonry walls and gypsum roof deck on unprotected steel trusses, beams, and columns. The expansion of the fire area caused buckling in the steel trusses. In addition, the masonry separation wall was displaced and cracked in several locations. (See Photograph 7)

Battalion 6, who responded on the Second Alarm, was assigned to check the interior of the north exposure in Sector 2. This one story masonry walled building with a metal trussed roof was occupied by a paper records destruction company and did not contain a lot of combustible contents. During the fire, the overhead steel trusses began to deform and the masonry wall between the fire building and the exposure was pushed to the north. This opened cracks in the wall and resulted in some crushed bricks.

**Photo 7. Masonry wall damage in Building II, north of the fire building, due to expansion of the fire wall between buildings. This corner is the southeast corner of Space 6.**

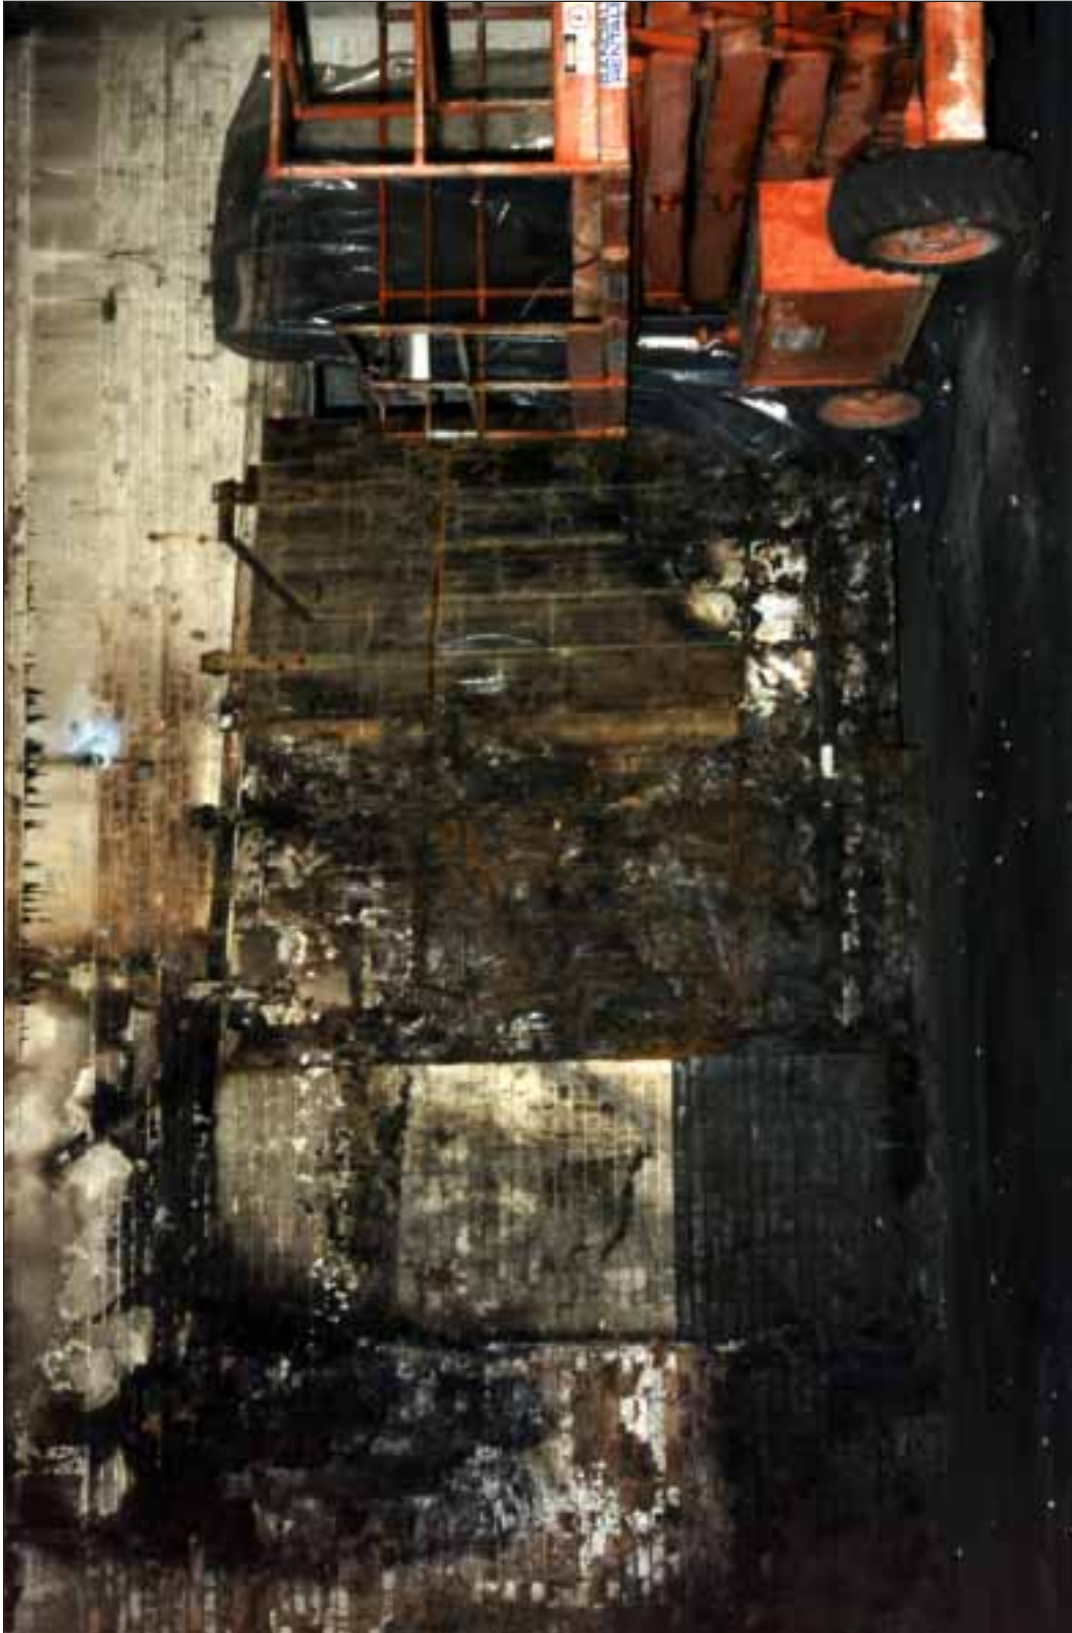
Photo 8. The fire side of the metal clad sliding fire door between Buildings III and IV. This door was supported by fire companies operating from the non-fire side of the door.

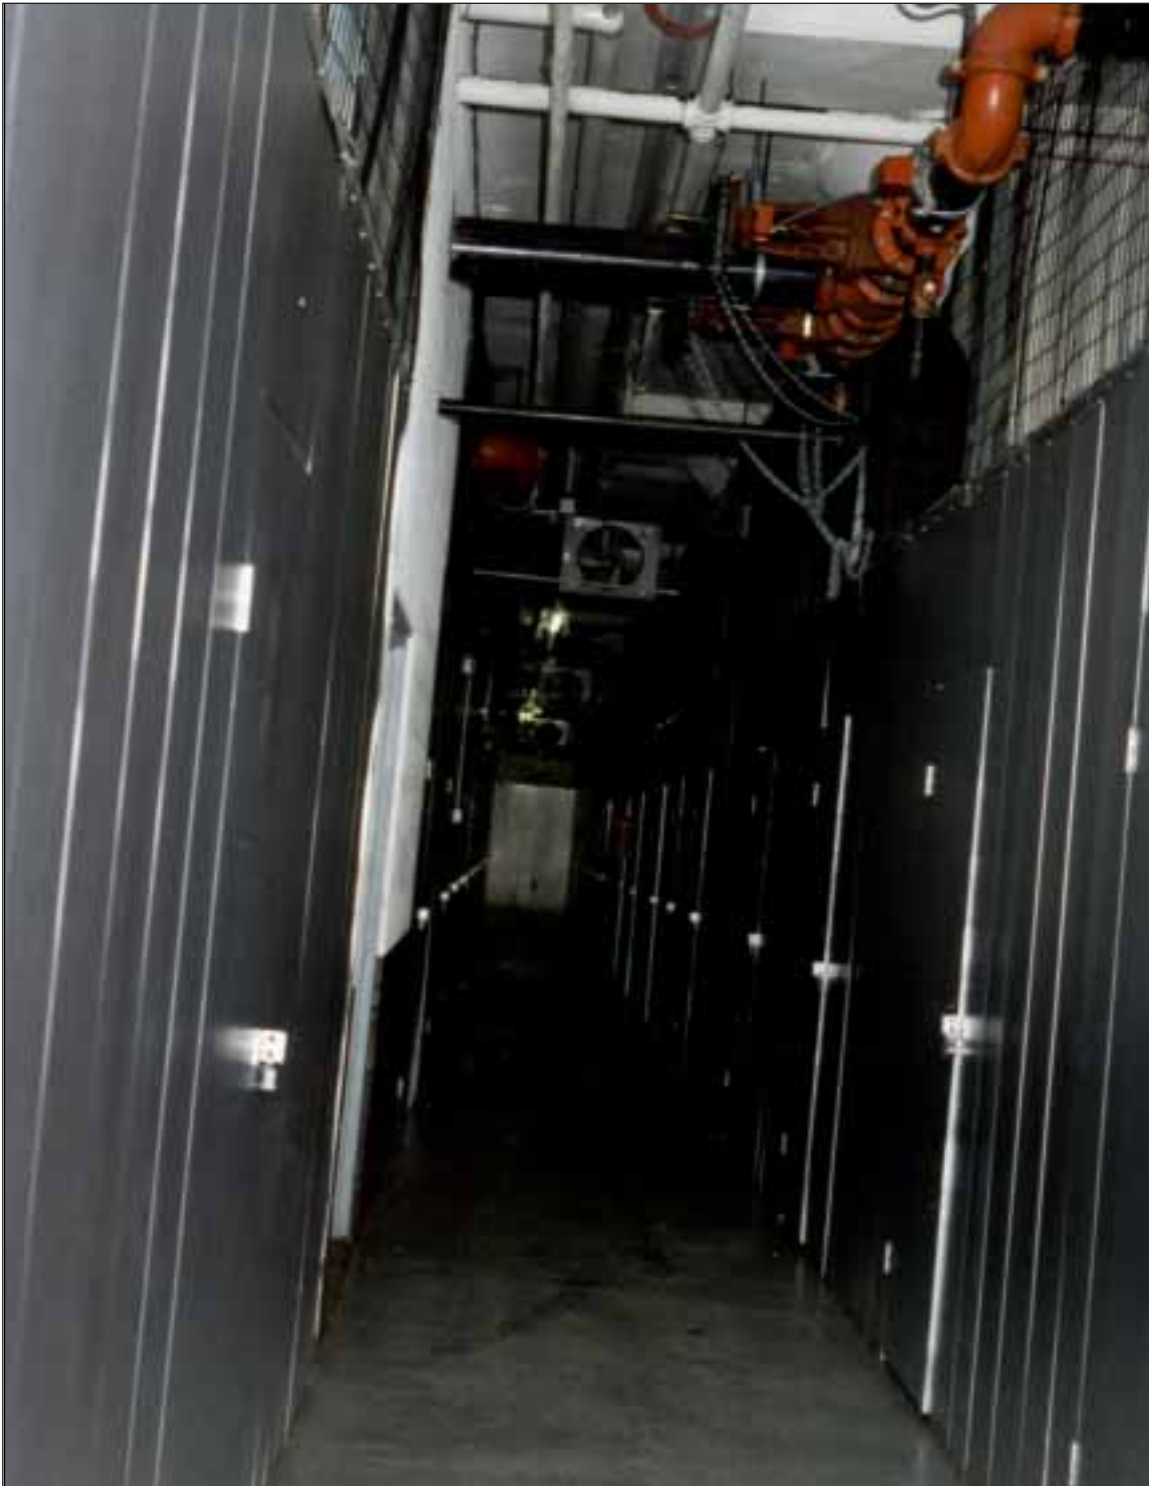
The storage “cubicles” on the second floor consisted of metal walls about eight feet high that were closed to the roof deck by heavy wire formed into about 3 inch by 3 inch squares. The access door to each unit was secured by a tenant provided lock. This arrangement provided security for each space yet did not necessarily interfere with the automatic sprinkler water distribution. Sprinkler heads were provided at the ceiling only and were spaced using an ordinary hazard schedule. There did not appear to be an attempt to locate an individual sprinkler head within each storage locker.

Photo 9. Typical public storage rooms or lockers located on the floor above the fire. Note the automatic sprinkler control valves and flow switch located at the ceiling level and the eight feet high solid walls topped by heavy wire mesh.

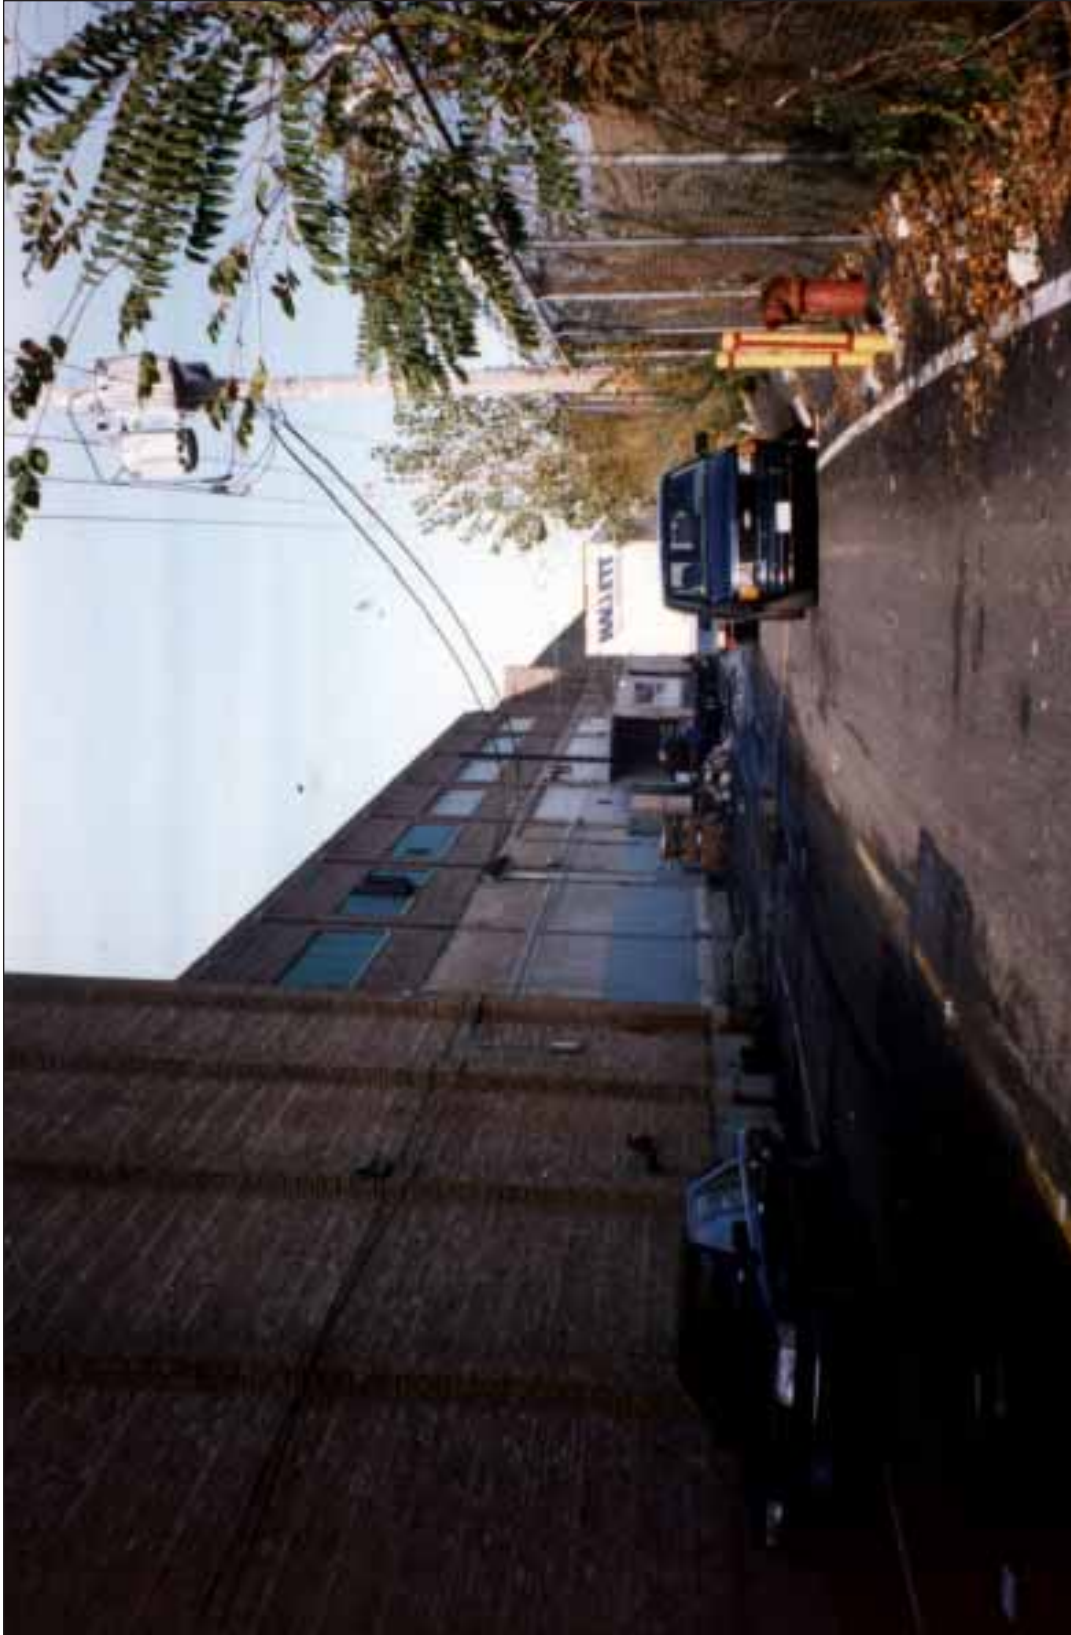
Photo 10. Hall Drive on the east side of the building looking to the north. The southeast corner of the fire building is just left of the center.
