U.S. Fire Administration/Technical Report Series

St. George Hotel Complex 16 Alarm Fire

Brooklyn, New York

USFA-TR-108/August 1995

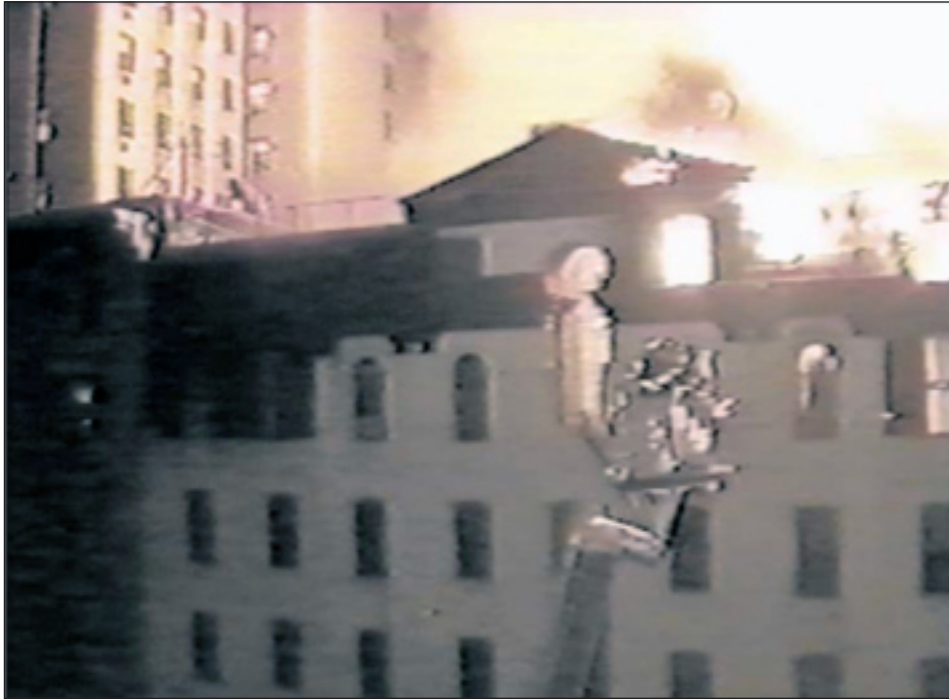
Photo 1. Early conditions on the Clark Street (front) side of the Clark Building with Truck 119 in position to operate its elevated master stream.

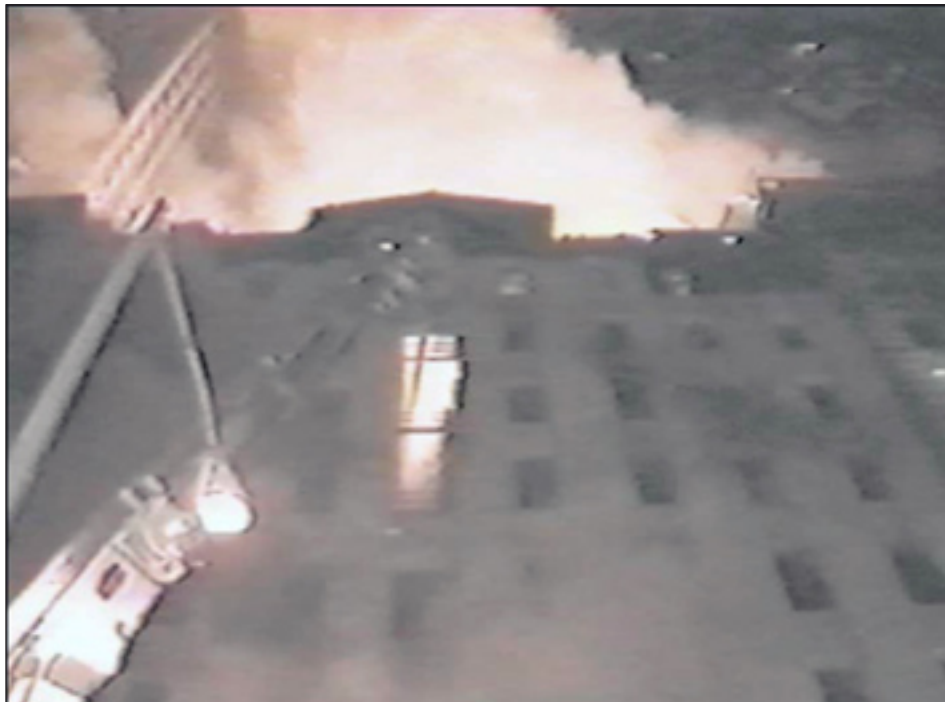
Photo 2. Later conditions on the front of the Clark Building from street level.

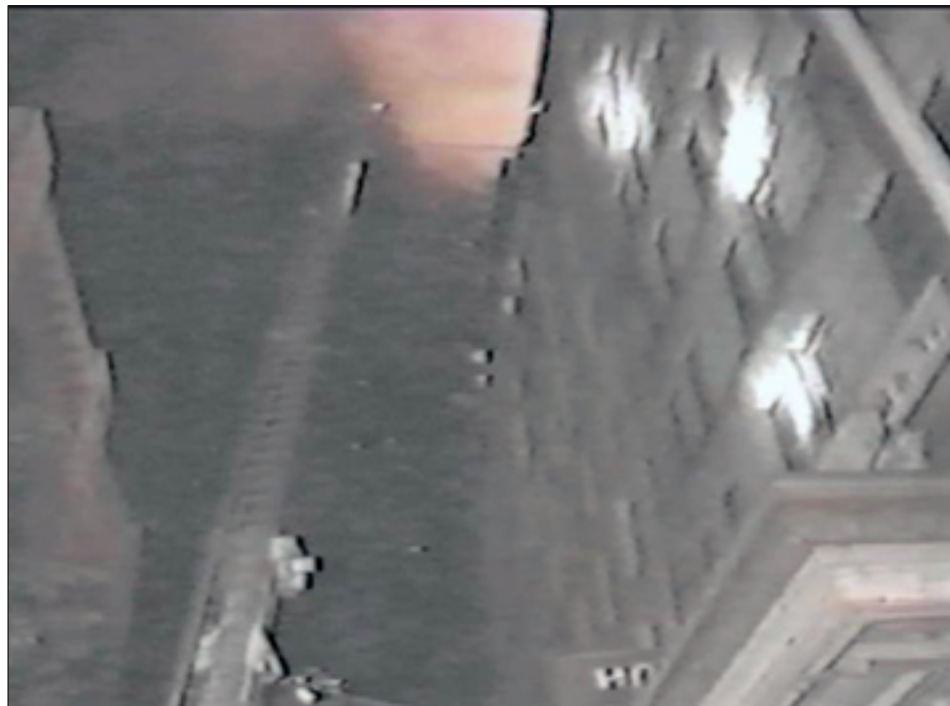
Photo 3. Conditions from the street

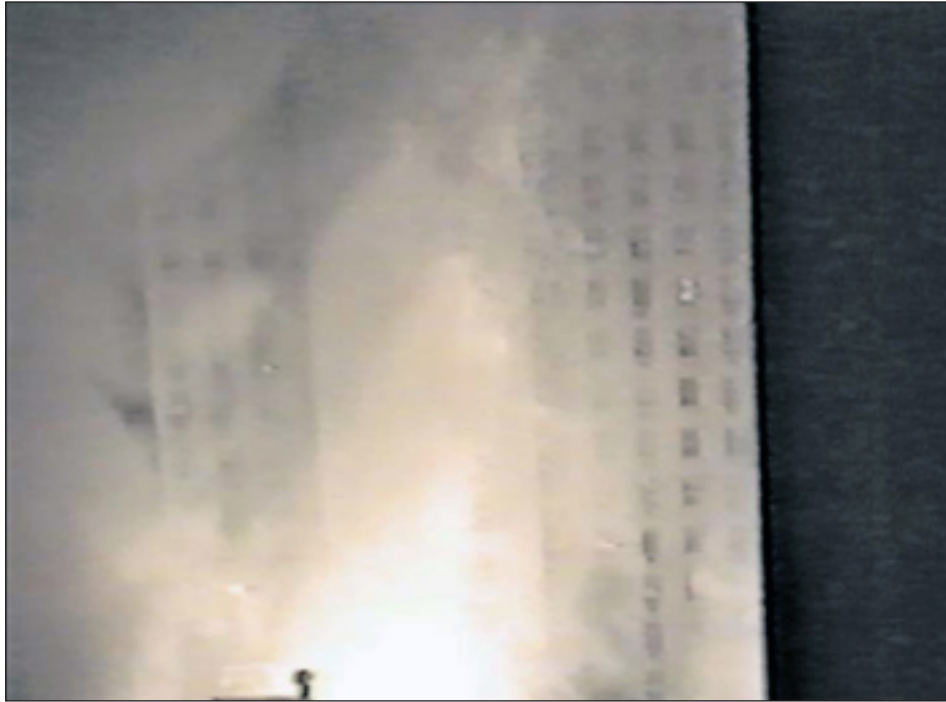
The fire brand problem was multiplied as the floors of the Clark Building collapsed. Flaming brands found their way into the open or failed windows of apartments and landed on the rooftops of sur-

Photo 5. The fire, brand, and energy plume from the now totally involved and collapsed Clark Building silhouetted against the rest of the 31 story Tower Building.

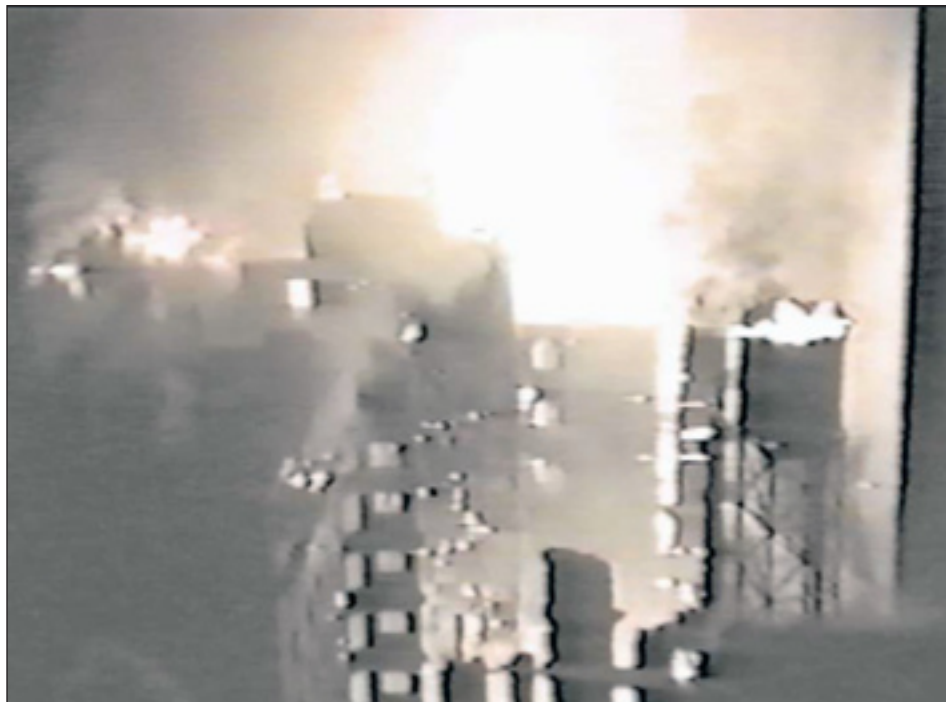
Photo 6. Fire conditions at the center of the block behind the Clark Building. The Tower Building is in the background.

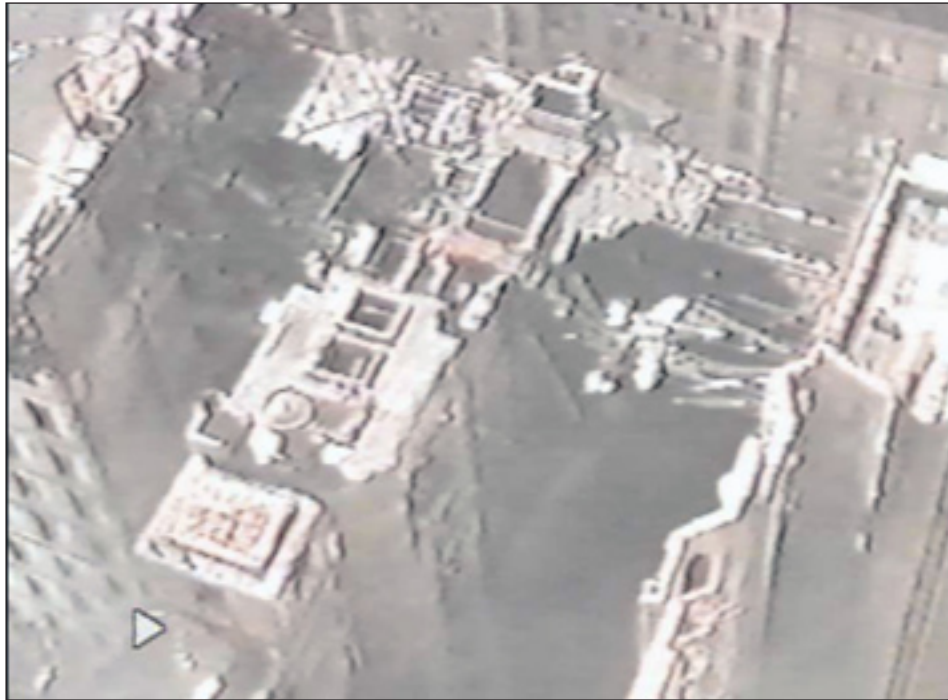
The masonry bearing walls were all that remained of the original fire building. Virtually all combustible materials had been consumed. Residents of many of the surrounding buildings were not allowed back into their apartments until the walls were demolished due to the collapse danger. Fire companies remained on the scene for several days putting out spot fires.

Photo 7. The rear of the Clark Building after the fire. The Tower Building and Grill Building is out of the picture to the right.

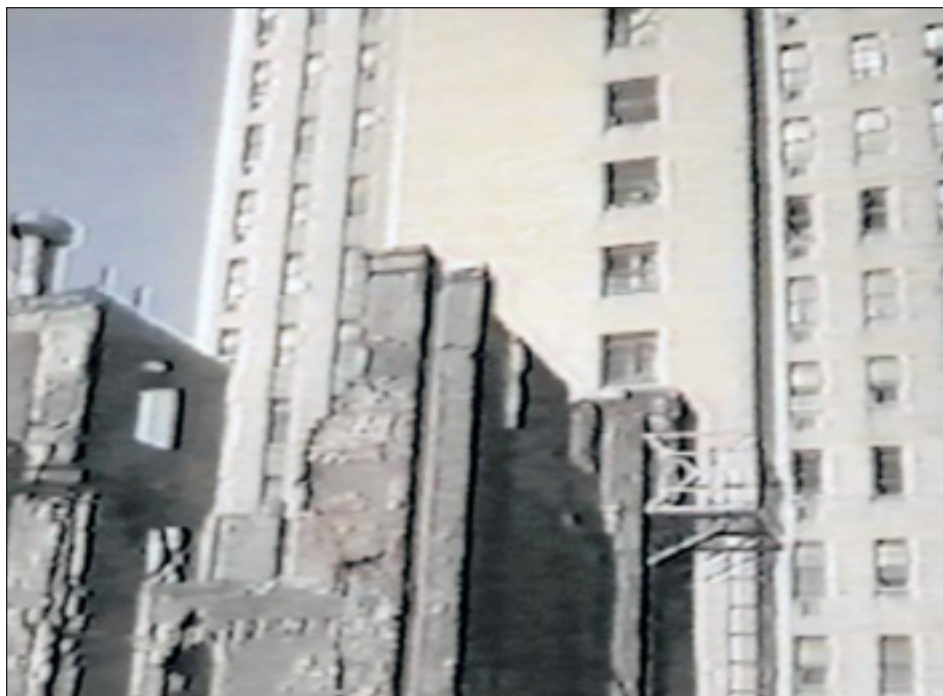
Photo 8. The Tower Building and Grill Building with the 31 story Tower Building in the background.

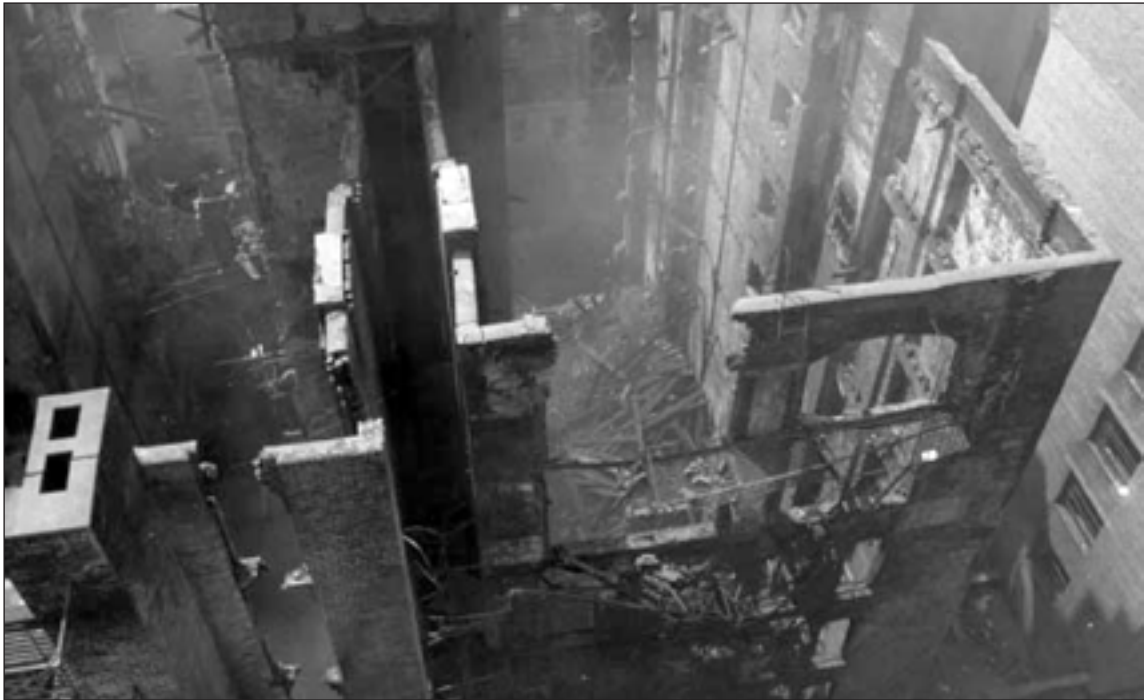
Photo 9. The Clark Building during demolition as viewed from the rear to the front.

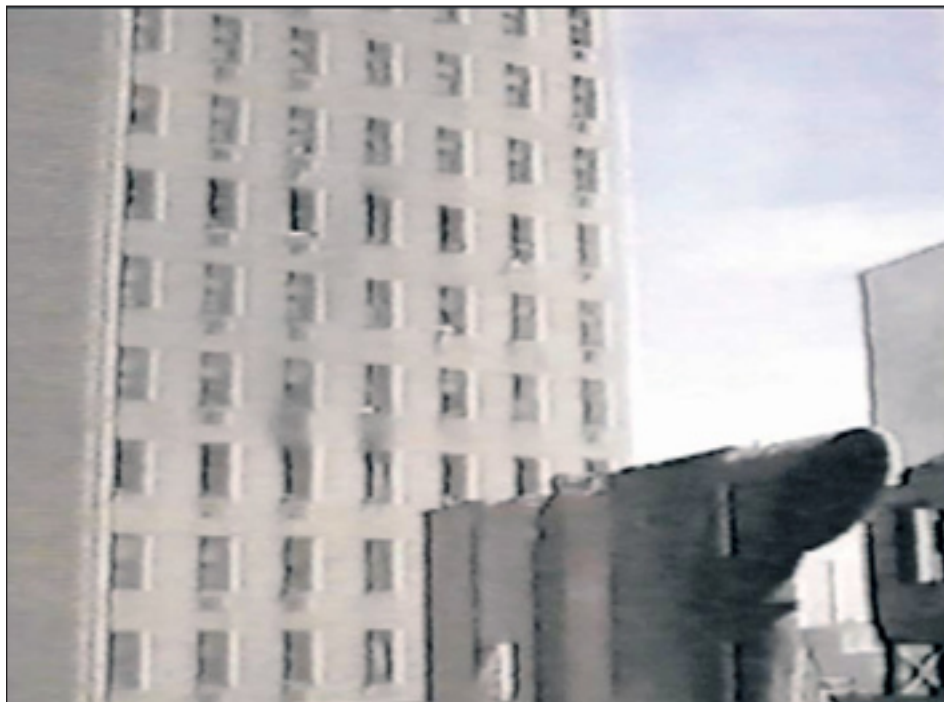
As the danger from the fire decreased, the residents of Exposure 1 at 52 Clark Street were removed to safety. This building suffered only slight water damage from the hoselines that were used to protect it from the radiant heat.

Photo 10. Damage to exposures across Clark Street from the fire building.
