U.S. Fire Administration/Technical Report Series

St. George Hotel Complex 16-Alarm Fire

Brooklyn, New York

USFA-TR-108/August 1995

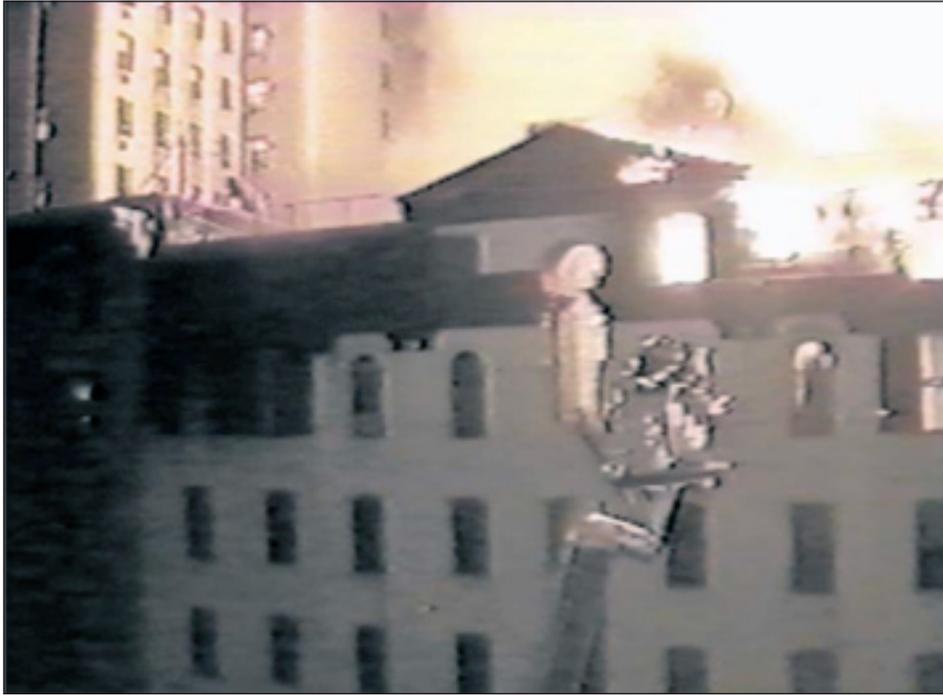
Photo 1. Early conditions on the Clark Street (front) side of the Clark Building with Truck 119 in position to operate its elevated master stream.

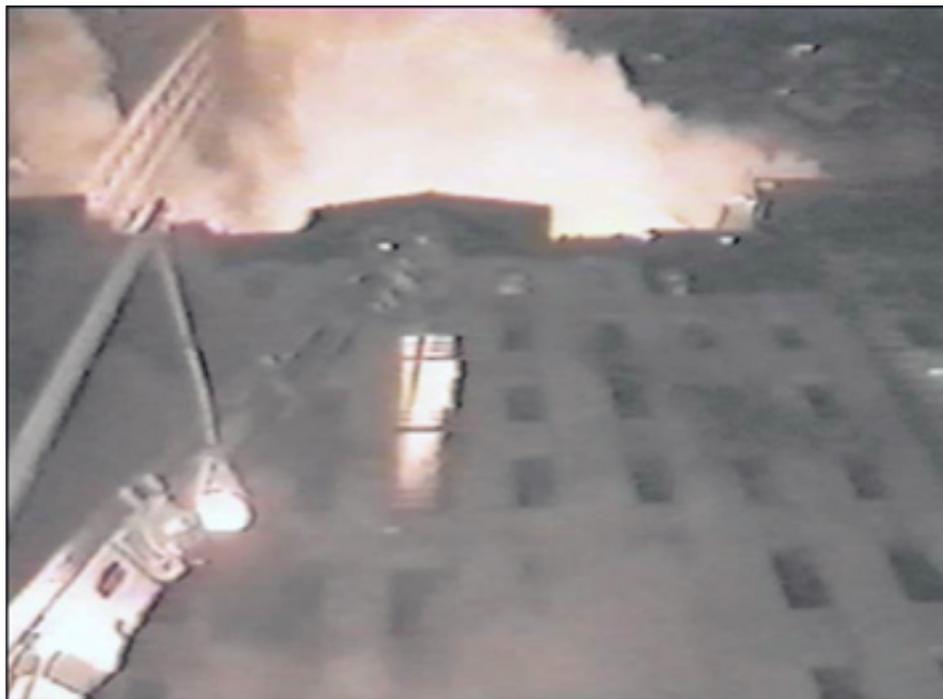
Photo 2. Later conditions on the front of the Clark Building from street level.

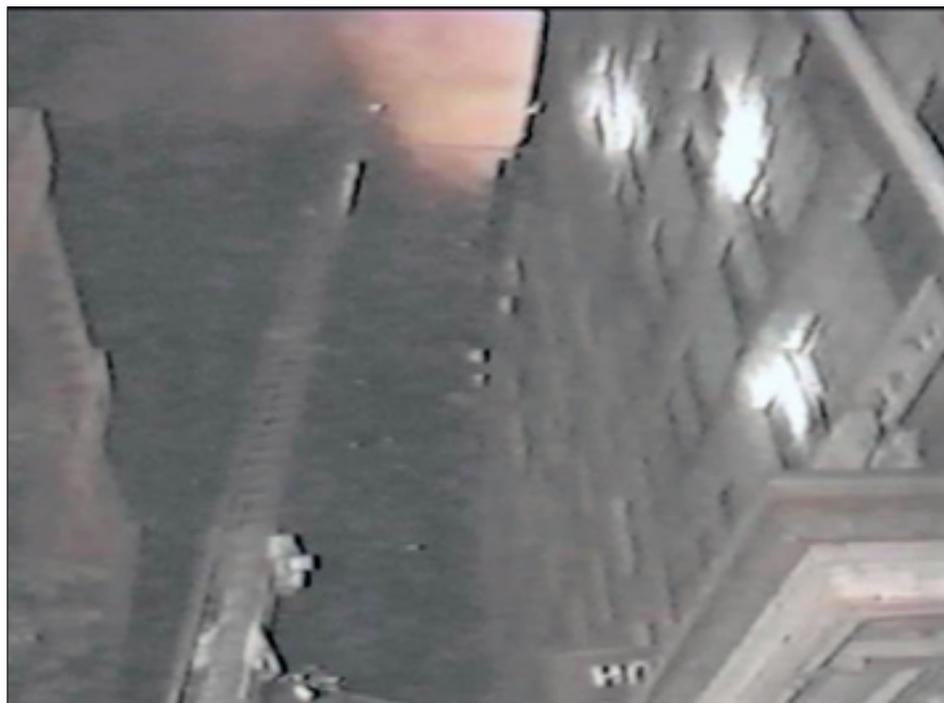
Photo 3. Conditions from the street

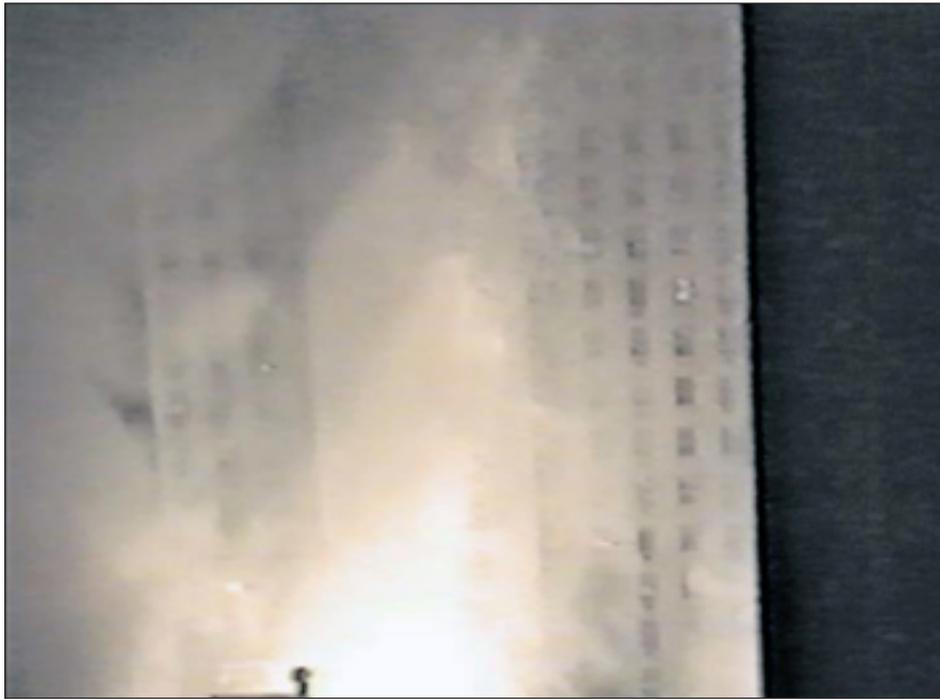
Photo 5. The fire, brand, and energy plume from the now totally involved and collapsed Clark Building silhouetted against the rest of the 31 story Tower Building.

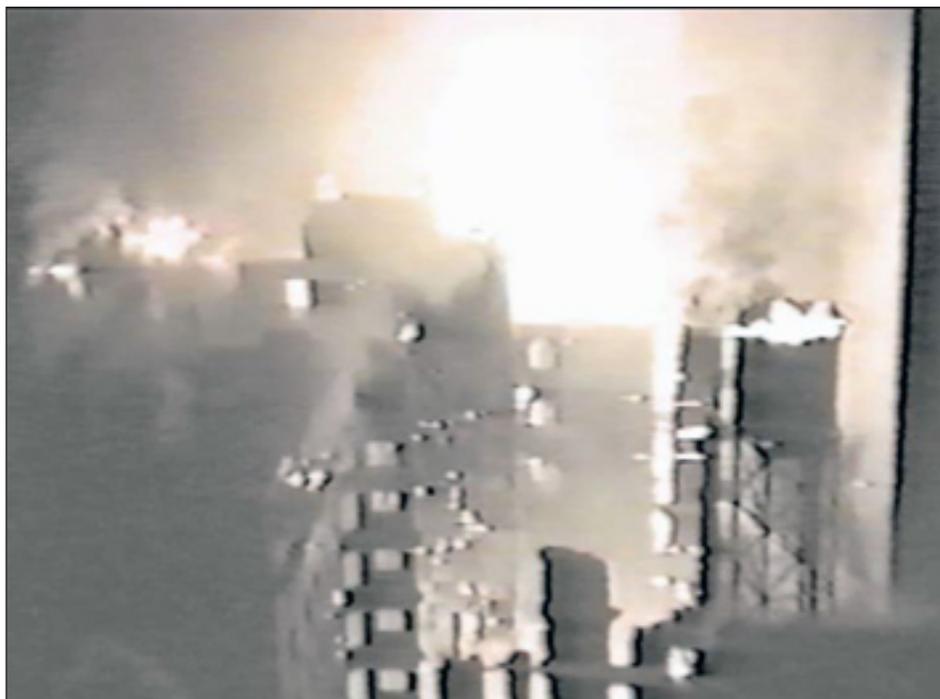
Photo 6. Fire conditions at the center of the block behind the Clark Building. The Tower Building is in the background.

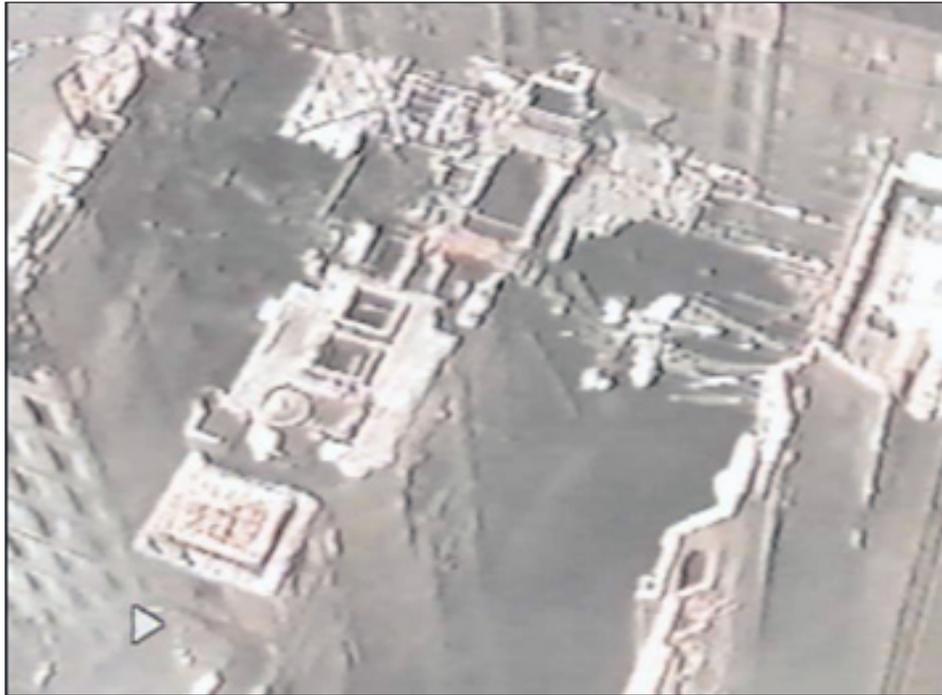
Photo 7. The rear of the Clark Building after the fire. The Tower Building and Grill Building is out of the picture to the right.

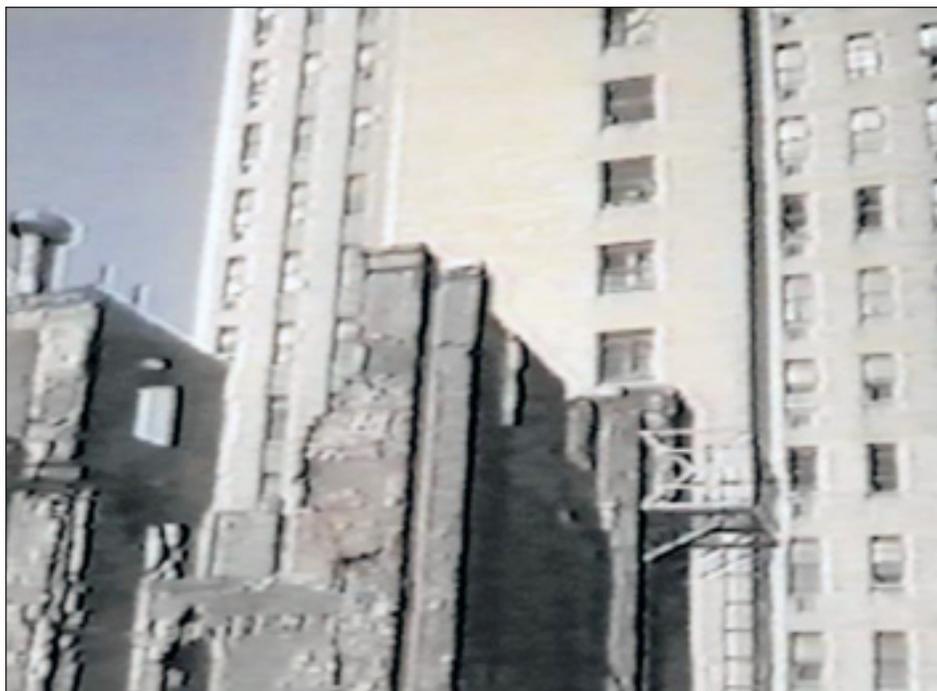
Photo 8. The Tower Building and Grill Building with the 31 story Tower Building in the background.

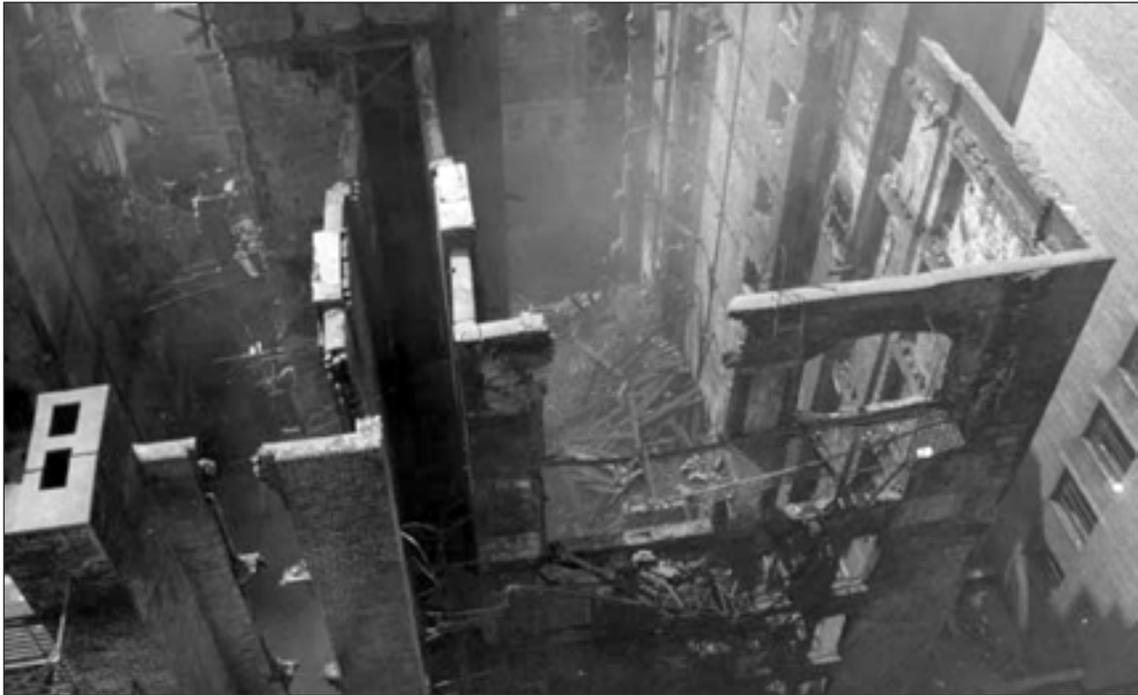
Photo 9. The Clark Building during demolition as viewed from the rear to the front.

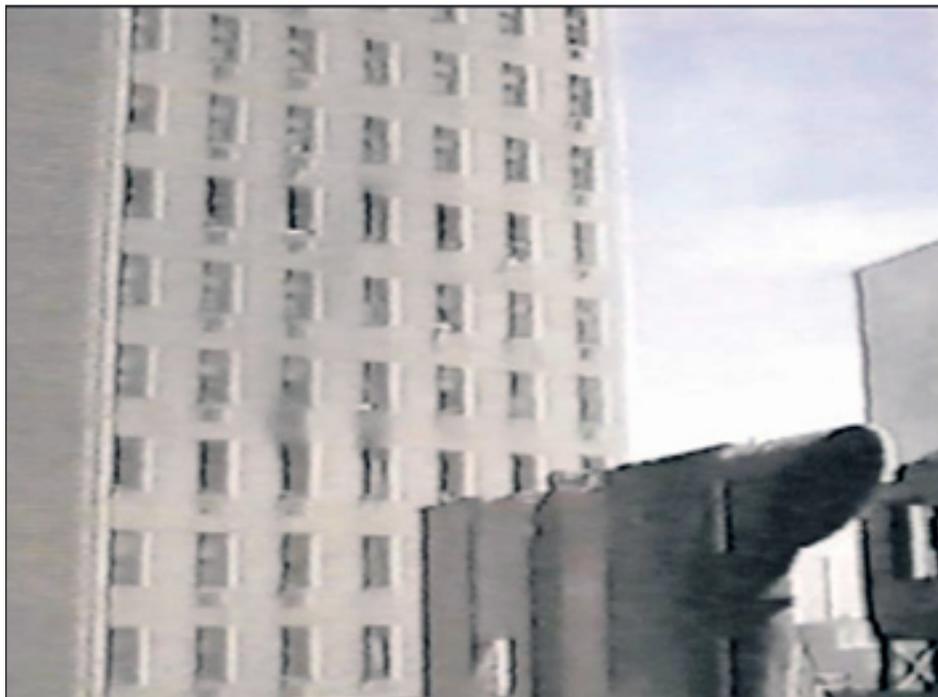
As the danger from the fire decreased, the residents of Exposure 1 at 52 Clark Street were removed to safety. This building suffered only slight water damage from the hoselines that were used to protect it from the radiant heat.

Photo 10. Damage to exposures across Clark Street from the fire building.
