Industrial Silo Fire and Explosion

Charlotte, North Carolina

USFA-TR-122/December 1997

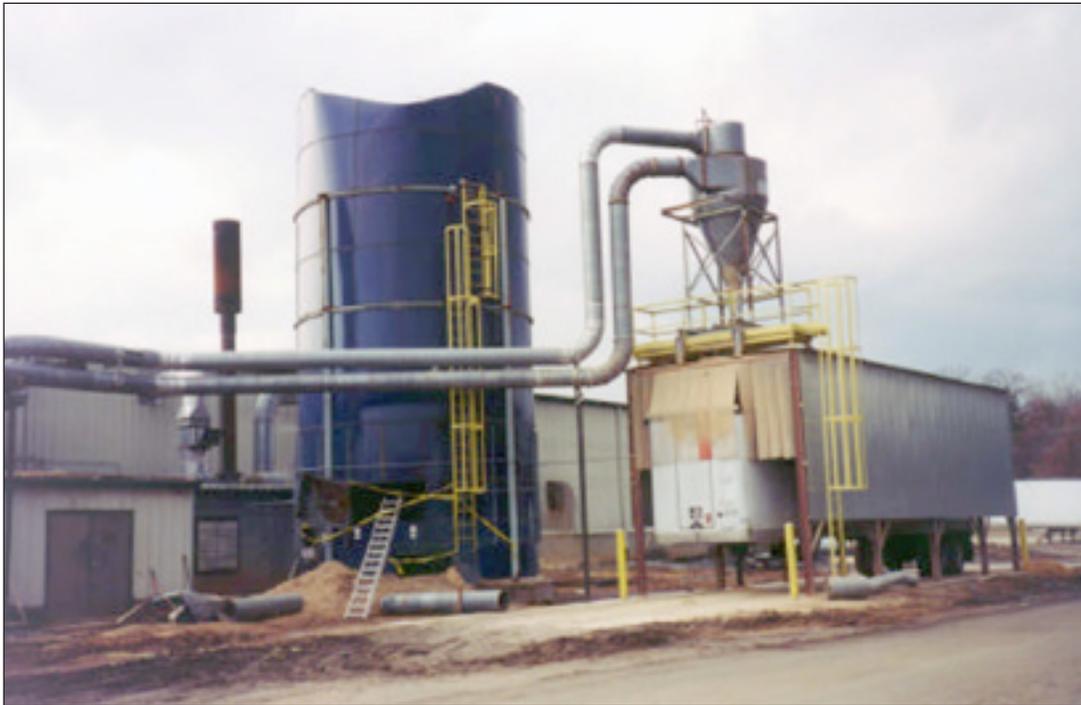
Photo #1 gives a perspective of the silo and its orientation to the building. The trailer shed to the right received wood waste via ducting and cyclone arrangement similar to that of the silo, for short-term storage in an open-box trailer and then disposal off site.

Photo 1. Silo with trailer shed to right and manufacturing facility in background

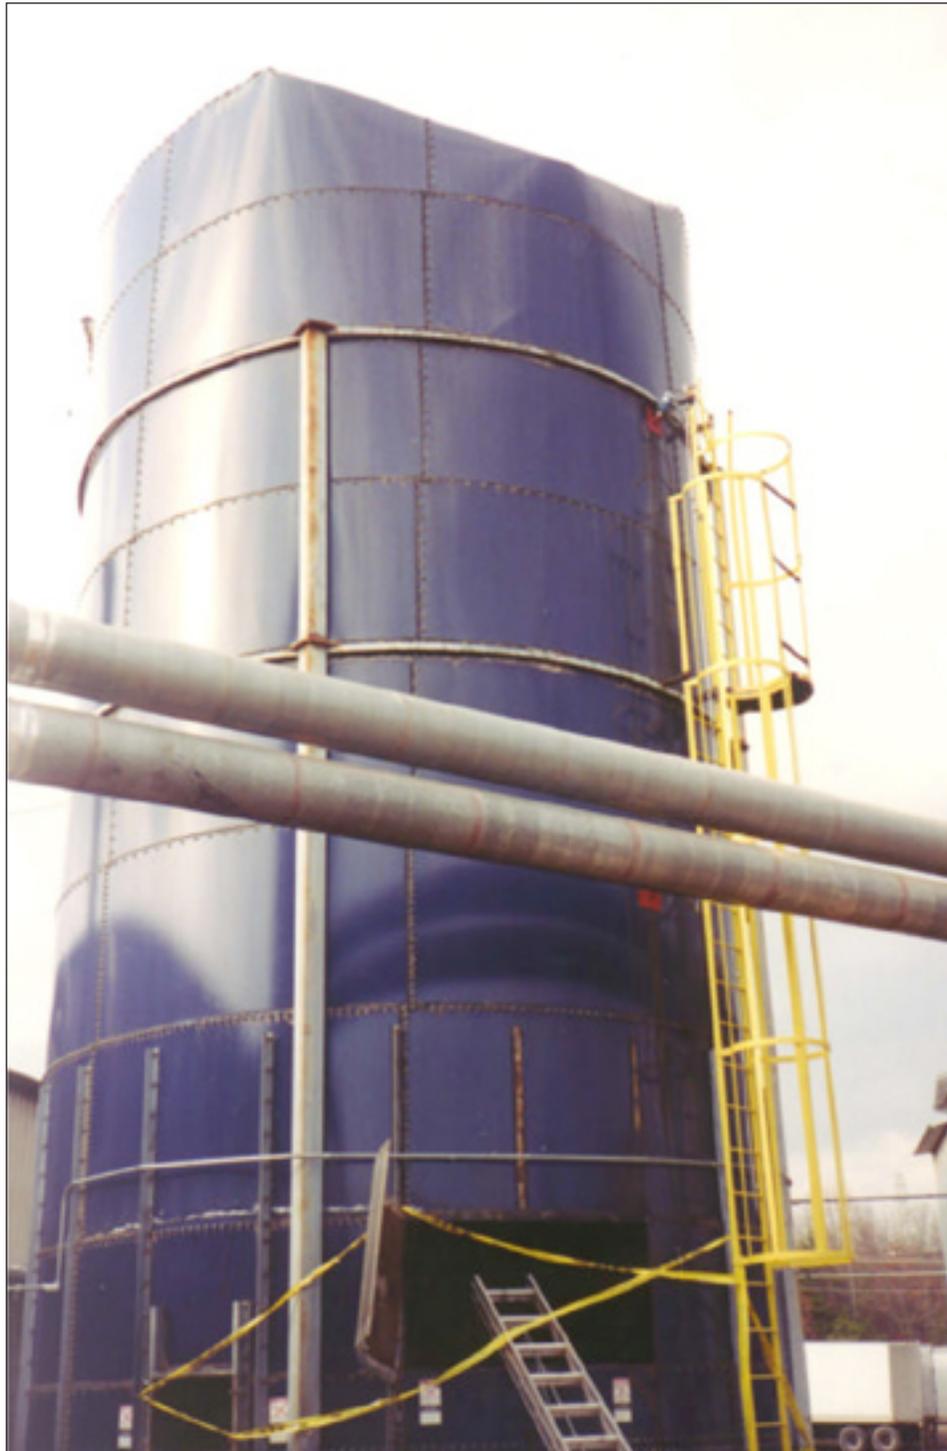
The Chief had moved all but essential personnel from around the base of the silo area as the crew commenced to remove the plates. As they worked on removing the last bolt of the 3 x 4 plate, one of the firefighters at the plate area noticed water flowing out along with burning ashes in the air space above. He then described a sucking and gurgling sound that followed by a loud, low order explosion. The firefighters on the roof recalled the same type of inrush of air at their position followed by a dull thump and the roar of the main explosion. (Photo #2 shows access plate in relation to silo, photo #3 is a closer view of the access plate area.)

Photo 2. Access plate, origin of explosion

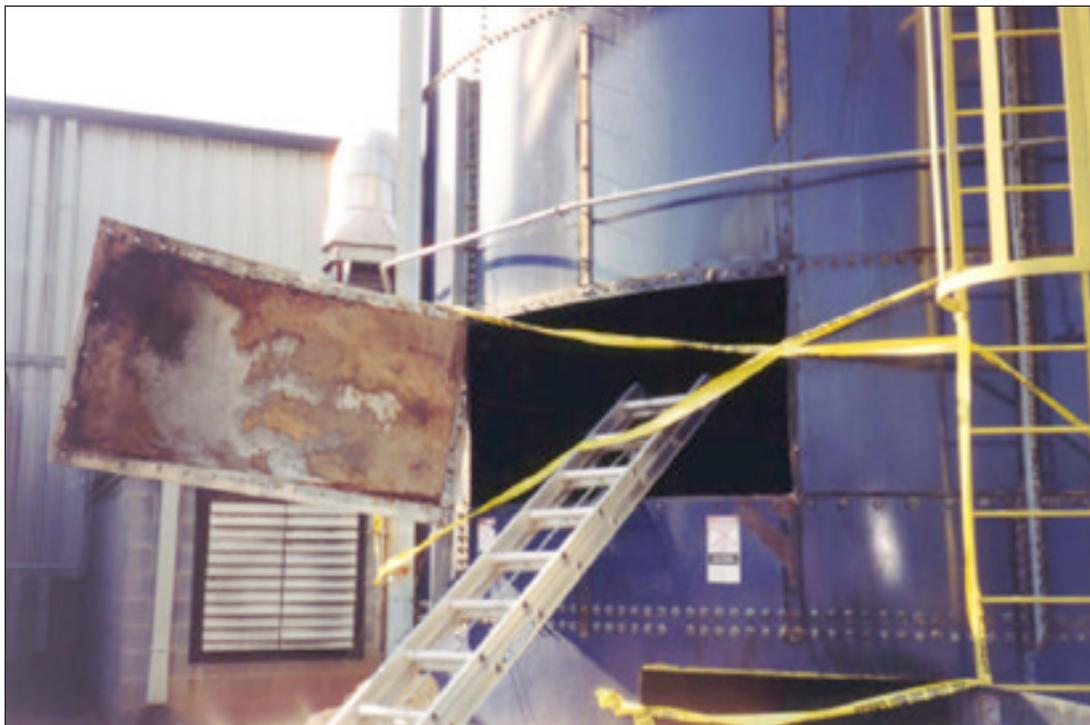
Photo 3. Access plate; area of origin of explosion

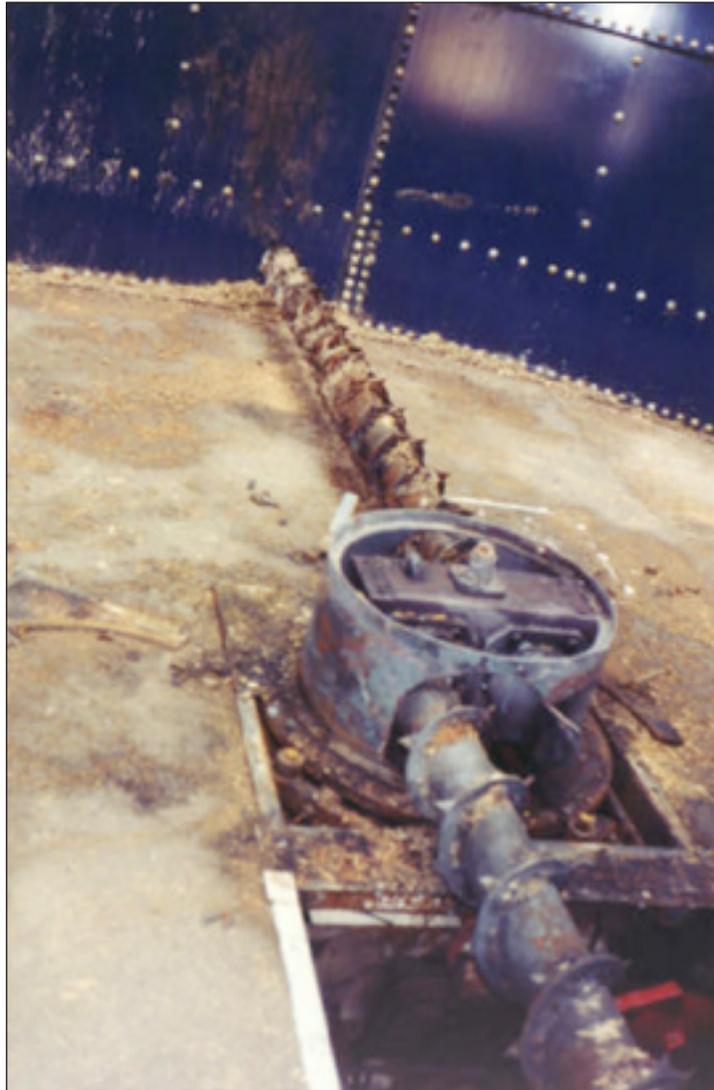
The observation indicated a large void area (approximately 12 feet by 16 feet by 10 feet) at the bottom of the silo radiating from the screw auger area. One of the "fingers" (Photo #4) of burned material ran to the direction of the access panel that was the focal point of the explosion. The direction of the burned void indicated fire travel in the direction of the screw auger to the compromised areas of the silo shell: the access panels. (Photos #5 and #6.) Despite the application of several thousand gallons of water, **apparently no water penetrated to sufficient depth to reach the burning wood material.**

Photo 4. View of auger inside silo; fire burned along the auger shafts to access panels

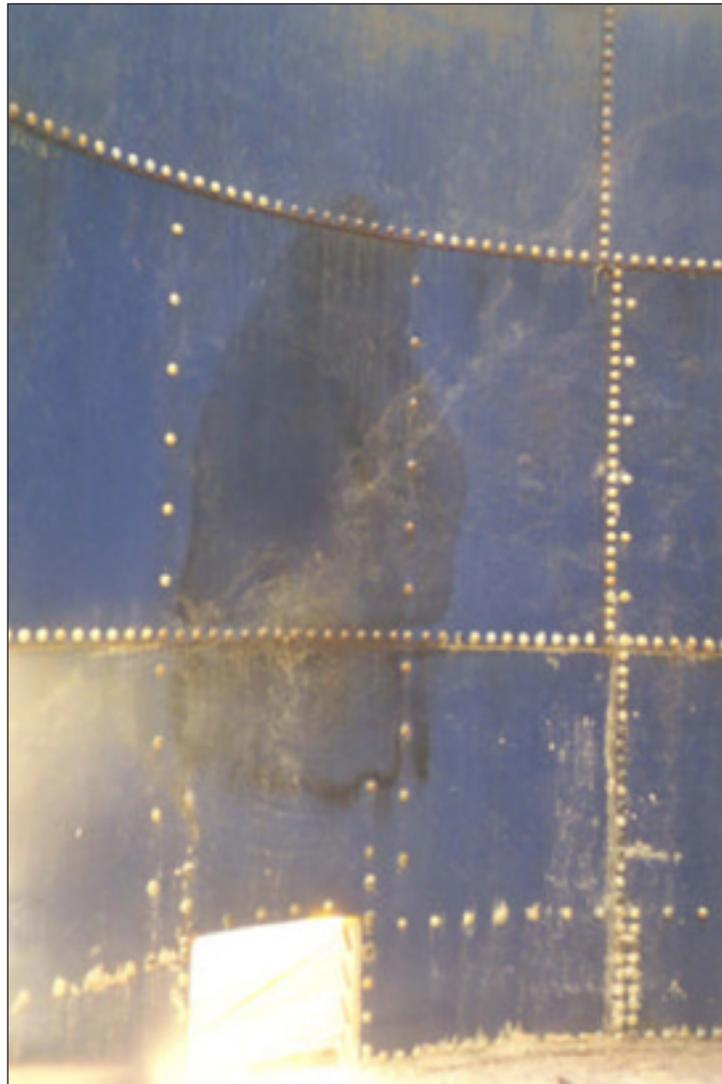
Photo 5. Smaller access panel indicating burning in stack about 2' x 2' access panel (panel removed for post-fire investigation)

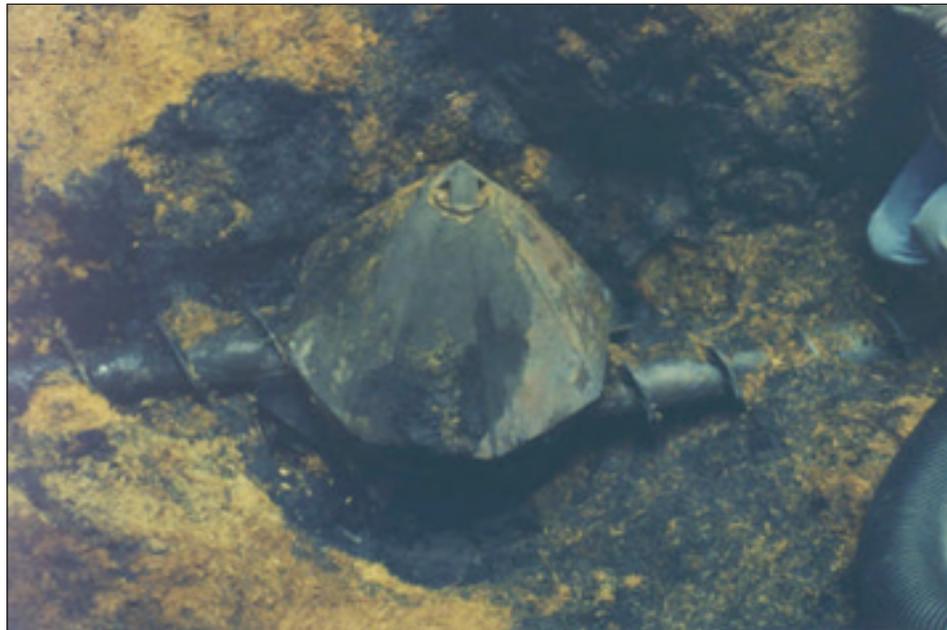
The fire marshal determined that the fire started when the gear box seized – burning the belt of the drive unit. The actual fire origin was deemed to have come from the plant side rather than from inside the silo. The day of fire origin was estimated to have been Tuesday or Wednesday. It was surmised that the fire burned void areas out of the sawdust over the auger. The fire also burned from the center toward the bolt holes in the access plates. (Photo #7).

Photo 6. Auger gear box, covered by a shield suspected origin of fire

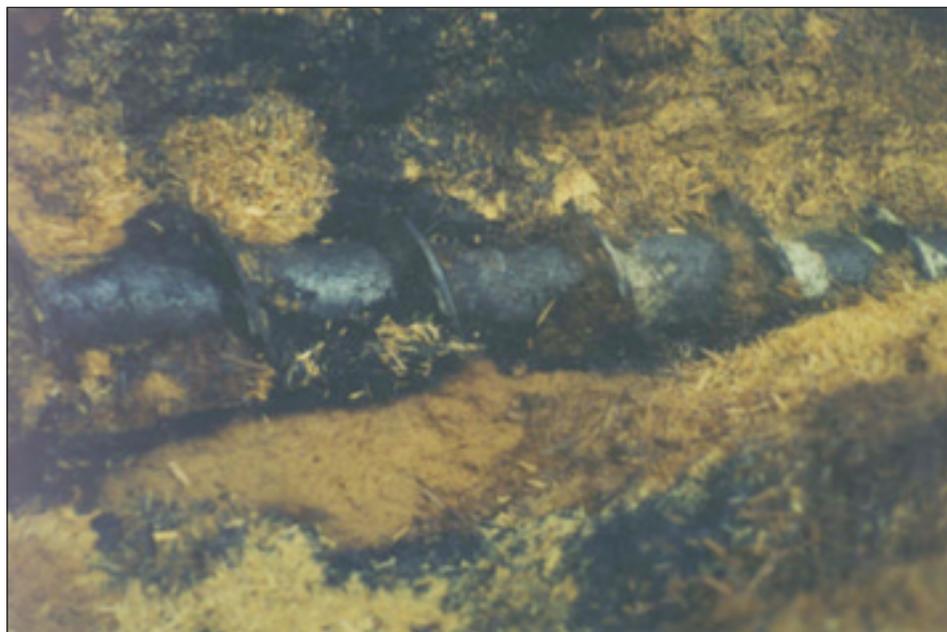
Photo 7. Fire travel along auger shaft

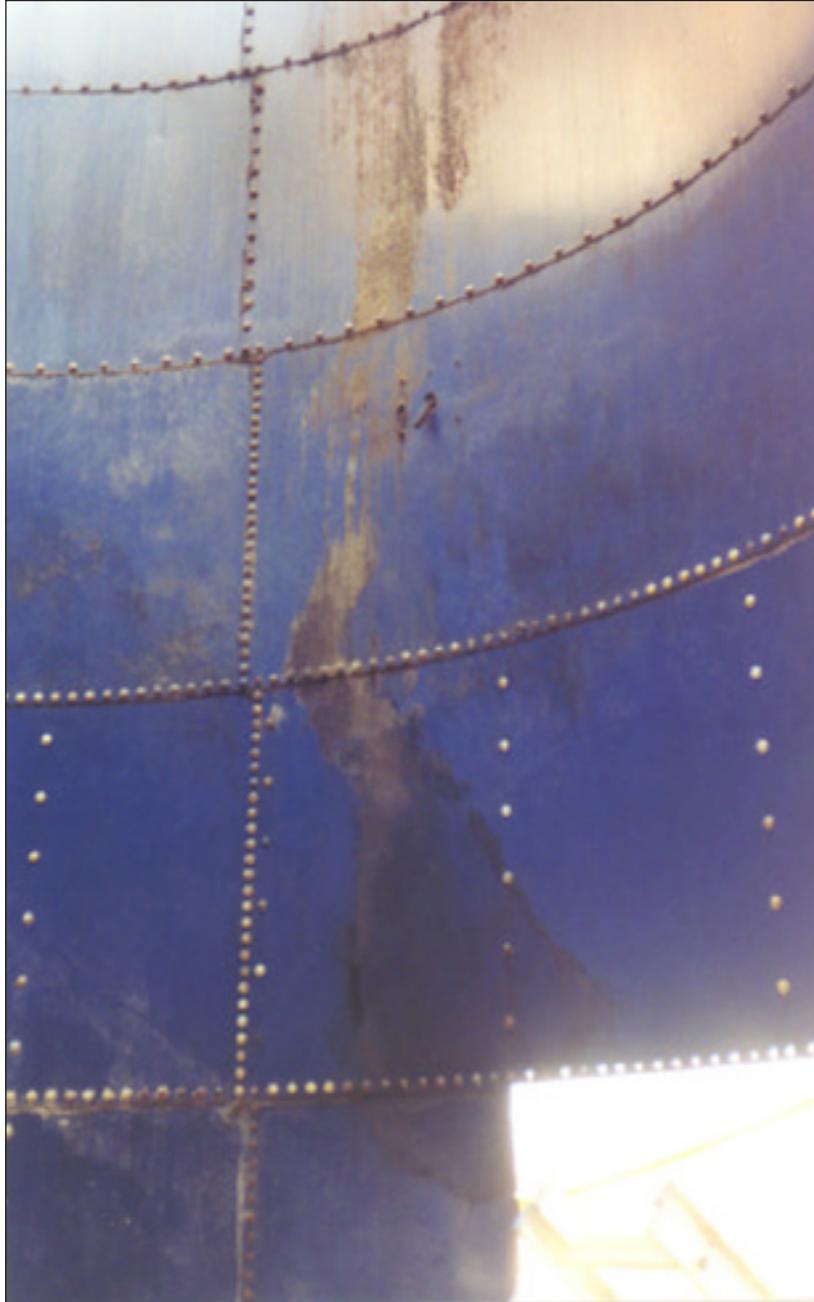
The explosion occurred when the 3 foot by 4 foot side panel was removed, thus allowing oxygen to enter the burning area. (Photo #8). Because of the compromise of the integrity of the shell by the bolts and access plate, a minute source of oxygen-bearing air permitted the fire to burn in finger-like fashion from the source in the gearbox to the silo wall. This was an area of deep-seated, incomplete combustion, which needed only a source of oxygen to ignite explosively. This is consistent with backdraft-like explosions that have occurred in agricultural product silos. The sawdust also entrained dust to combine with the rapid oxidation of the backdraft to produce the energy sufficient to damage the silo and injure firefighters. The water applied in the extinguishment attempts apparently either ran off the surface or was absorbed and acted as a tamper over the burned out voids in the wood waste.

Photo 8. View from inside silo showing burned-out areas in relation to access panel (origin of explosion)
