U.S. Fire Administration/Technical Report Series

Multiple Fatality Highrise Condominium Fire

Clearwater, Florida

USFA-TR-148/June 2002

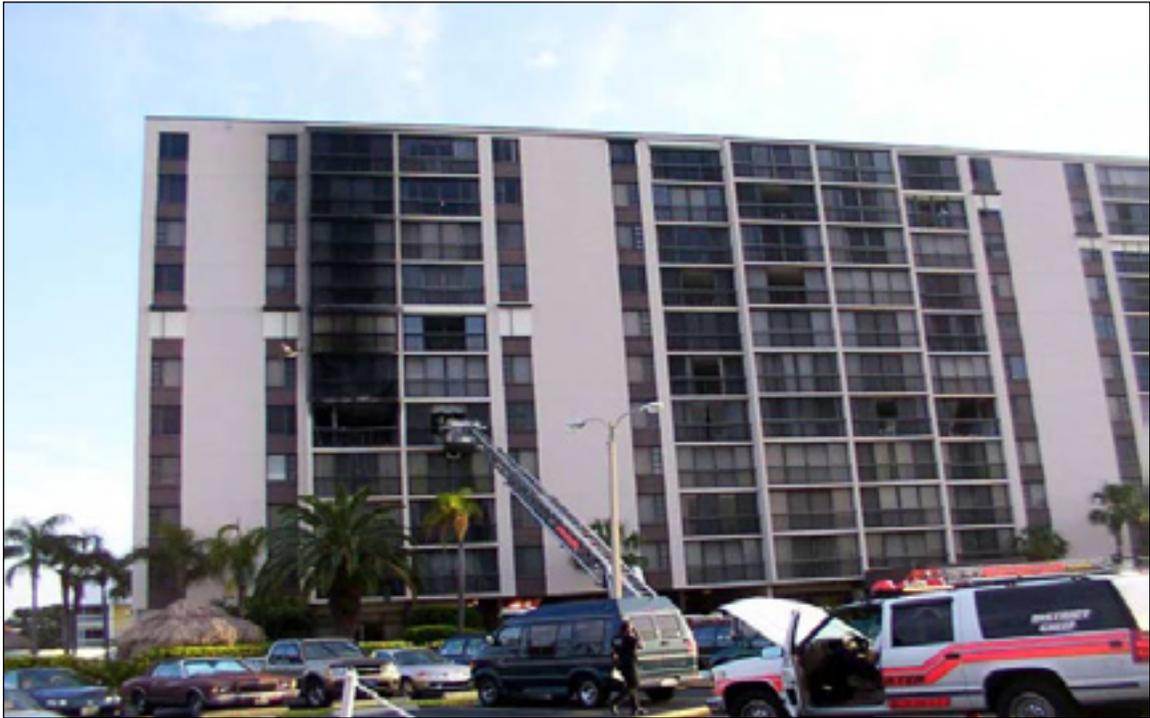
1. View of southwest corner of building; note location of Truck 45 and open sliding glass door of Unit 501 (area of origin) and extension up exterior face of building

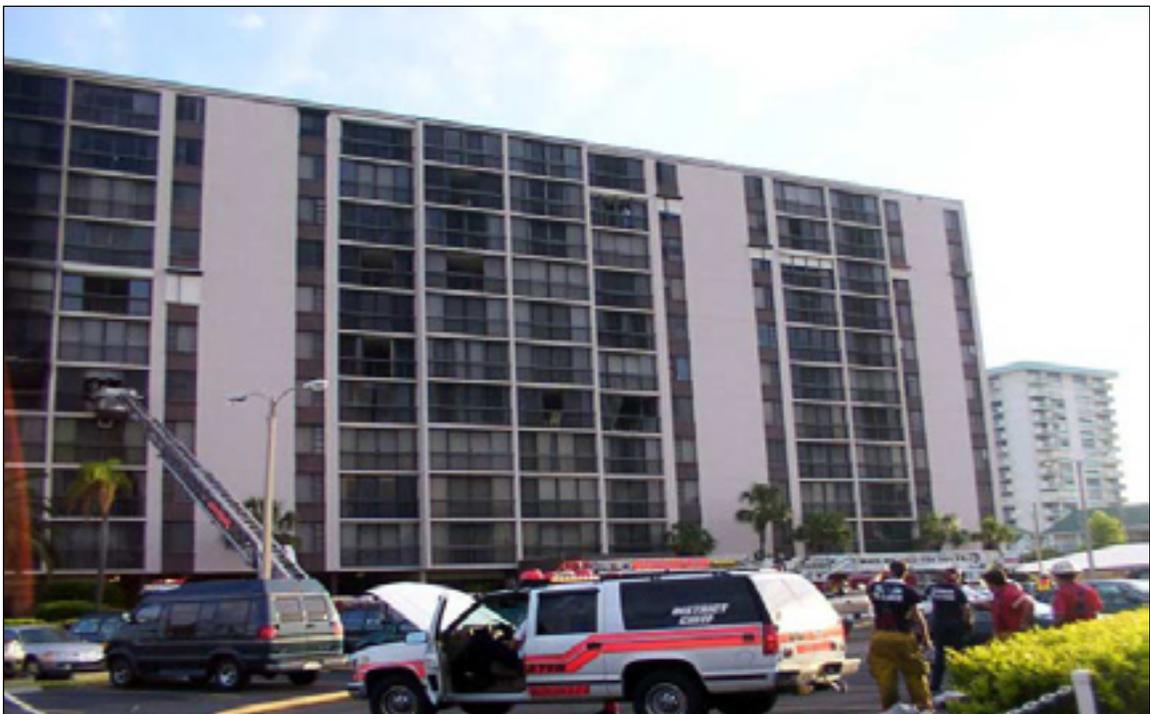
2. View of southeast corner

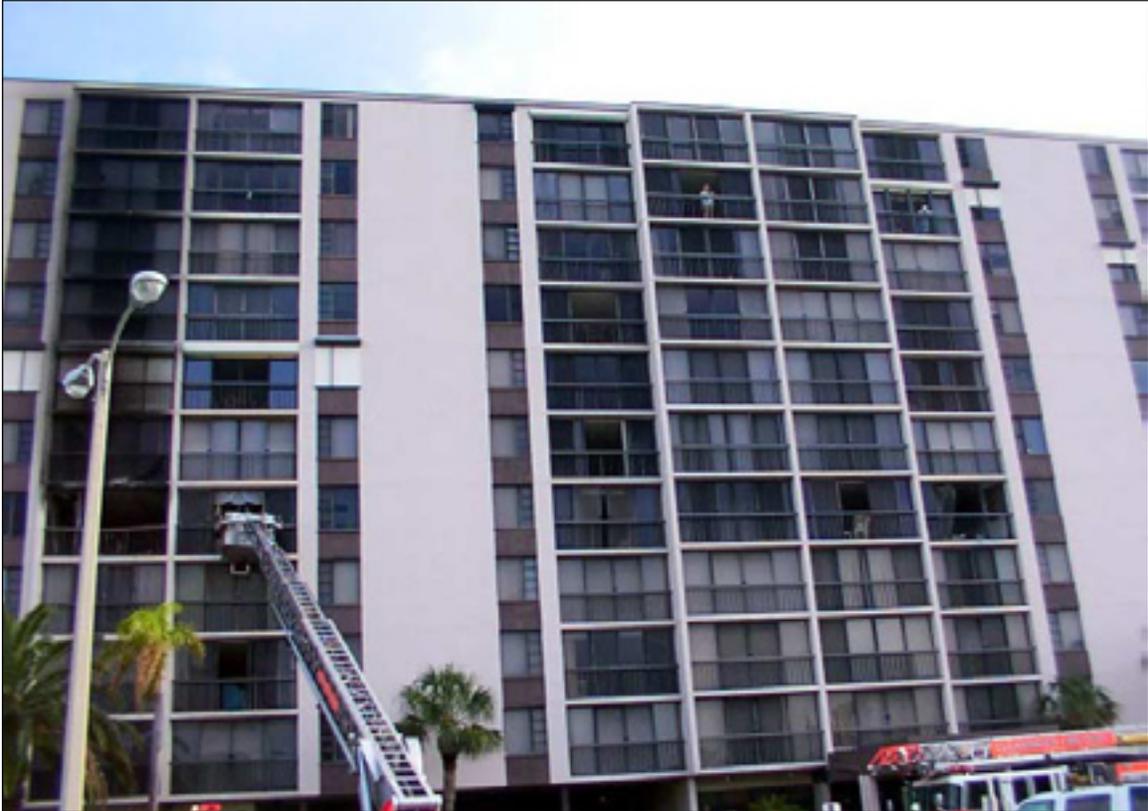
3. Note occupants on 10th floor balconies. This provides indication of the narrow depth of balcony landings.

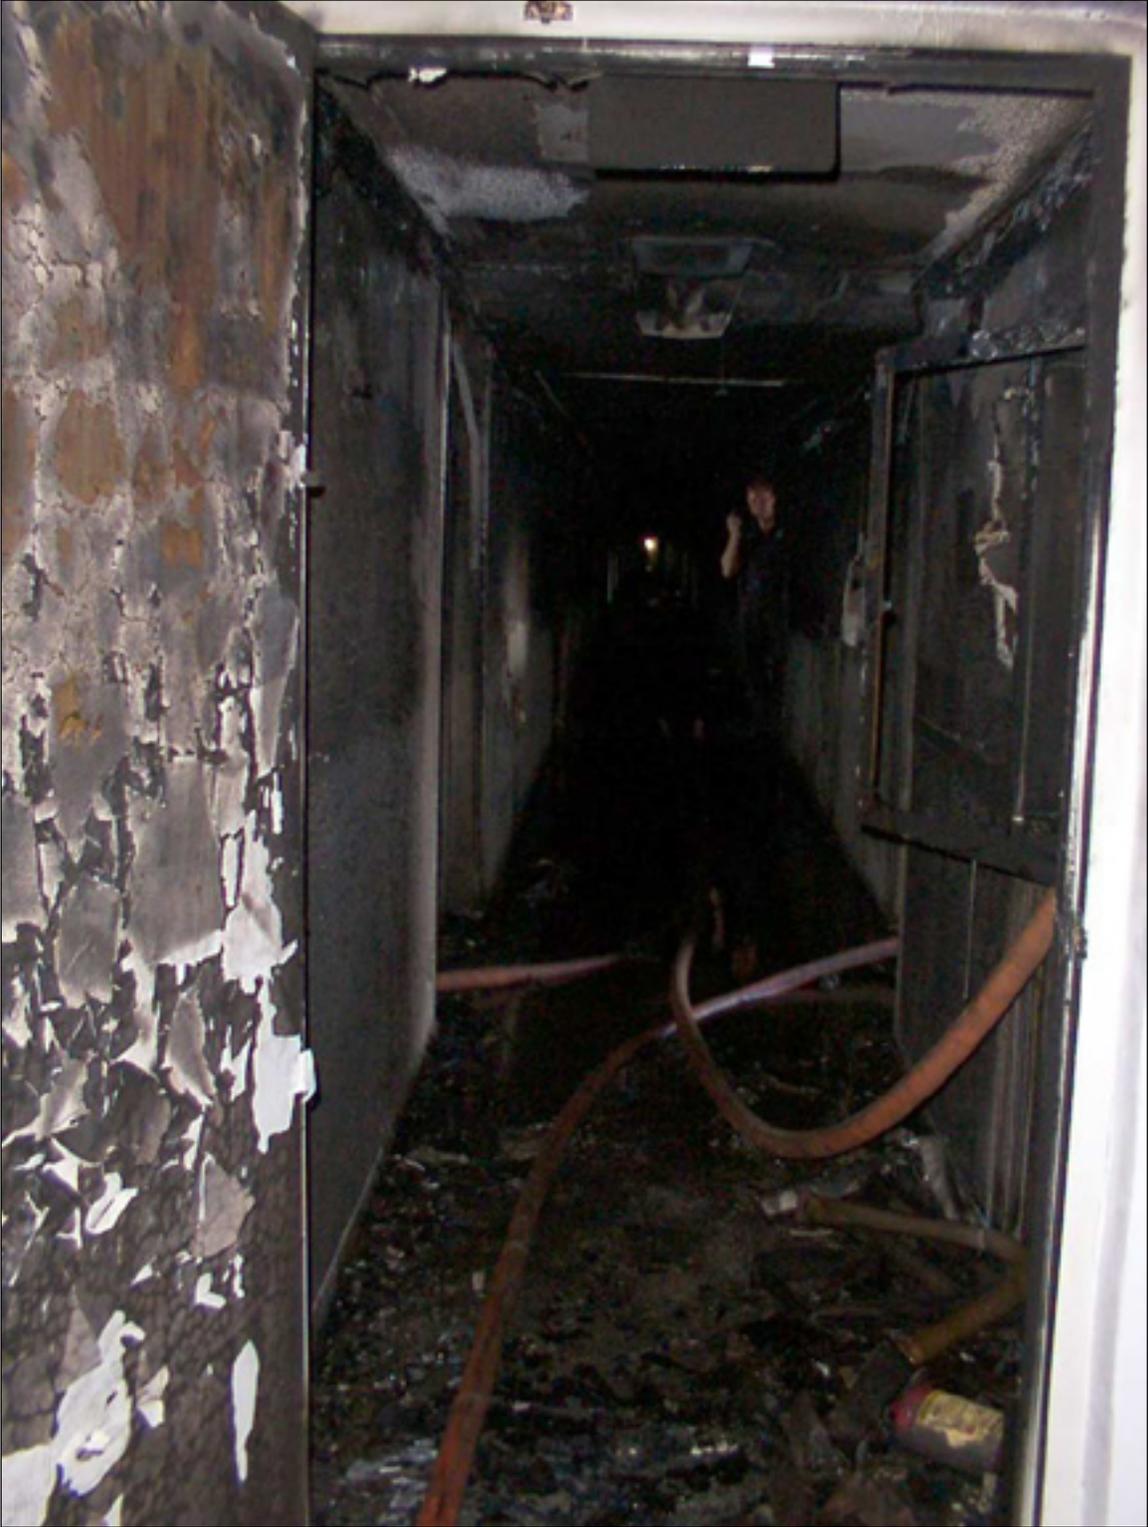
4. View of damage to fifth floor hallway.

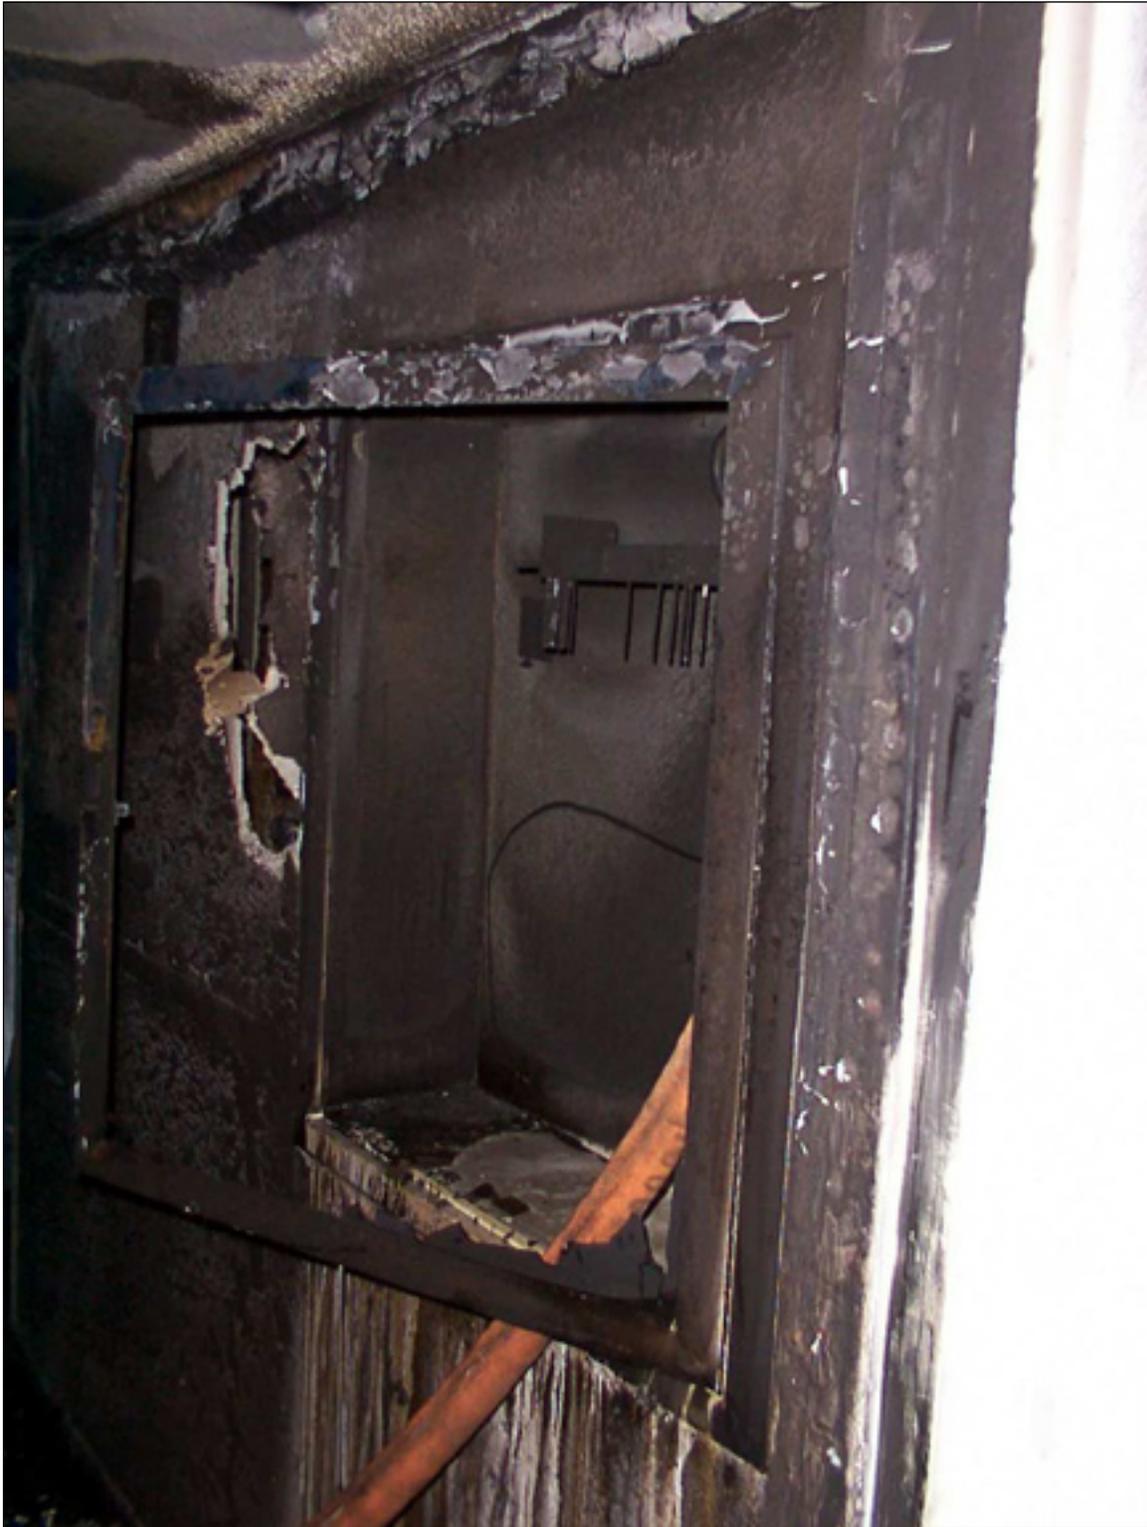
5. View of FD line attached to standpipe connection near west stairwell.

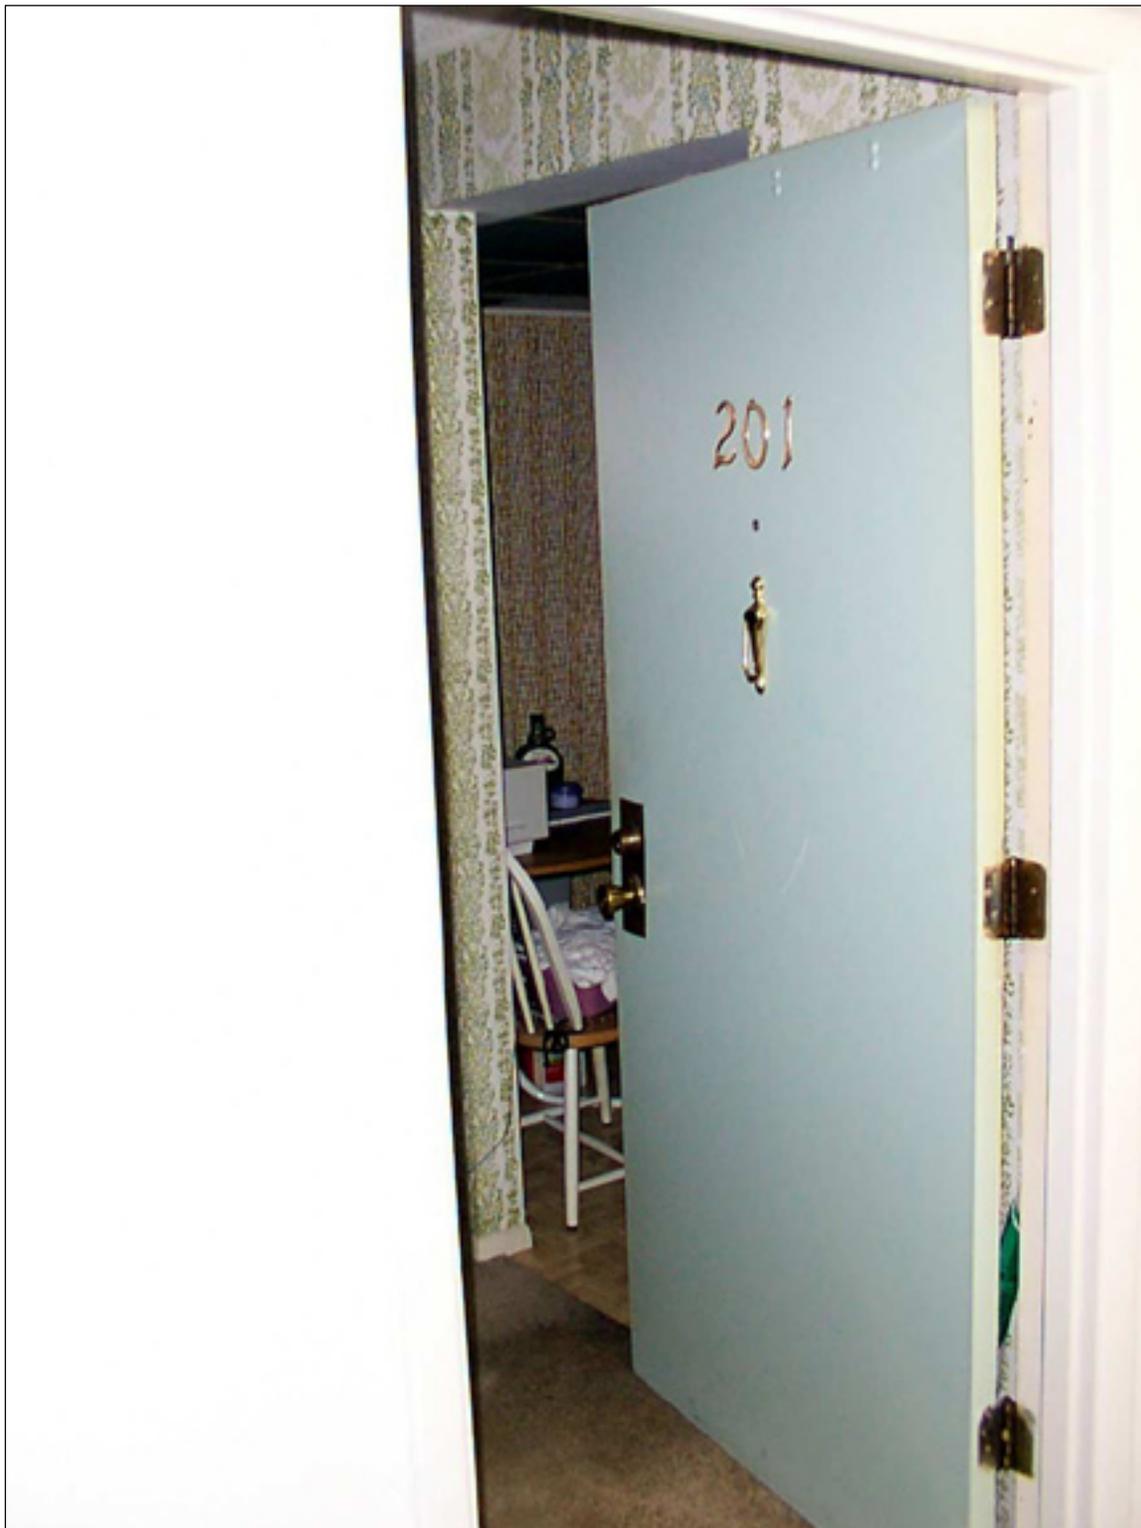
6. Representative occupancy door to condo units. This unit is three floors below unit of origin and is equipped with automatic door closure.

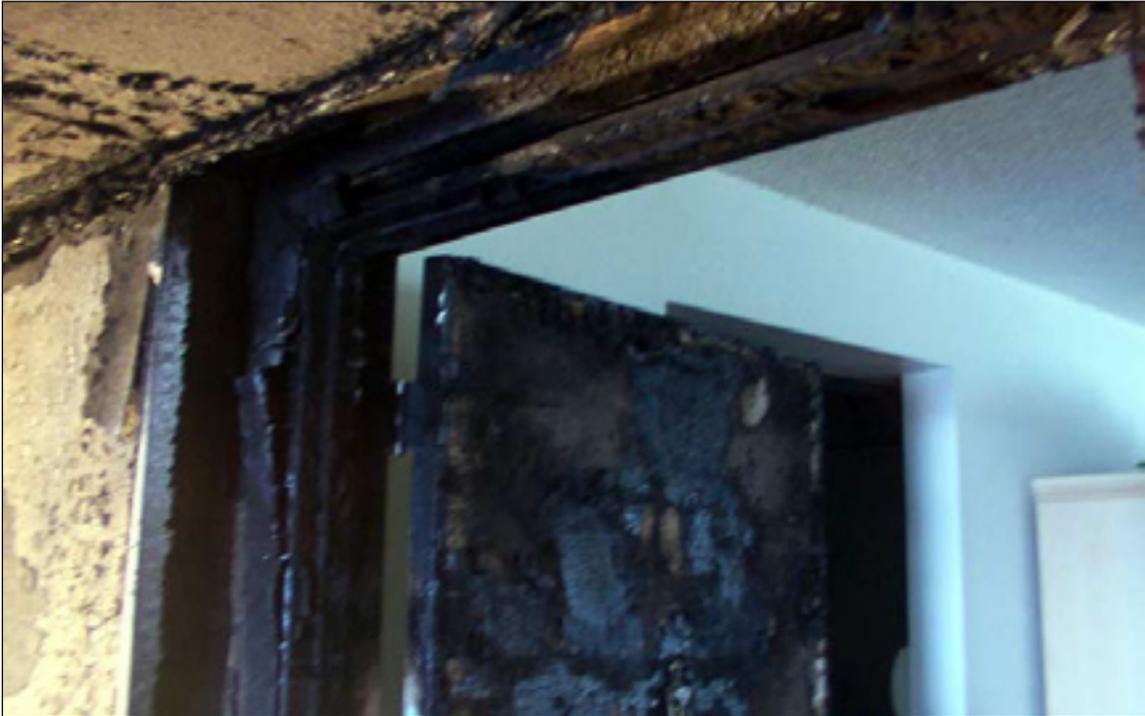
7. Door to Unit demonstrating how well the doors held

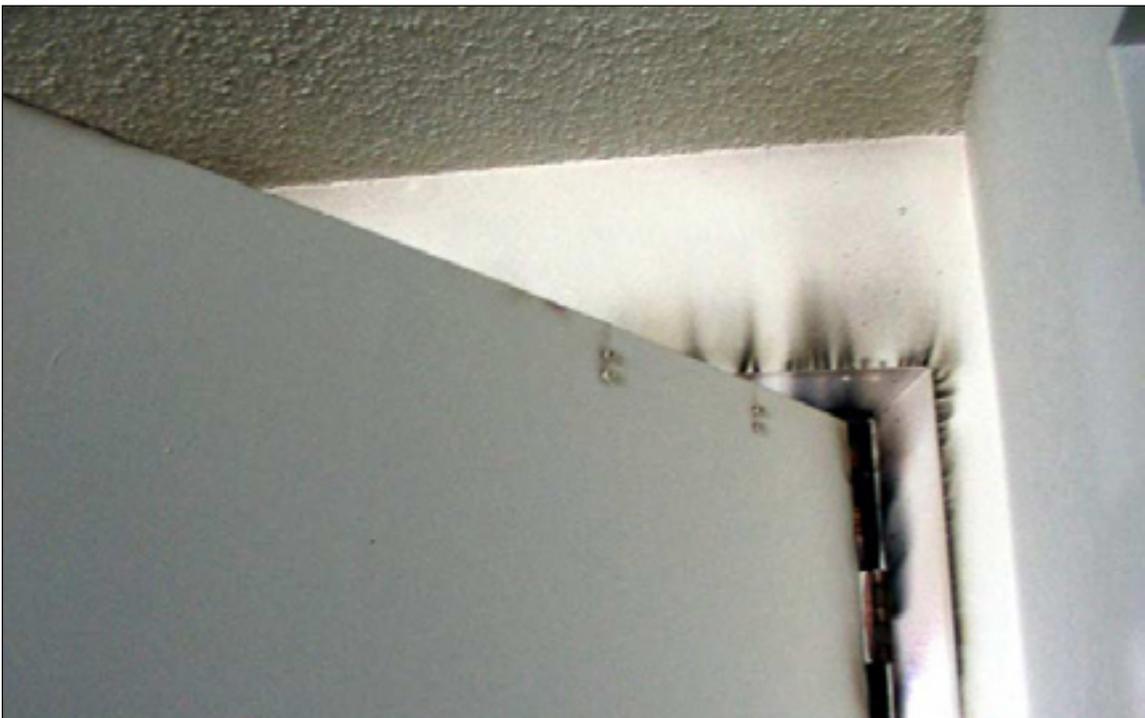
8. Smoke penetration around door into unit on fifth floor.

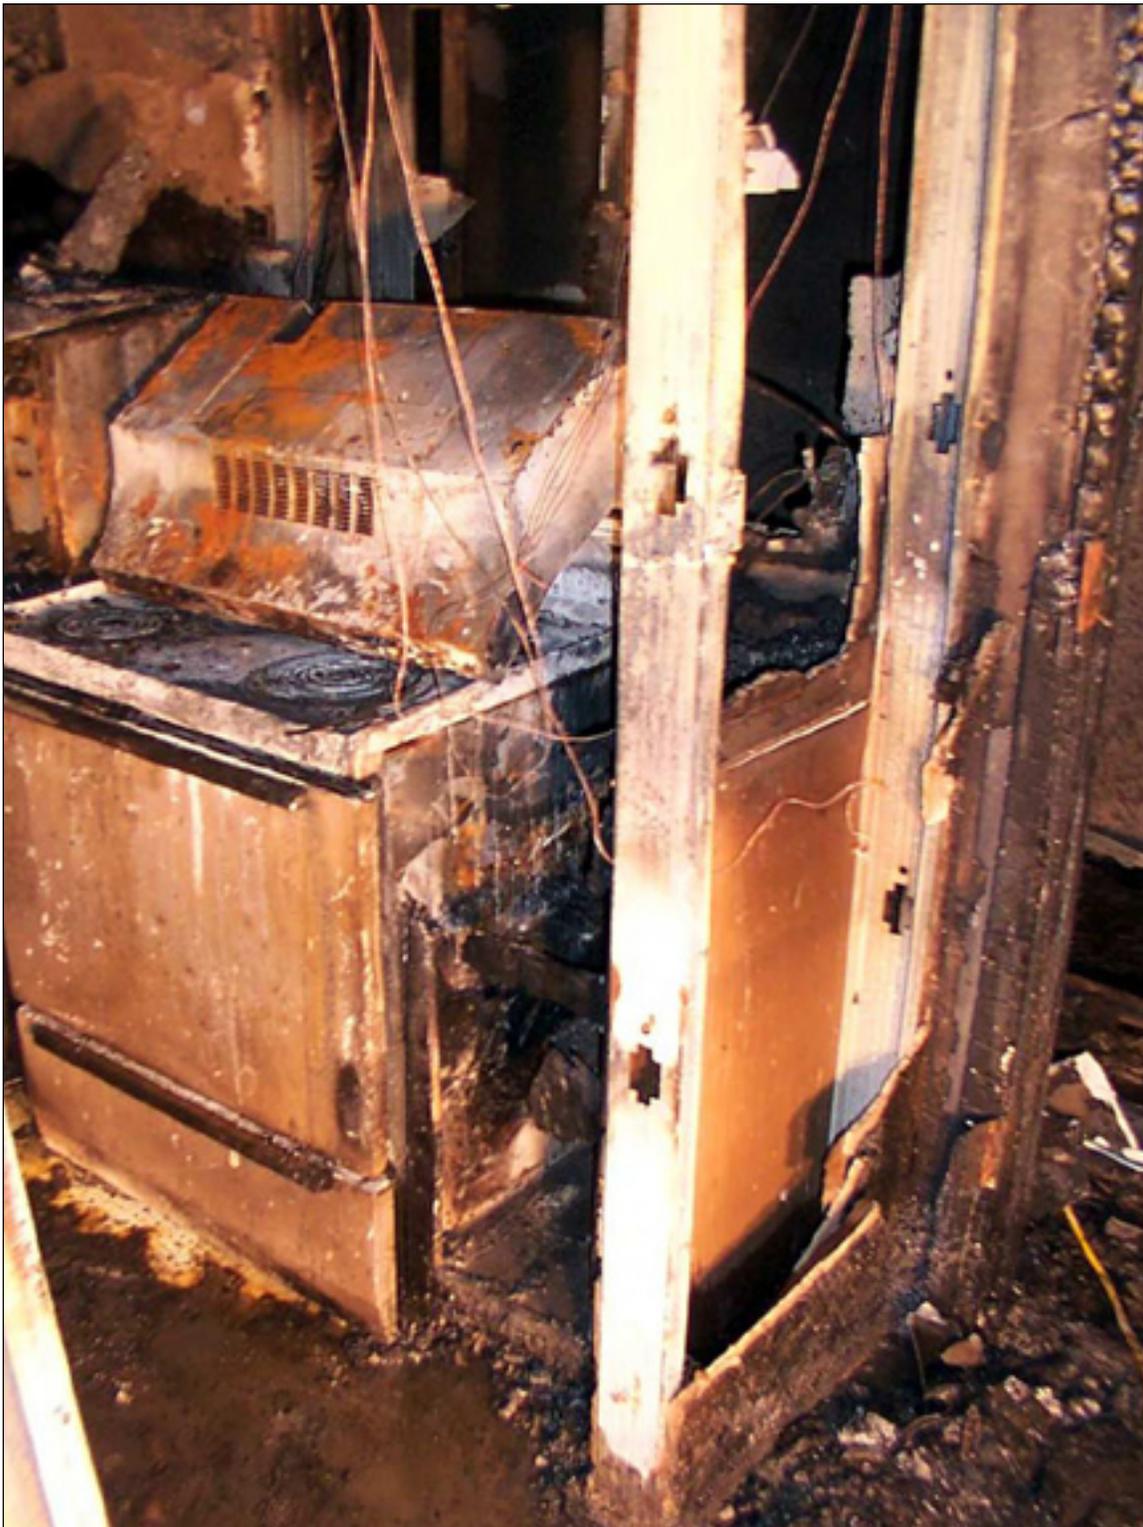
9. Stove and hood in Unit 501, note door opening into hallway right hand portion of picture. Photo shows metal studs, typical of interior construction.

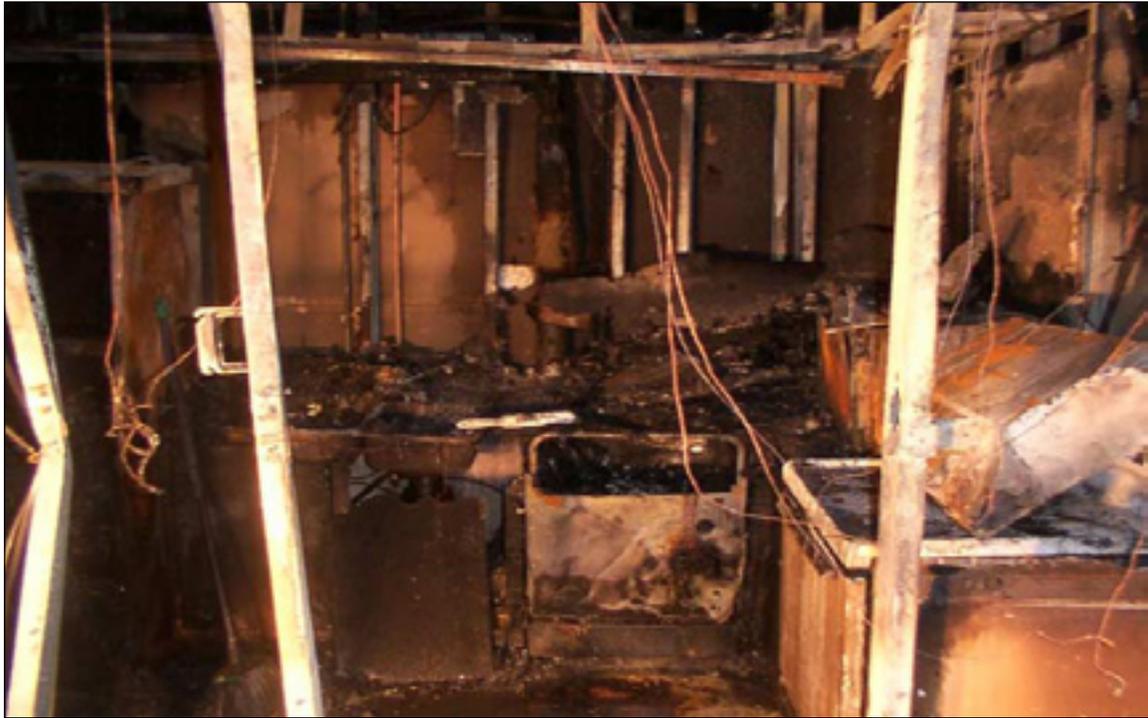
Investigators concluded that the fire was accidental and caused by the burner on the right front of the electric stove located in the kitchen of Unit #501 being left in the on position, which ignited combustibles that were present on the stovetop.

10. Area of origin, kitchen of Unit #501.

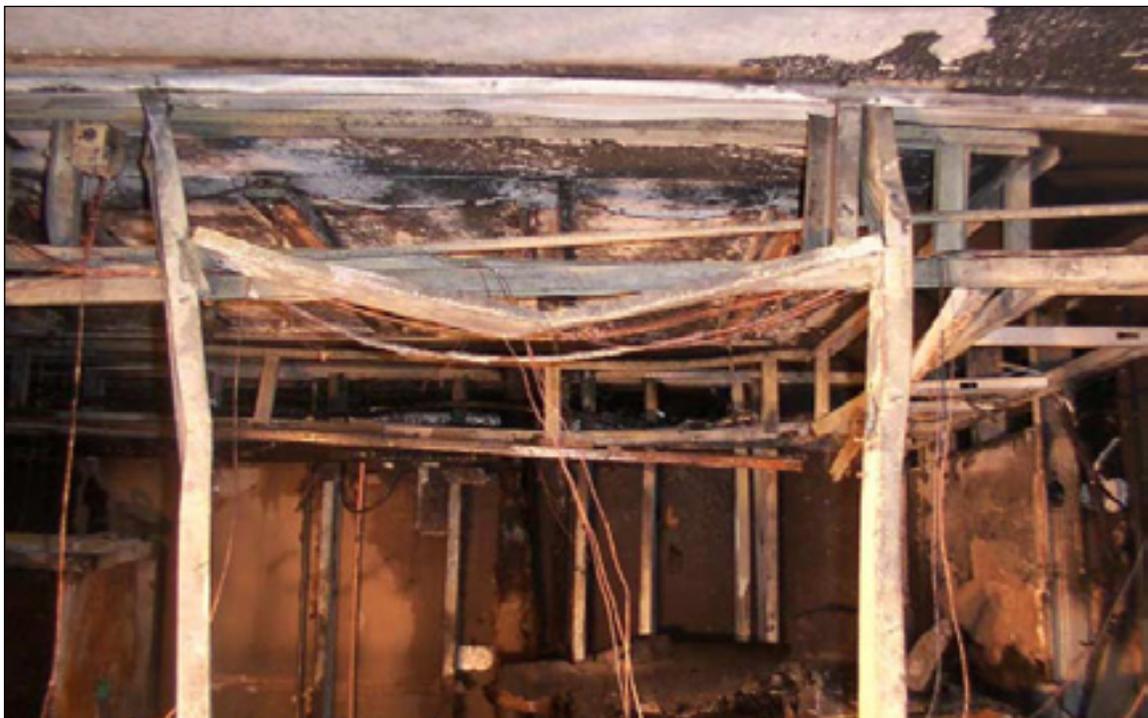
11. Note top of photo: shows concrete floor typical of building construction.

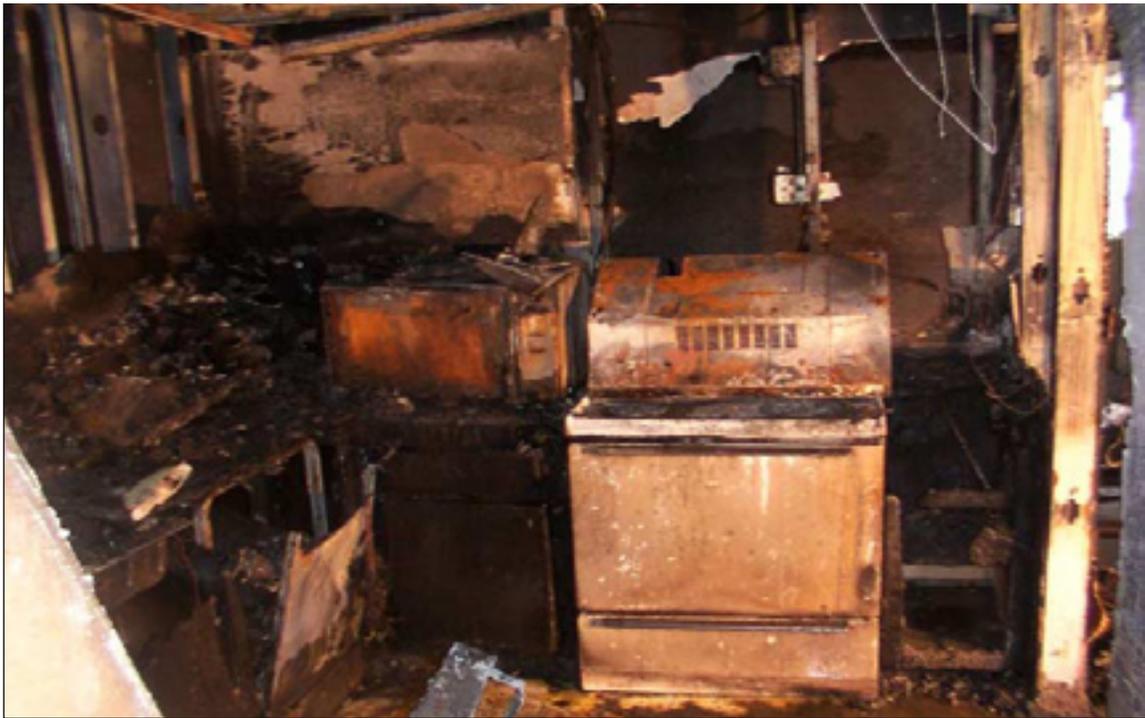
12. Interior view of kitchen showing extent of damage.

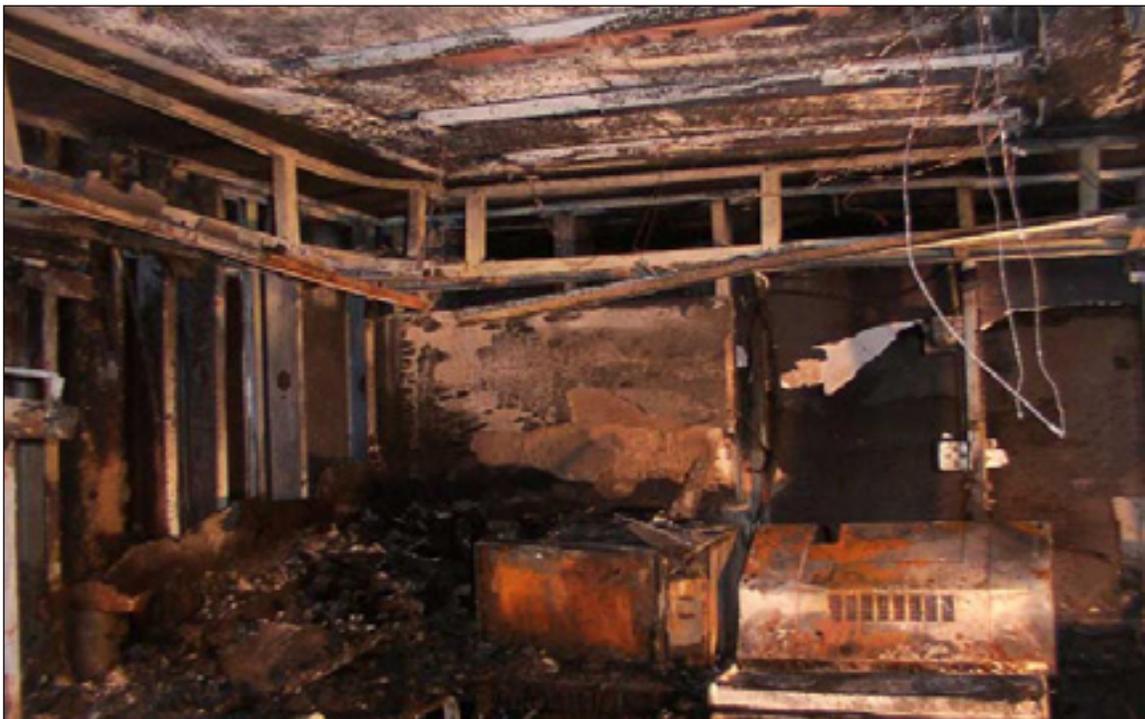
13. View of interior of kitchen and ceiling.

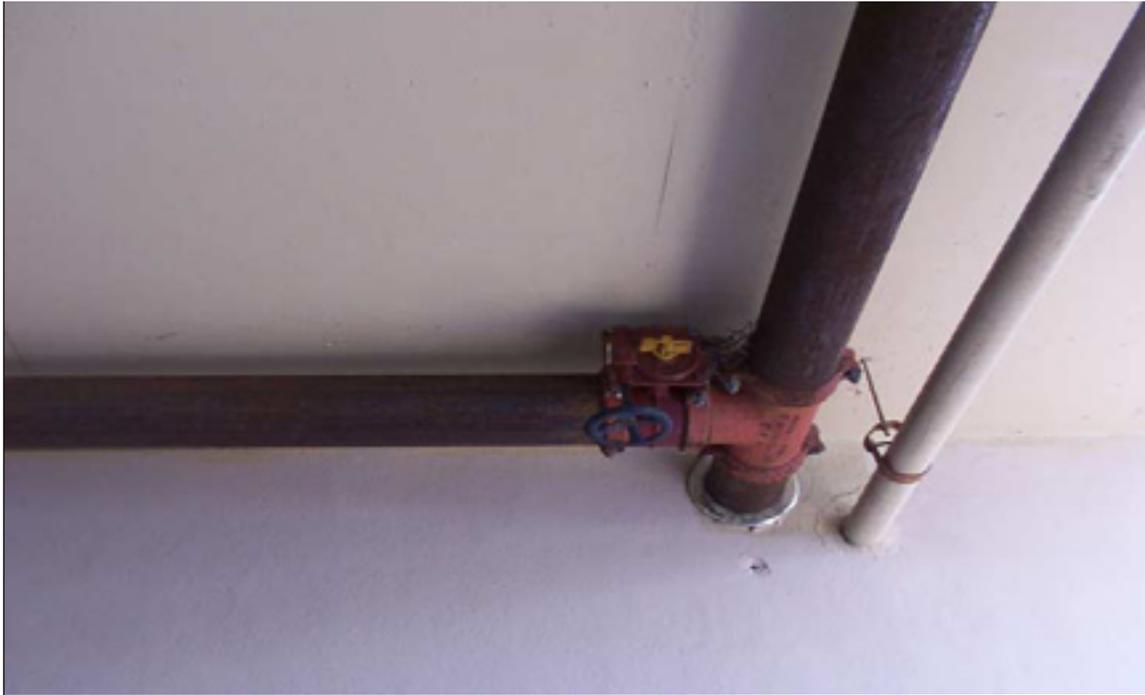
The control valves for the fire pump and standpipe system were monitored for position, except for the valve controlling the water supply to the center riser. For some reason the monitor for this valve was not connected to the fire alarm system. The control valve that was closed was approximately fourteen feet from the ground and not readily visible.

14. Control valve to central standpipe riser found to be closed during fire.

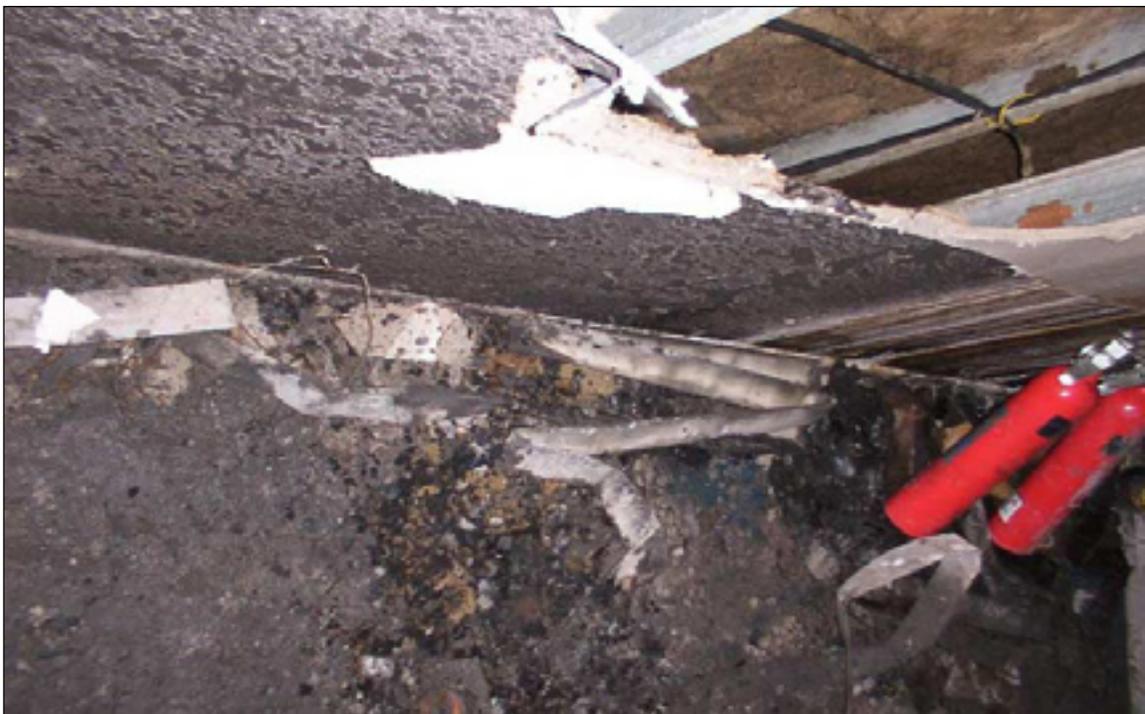
15. Two discharged 5-lb. ABC extinguishers and 1-1/2-inch house line found outside Unit 501.

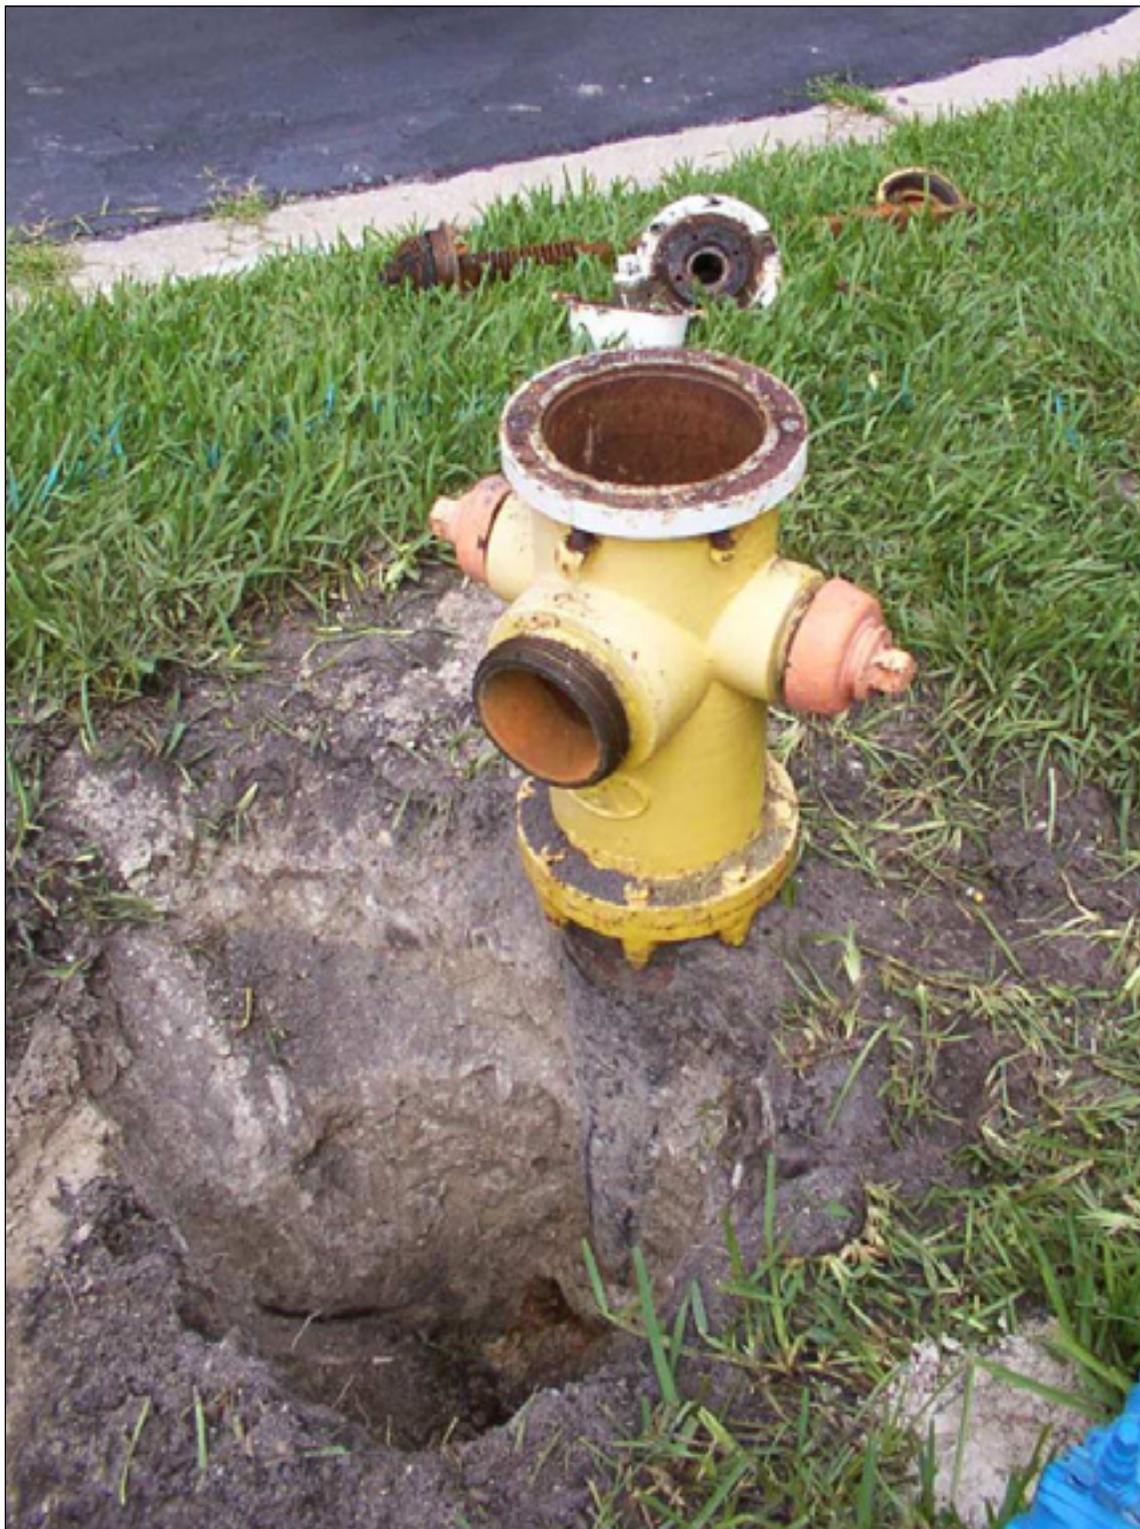
16. Hydrant that failed to operate during fire; note parts in background.

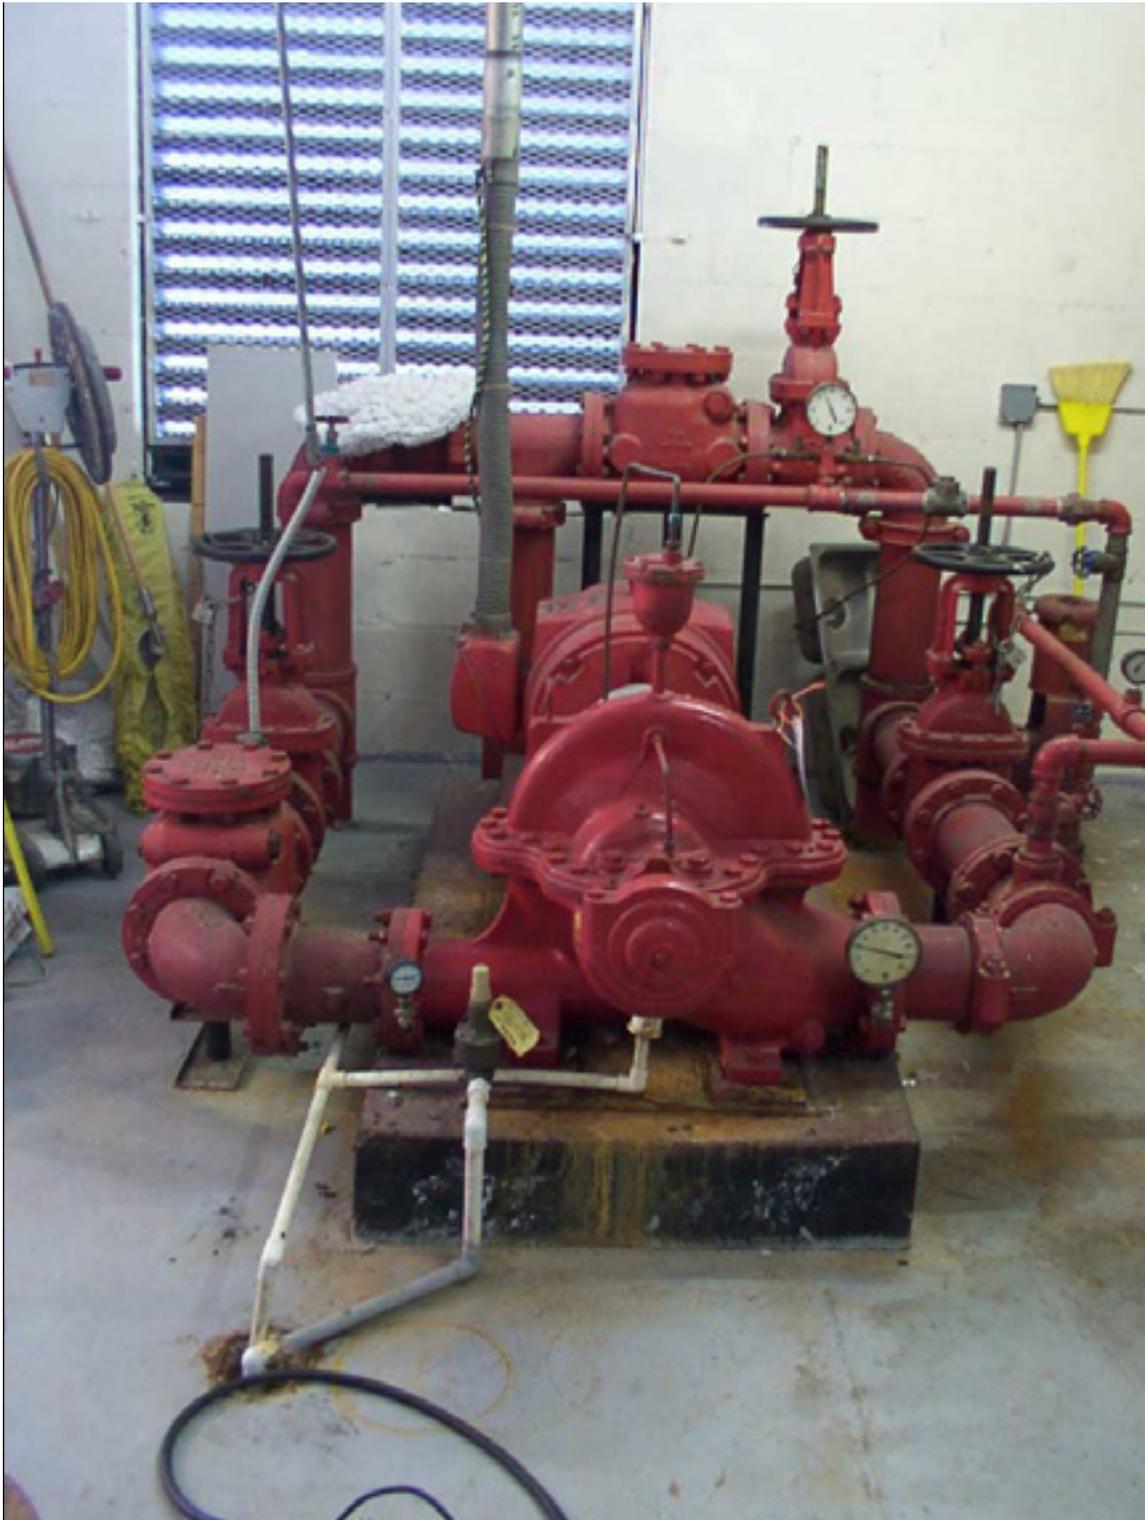
17. Electrically powered fire pump rate at 1,000 gpm at 90 psi.

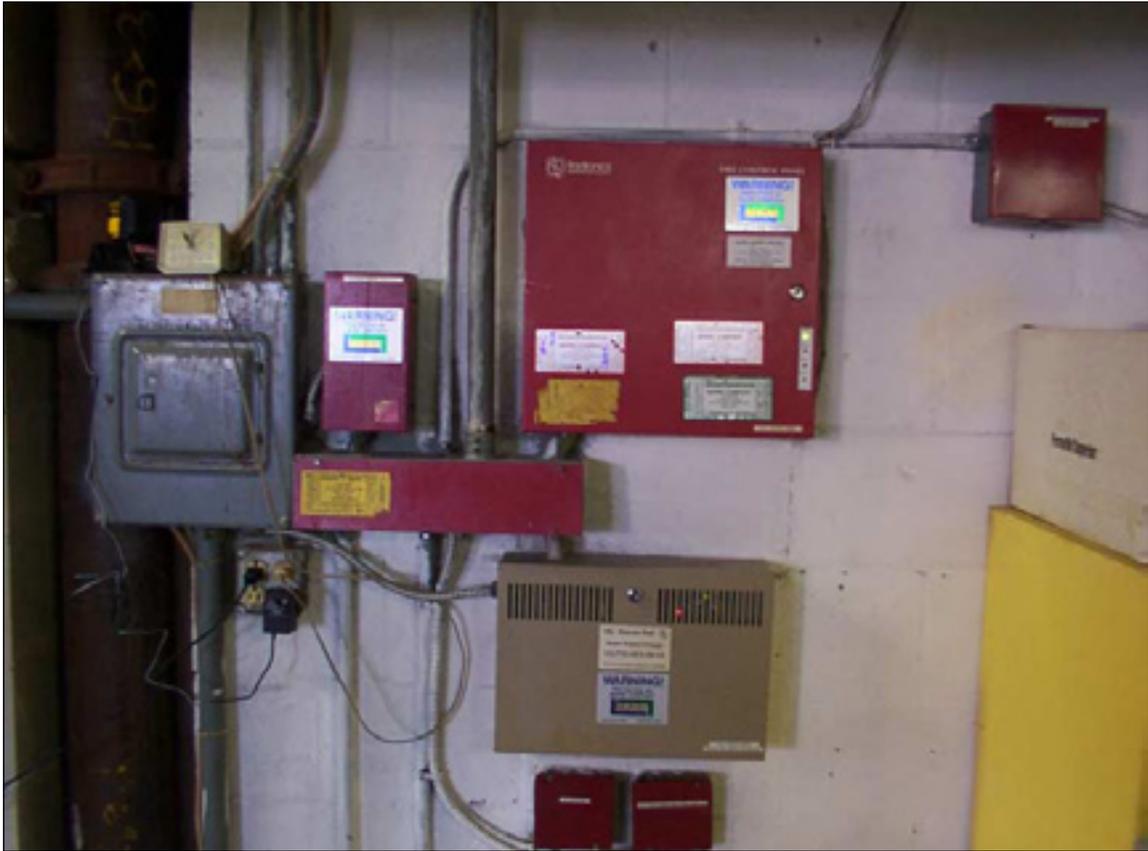
18. Alarm panel located in second floor mechanical room.

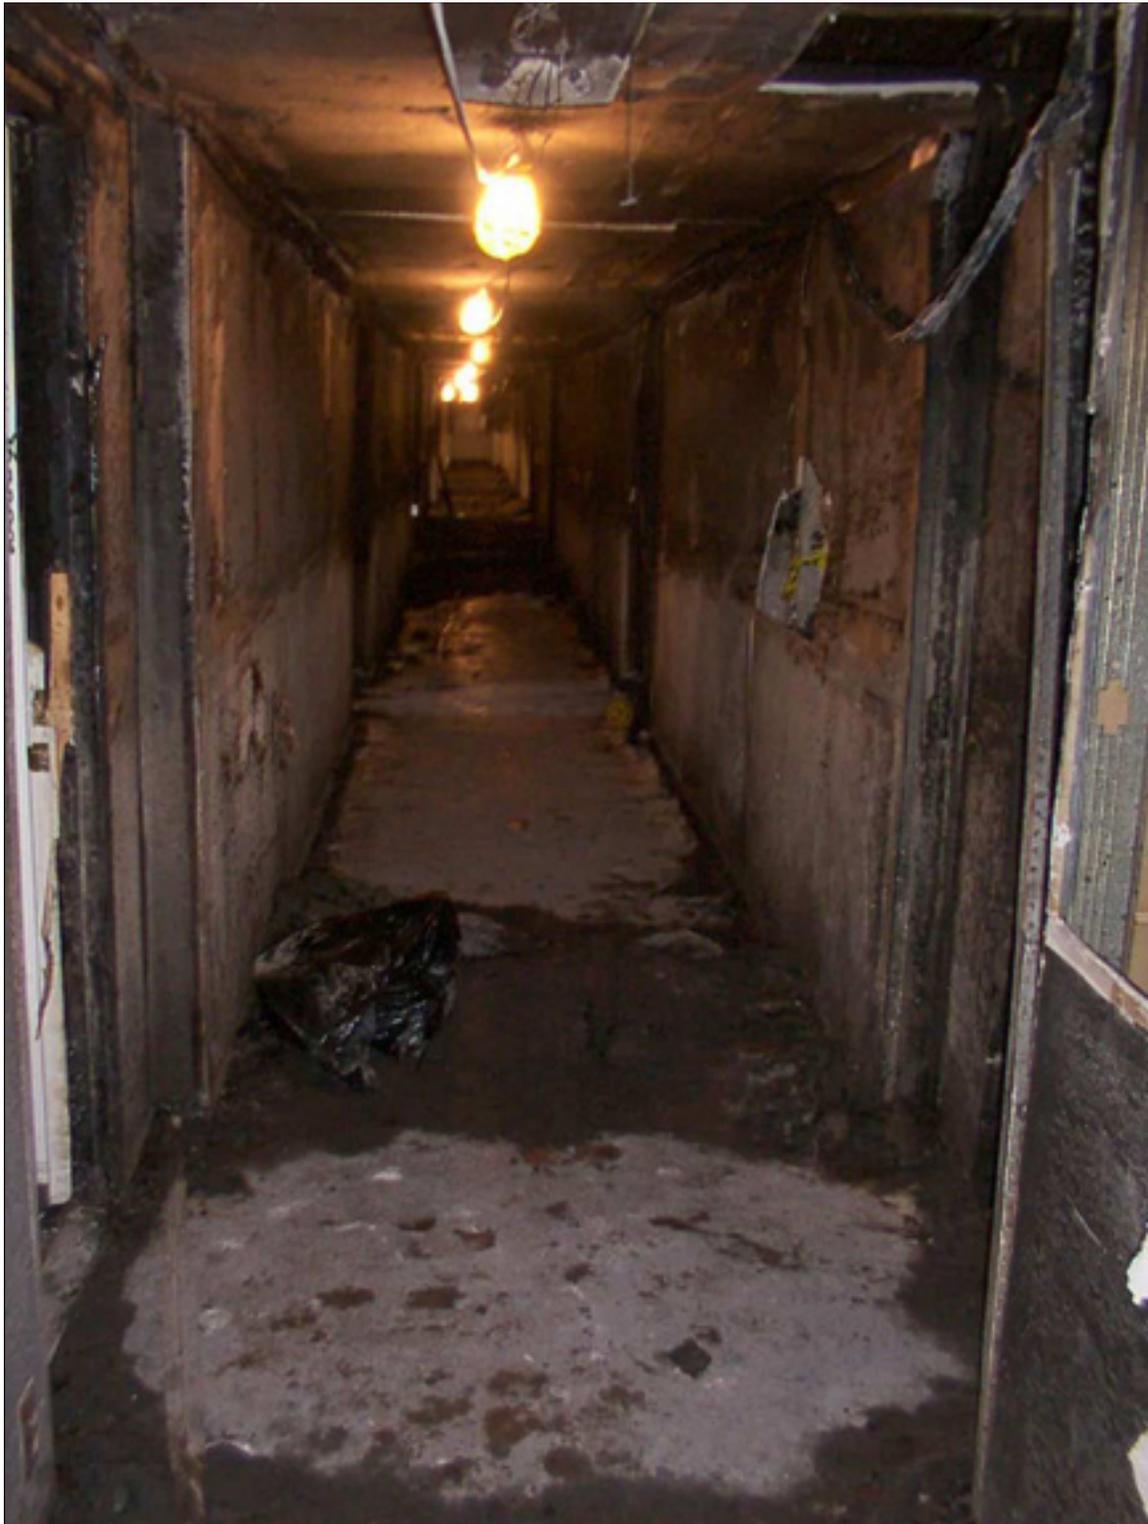
19. Extent of damage to fifth floor hallway.
