U.S. Fire Administration/Technical Report Series

Multiple Fatality Highrise Condominium Fire

Clearwater, Florida

USFA-TR-148/June 2002

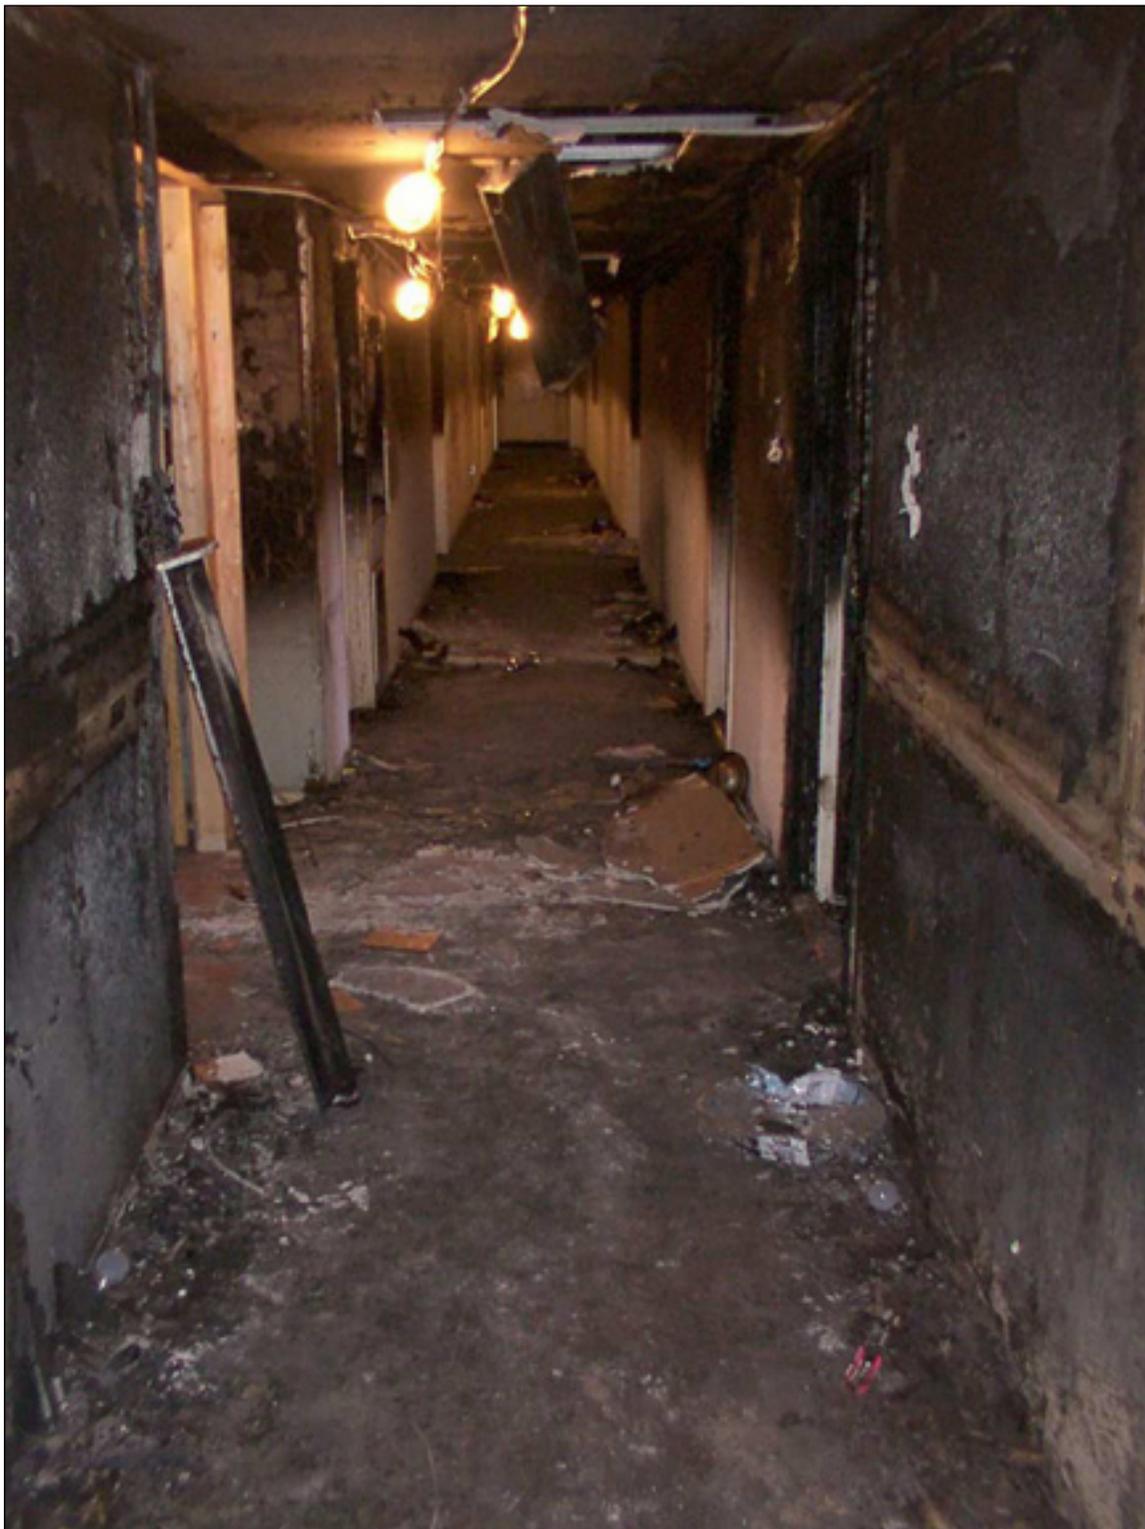
20. Damage to hallway east of elevators, note less damage midpoint to floor.

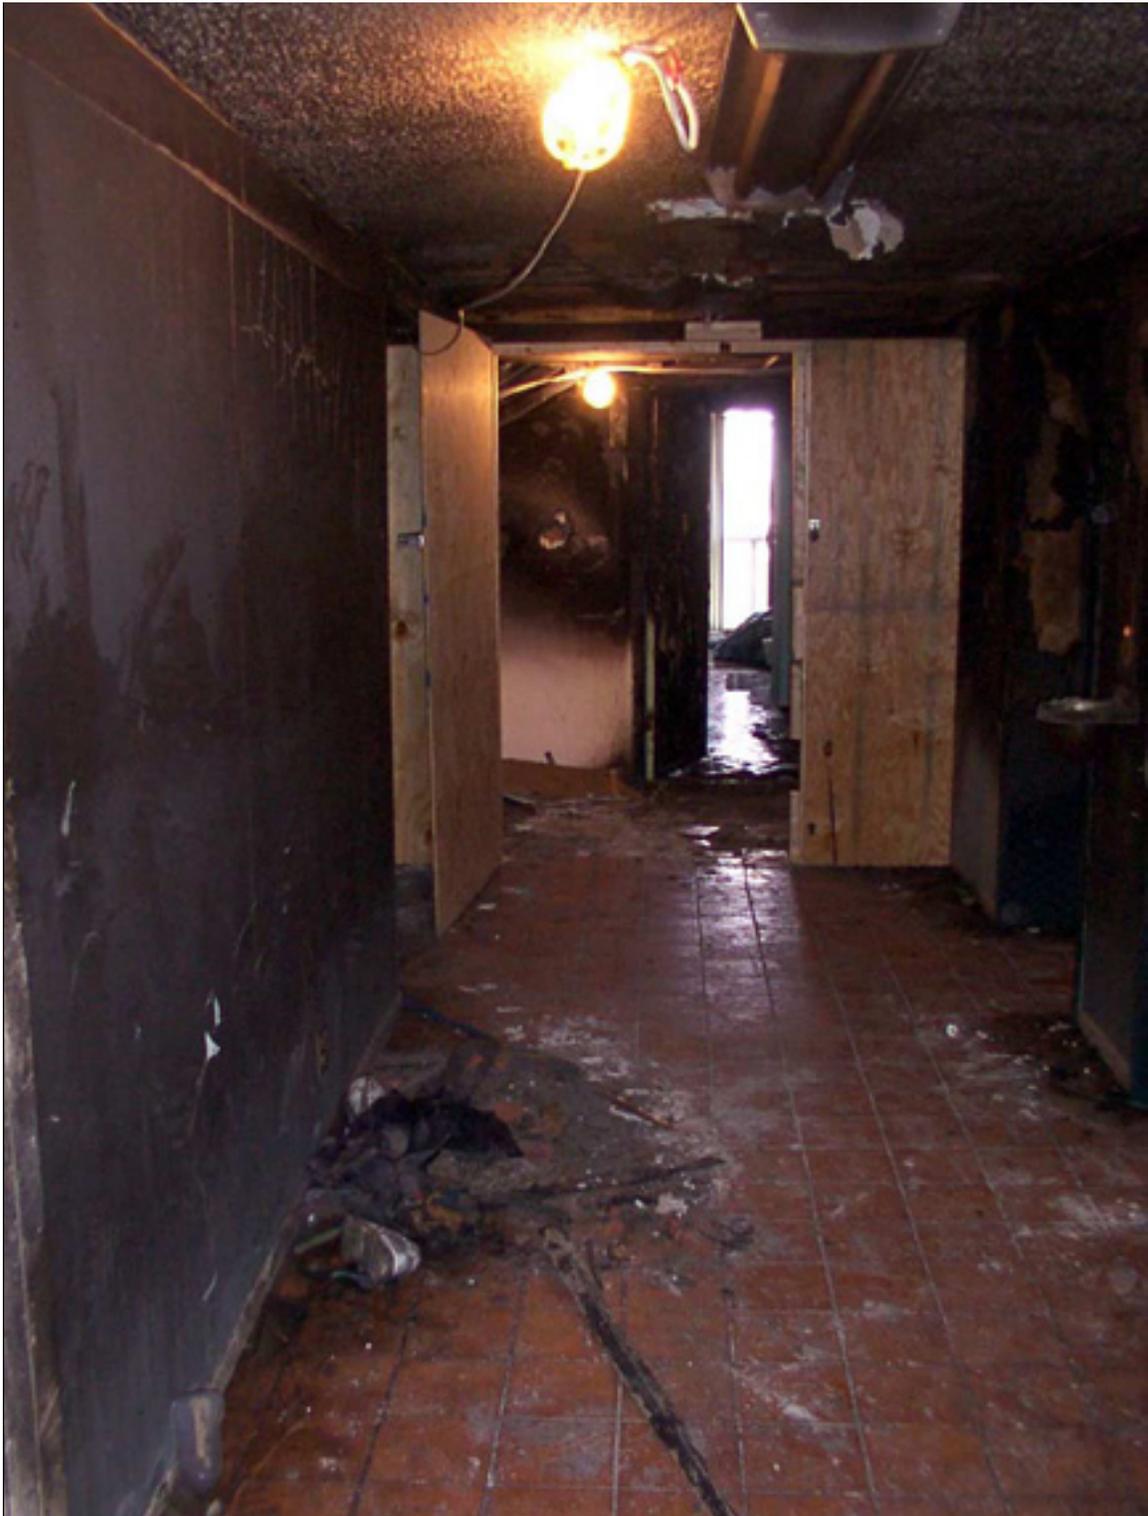
21. Fifth floor elevator lobby

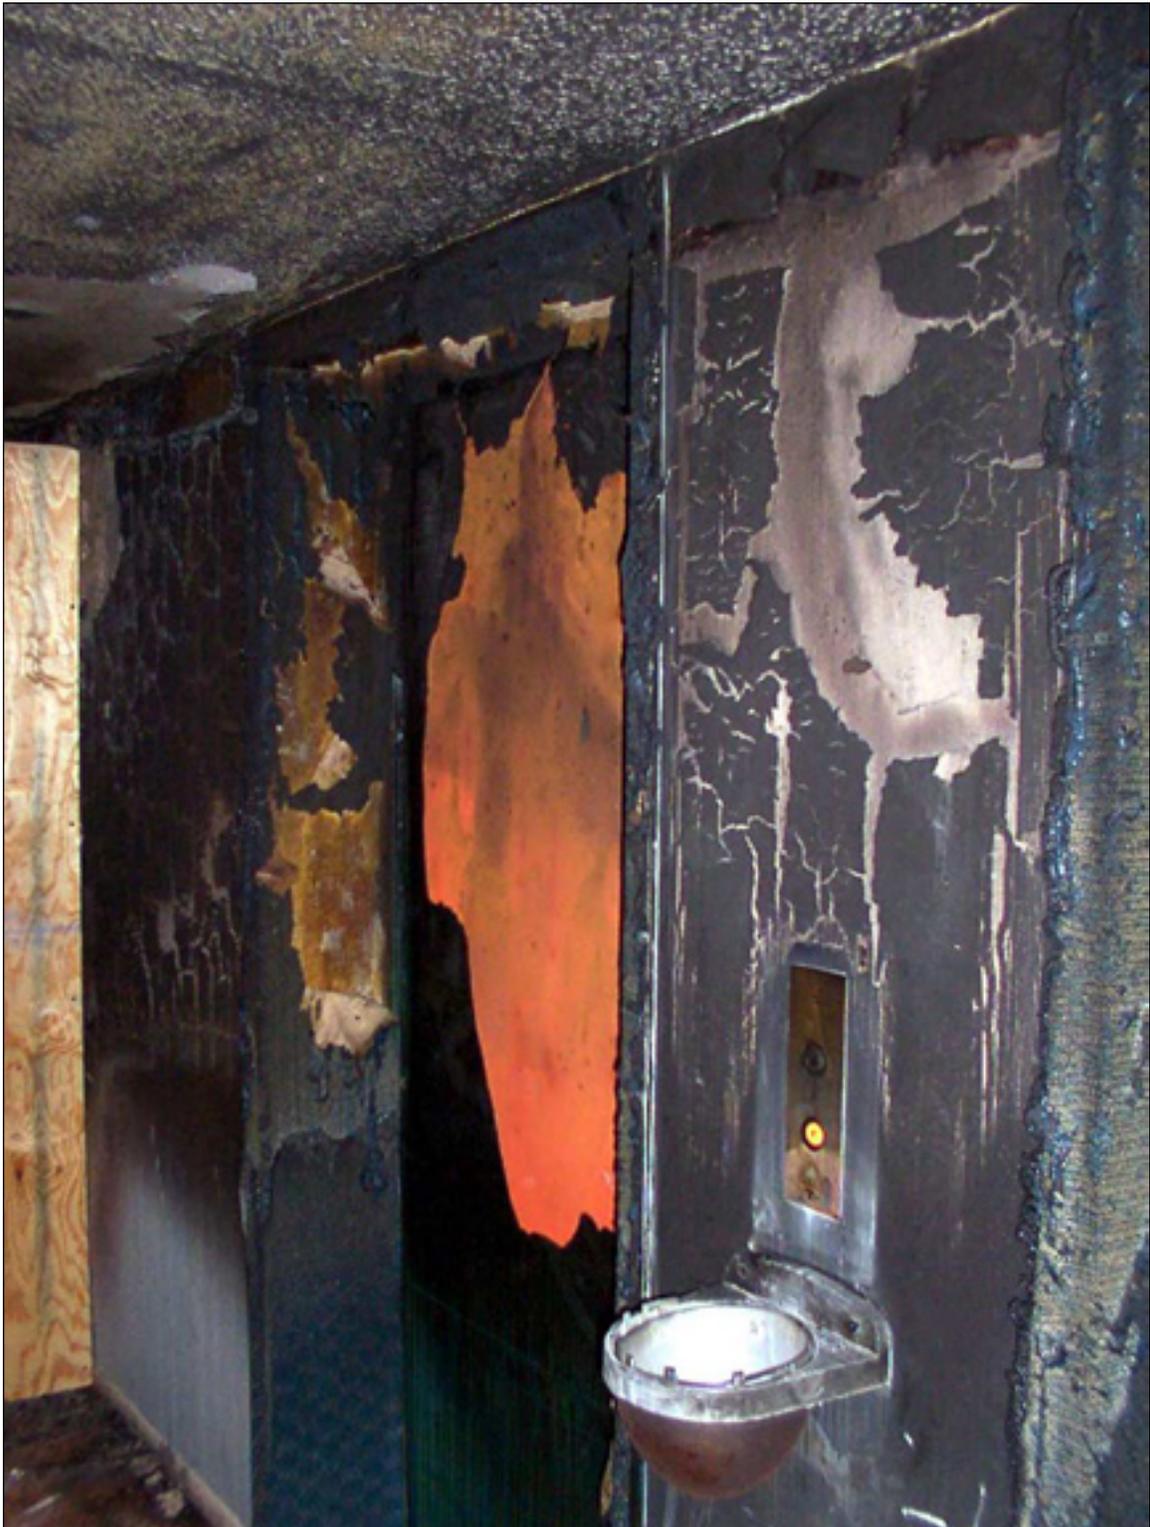
22. Fifth floor elevator doors and call buttons
