Coffee Break Training - Fire Protection Series

Inspection Techniques: Job Site Coordination

No. FP-2012-48 November 27, 2012

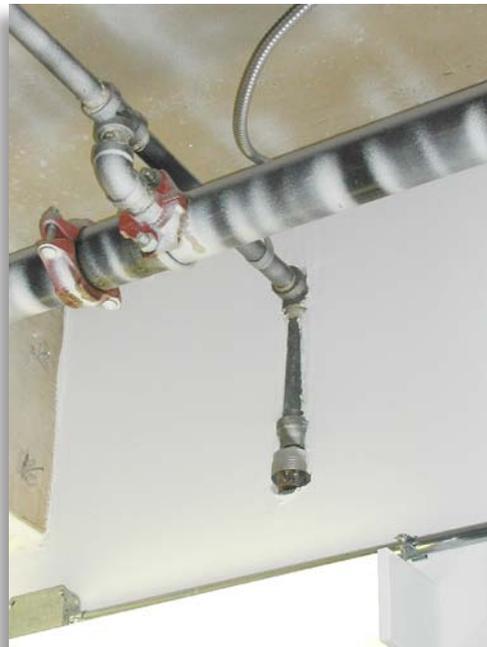
A temporary wall during a remodeling project interferes with the operation of this pendant sprinkler.

In this example, the framing and wallboard contractor was assigned the responsibility of erecting a temporary partition to isolate a tenant space from a corridor while the entire building was undergoing a significant remodeling project. According to the plans provided by the project architect, the contractor installed the partition specifically as directed. If he gave any thought to its effect on the fire protection system, the result speaks for itself.

Buildings under construction, remodeling, or even demolition are particularly vulnerable to fires. Workers often are using cutting torches or other open flame devices, there may be large amounts of combustible materials throughout the work space, and fire protection systems or fire barriers may be incomplete. Compromising the effectiveness of any fire protection component—such as the sprinkler system in today's picture—increases the likelihood of a catastrophic fire outcome.
