Ten Elderly Victims From Intermediate Care Facility Fire

Colorado Springs, Colorado

USFA-TR-050/March 1991

Ten Elderly Victims from Intermediate Care Facility Fire Colorado Springs, Colorado March 1991

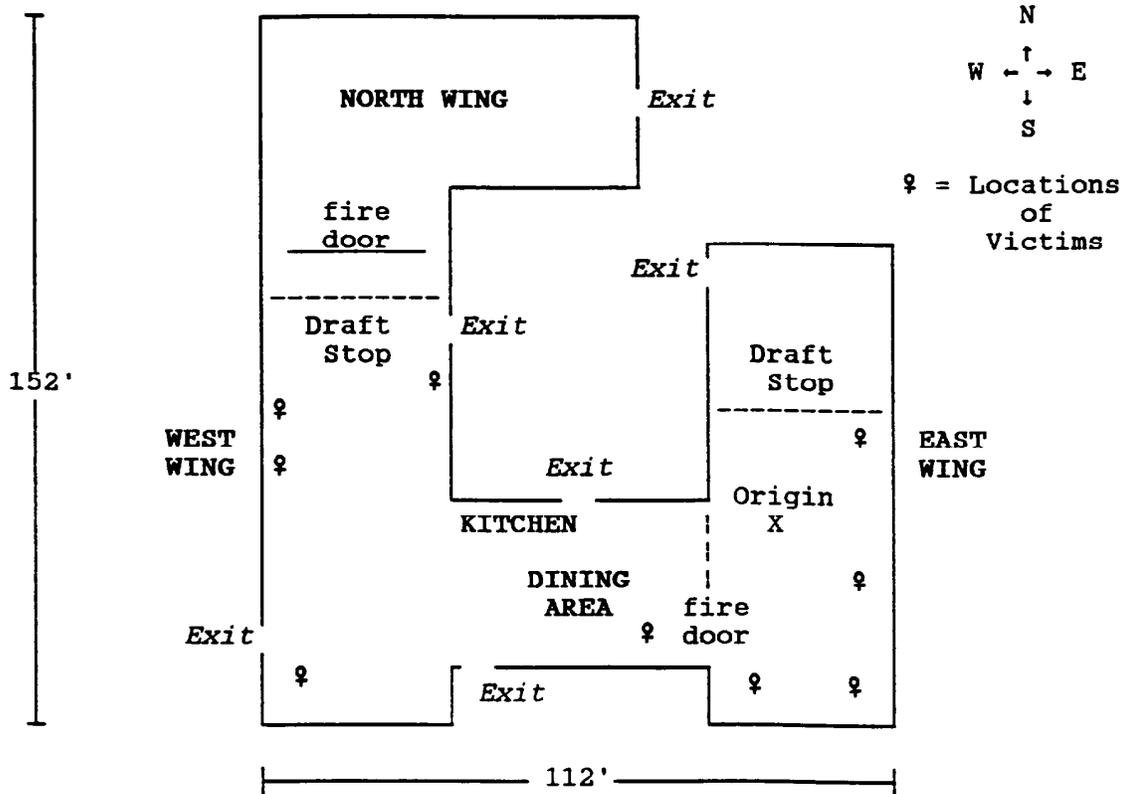
The building is a single-story, brick veneer structure. It is configured as 4 interconnected wings which enclose a center courtyard. The north and east wings do not connect at the northeast corner of the property, allowing access to the center courtyard. The sketch below illustrates the general layout of this 11,590 square foot building.

The east wing contains 8 resident rooms and a smoking room. There is a draft stop separating the north one-third of the attic from the larger south portion. This draft stop, however, is breached by an opening measuring approximately 4' by 4' according to an electrician performing work in the building the week before the fire.
