Wood Truss Roof Collapse Claims Two Firefighters

Memphis, Tennessee

USFA-TR-069/December 1992

U.S. Fire Administration Fire Investigations Program

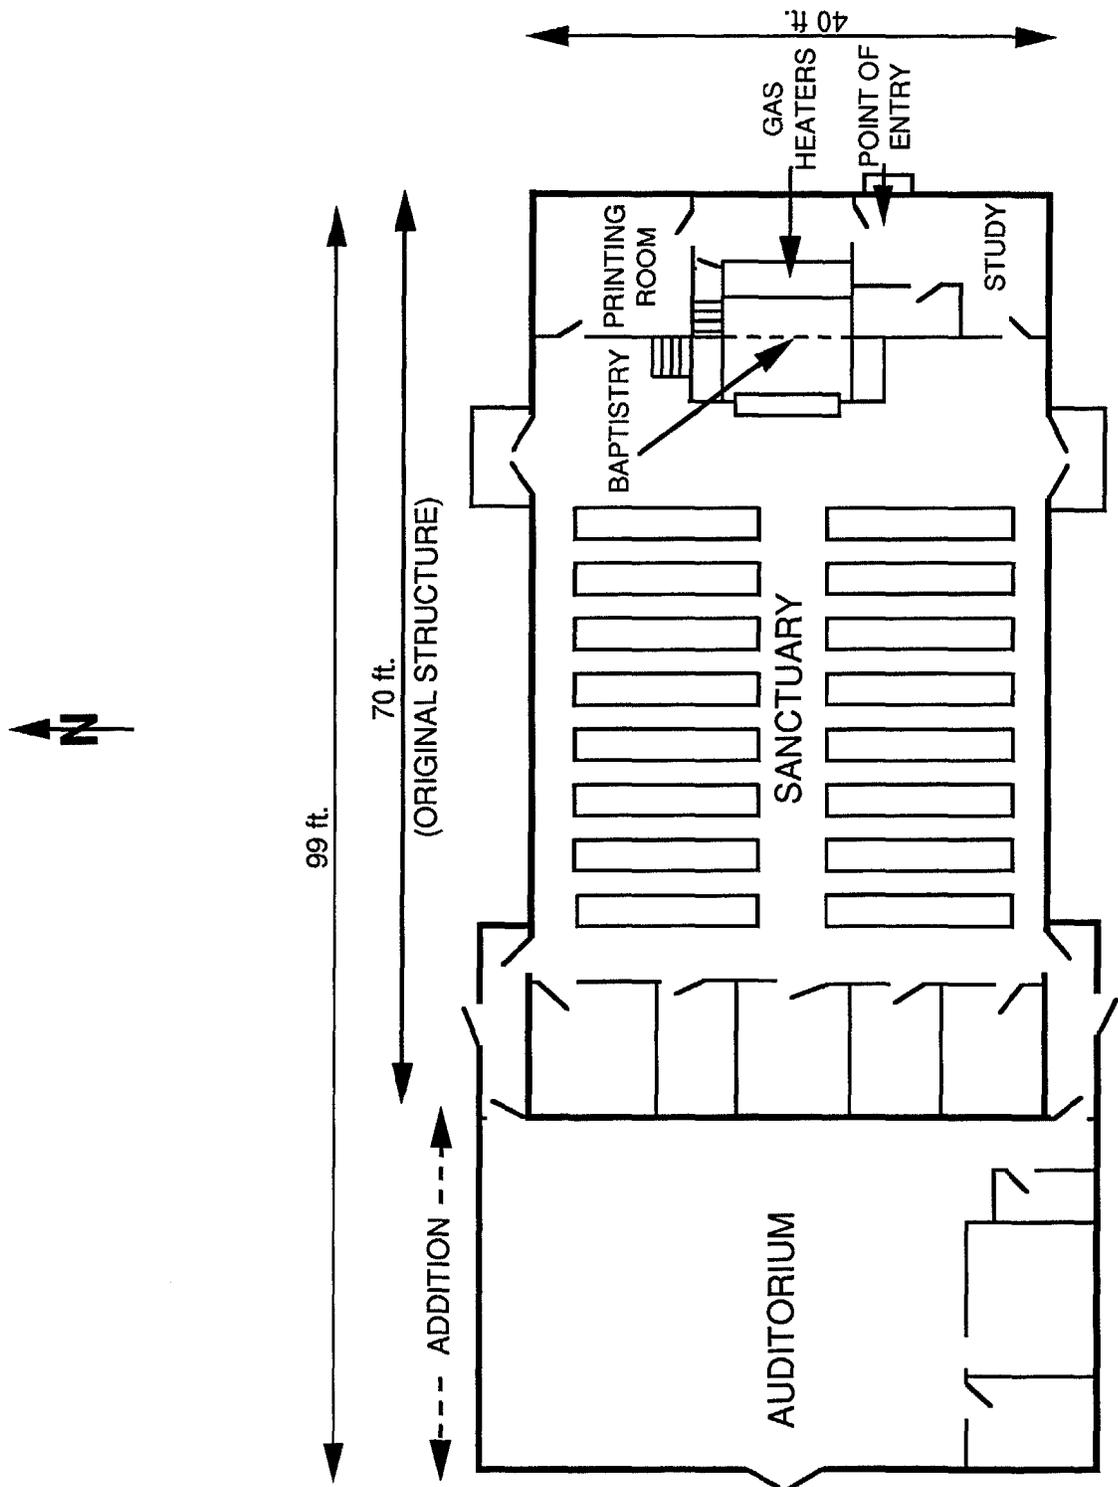
BUILDING PLAN

The suspect apparently made entry to the church during the late morning or noon hour on December 26 with the intent of committing a burglary. Entry was made through an opening in the east (rear) wall. The opening was originally a window, but it had been modified to provide a passage for an air duct that was connected to an exterior air conditioning unit. After loosening a section of the duct work, the suspect made entry to the study and printing rooms. (See building plan on Page 5.)
