Doubletree Hotel Fire

New Orleans, Louisiana

USFA-TR-008/July 1987

Investigated by: Jeffrey M. Shapiro, P.E.

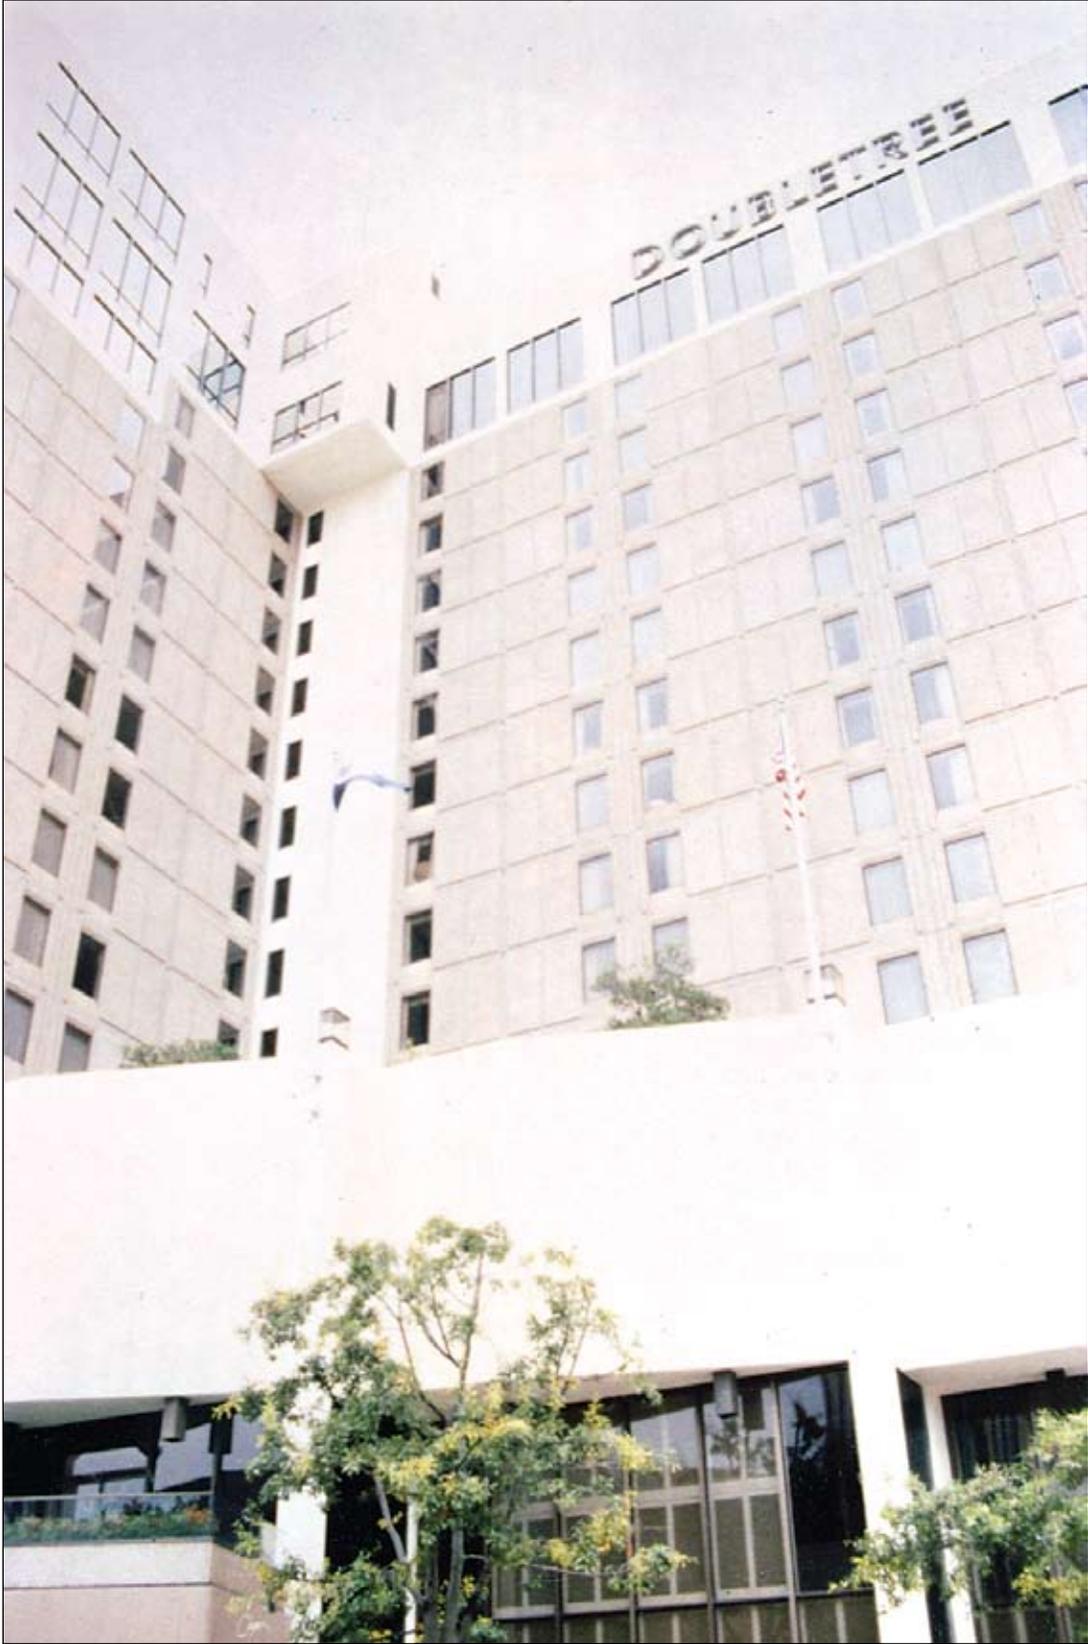
Figure 1. The Doubletree Hotel, a 17-story high-rise.

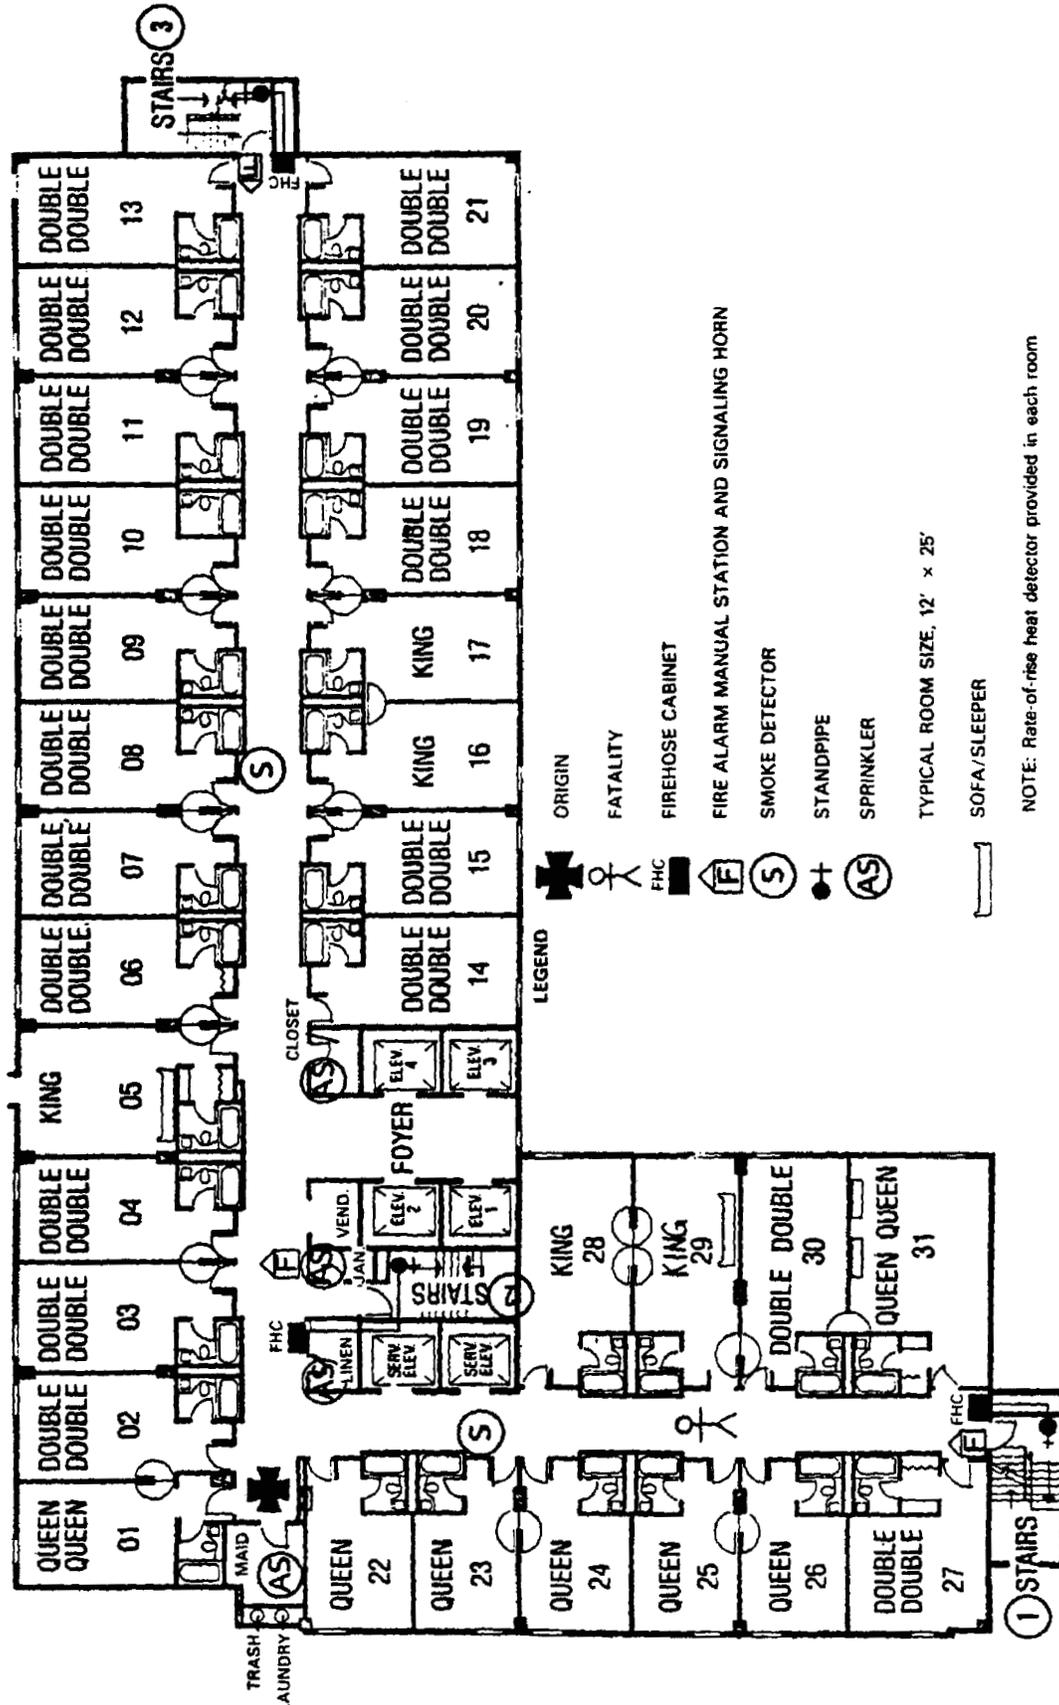
Figure 3. FLOOR PLAN: 10th FLOOR

At the time of the fire, the hotel was equipped with a substantial complement of fire protection systems, considering its age. In addition to a partial automatic sprinkler system, the hotel was provided with a combination standpipe for both occupant and fire department use, automatic and manual fire alarm systems, and portable fire extinguishers. Figure 3 shows the location of these systems on a typical floor.
