U.S. Fire Administration/Technical Report Series

Four Firefighters Killed, Trapped by Floor Collapse

Brackenridge, Pennsylvania

USFA-TR-061/December 1991

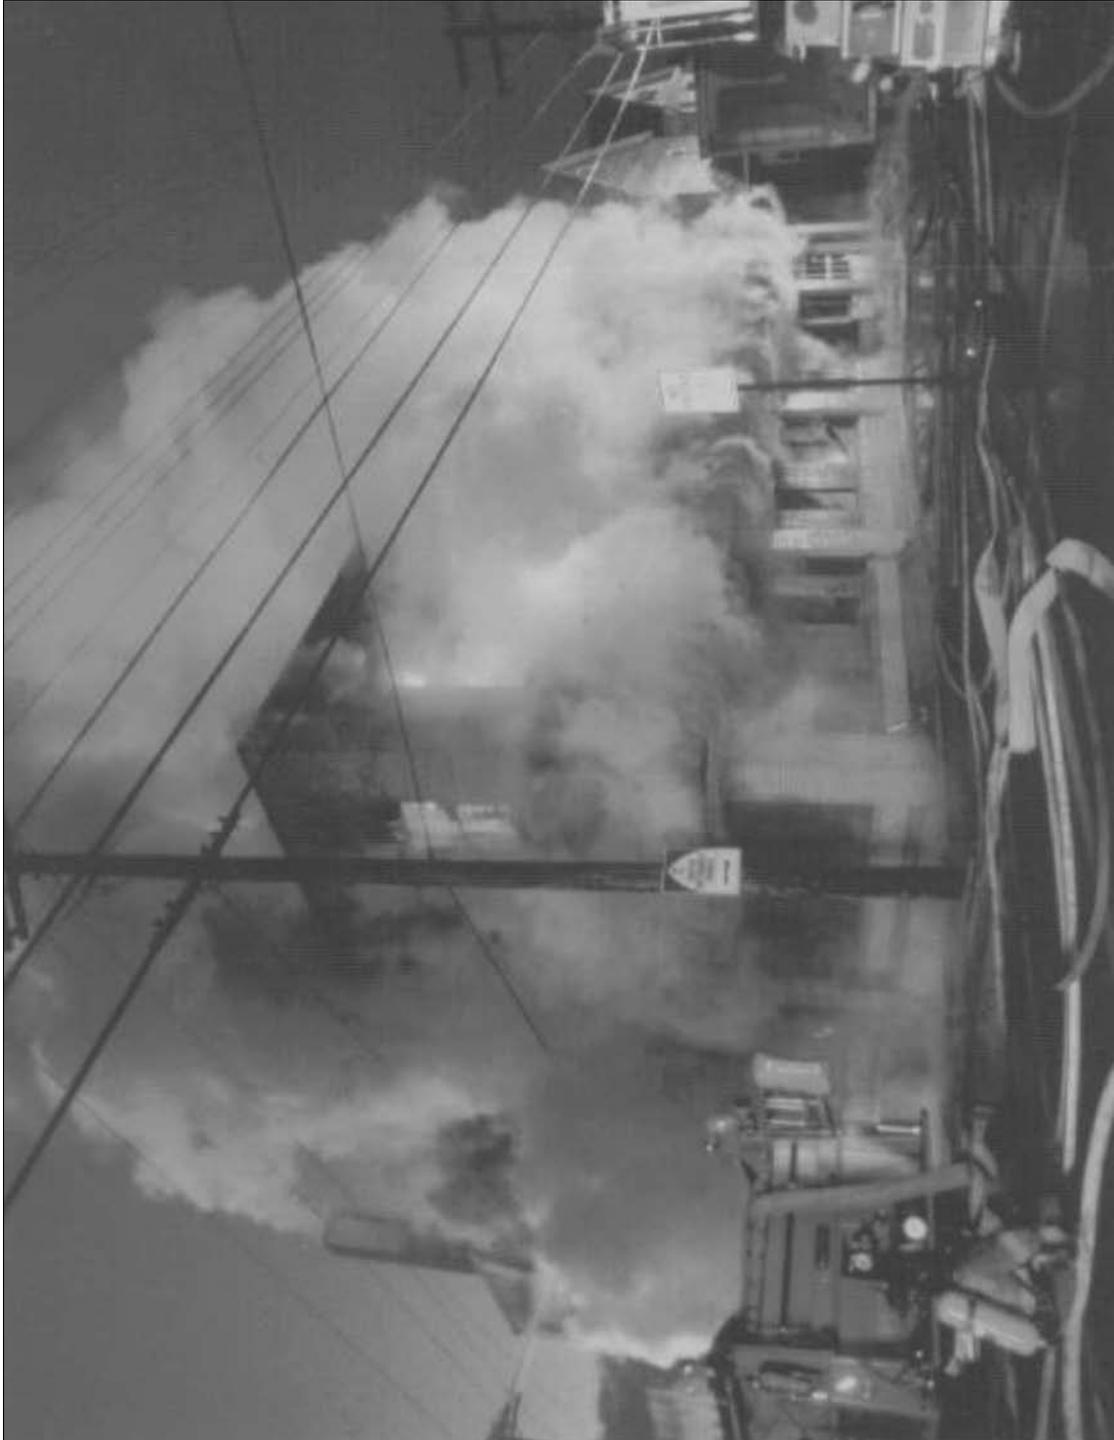
At the height of the fire; firefighters have pulled back.

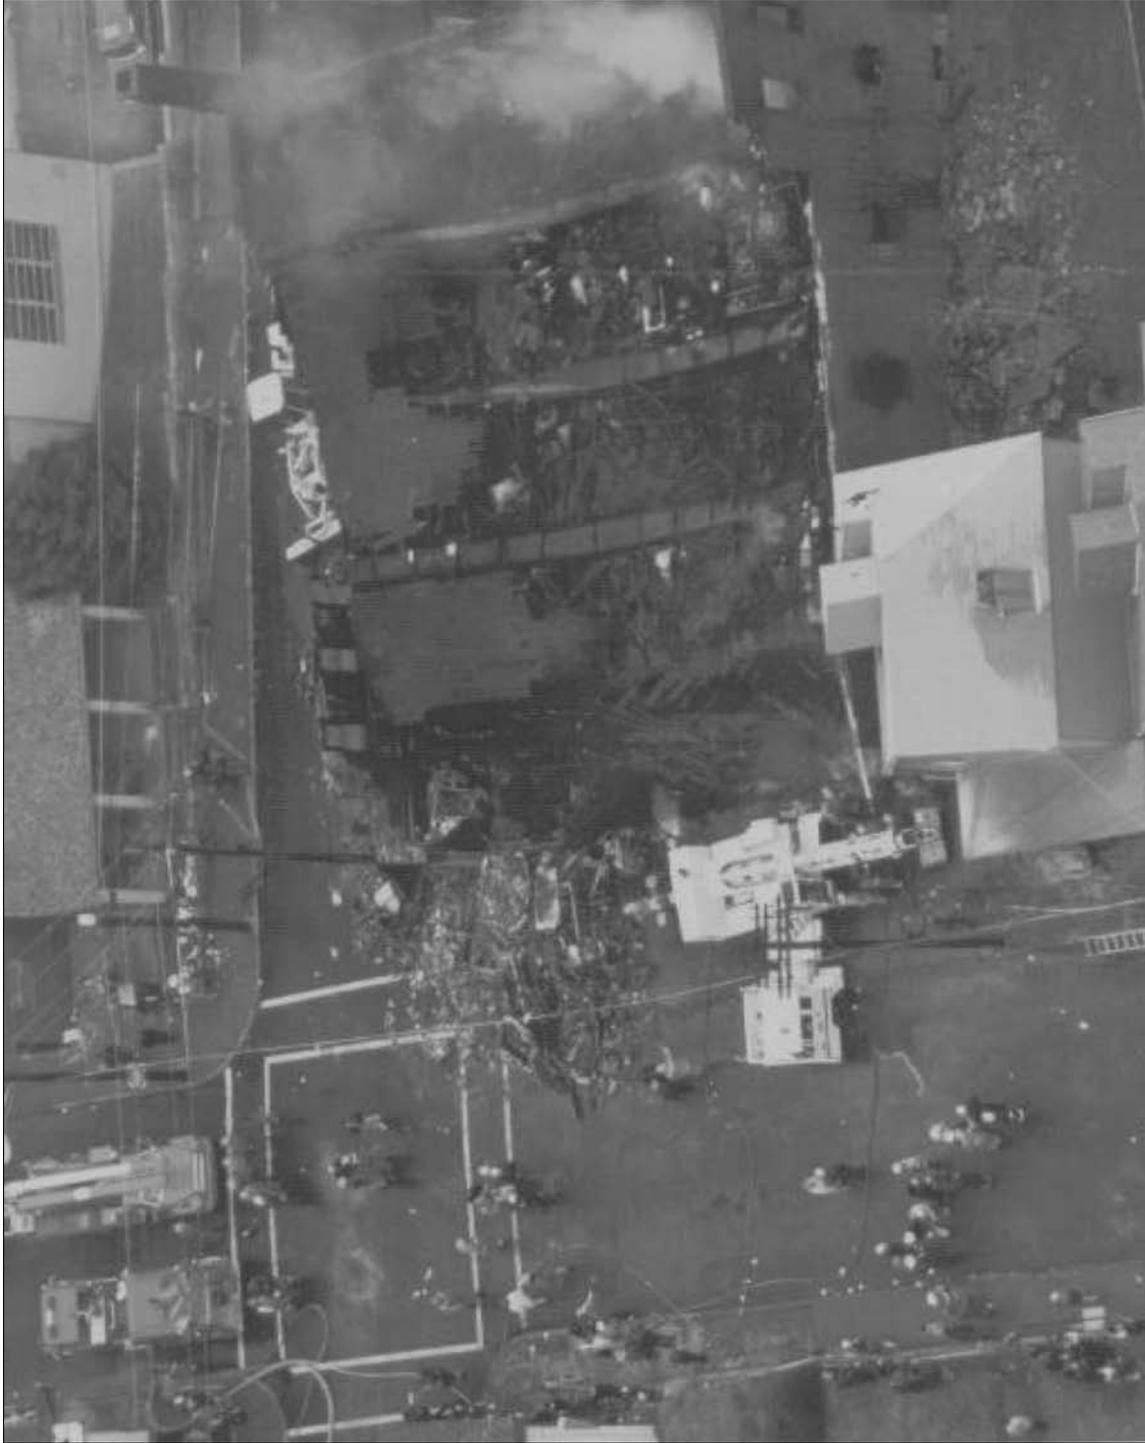
Aerial view of fire building after the fire.

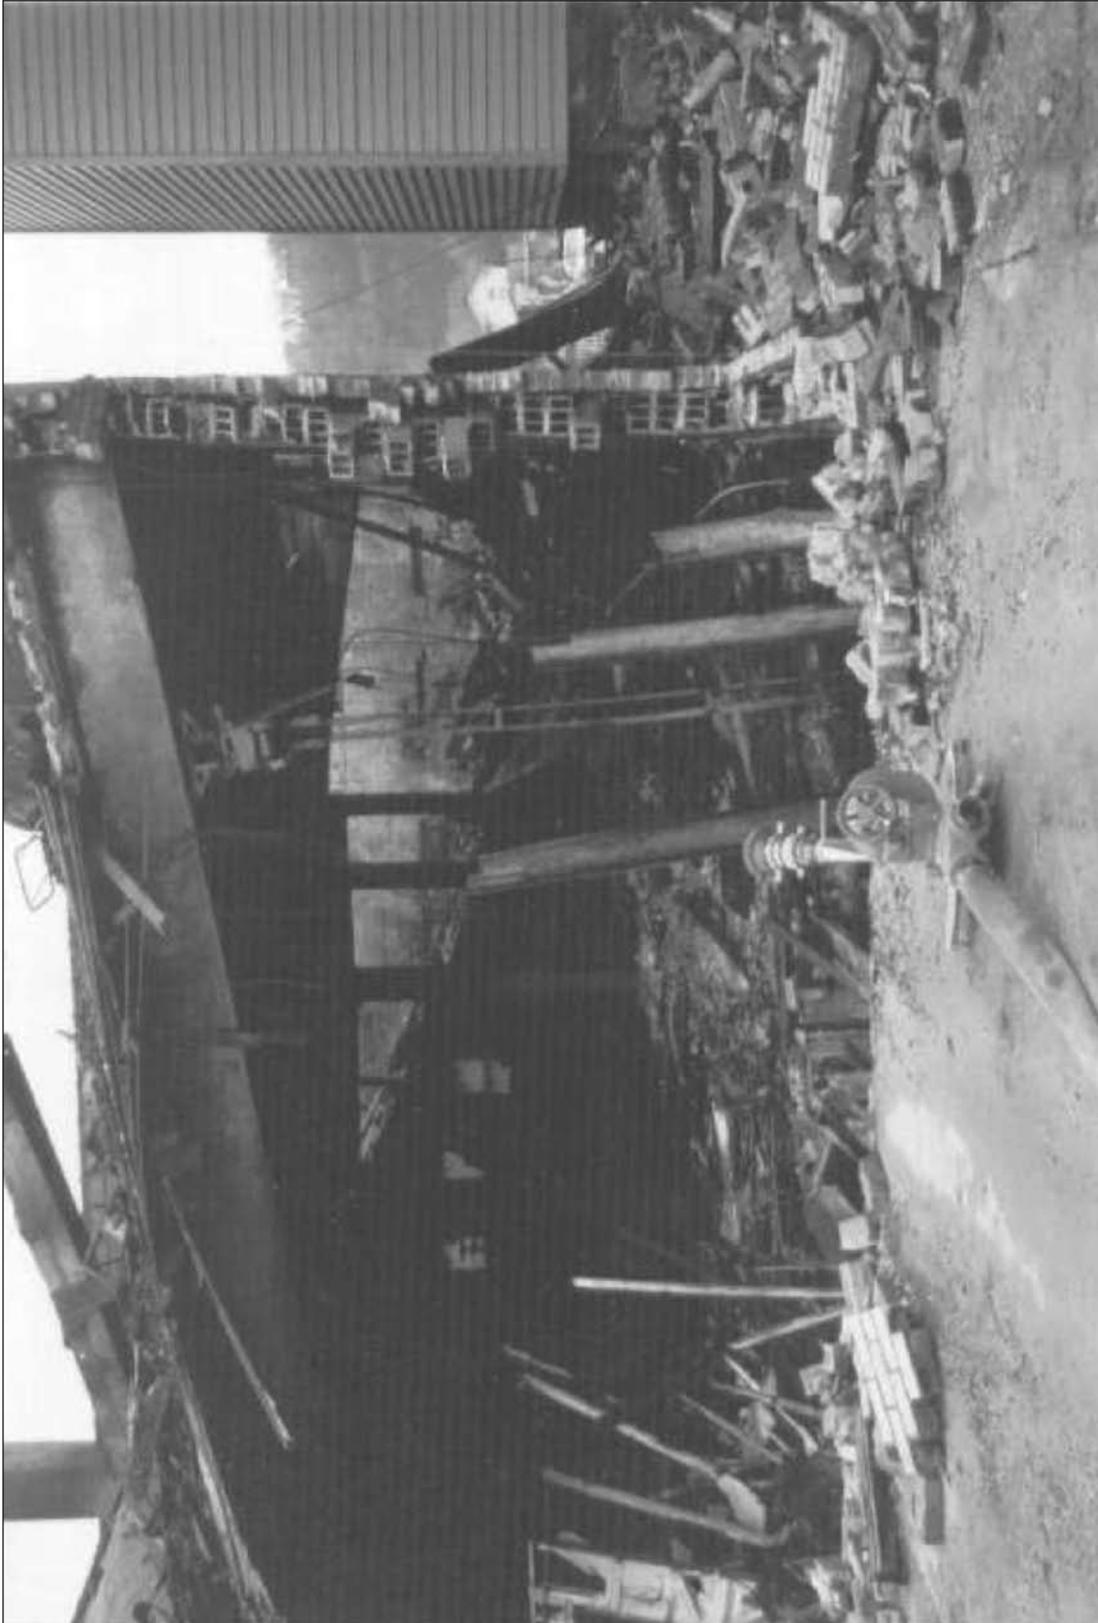
View from front (Brackenridge Ave.) looking toward rear of ground floor. Ramp to upper level is visible at rear wall. Monitor nozzle is placed at location of roll-up door.

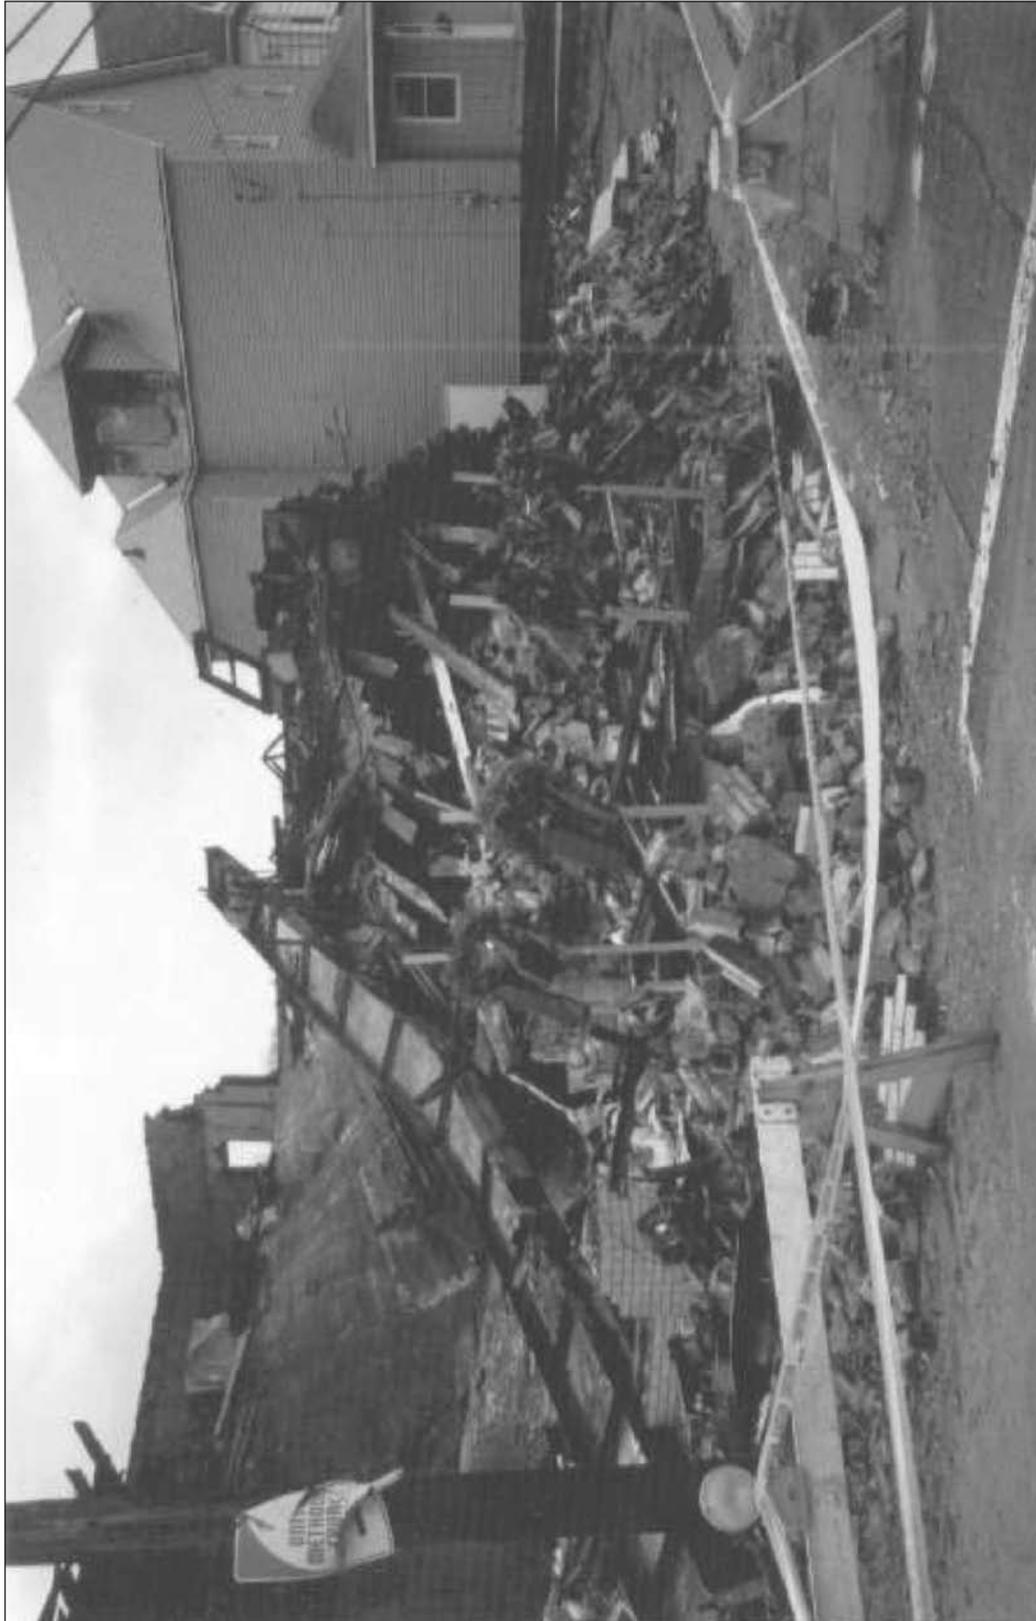
Intersection of Brackenridge Ave. and Morgan St., showing four wreaths placed in debris to honor dead firefighters. One of the large roof girders rests on top of the debris. Front portion of the structure was demolished during recovery operations. Note the close exposure between the fire building and the adjacent dwelling. Upper level of the dwelling was damaged by the fire, and one of the steel window frames from the fire building rests against the adjacent structure.

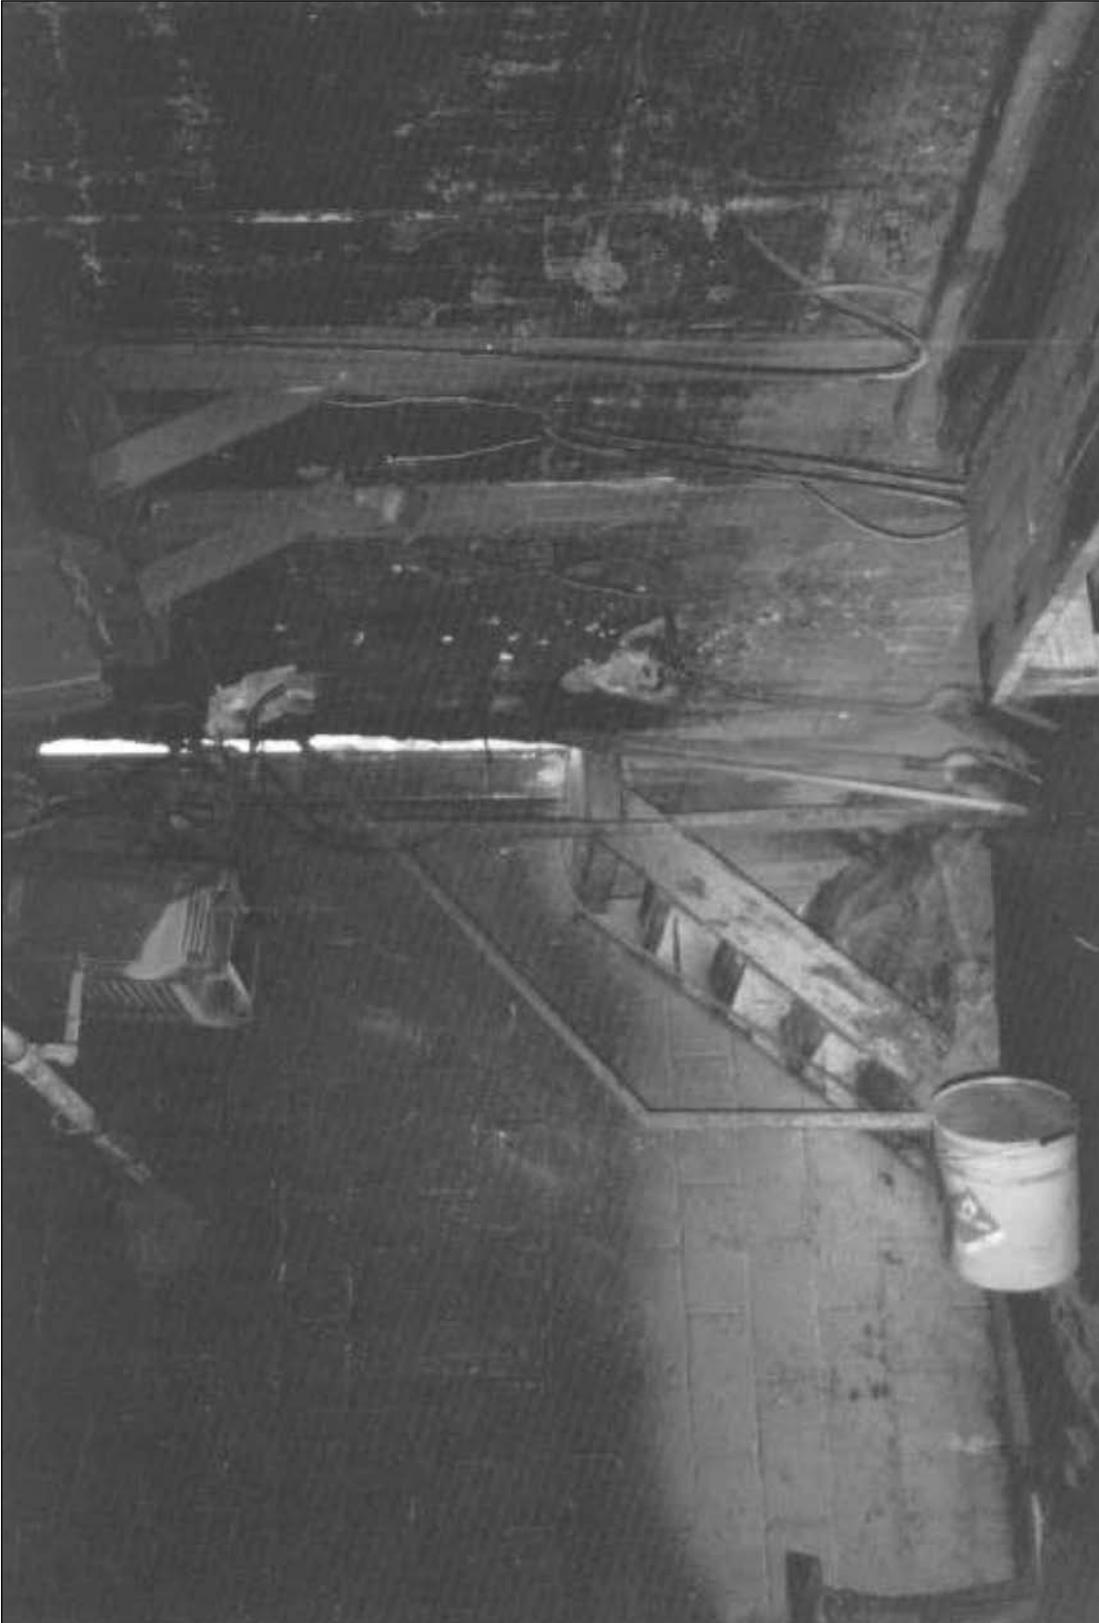
Photo by J. Gordon Routley
Stairs from rear entrance door into basement. This entrance was used for the first 2-inch attack line entering the basement.

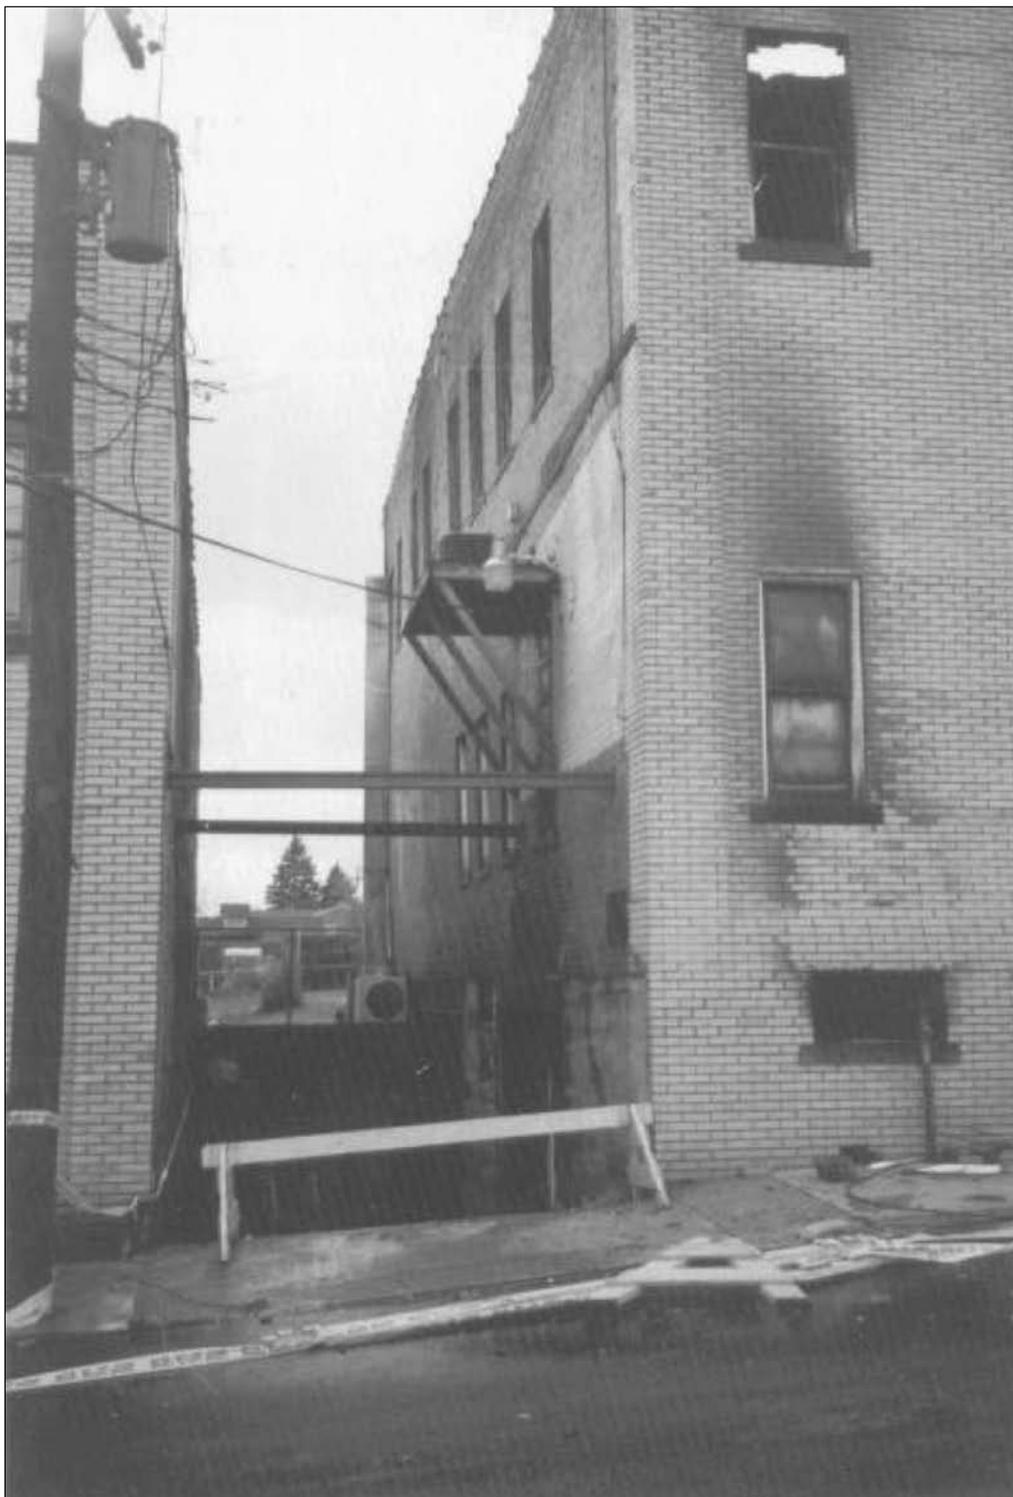
Rear driveway. Note beams spanning driveway, which used to support bridge between buildings.

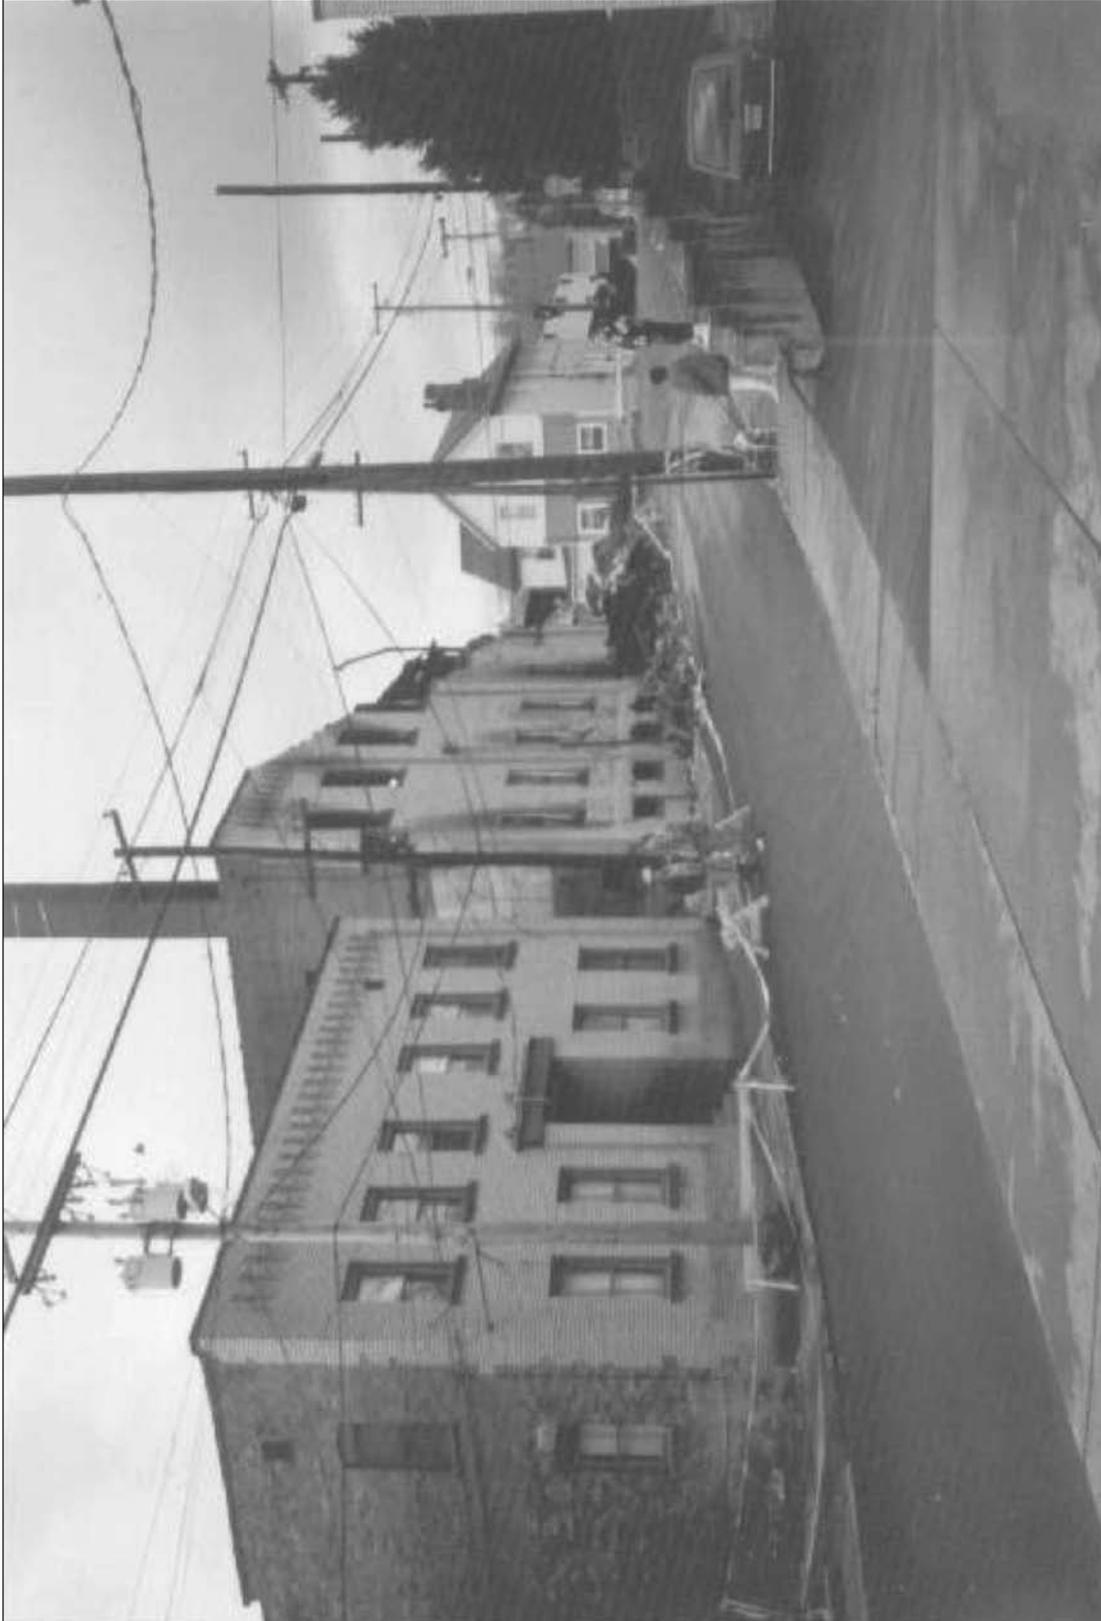
Looking from Pioneer Hose Company Station 50 toward fire building. Entrance to rear driveway (access to basement) is between buildings. Bridge once spanned driveway from second floor of building on left to the fire building.
