Wood Truss Roof Collapse Claims Two Firefighters

Memphis, Tennessee

USFA-TR-069/December 1992

Investigated by: J. Gordon Routley

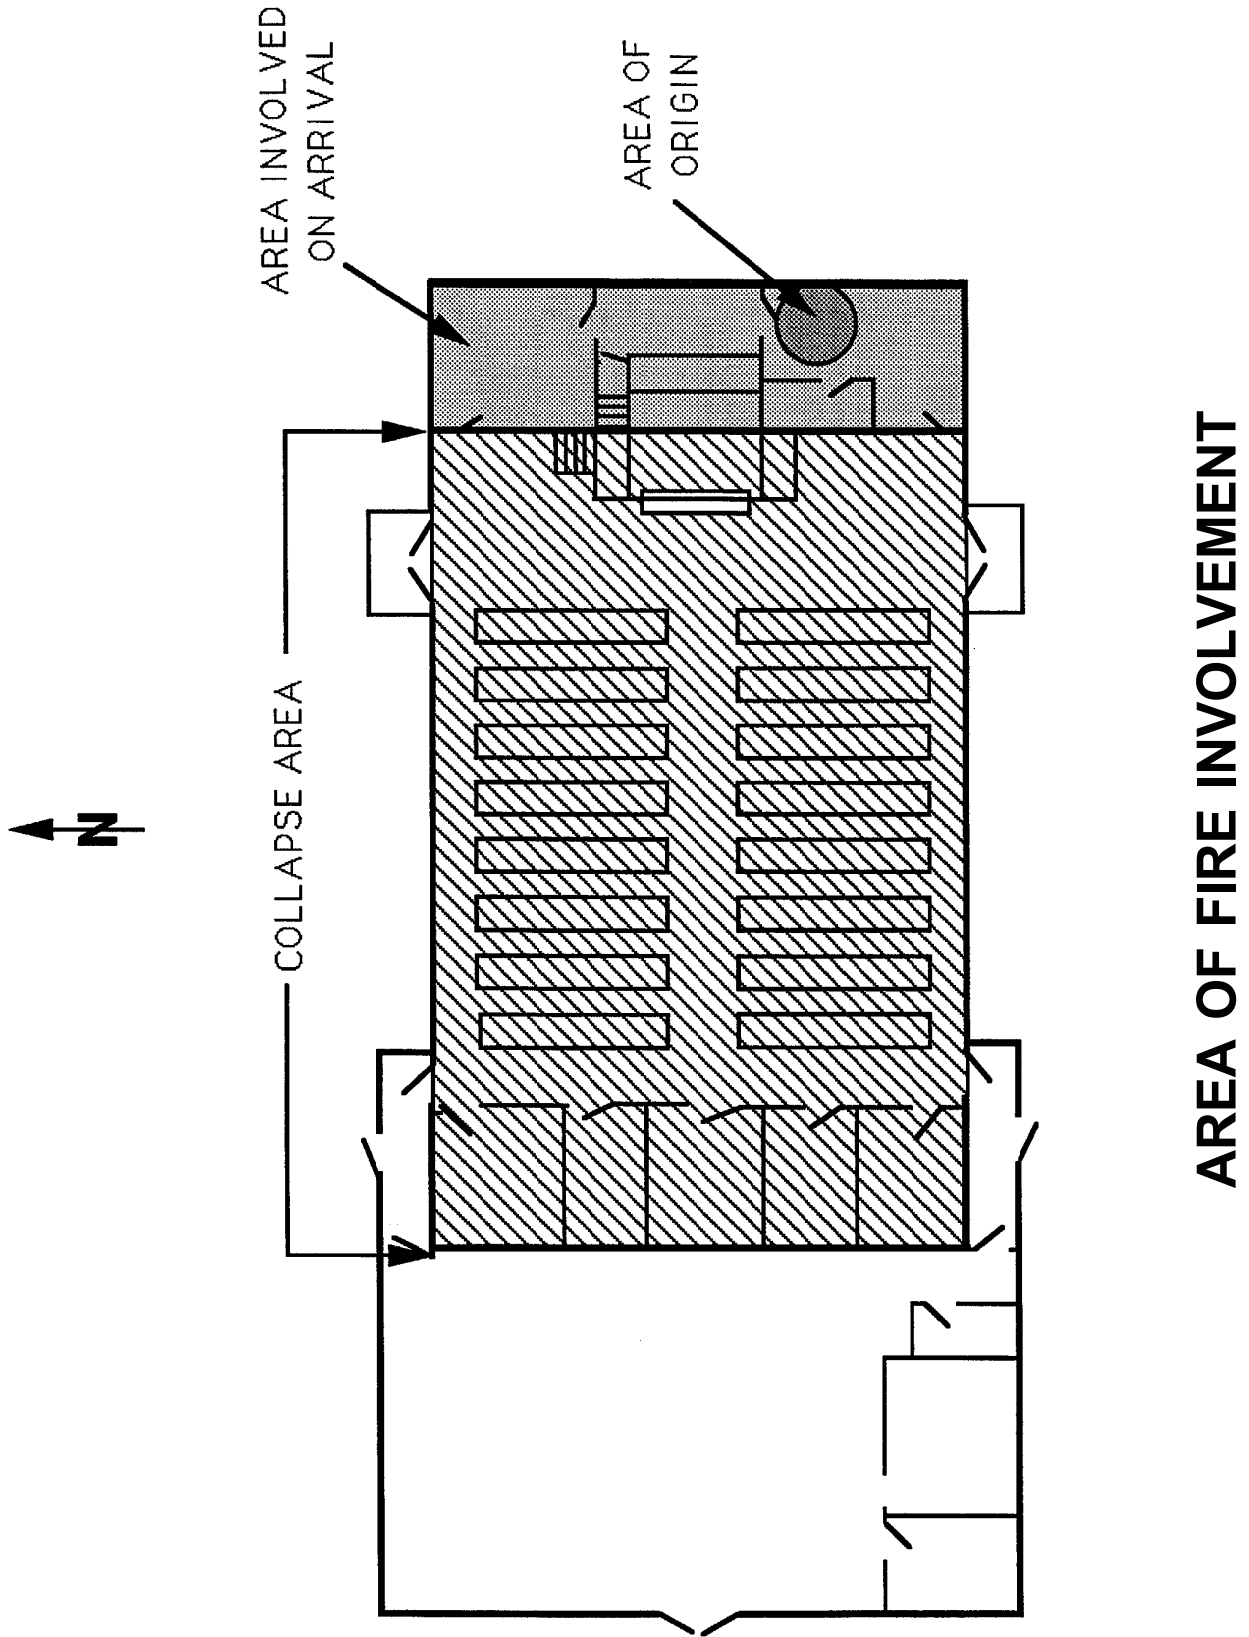
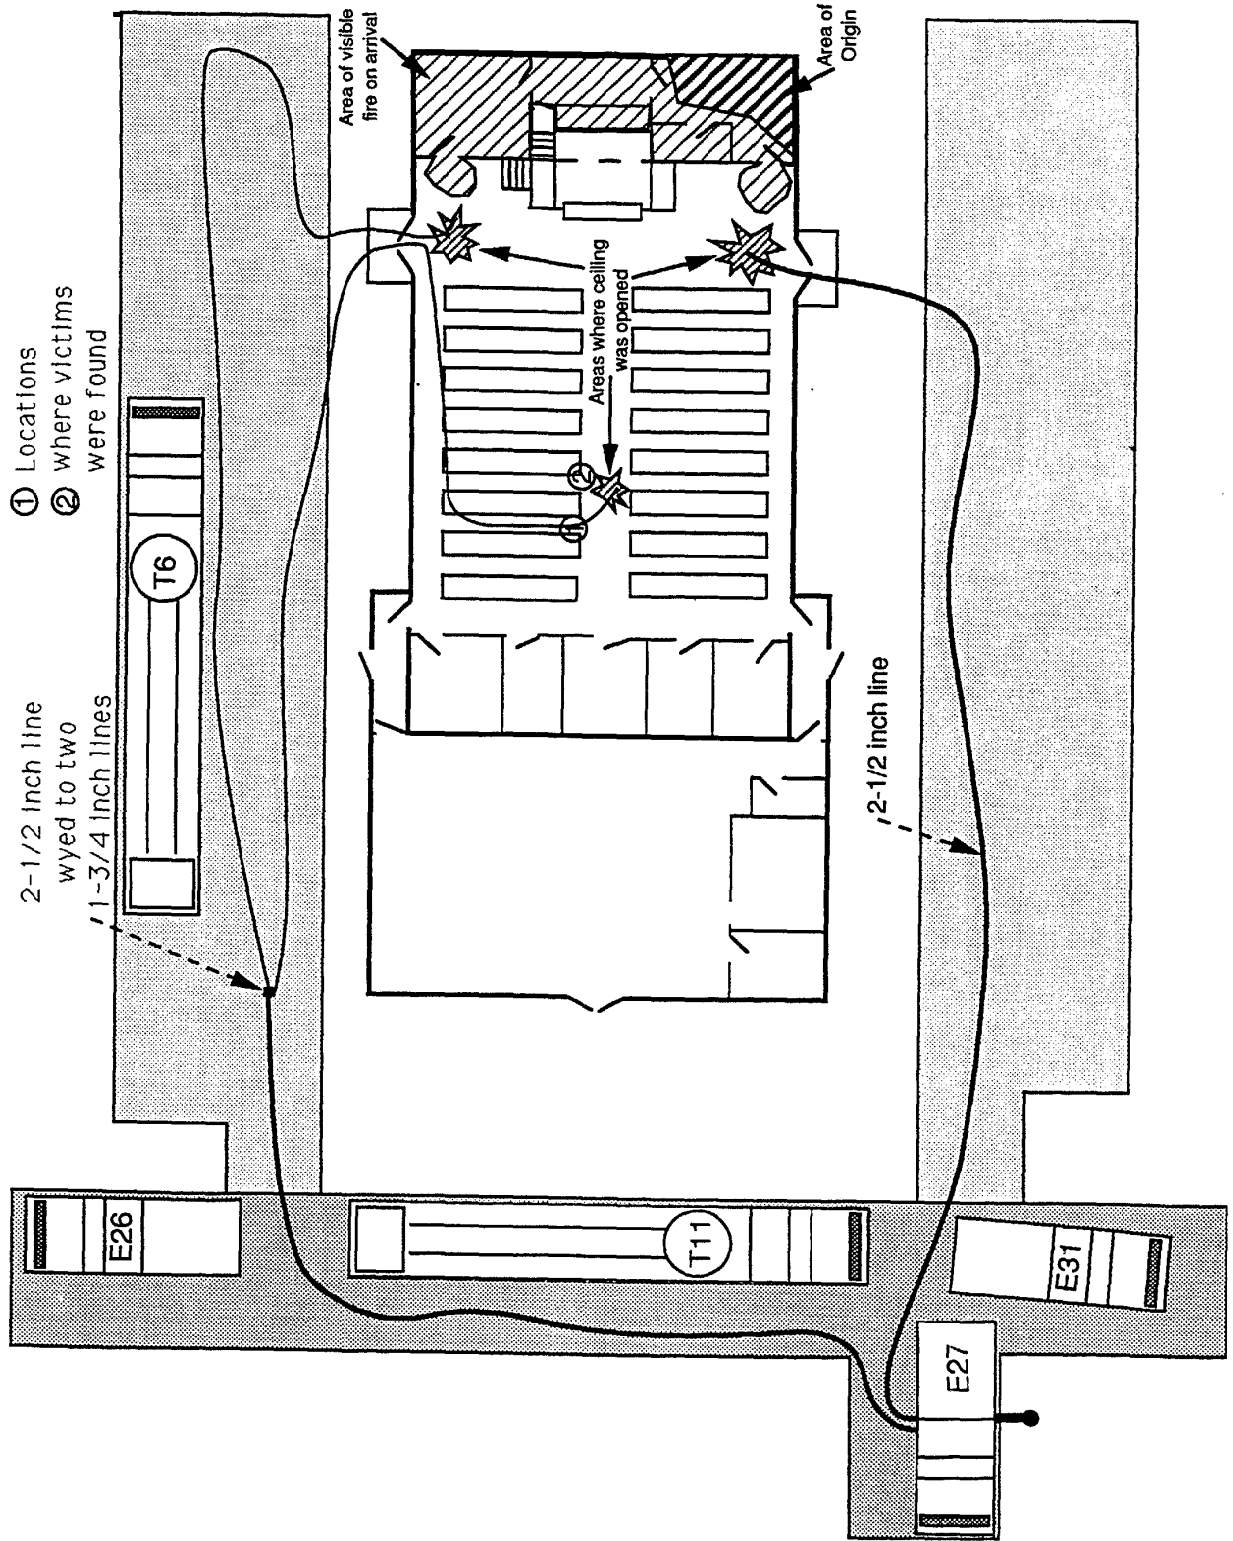
The fire appears to have traveled along the underside of the roof, following the peak from east to west. The tops of all of the trusses were completely burned away for approximately 12 to 18 inches below the top connection point and could not be retrieved from the rubble. All of the lower connections could be located and most were still intact. The depth of char varied from almost full depth on the remnants of the higher members near the center of the span to almost no sign of burning on the lower and outer sections.

All of the top and bottom chords had splices near the mid-span points on each side of the trusses and most of these splices had failed, dropping the center section all the way to the floor, while the ends only rotated on their wall supports.

Many of the gusset plate connectors had failed, either by completely disengaging from the wood or by allowing one or more of the members to work free from a connection point. At the higher points the wood was charred beyond the depth of penetration of the gusset plate points, leaving empty pits in the charred wood where the gusset plates had been attached. As noted previously, virtually all of the top connection points were completely burned away. Some of the kingpost members were charred to a depth of more than 1/2-inch before the remaining unburned wood had broken; the diminished cross section of unburned wood fractured when it was unable to carry its load. (This would account for the “snap” sound reported by some of the firefighters just before the roof caved in.)

The roof collapse can be directly attributed to failure of the top connection points of the trusses, where the kingpost meets the top chord sections. It cannot be determined precisely which truss failed first and whether the gusset plates came loose from the top connection or the kingpost snapped and pried the gusset plates loose. The top connection is a critical point in each truss and its failure would result in the failure of that truss. It appears that several trusses failed in rapid succession – almost simultaneously following the first. All of the trusses would have been close to the point of failure and unable to support any additional load, so the load shift that occurred with the first failure probably caused several more trusses to collapse.
