# Two Firefighter Deaths in Auto Parts Store Fire

Chesapeake, Virginia

USFA-TR-087/March 1996

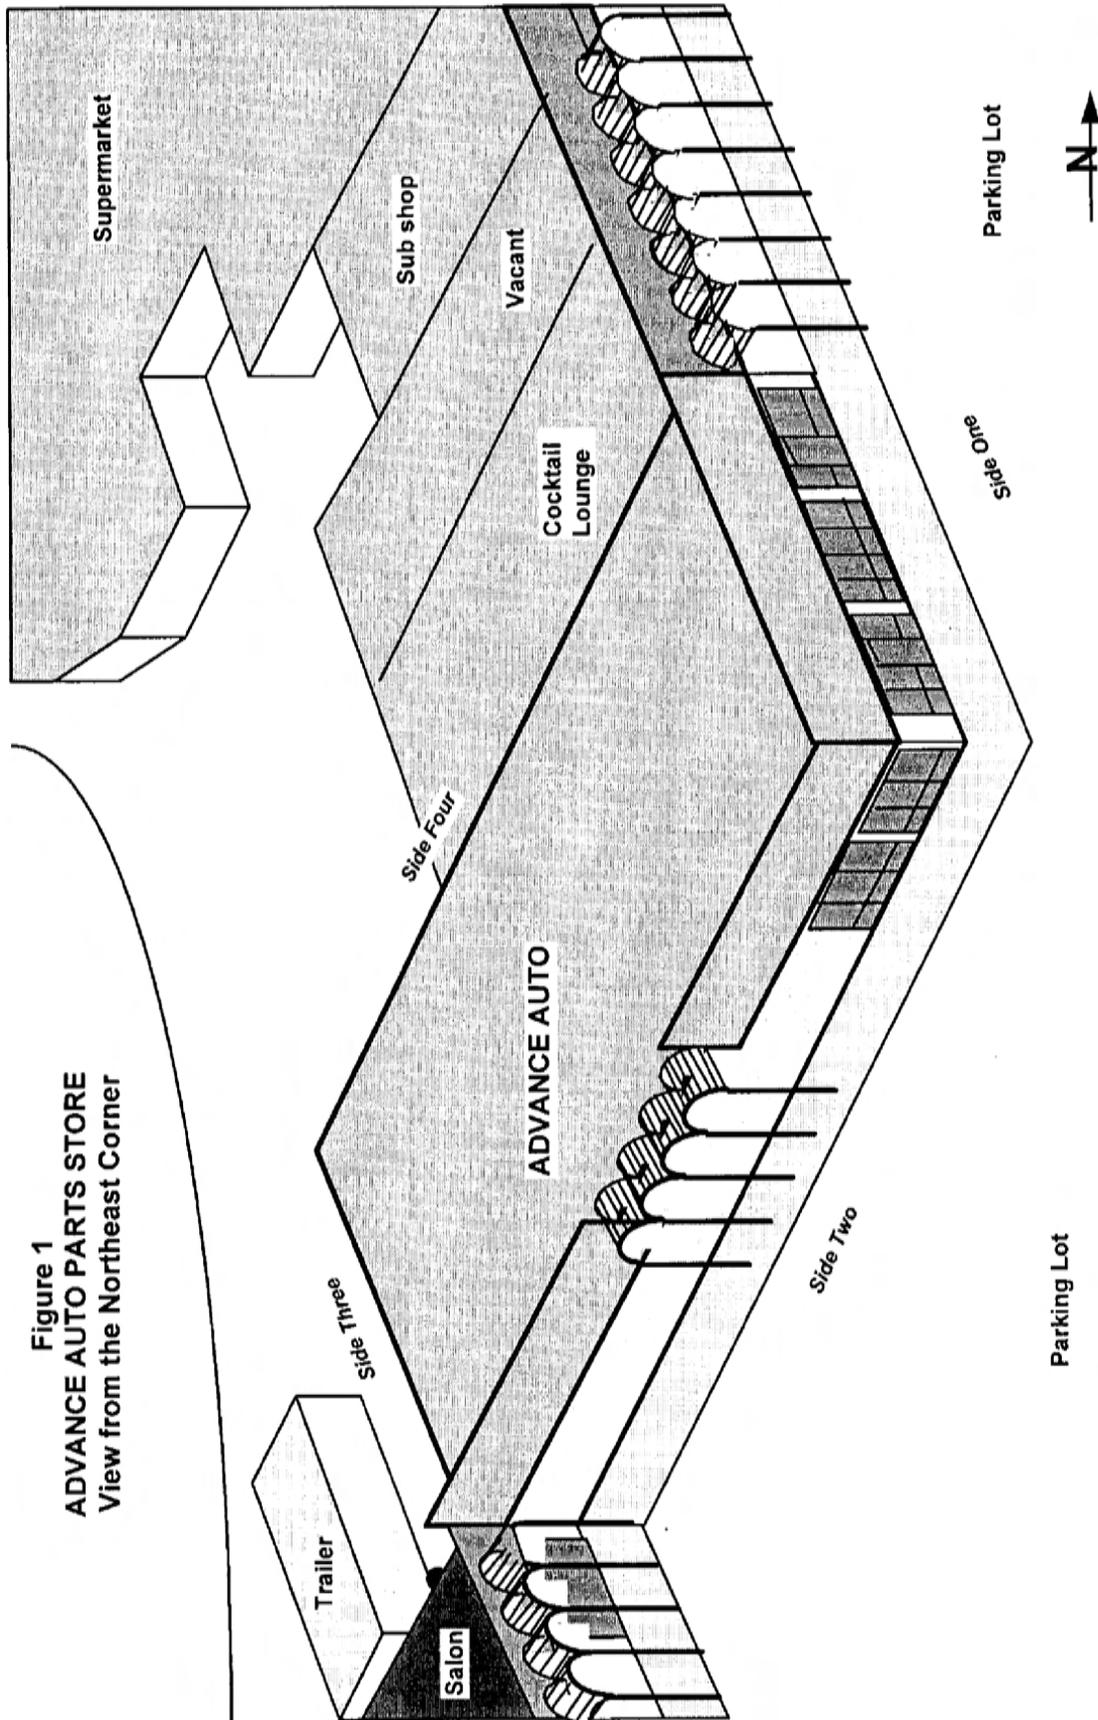
The auto parts store was constructed with two masonry exterior walls and two wood frame exterior walls, with a lightweight wood truss roof assembly. It was approximately 120 feet deep and 50 feet wide, providing about 6,000 square feet of open display and storage space. The roof assembly was a pre-engineered lightweight wood truss assembled from 2 x 6 top and bottom chords, with 2 x 4 web members held together with metal gusset plates. There were no interior bearing walls or supports for the roof structure. At one end, the trusses were supported by a wood plate that was bolted to a metal beam<sup>1</sup>. The other end rested on top of the concrete block wall. Each truss was separated by 24 inches and they were covered with 1/2 inch CDX plywood sheathing under a two-ply rubber membrane. A drywall ceiling was attached to the underside of the trusses, creating a truss void space (truss loft) 24 to 36 inches above the ceiling. A drywall divider was located in the middle of the truss void as a draft stop. The roof had a slight pitch (Figure 2).

<sup>1</sup> Post incident investigations by the Chesapeake building inspector revealed that these ends may not have been properly secured to the beam.

Figure 2  
ADVANCE AUTO PARTS STORE  
Dissection of the truss roof as viewed from front to back  
of the building.
