# Five Fatality Residential Motel Fire

Thornton, Colorado

USFA-TR-104/January 1997

# **Five Fatality Residential Motel Fire Thornton, Colorado**

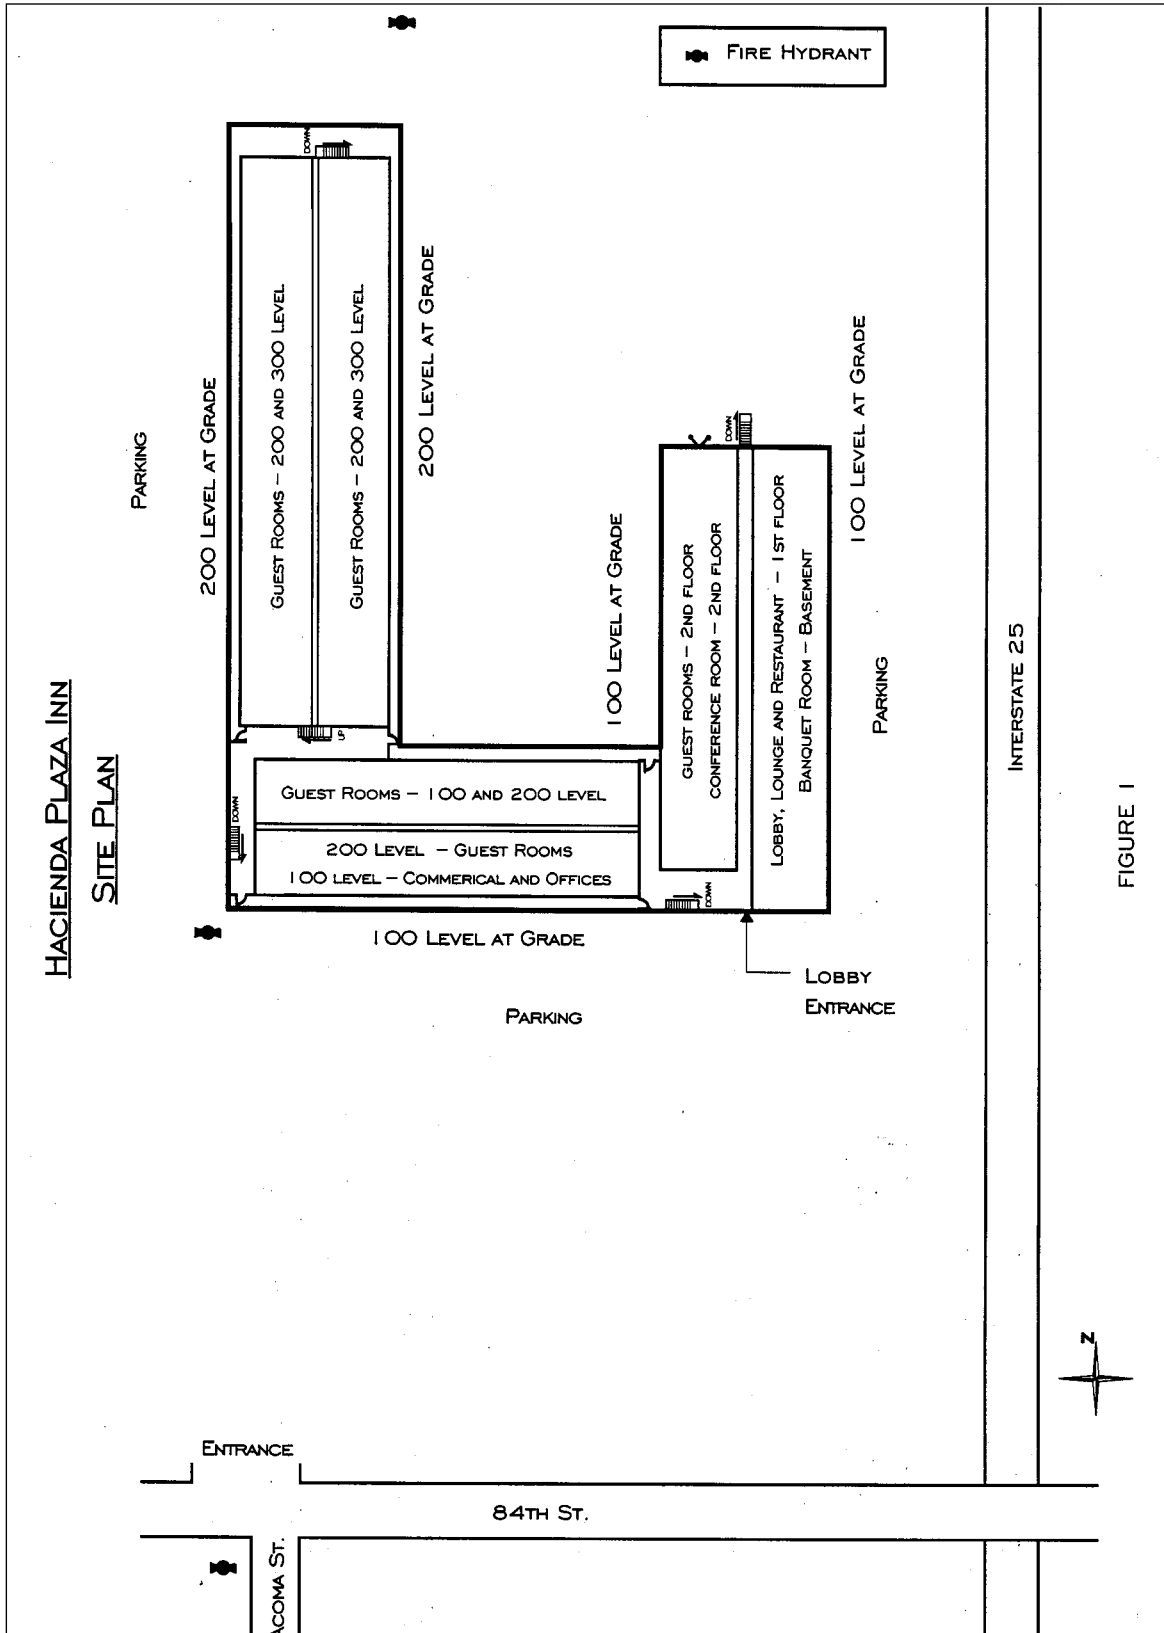
FIGURE 1

The Hacienda Plaza Inn was a partial "U" shaped structure consisting of three wings and was constructed in 1963. (See Figure 1 for diagram). The south or front wing and the west wing contained most of the guest rooms. The first floor of the front wing had several areas which were available for office and commercial use including one which was occupied by a quick print shop. The east wing contained the registration desk, offices, lounge, restaurant, banquet room, and on the second floor, efficiency style guest rooms with small kitchens.

Figure 1. Site Plan

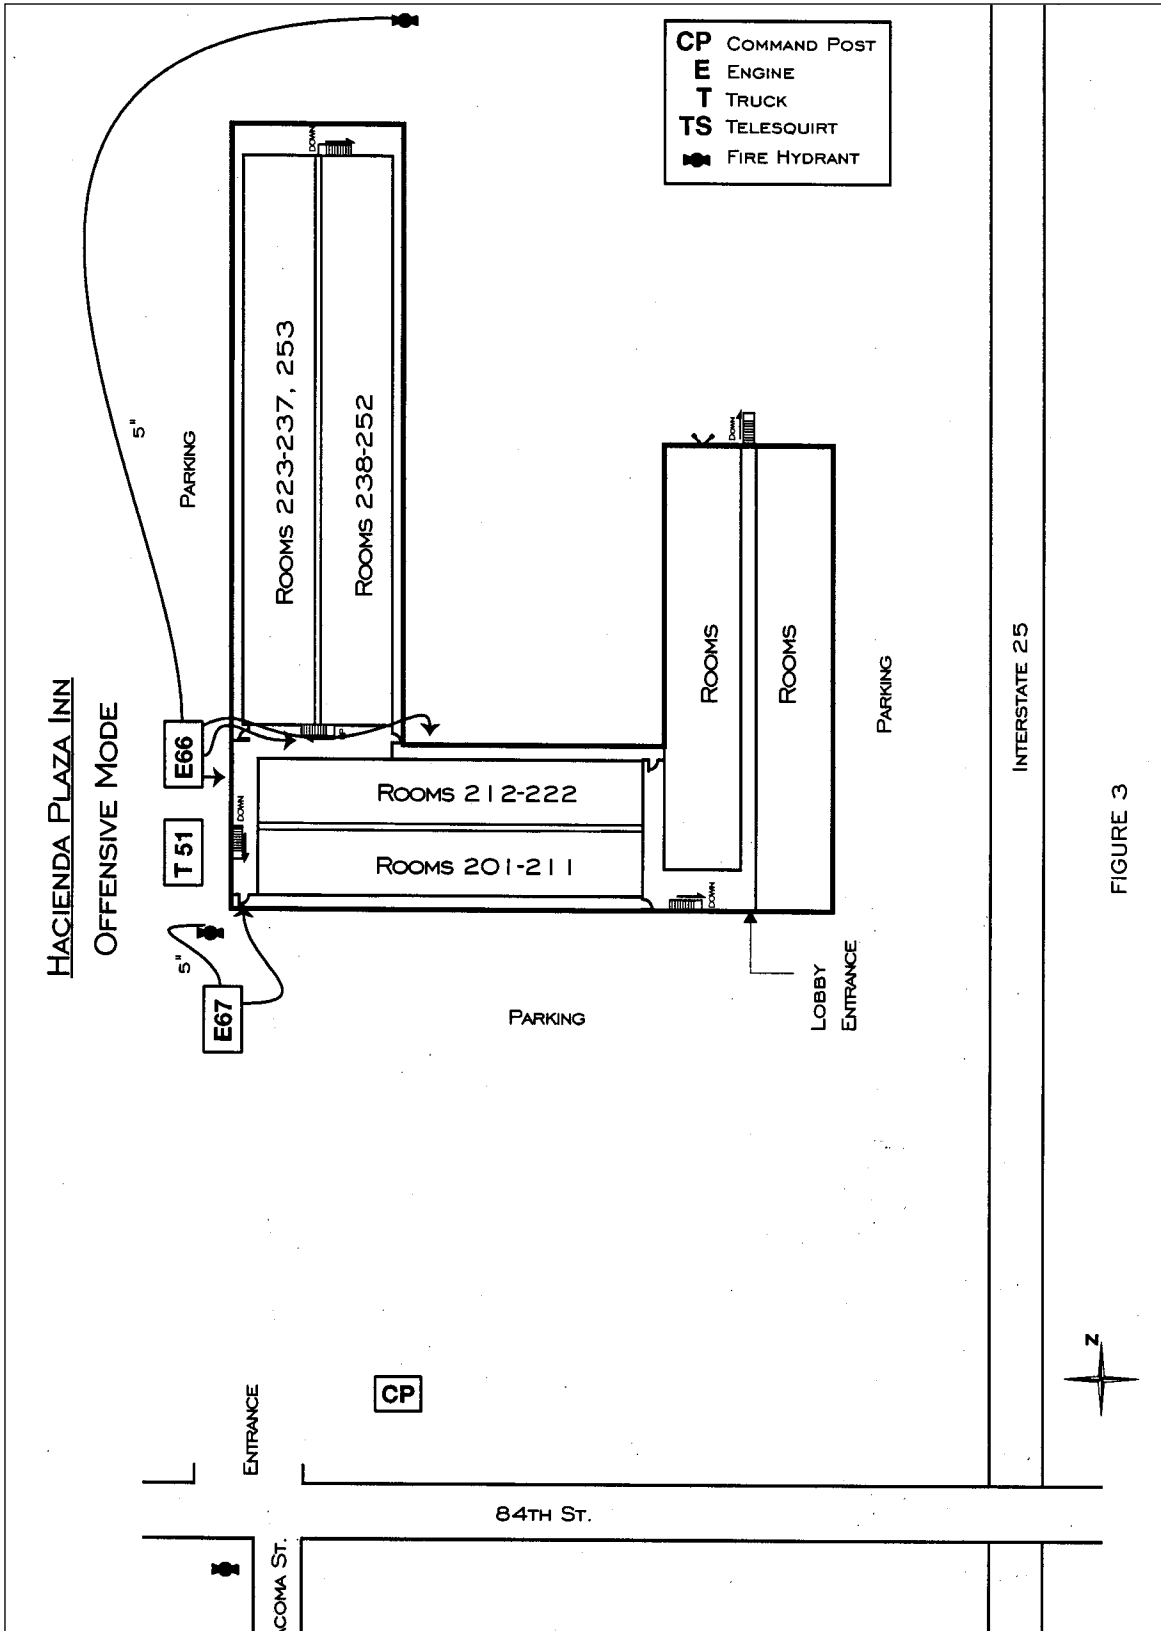
FIGURE 3

Engine 62 was the second engine on the scene just before 2:47 a.m. accompanied by Ambulance 62. The three member engine company assisted Engine 67 with rescue and advance of the hoseline. The ambulance crew established a triage area in the front parking lot and requested additional resources from its headquarters. Eventually five AMR ambulances plus supervisory personnel responded to the fire scene. The search of Rooms 201 to 210 was completed by 2:52 a.m. and this area declared “all clear” by Engine 62. Attention now focused on extinguishing the fire at the base of the stairs at the west end of the front wing. (See Figure 3 for diagram)

Figure 3. Offensive Mode

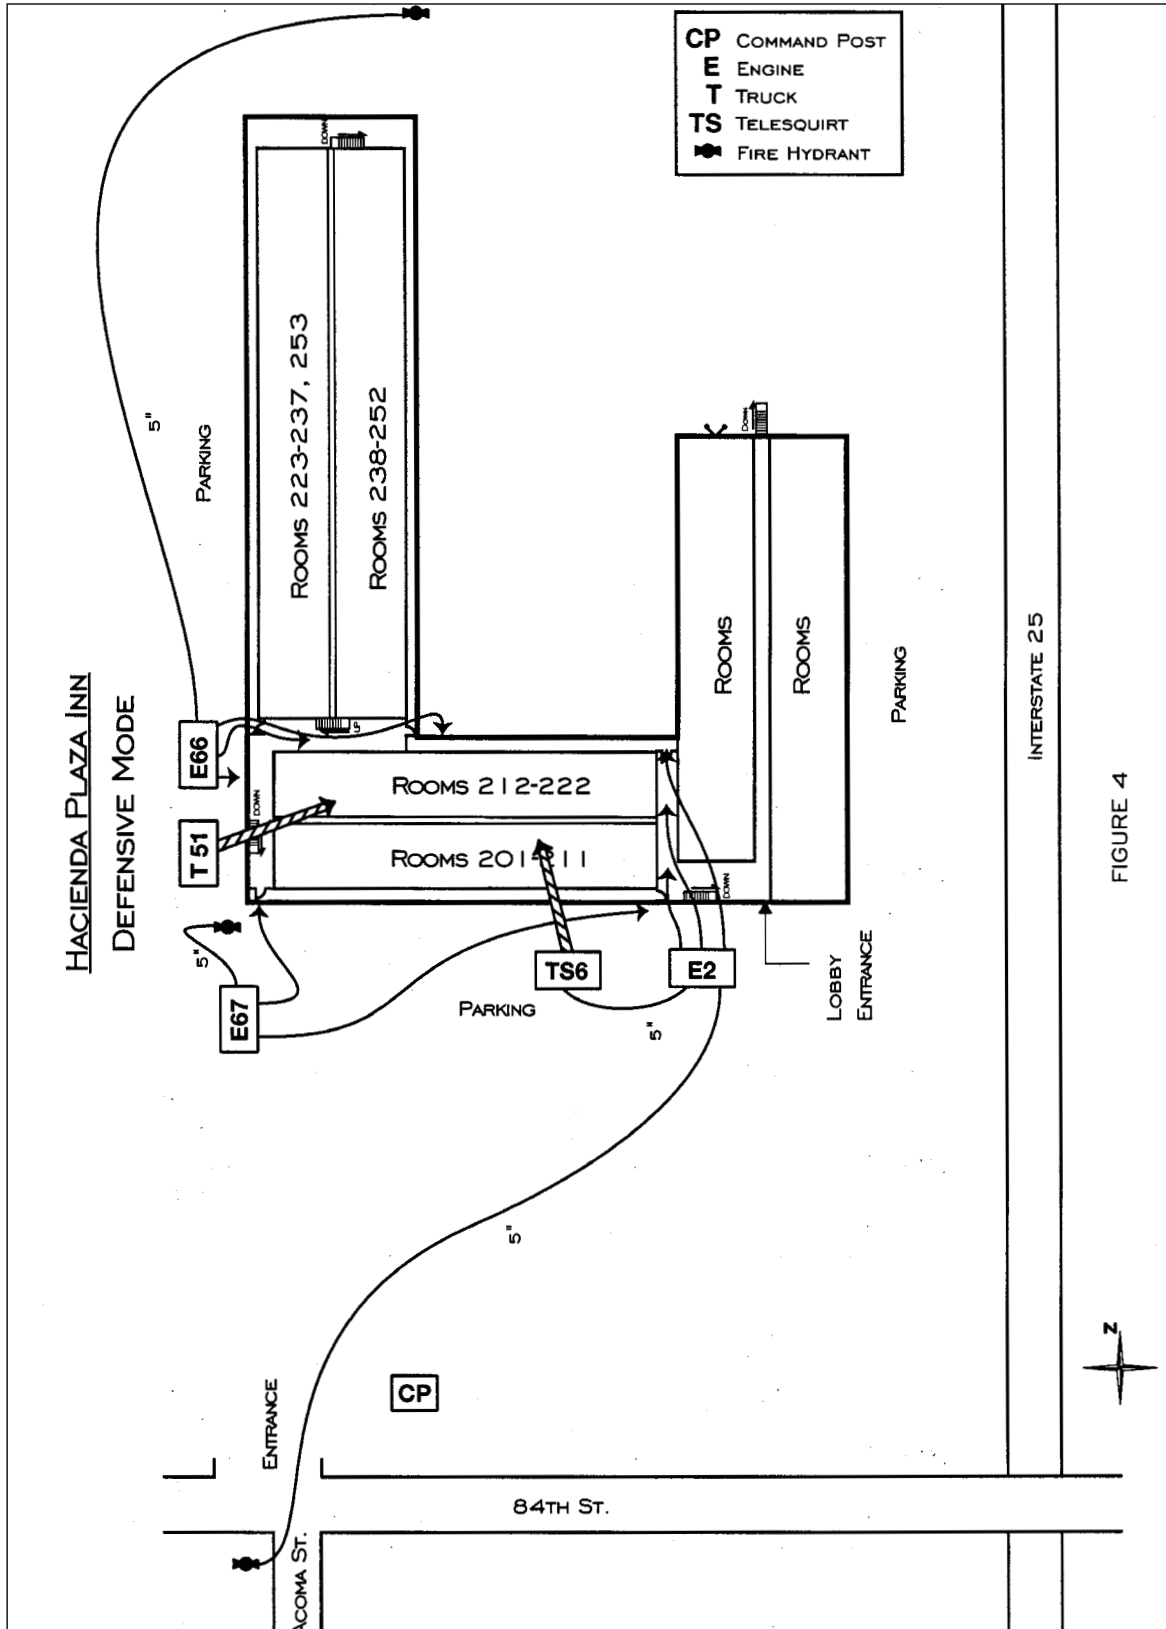
FIGURE 4

Tactical operations then changed from an offensive mode to a defensive one. About the same time the fire conditions were deteriorating, Incident Command was transferred to North Metro's Deputy Chief of operations. Command instructed Truck 51 to establish a ladder pipe operation at its position and two 2-1/2-inch lines were stretched from Engine 67. The "B" shift was recalled to their stations at 4:13 a.m. and two engines were requested from Southwest Adams County shortly after. (See Figure 4 for diagram)

Figure 4. Defensive Mode
