U.S. Fire Administration/Technical Report Series

Old Buckingham Station

Chesterfield, Virginia

USFA-TR-105/May 1995

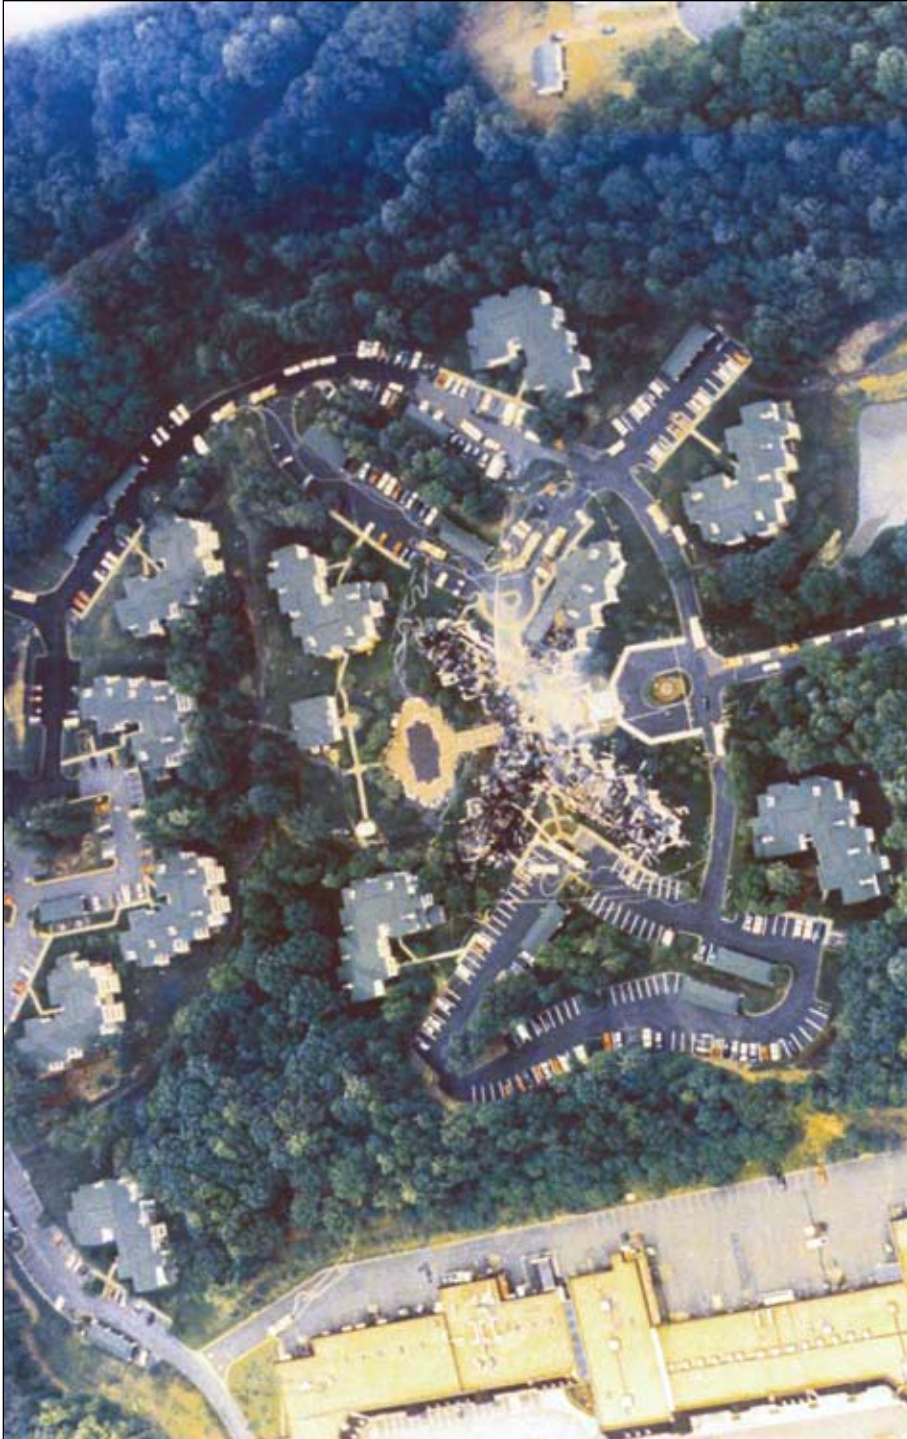
Photo 1. Site view of fire with north to the left. The shopping center and woods for the hand-stretched hose is on the left with Engine 73 still in position.

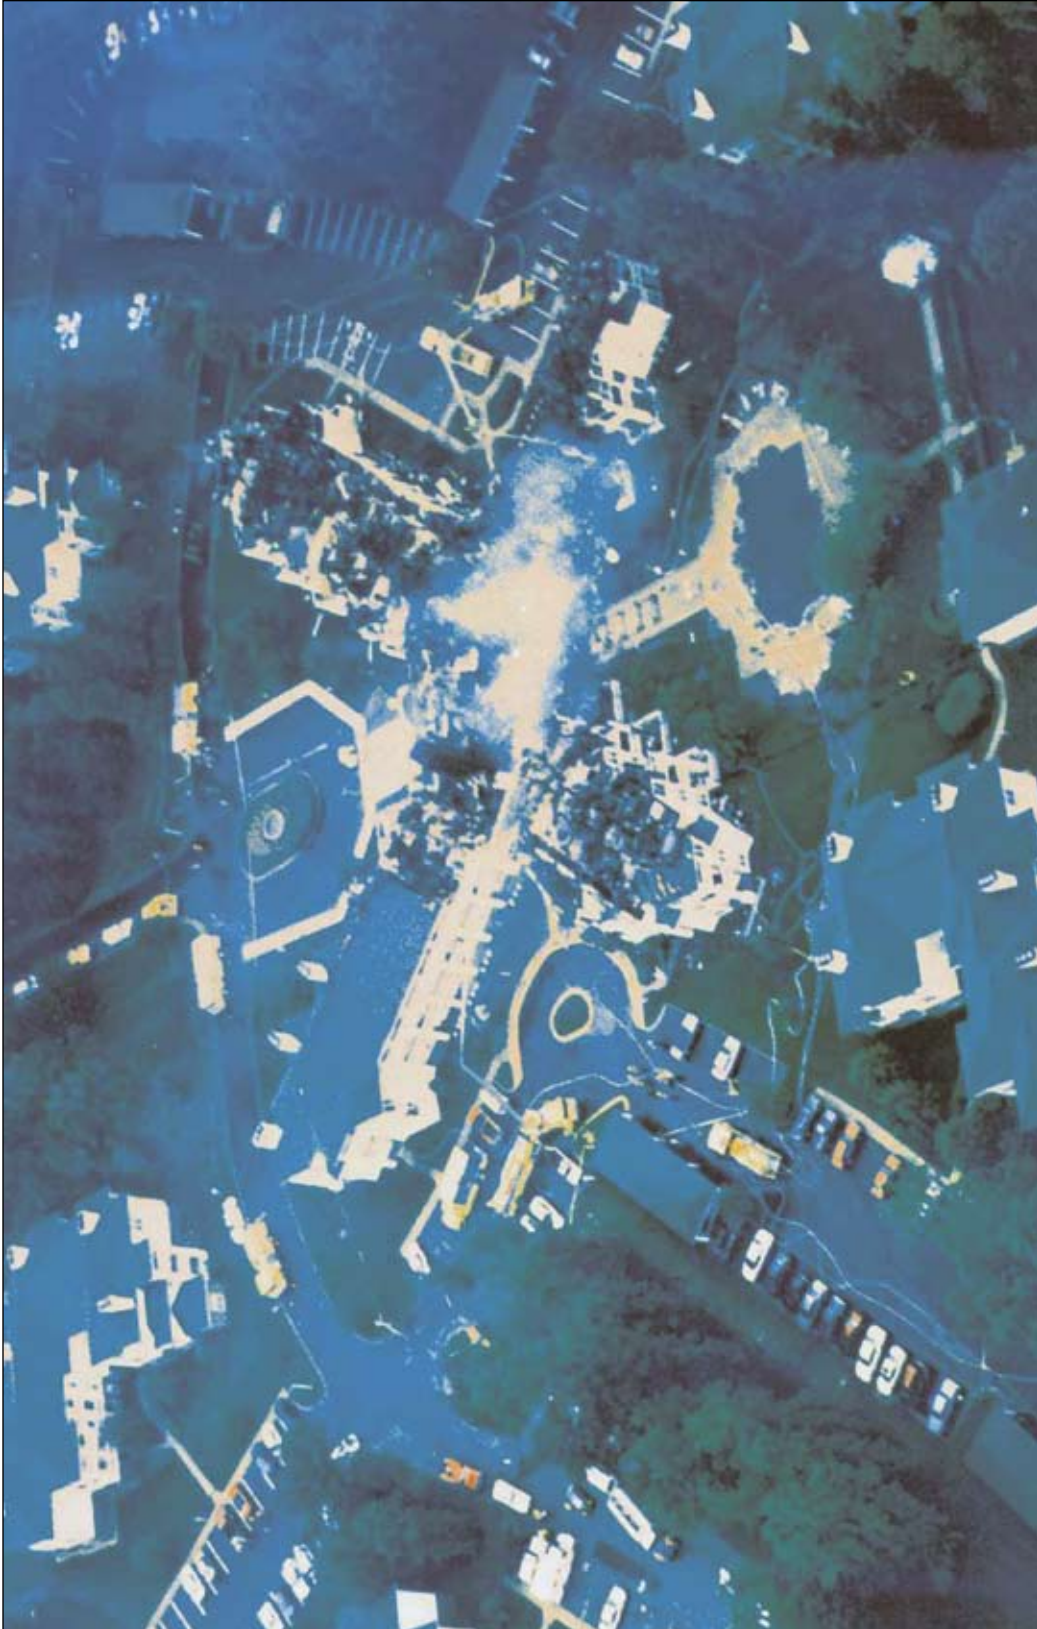
Photo 2. View of building with units still operating to complete extinguishment. North is to the left.

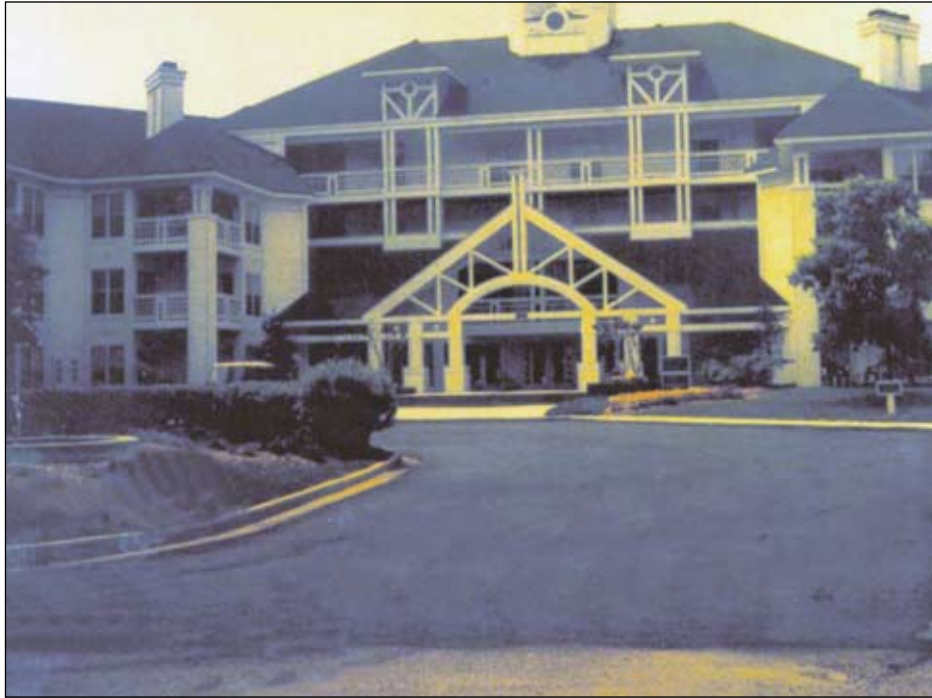
Photo 3. The main entrance to the building and the four story core building before the fire. North is to the right.

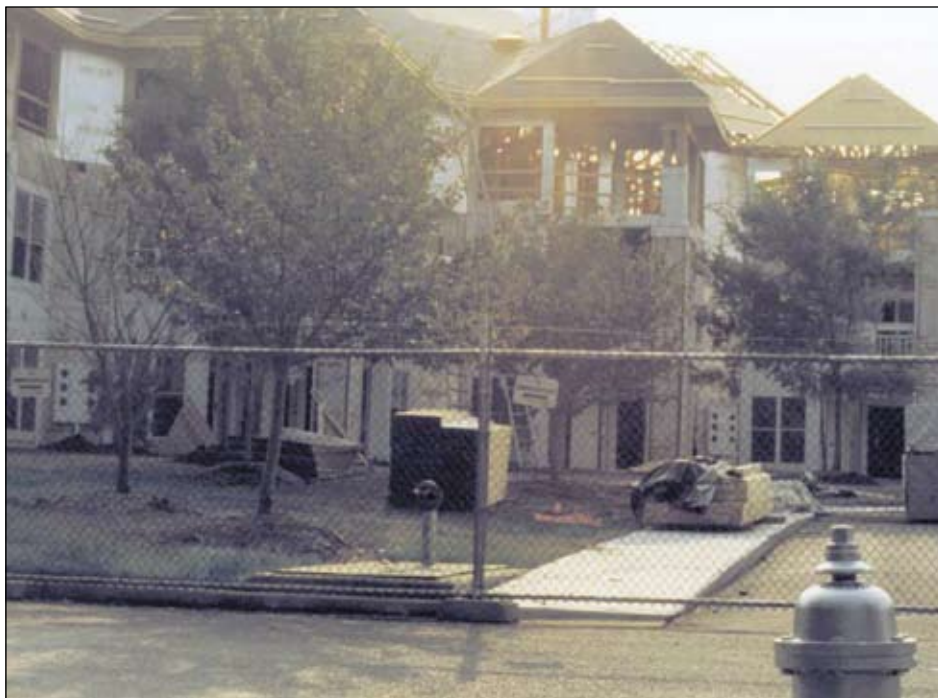
Photo 6. Fire hydrant and core siamese connection used by Engine 54 on arrival. Repairs and reconstruction are being made to the front wing; this side is the patio/balcony for each apartment.

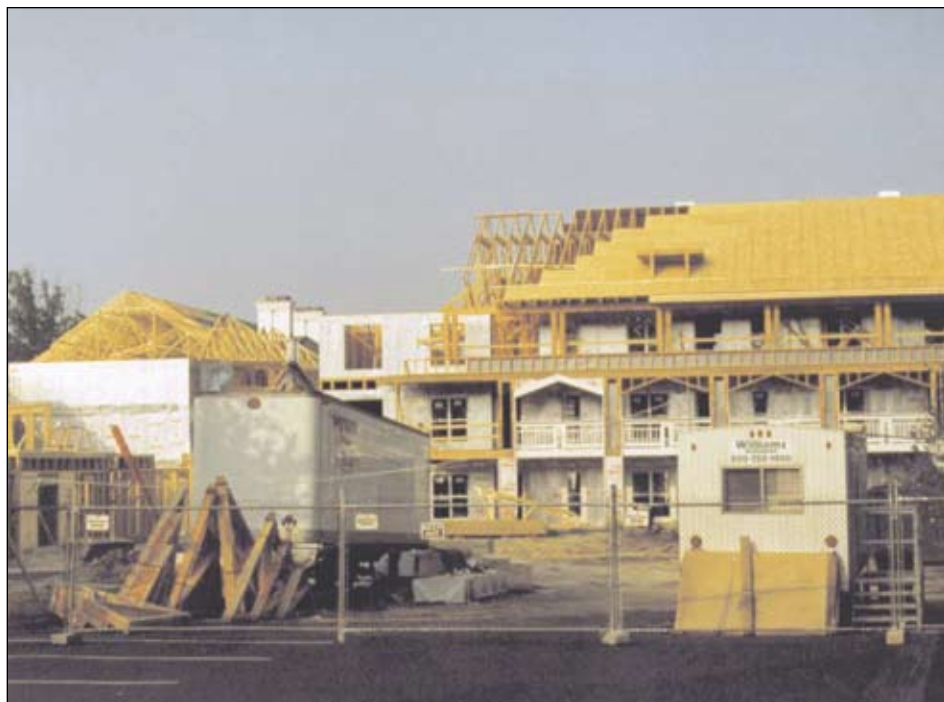
Photo 8. Reconstruction underway in Sector B, which is on the south side of the building. The exterior walkways were on the side of the wings.

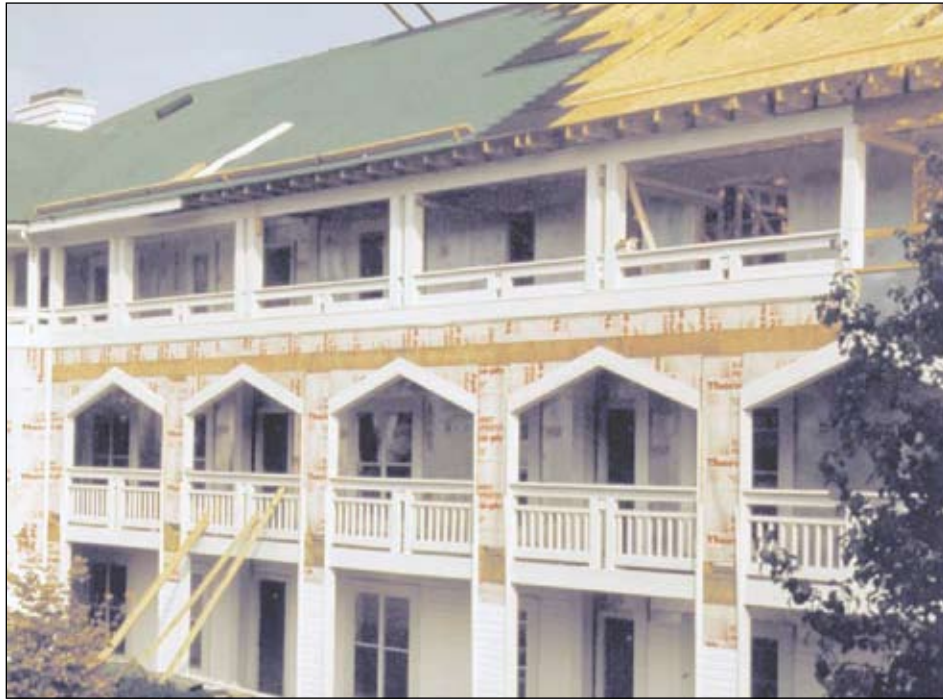
Photo 9. The exterior walkways in sector D, with the stairway located at the left edge of the photograph. The core is out of the picture to the right.
