U.S. Fire Administration/Technical Report Series

St. George Hotel Complex 16-Alarm Fire

Brooklyn, New York

USFA-TR-108/August 1995

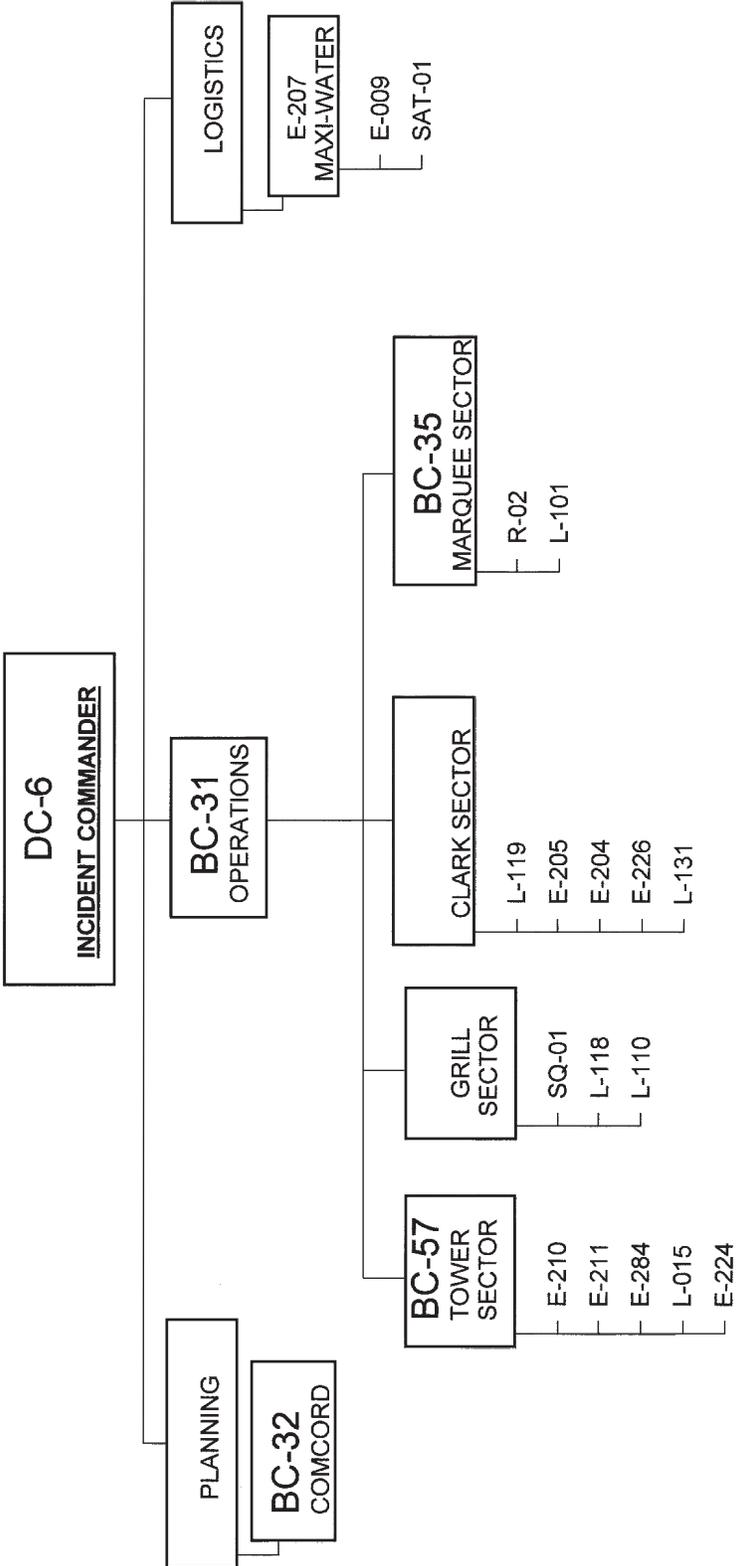
Figure 5. Incident Command Structure at About 4:20 a.m.

The Citywide Tour Commander FC-1 requested a fourth alarm at 4:11 a.m. while he was still enroute. From the Brooklyn Bridge he had an excellent vantage point to size up the volume of fire and the obvious exposure challenges. By this time the interior portions of the upper floors of the Clark Building were beginning to collapse, adding to the storm of fire brands. (Figures 5 and 6).

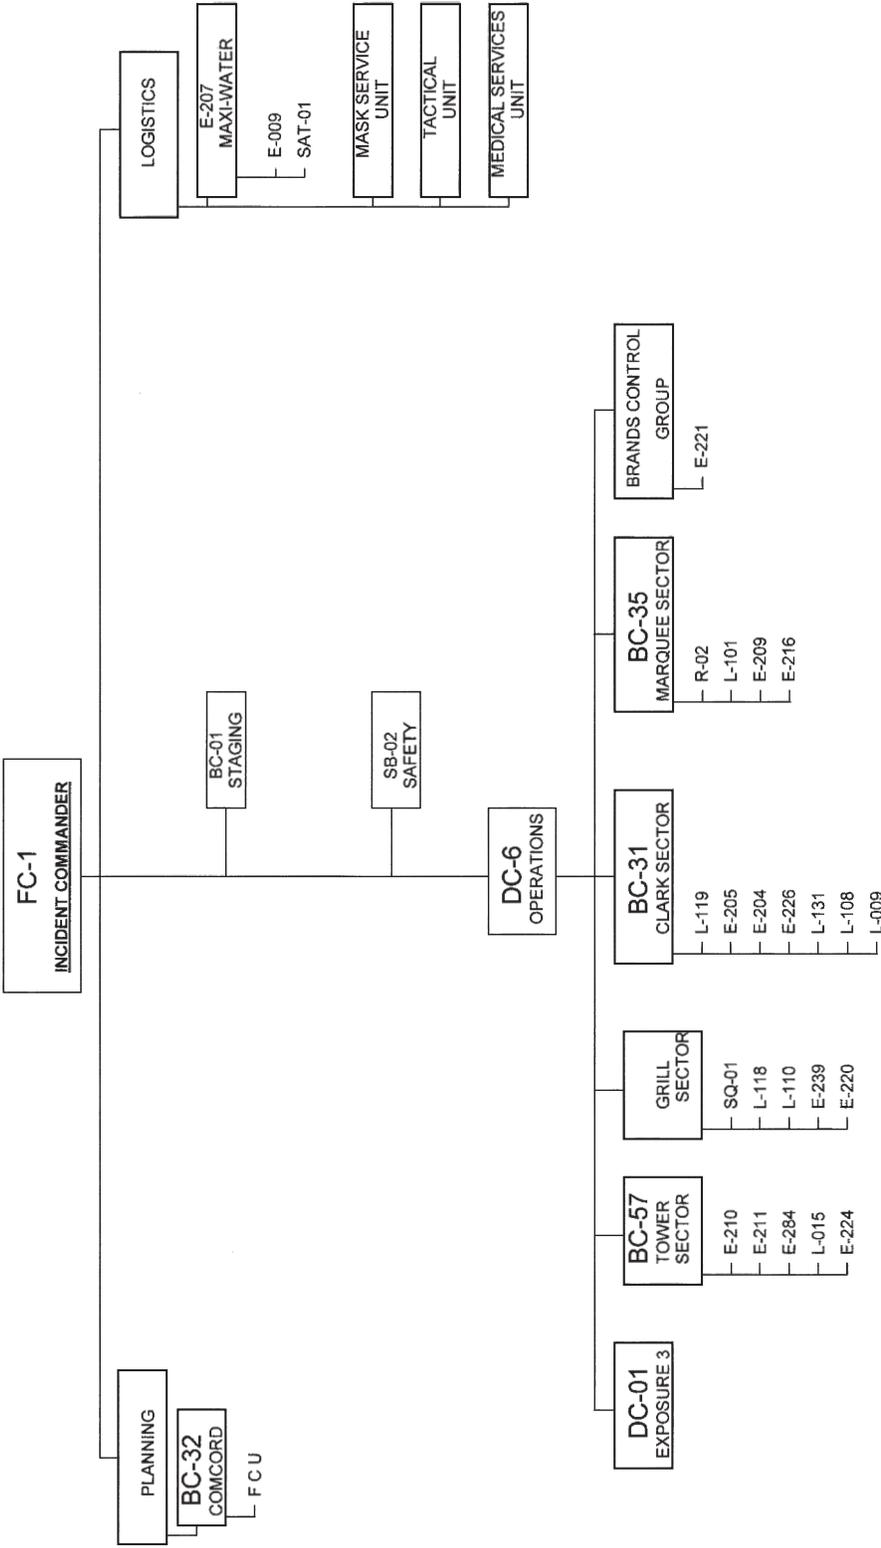
Figure 7. Incident Command Structure at About 4:35 a.m.

When FC-1 arrived on the scene at 4:18 a.m., he immediately called for a fifth alarm. The interior of the original fire building was well involved and the fire had spread to the upper floors of Exposure 4. A collapse zone was quickly established in front of the Clark and Marquee Buildings. The two tower ladders that had been set up in front of the buildings and the command post were repositioned out of the collapse zone. Battalion Chiefs were assigned to secure the collapse zone. (Figures 7 and 8).

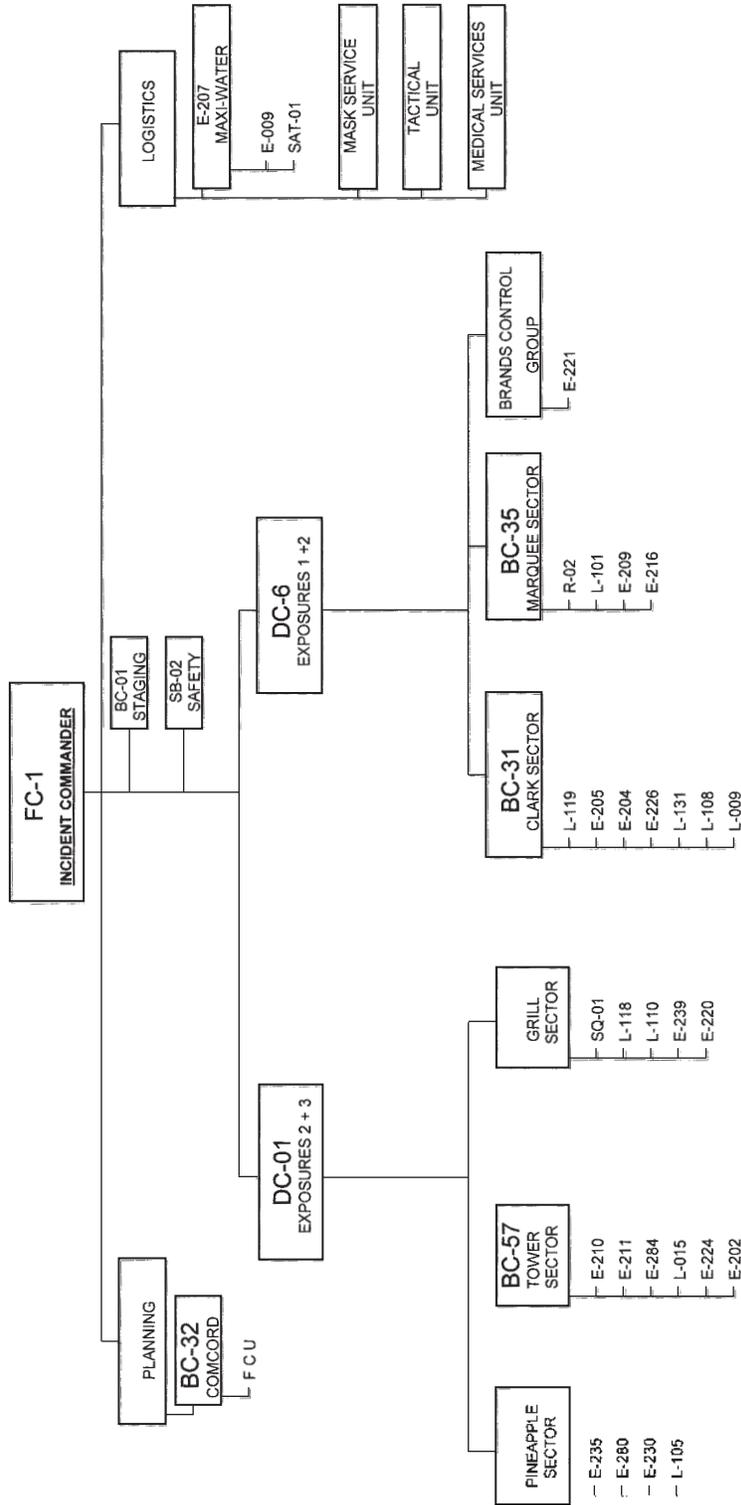
Figure 9. Incident Command Structure at About 4:45 a.m.

When the Incident Commander received this information he informed DC-1 of the building configuration and directed him to take charge of both Exposures 2 and 3 (Figure 9). The fireground was now divided into the Clark Street Branch, which included Exposures 1 and 2 and the fire building, and the Pineapple Street Branch, which included Exposures 2 and 3. Two Deputy Chiefs were assigned to direct operations in the two branches, DC-6 on the Clark side and DC-1 on the Pineapple side. The Incident Commander directed DC-1 to initiate a separate incident and to communicate directly with Brooklyn Communications to request resources.

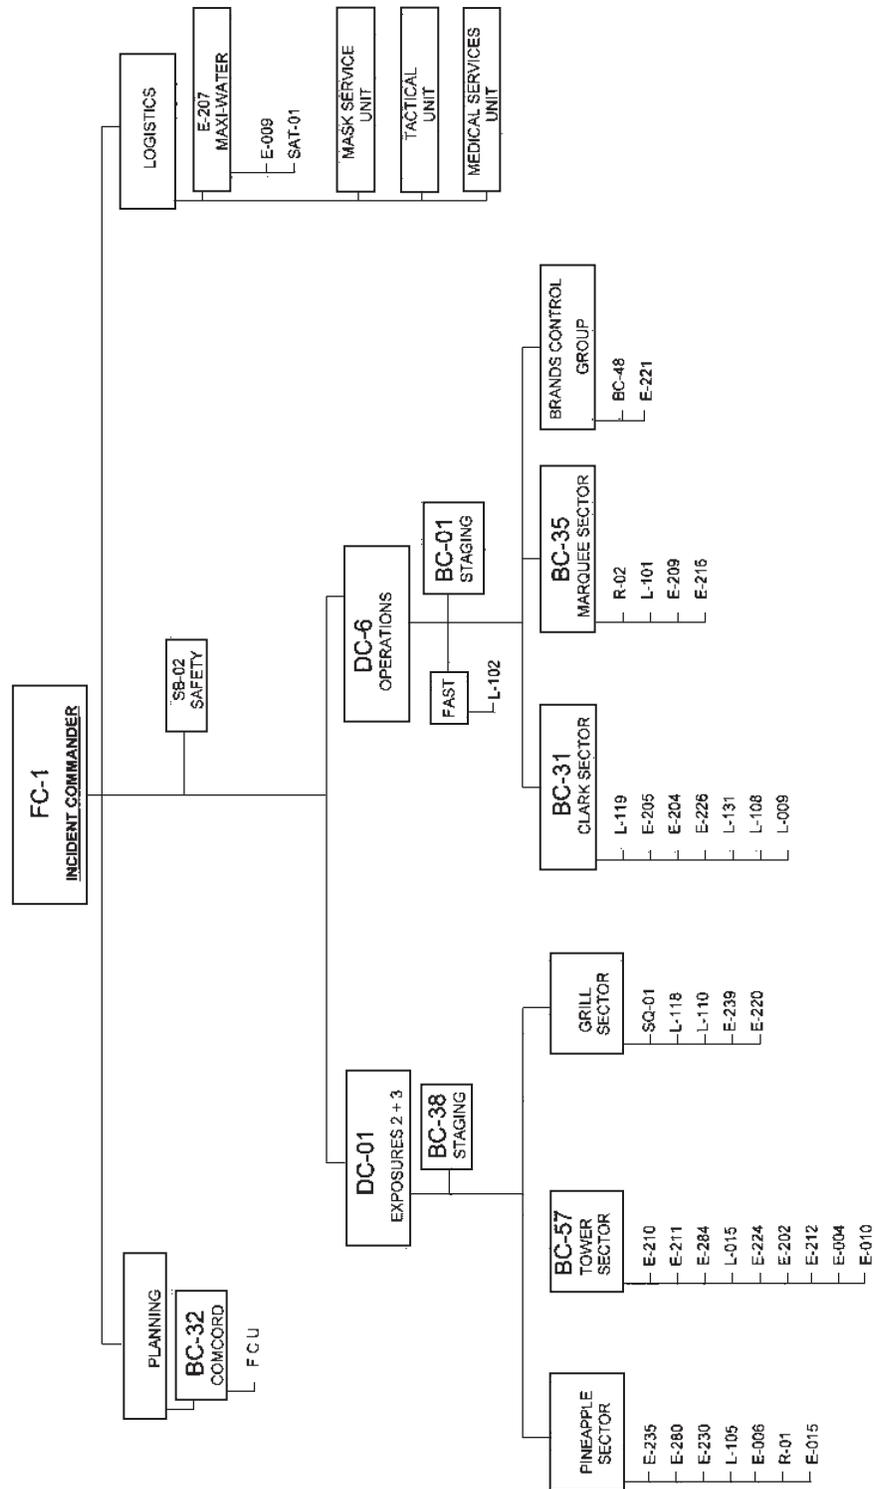
Figure 10. Incident Command Structure at About 4:55 a.m.

A secondary Command Post was established at the corner of Hicks and Pineapple and a second alarm assignment was requested by DC-1 to report to the Pineapple Sector, which included the Pineapple and Crosshall Buildings. The equivalent of a third alarm was requested to assist the companies that were already operating in the Tower Building (Figure 10).

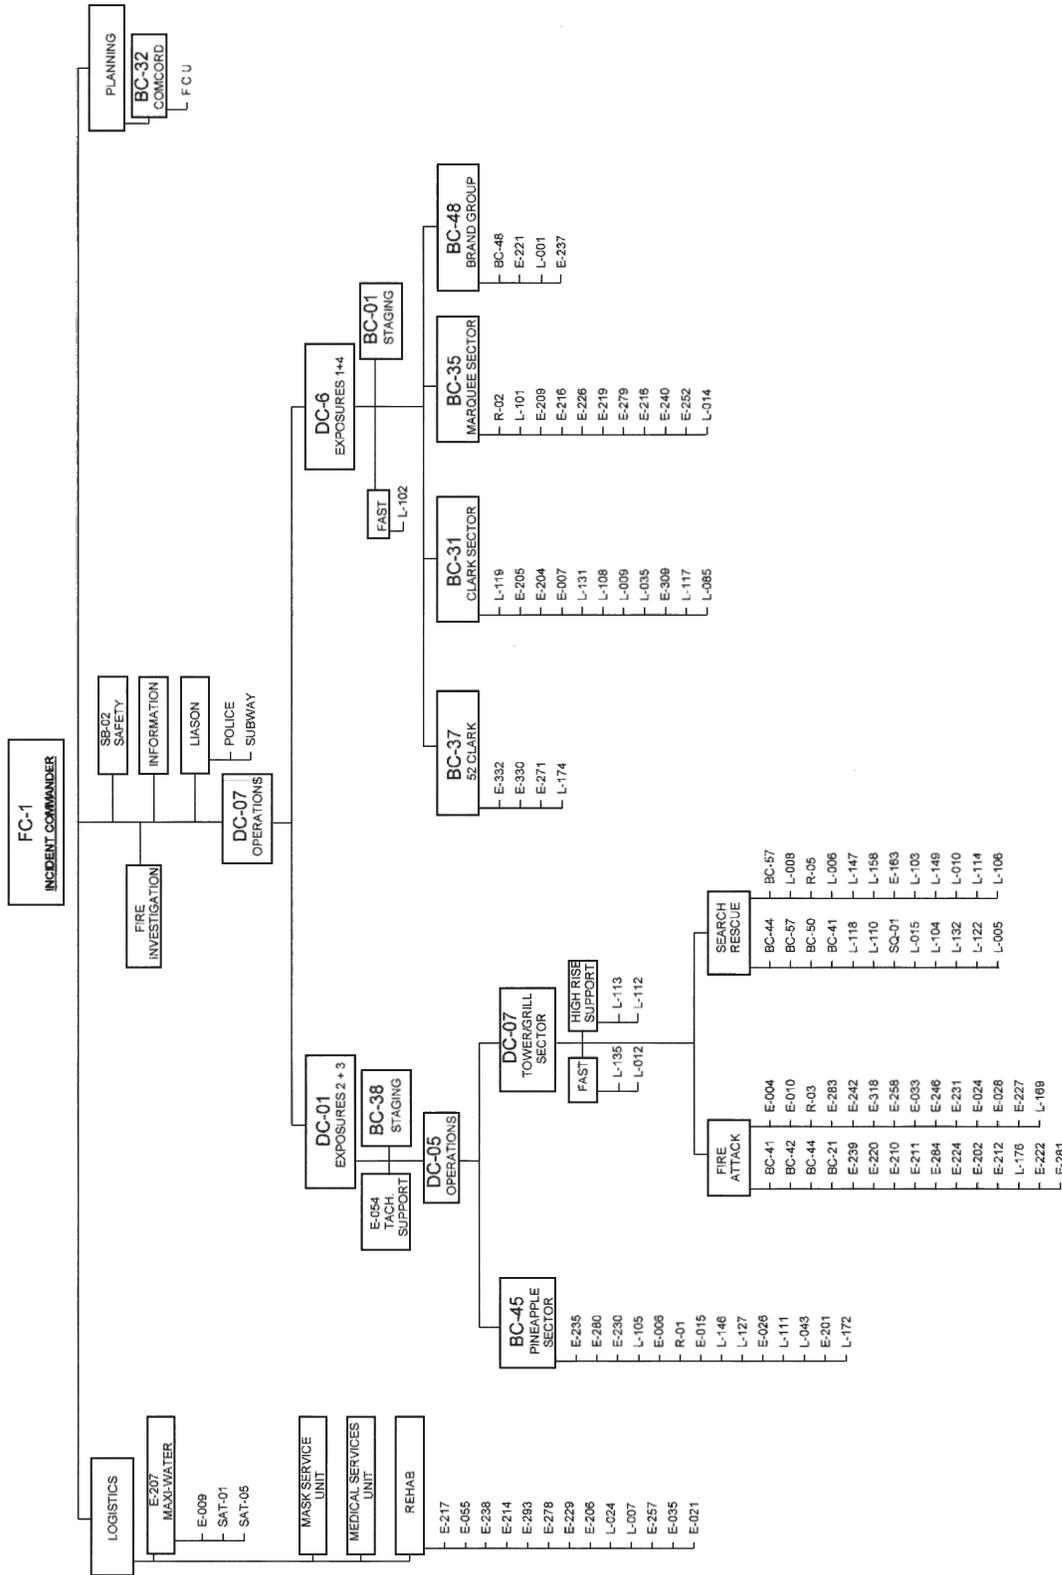
**Figure 11. Incident Command Structure for the History of the Fire.
Fire Under Control at 7:09 a.m.**

Additional alarms for the Clark Street side were transmitted as follows: the sixth at 5:06 a.m., the seventh at 5:09 a.m., the eighth at 5:28 a.m., the ninth at 6:15 a.m., the tenth at 7:17 a.m. and the eleventh at 7:20 a.m. The fire was declared under control at 7:09 a.m. (Figure 11).
