U.S. Fire Administration / National Fire Academy

*Coffee Break Training***Topic: Access to Fire Protection Equipment**

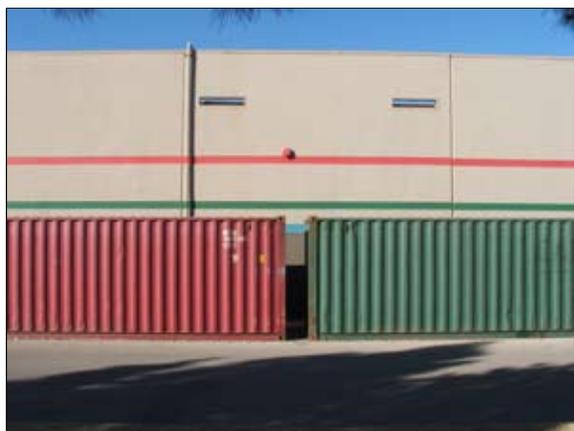
Can you find the automatic sprinkler system fire department connection in this photograph?

It's behind the shipping container in the right hand side of the picture. The two storage containers are about 2 feet (610 mm) from the exterior wall of the building, making it impossible for firefighters to reach the fire department connection.

Containers should be moved to expose the fire department connections.

Quick and convenient access to fire protection systems and equipment often is needed to minimize losses. The model fire codes all require that fire hydrants, fire department connections and fire system control valves (sprinklers, standpipes, tanks, pumps, etc.) are immediately "visible and accessible."

If interfering conditions exist, the property manager or owner should be notified right away to have the obstructions moved. A record of the correction notice should be maintained in the occupancy's inspection file.
