Fire, Police, and EMS Coordination at Apartment Building Explosion

Harlem, New York City

USFA-TR-068/November 1992

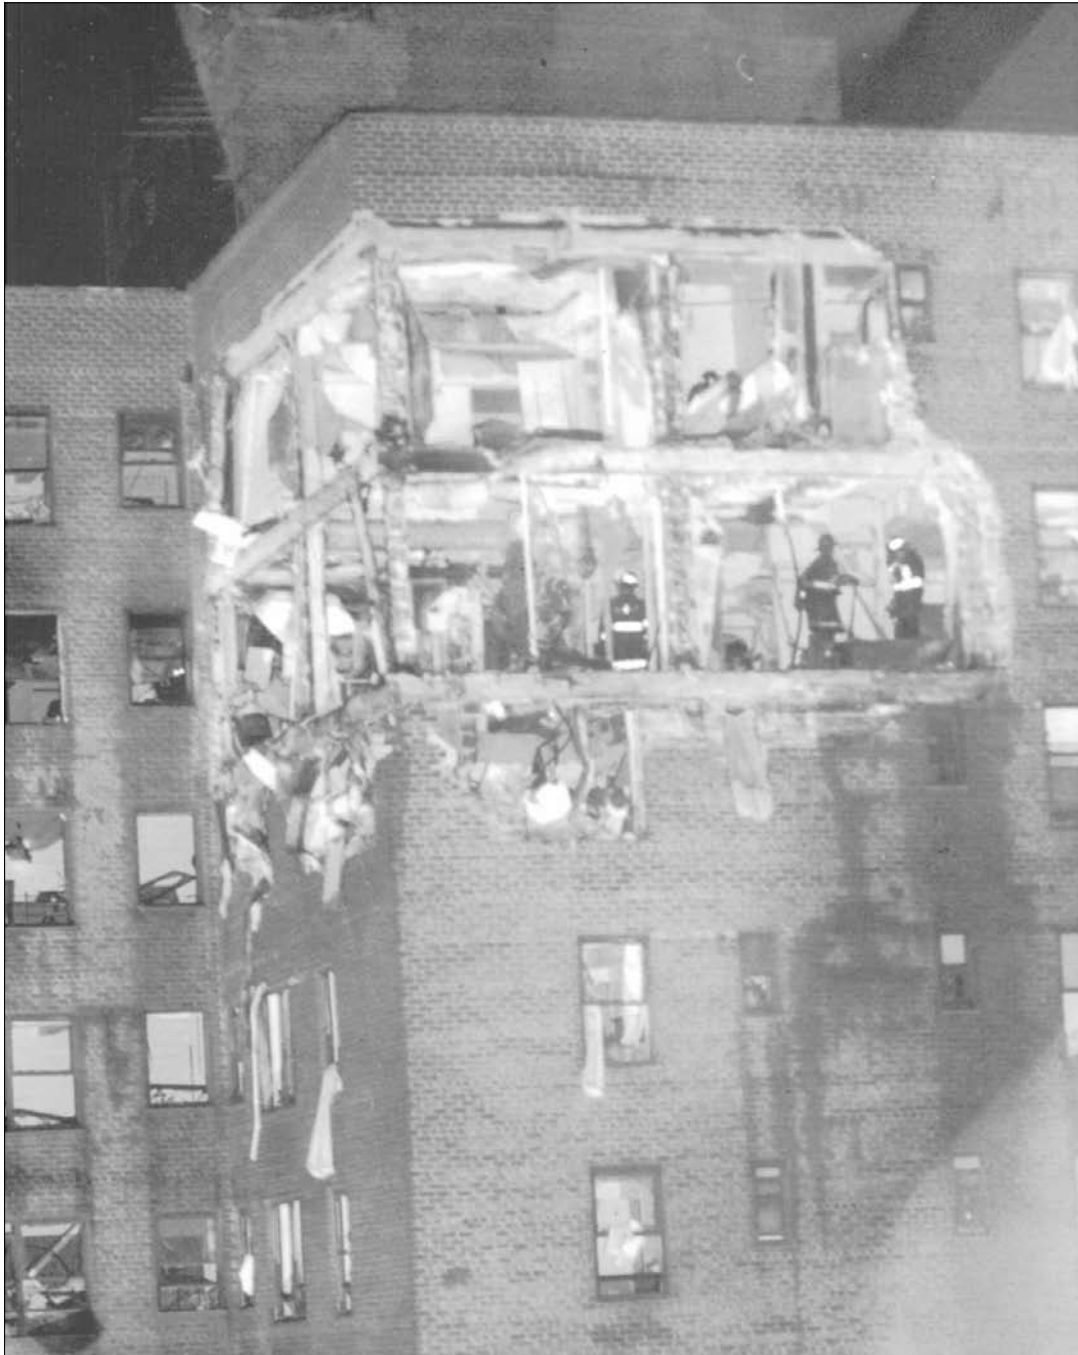
Photograph

Exterior view of explosion damage on upper floors of 12-story apartment building at 45 East 135th Street, New York City

The force of the explosion blew out the exterior brick walls on the ninth through the twelfth floors on the south and west sides of the building, and shattered windows in surrounding buildings in the neighborhood. In the area of the explosion, sections of floors crumbled, leaving the steel skeleton of the structure exposed. Building debris, bricks, broken glass, and apartment contents were blown out and down to the streets below. Flames were visible on the eleventh and twelfth floors. The noise and vibration of the explosion was felt by some fire department units that were 12 blocks away.
